Inspection Photos 12/6/2017

Caerus API 045-14855

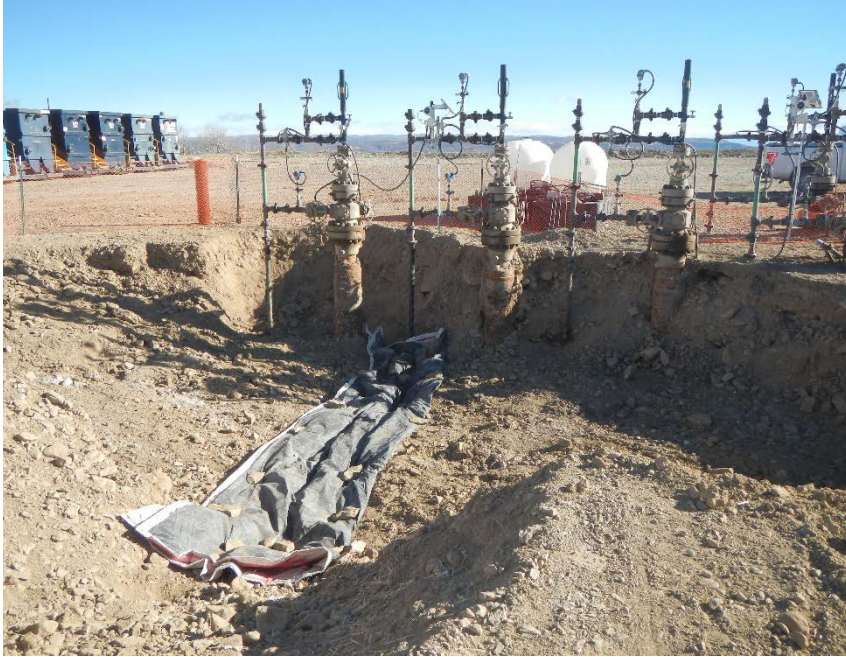
Flowline spill area looking east

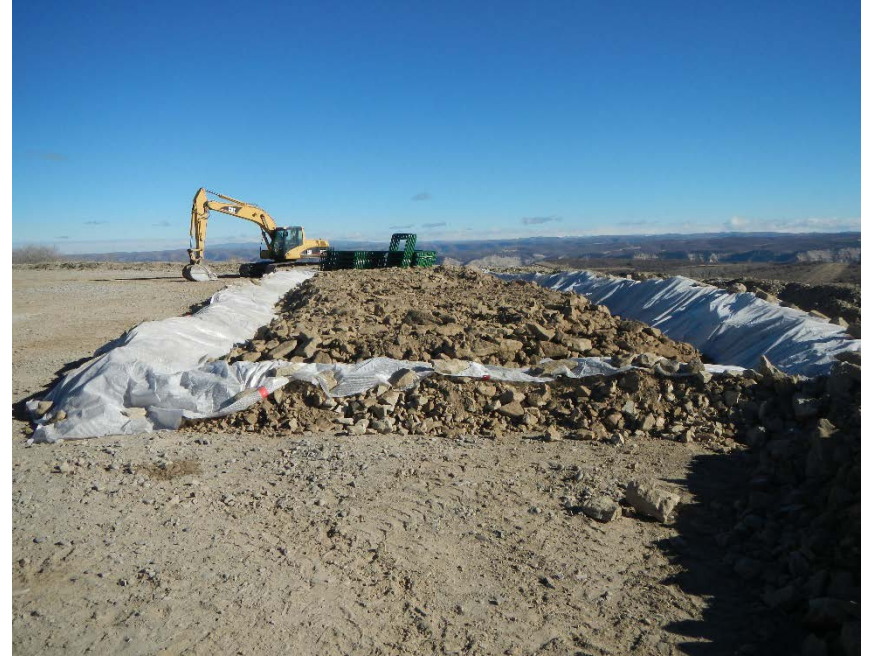
Landfarm looking east
