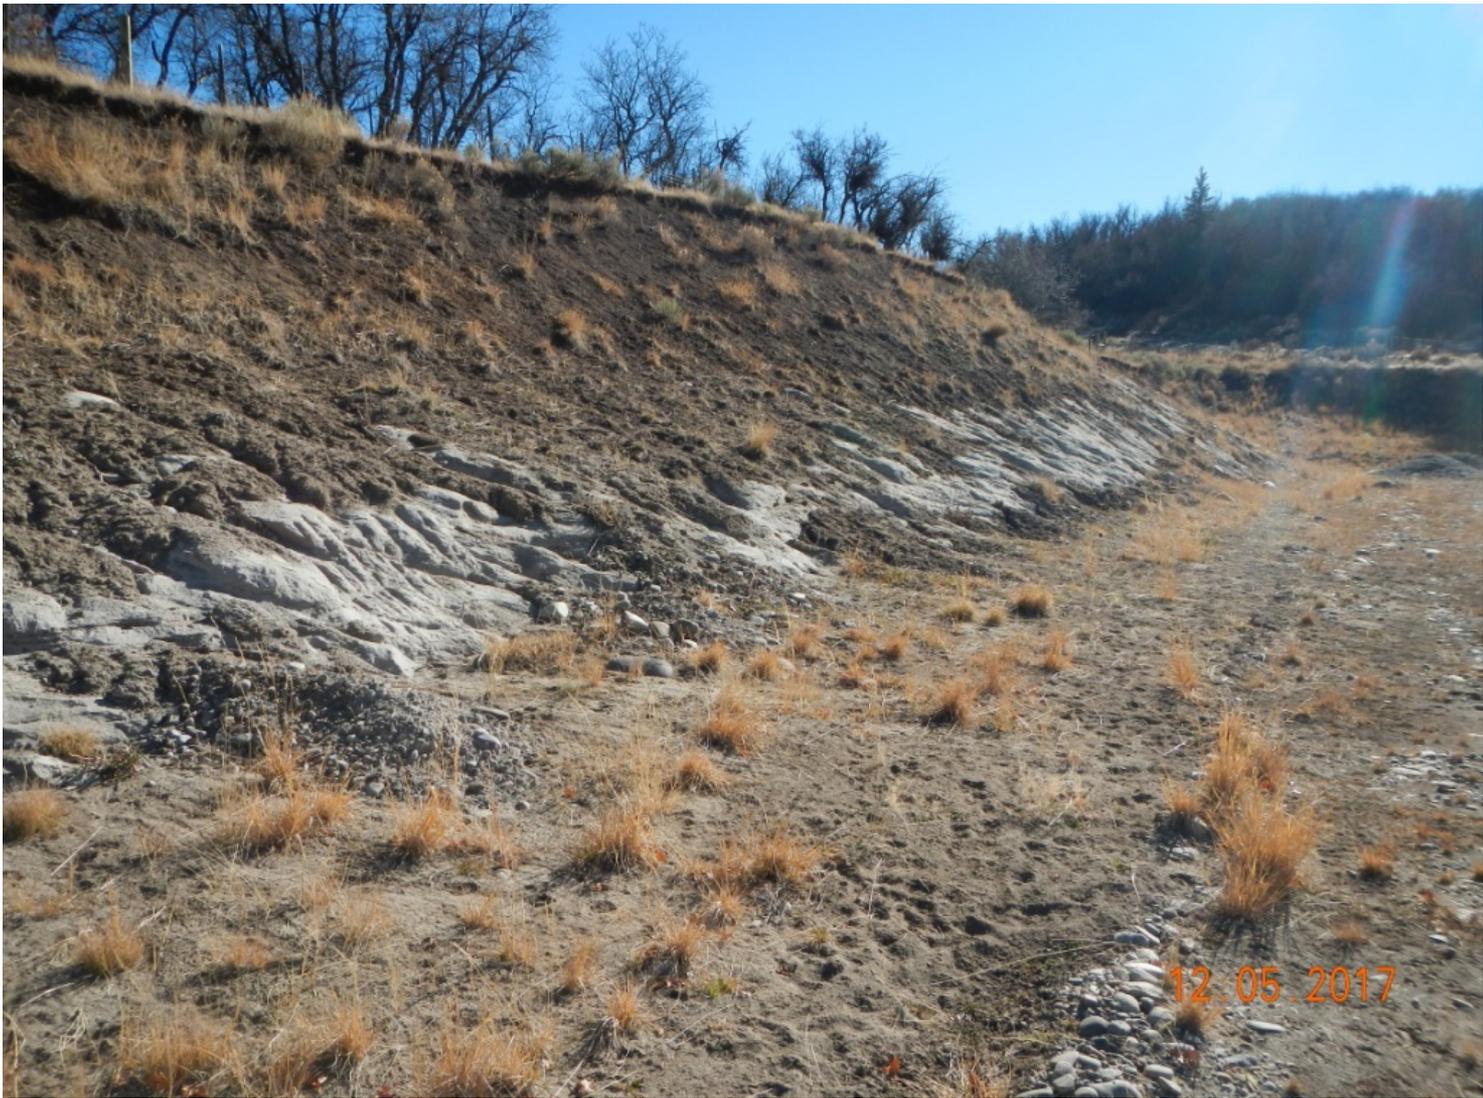
Photo 1. View of erosion occurring in the eastern portion of the project area. No stormwater controls have been installed.

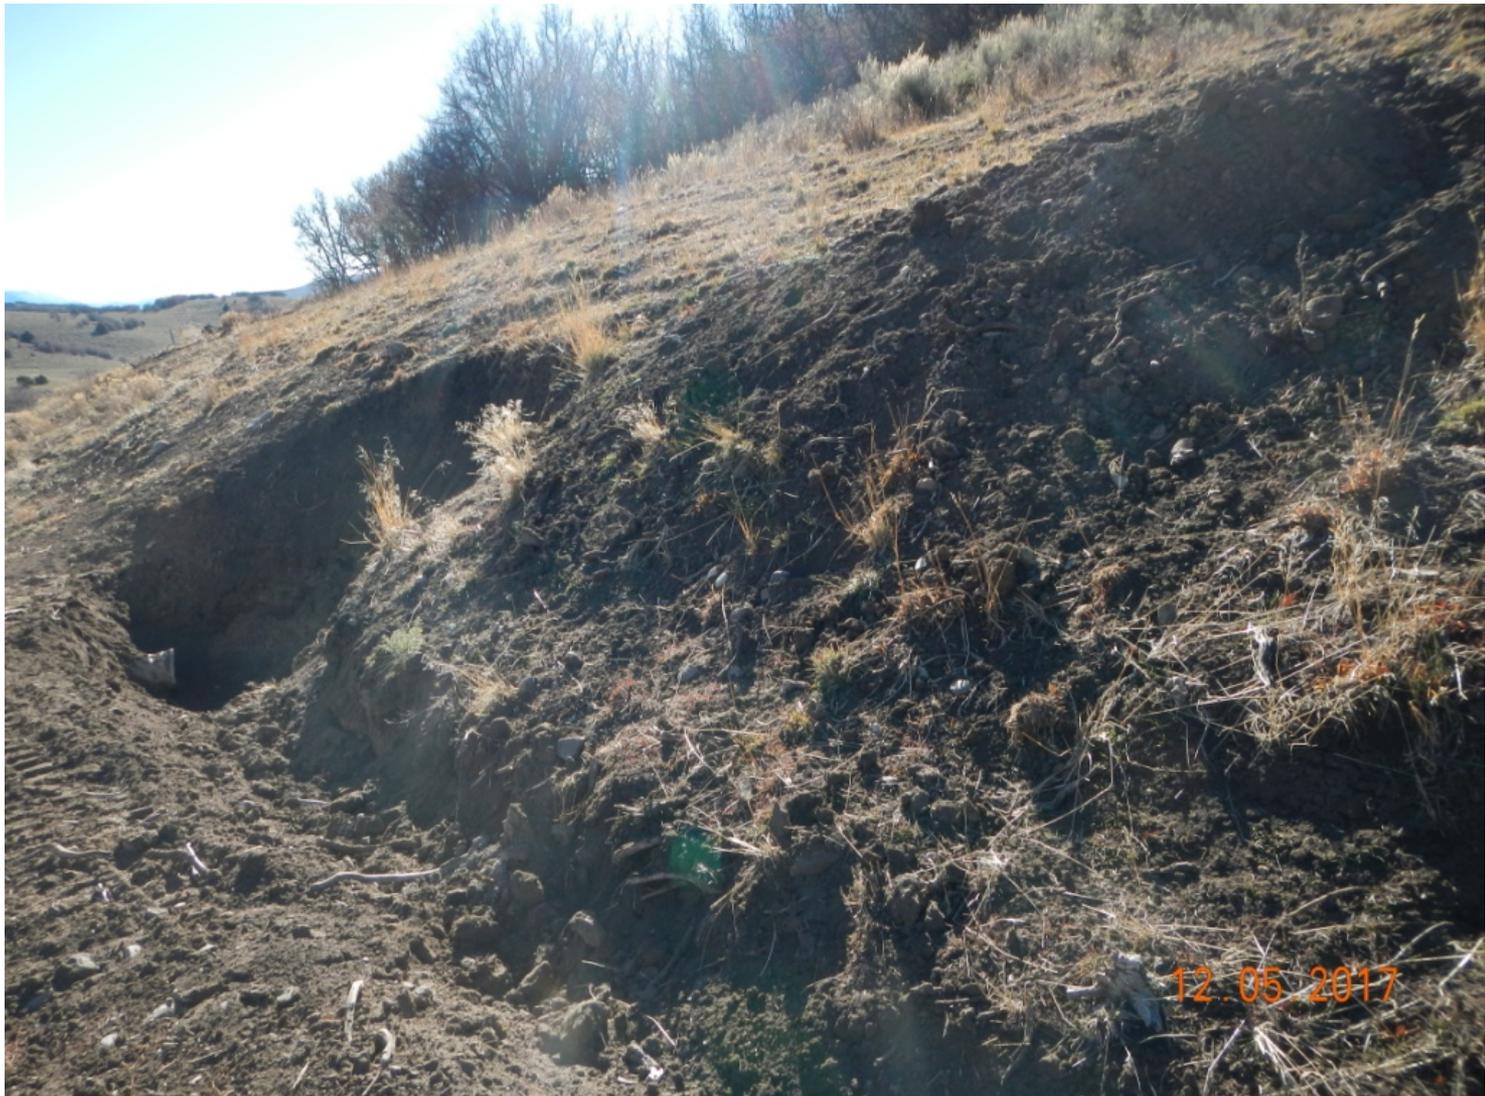
Photo 2. View of culvert inlet at that was recently cleaned, and sediment placed adjacent and up-slope from the access road. This disturbed soil will erode back to the roadside drainage and expands the disturbance, and needs to be properly managed.

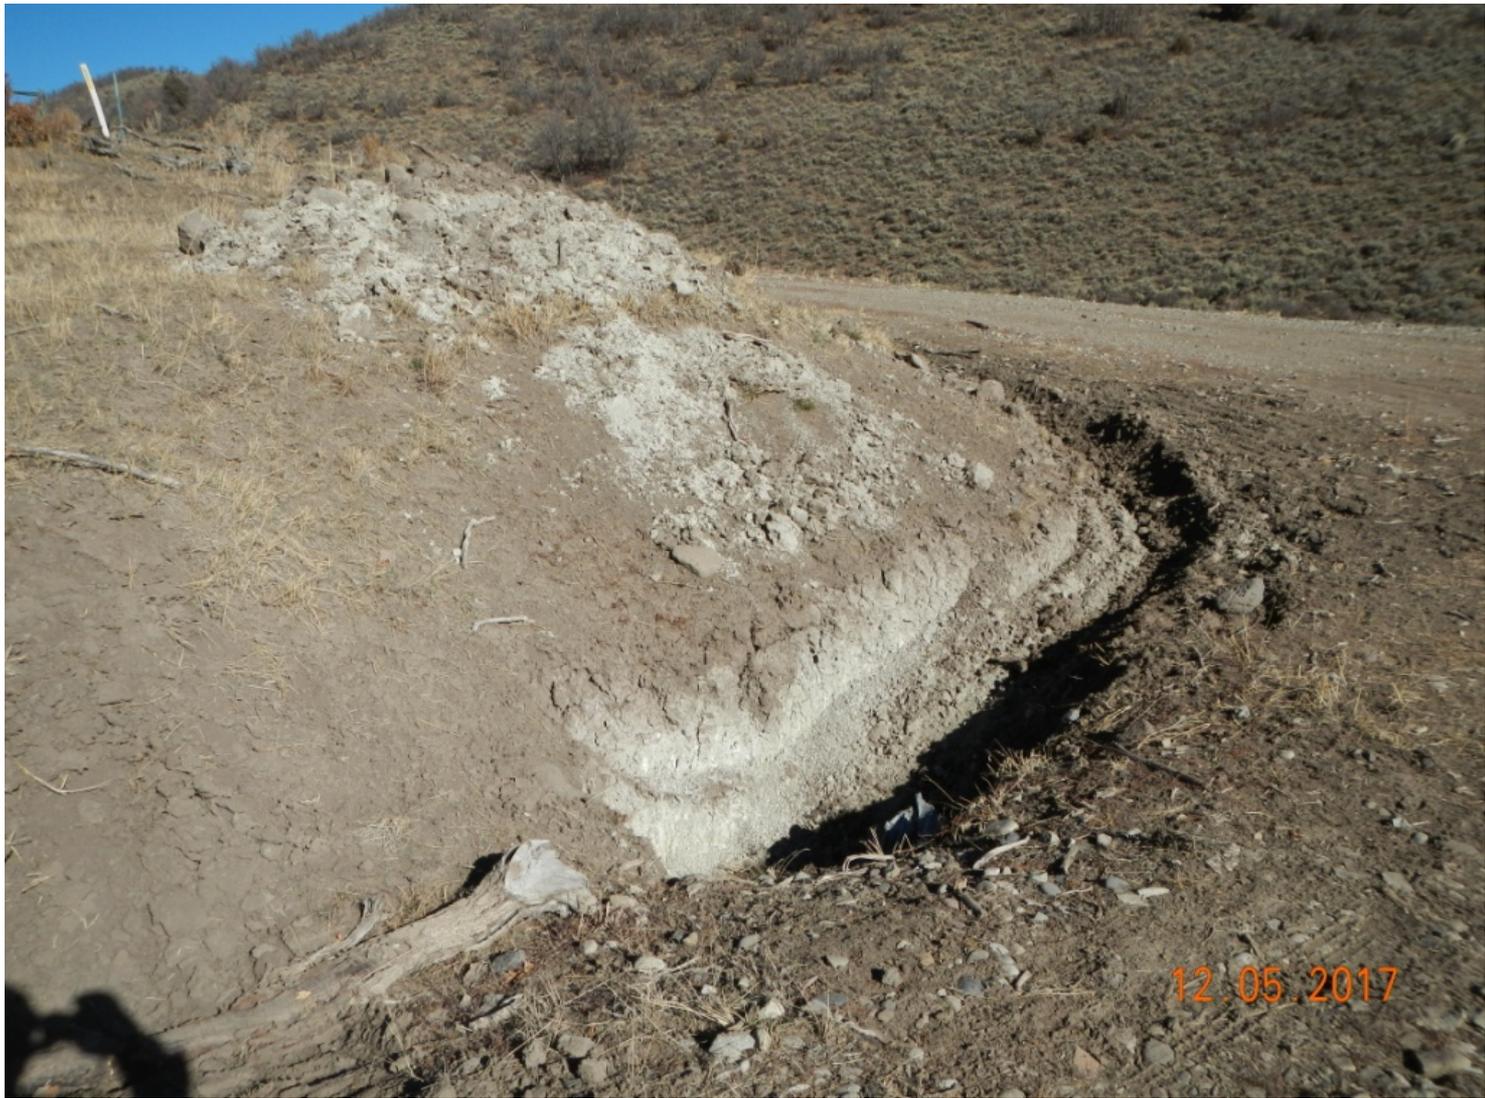
Photo 3. View of area along the access road where sediment and soil has been scraped and placed up-slope of the roadside drainage. Exposed sediment will rapidly erode, and this practice expands project disturbance by smothering vegetation.
