Inspection Photos
Location Name: Falcon Seaboard 11-90-2
API: 05-051-06139
Inspection Number:685100414

Inspection Photos
Location Name: Falcon Seaboard 11-90-2
API: 05-051-06139
Inspection Number: 685200414

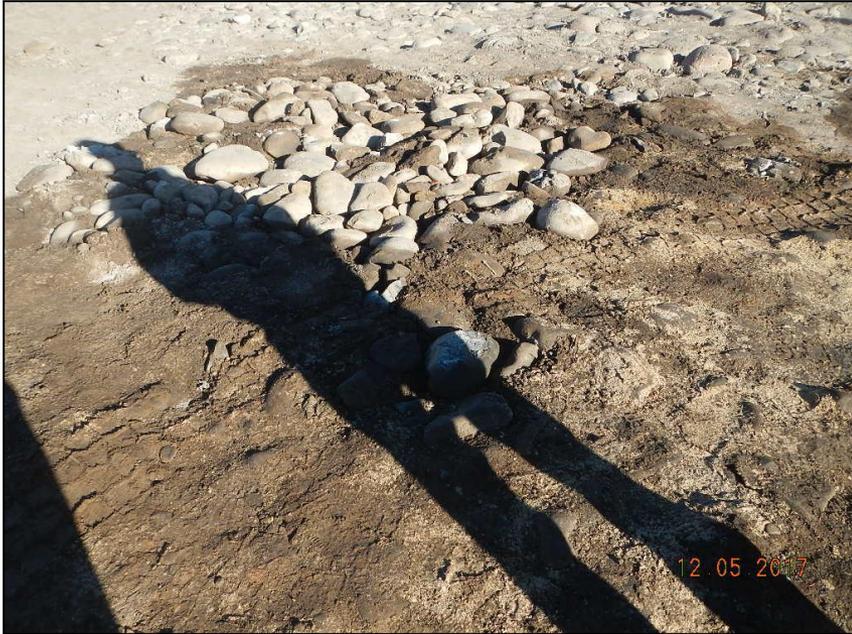
Release south of well, minimal sawdust used as response

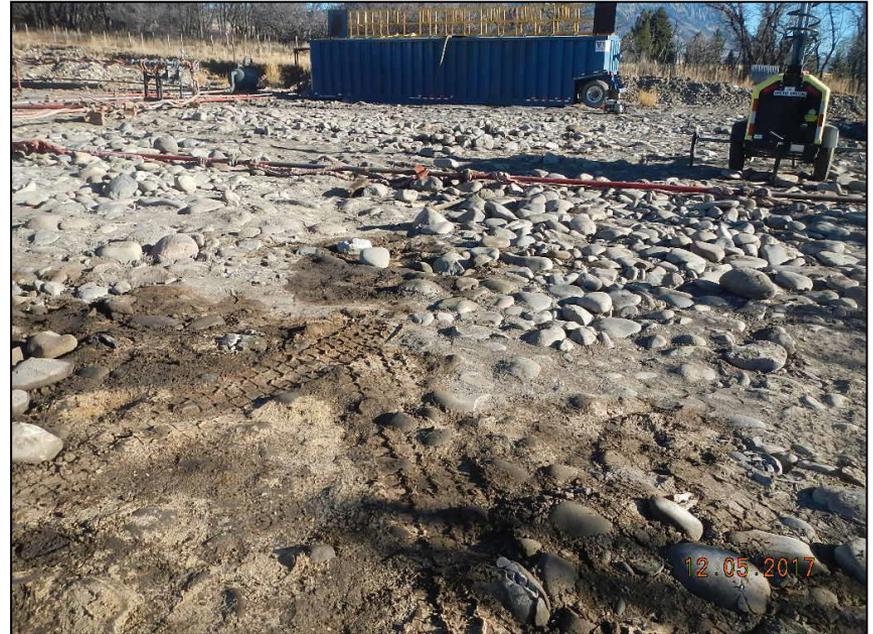
Impacted area in relation to equipment and frac lines

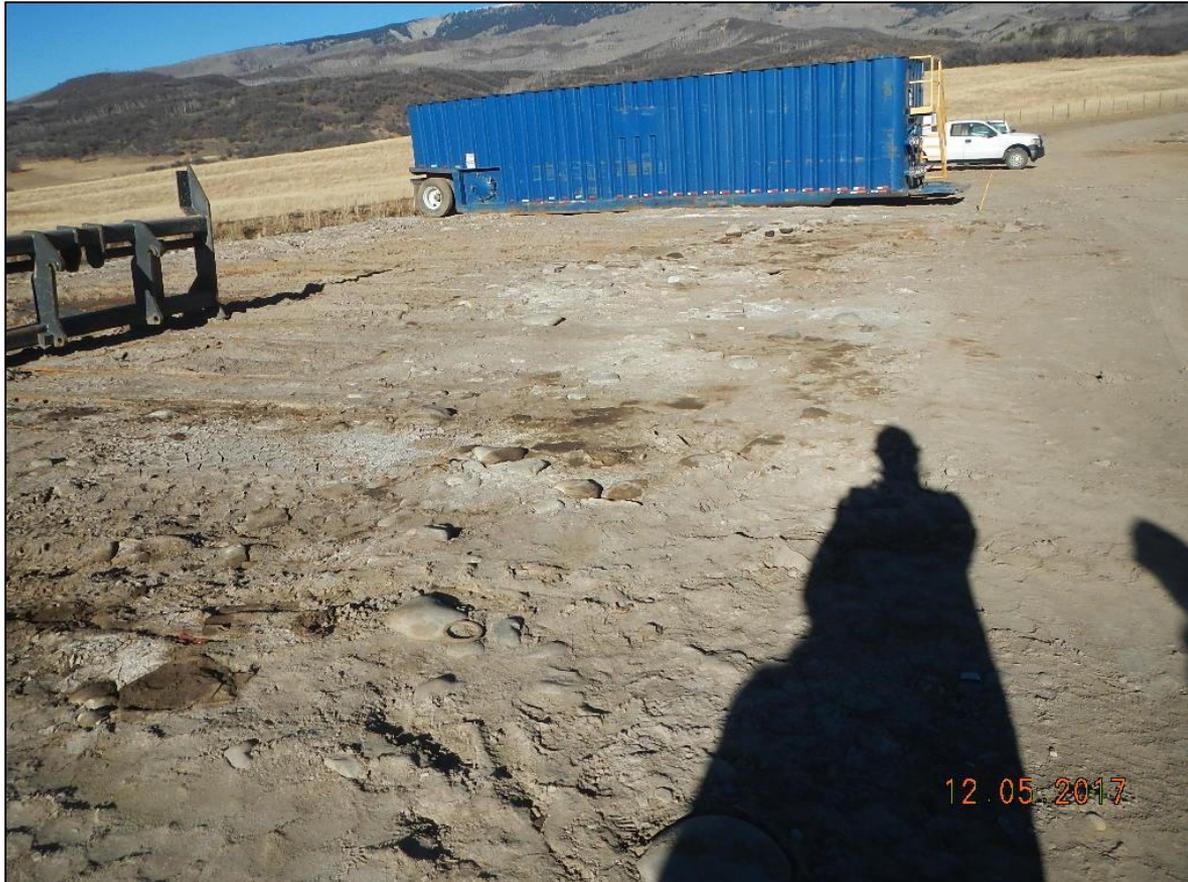
Oily and stained material where frac tanks were placed

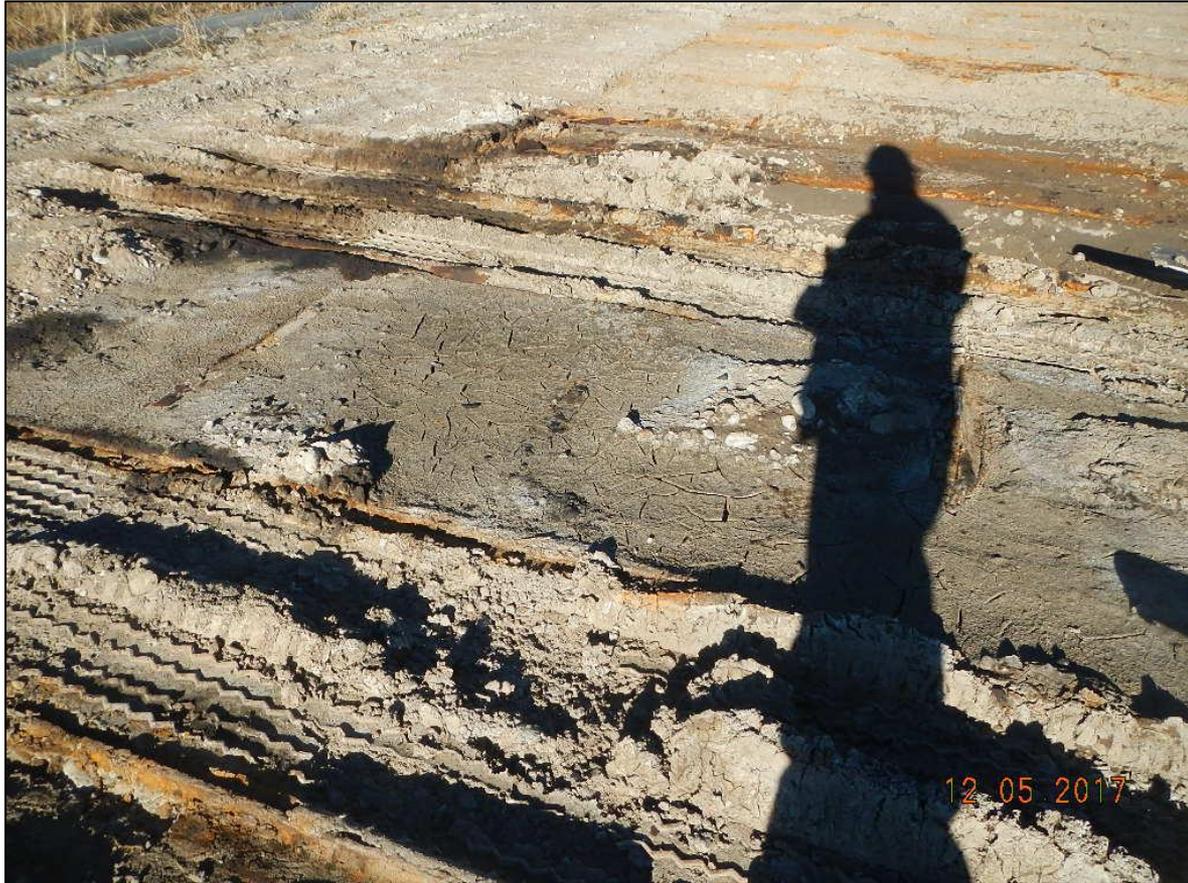
Impacted material where frac tanks were located

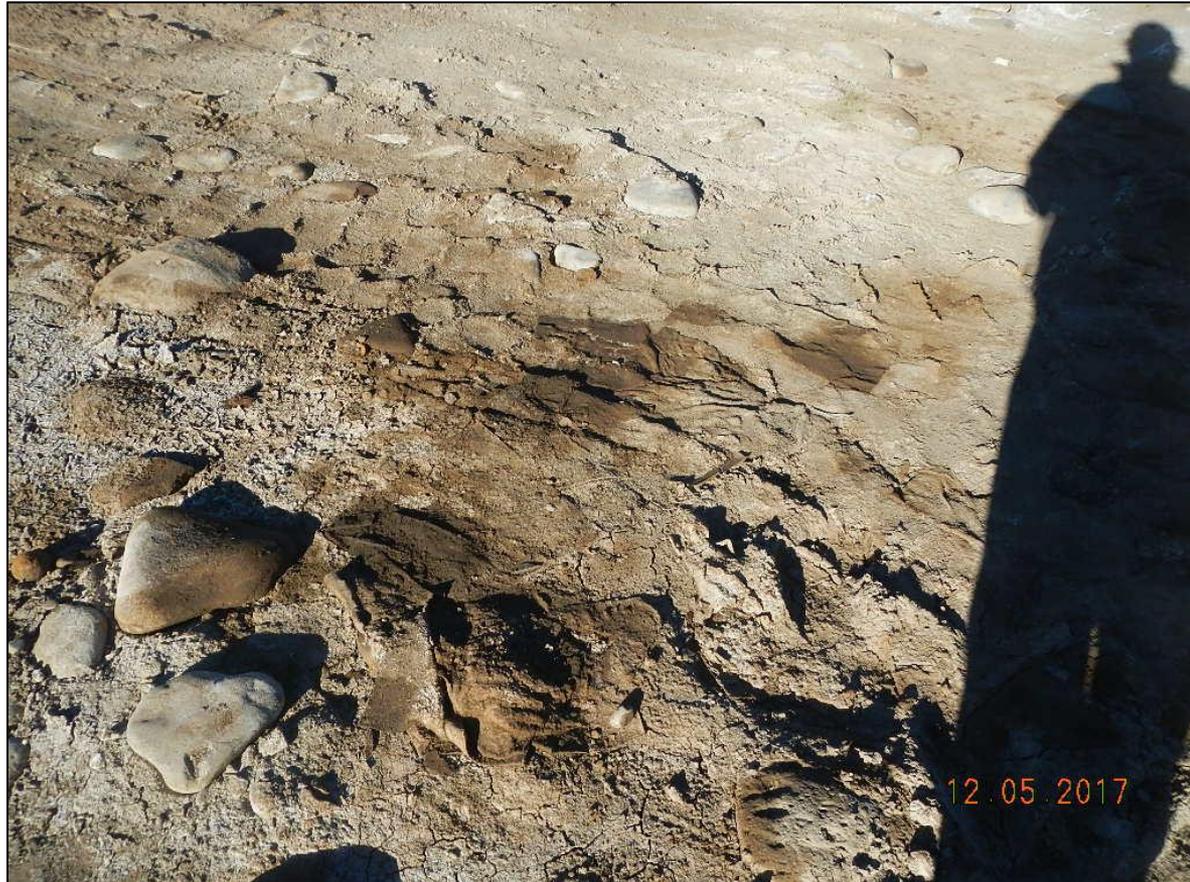
Oily rags and stained soils
