COLORADO
Oil & Gas Conservation
Commission
Department of Natural Resources

Inspection Photos: Laramie Cascade Creek Loc#324314

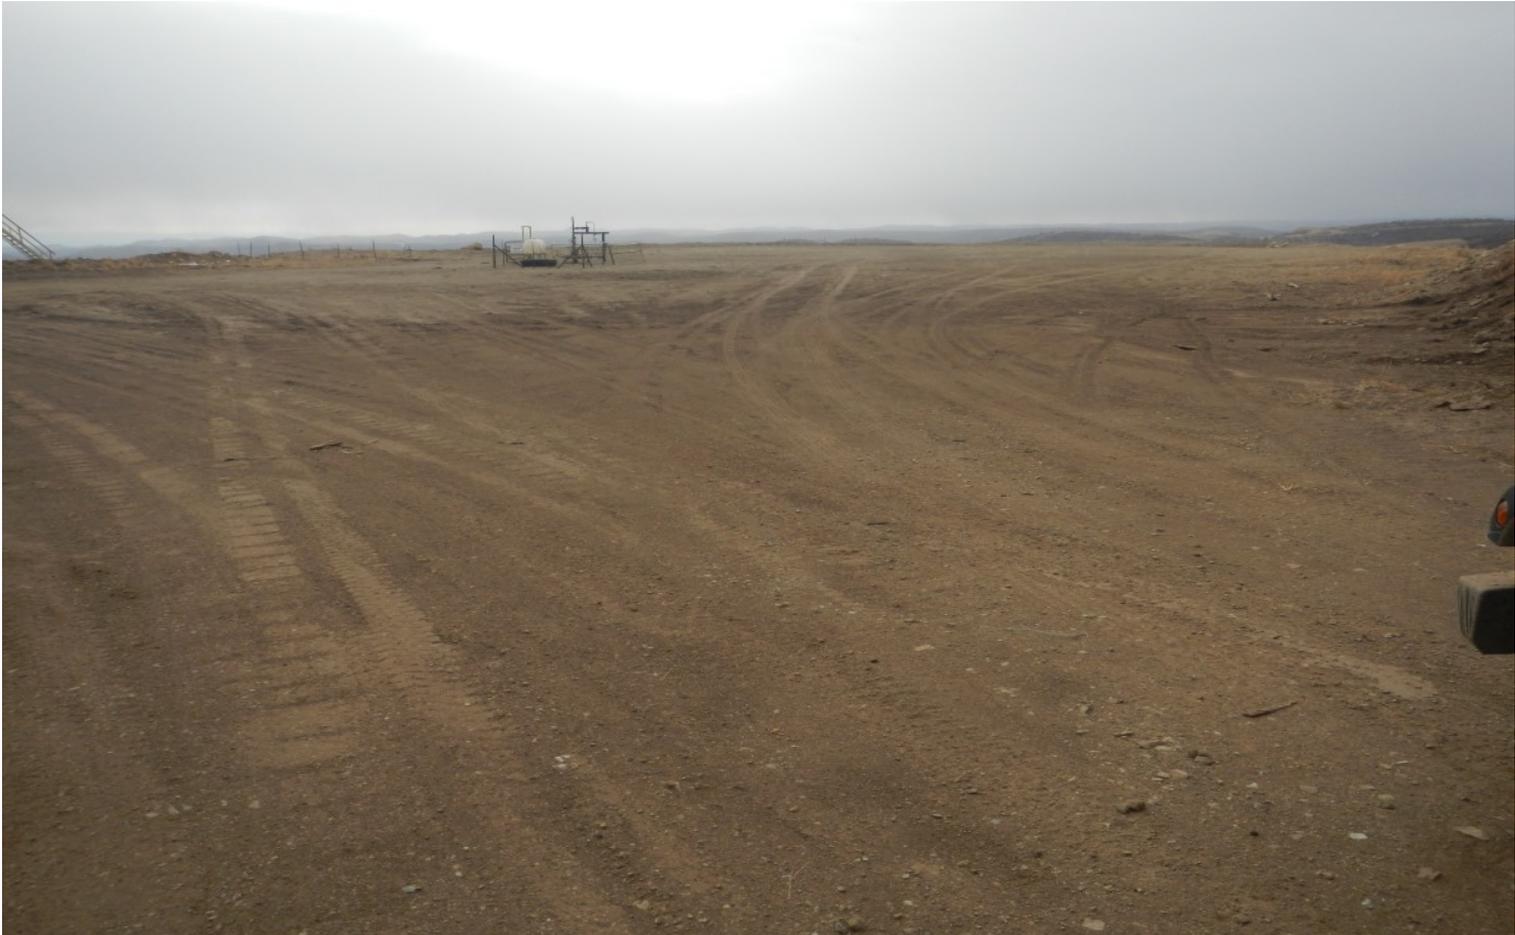
Photo#1:
Overview of Location from Entry to Southwest.

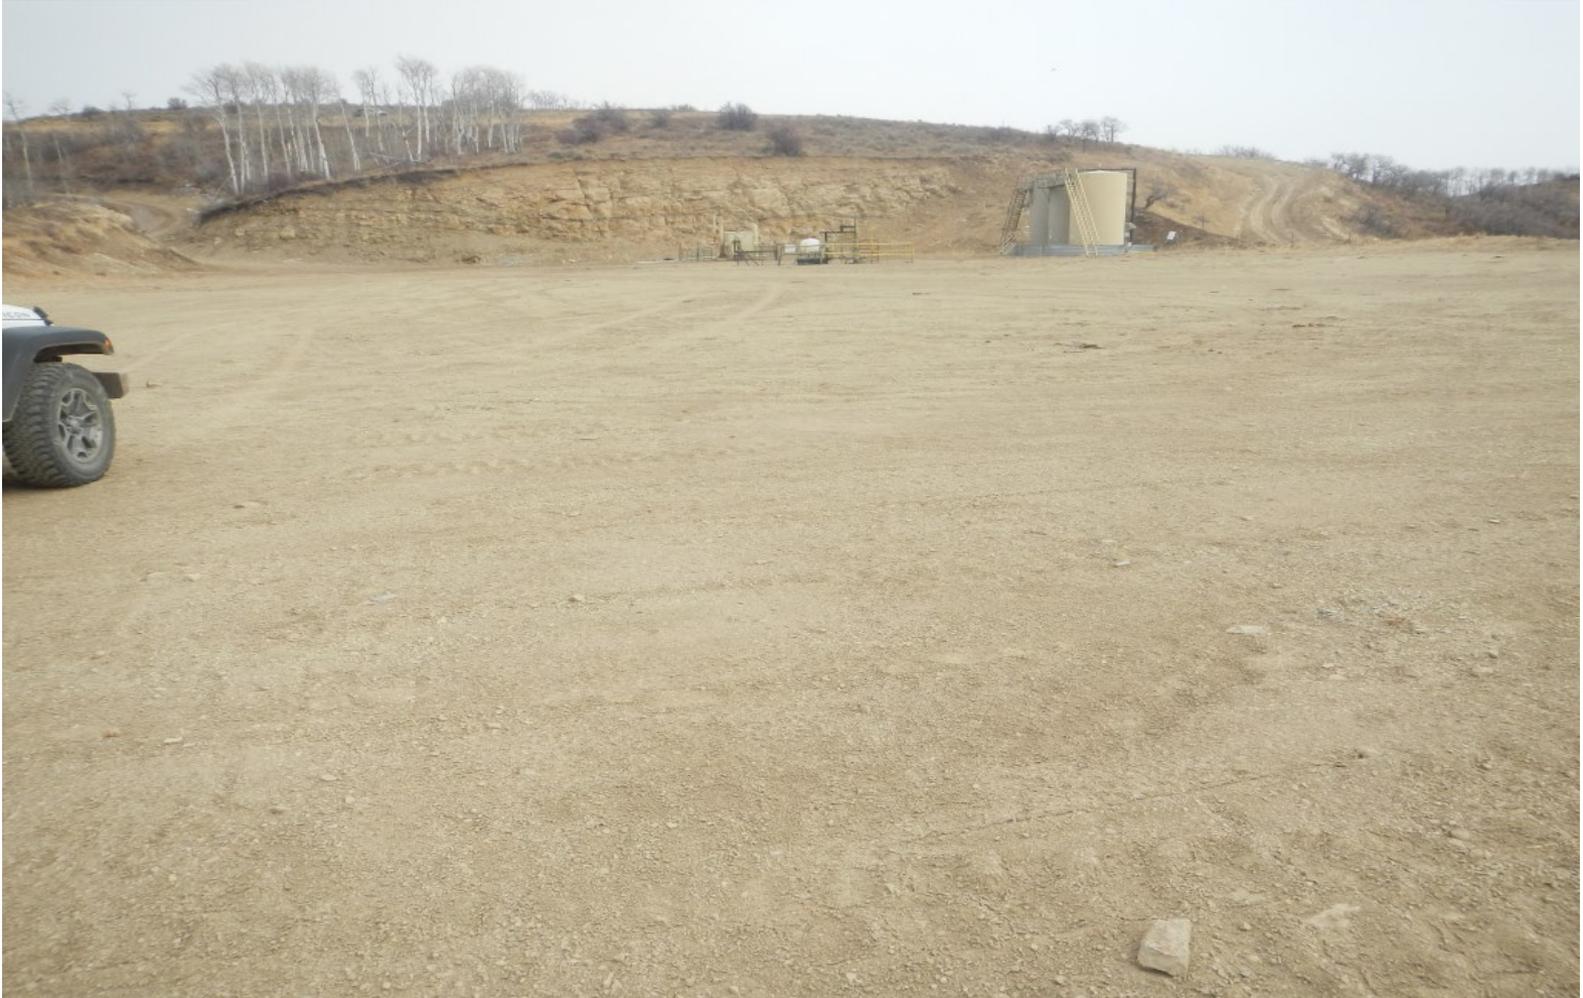
Photo#2:
Overview of Location from West end of Pad to East.

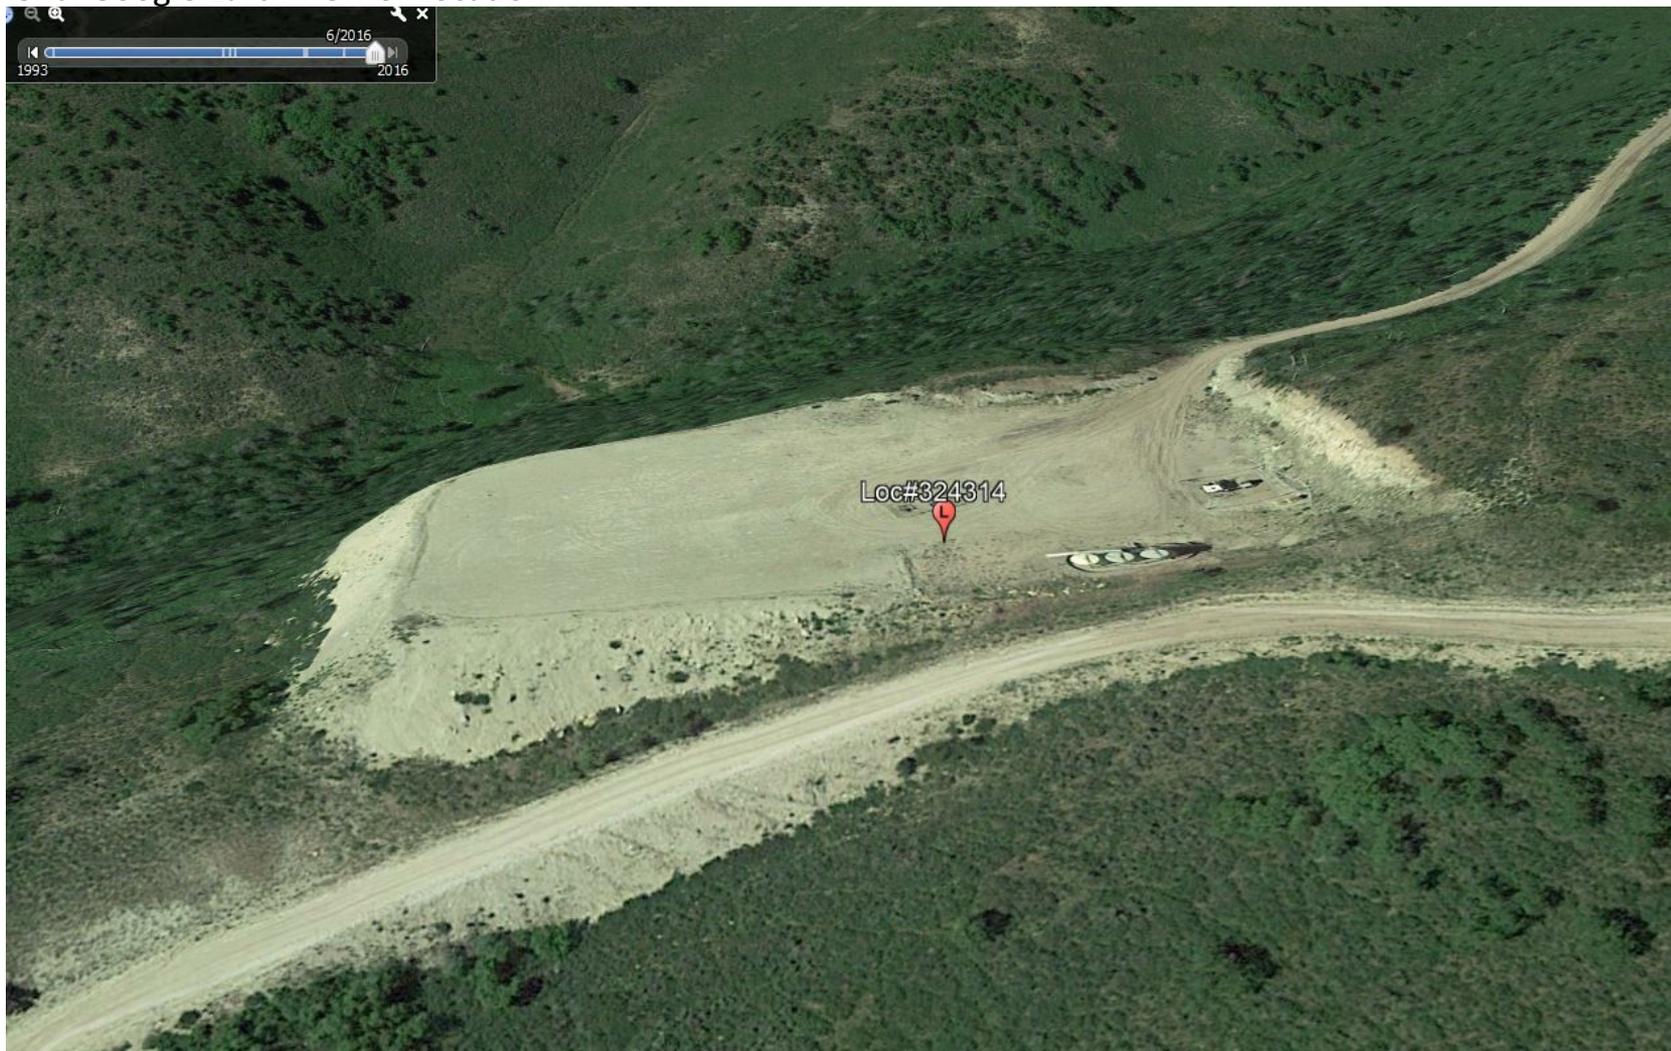
Photo#3:

Aerial Google Earth view of Location.

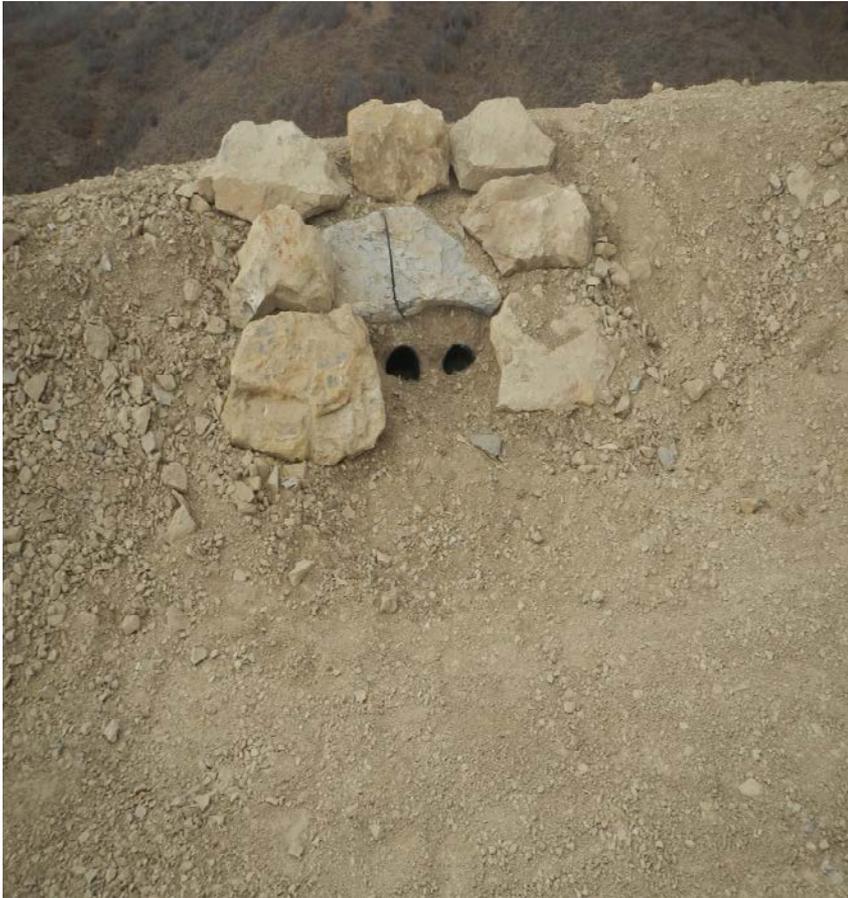
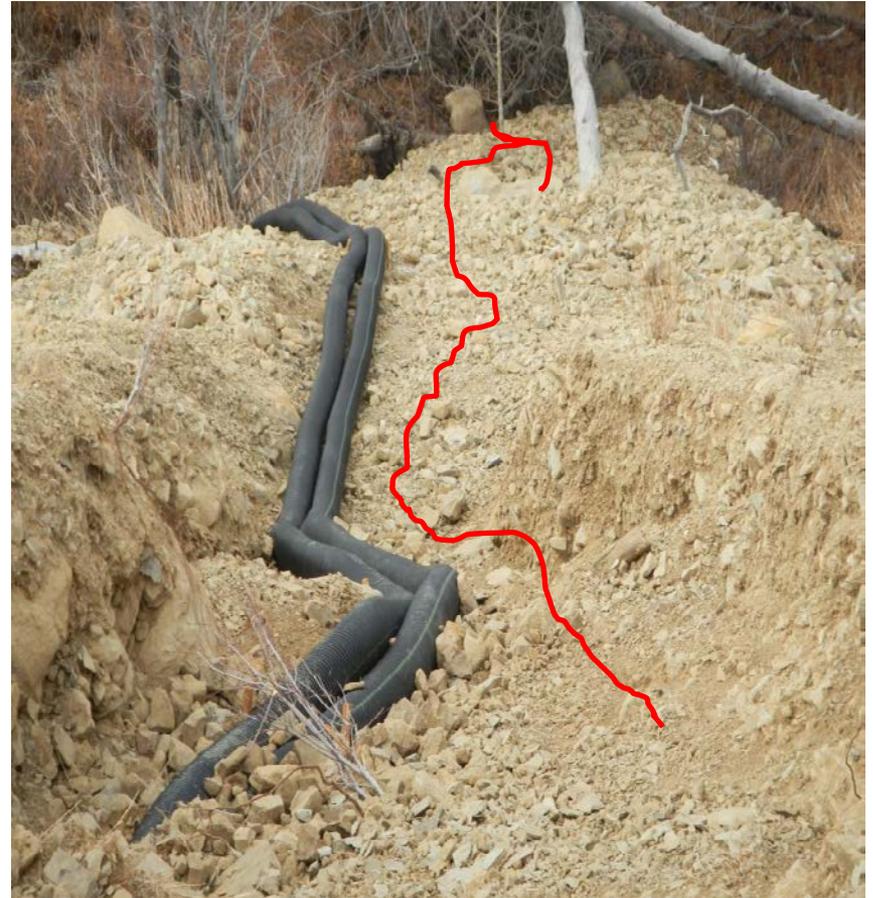
One of two Drains located at West edge of Pad; showing installation at top of Pad & flexible Pipe that conveys SW to bottom of Fill Slope; BMPs not properly Installed. Red line indicates erosion of Fill Slope .

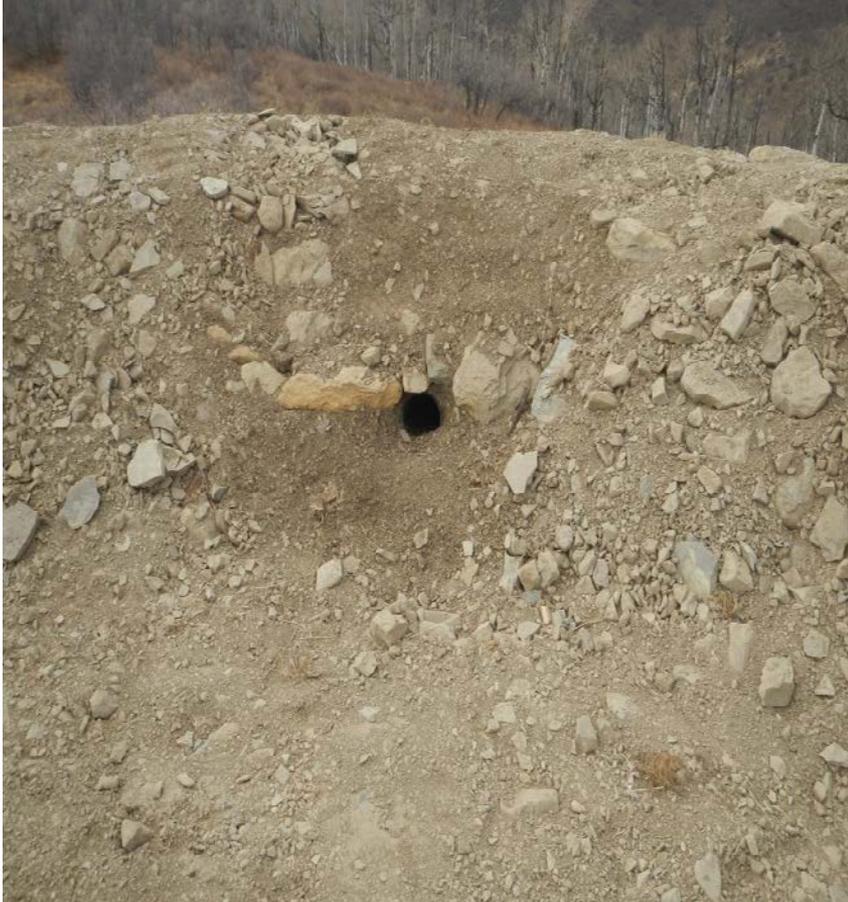
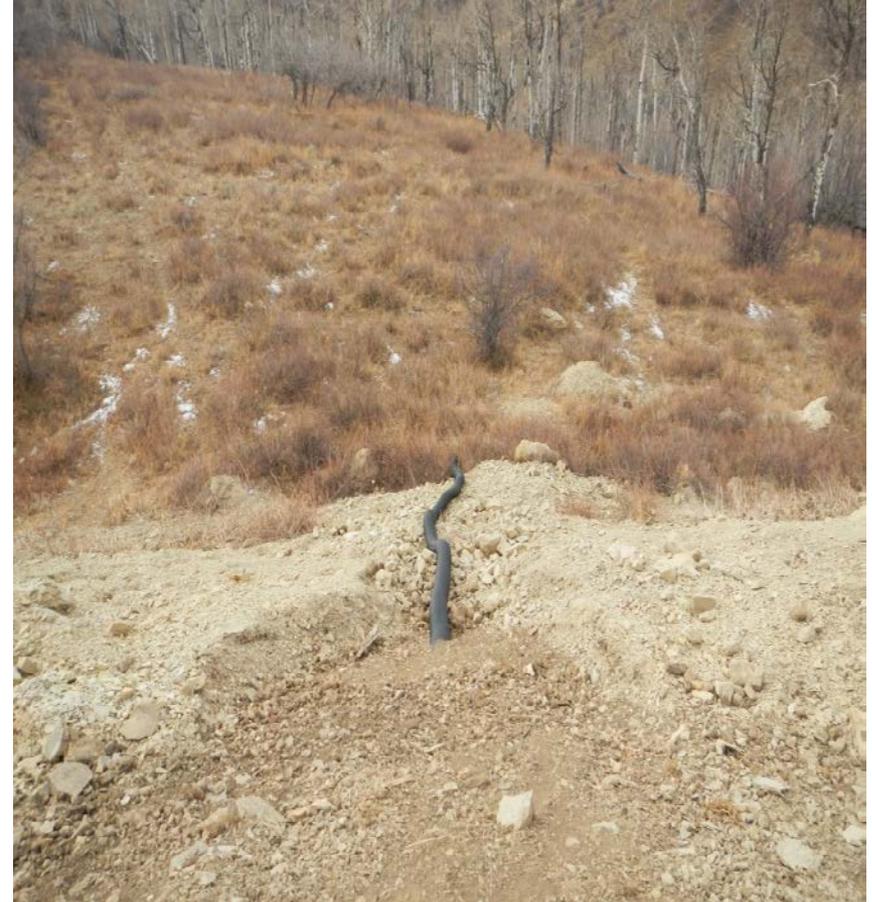
One of two Drains located at West edge of Pad; showing installation at top of Pad & flexible Pipe that conveys SW to bottom of Fill Slope; BMPs not properly Installed per Good Engineering Practices.

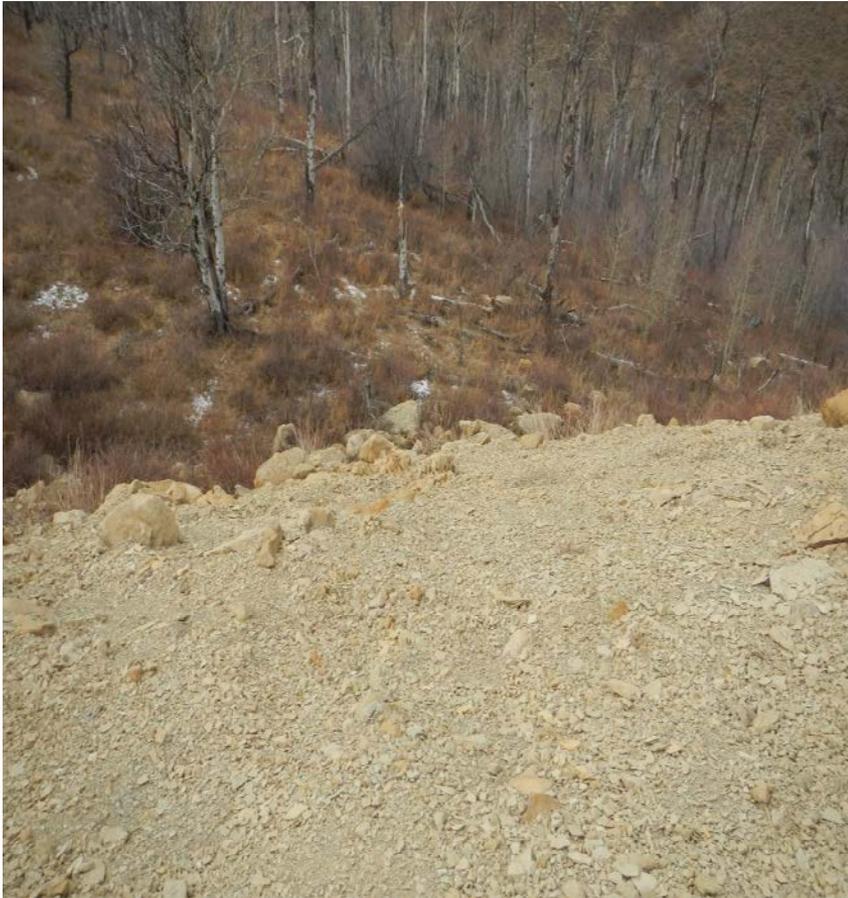
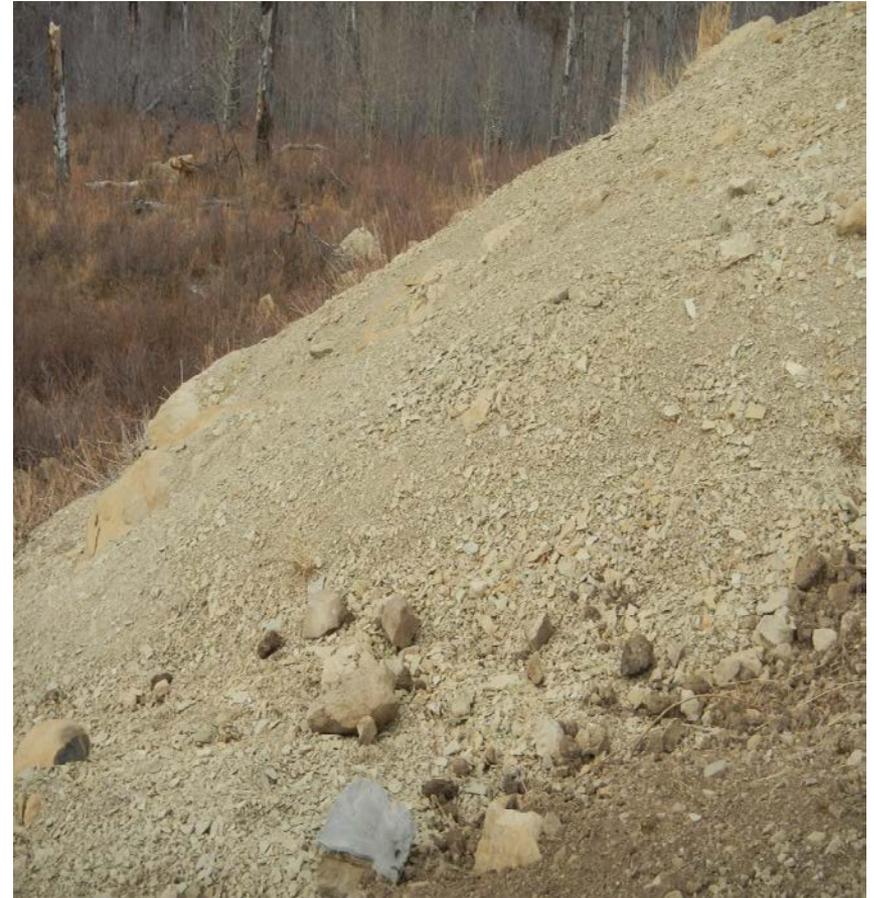
Views of Unstabilized overly Steep Fill Slopes.

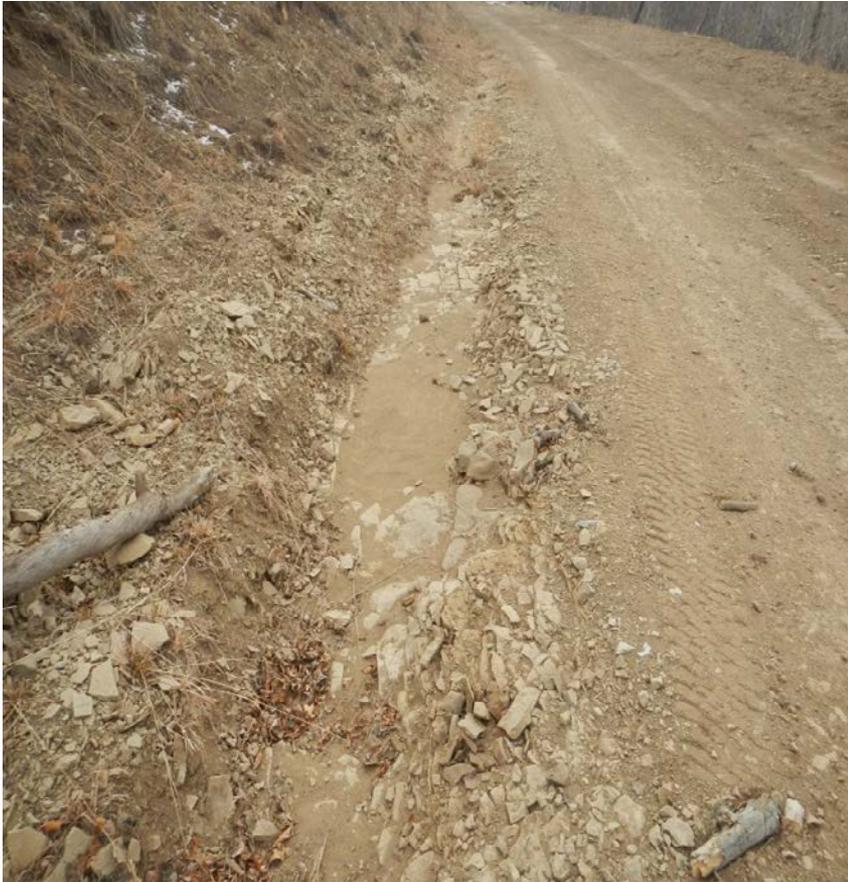
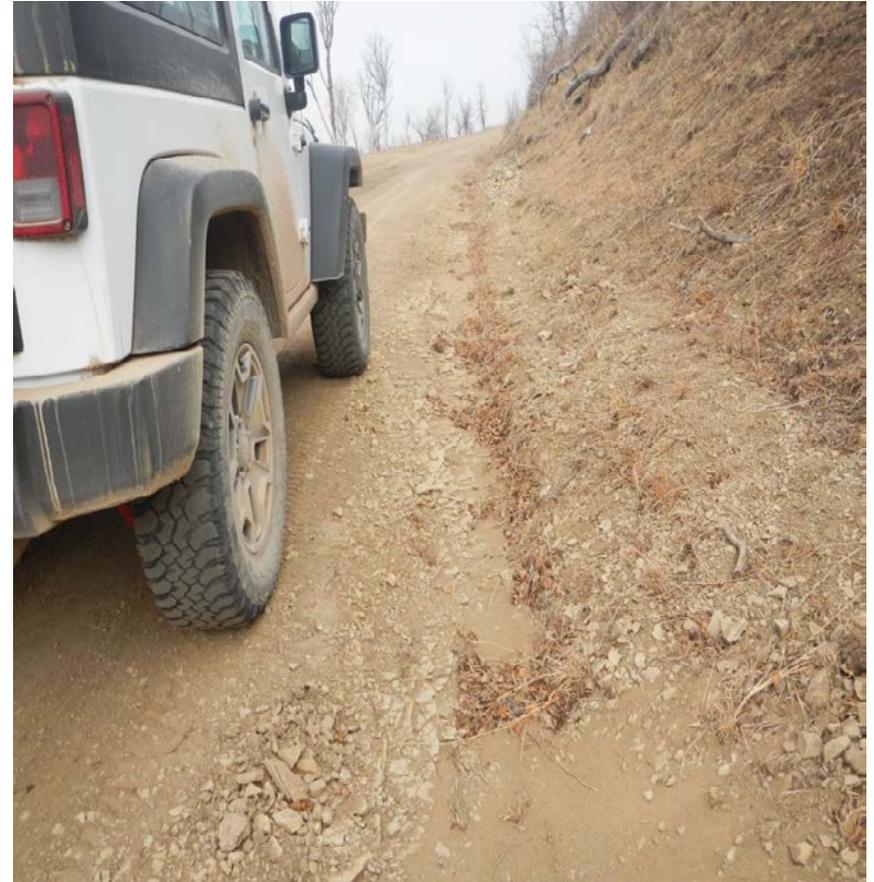
Cut Slope side of Access Road up at steeper section, has Sediment Migration occurring.
