Inspection Photos
Location Name: Allison Unit #19
API: 05-067-05008

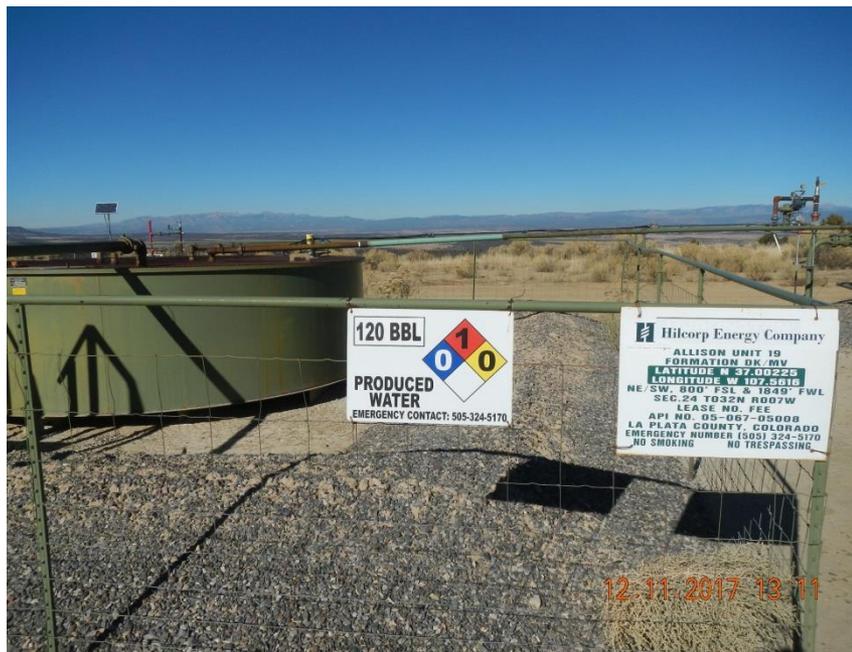
Open topped produced water vessel.

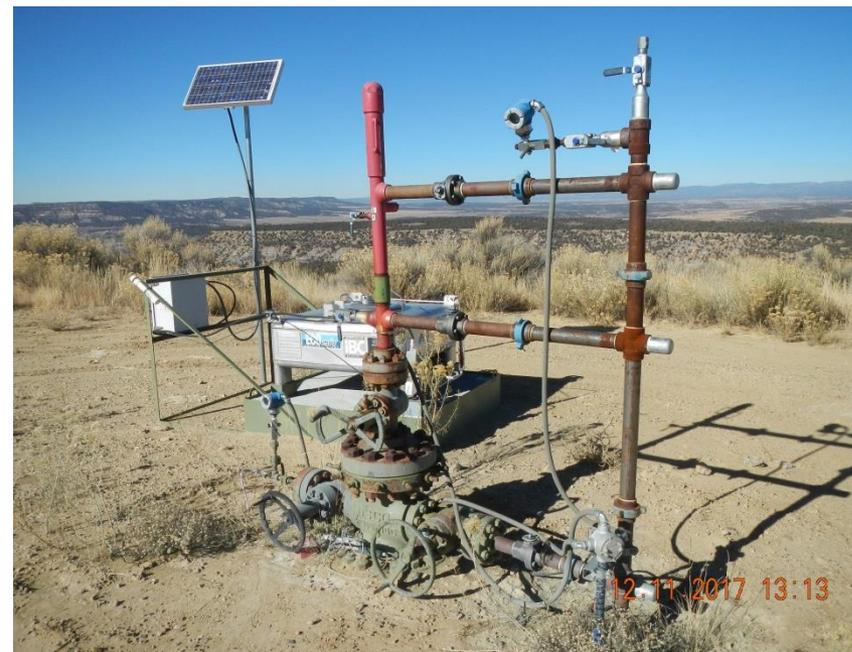
Allison Unit #19 well head.

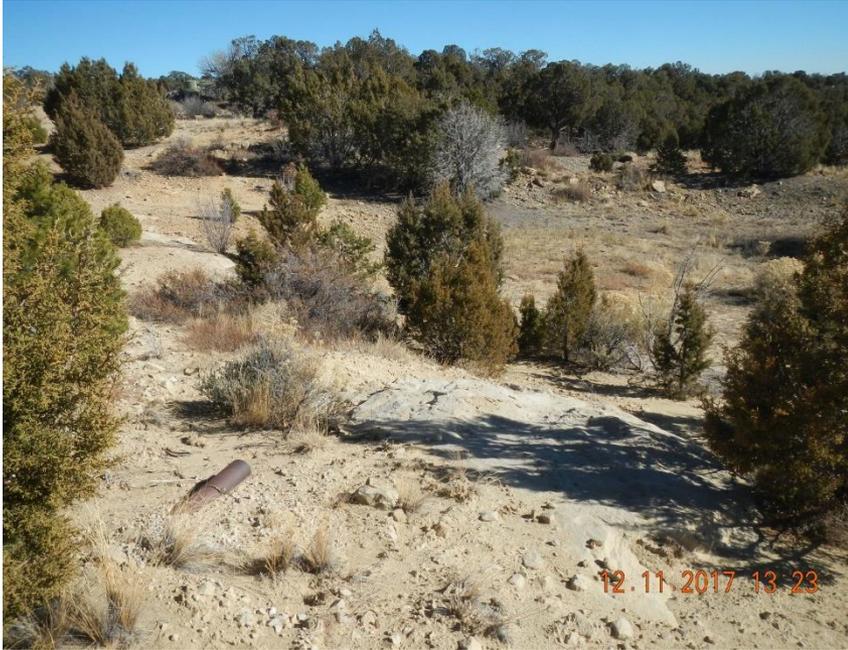
Pit area SE of location with 4" steel pipe outlet.

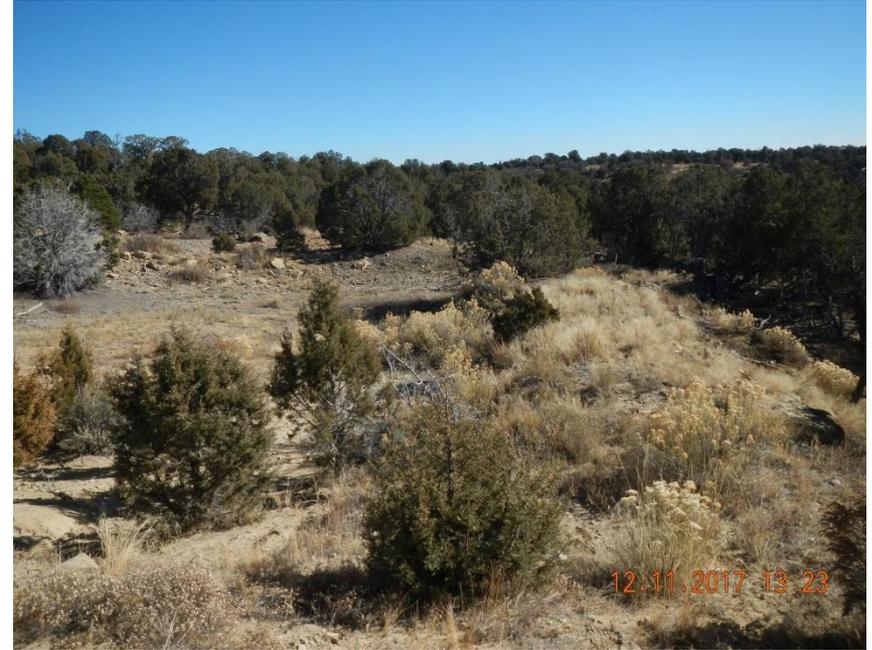
Bermed area SE of location.

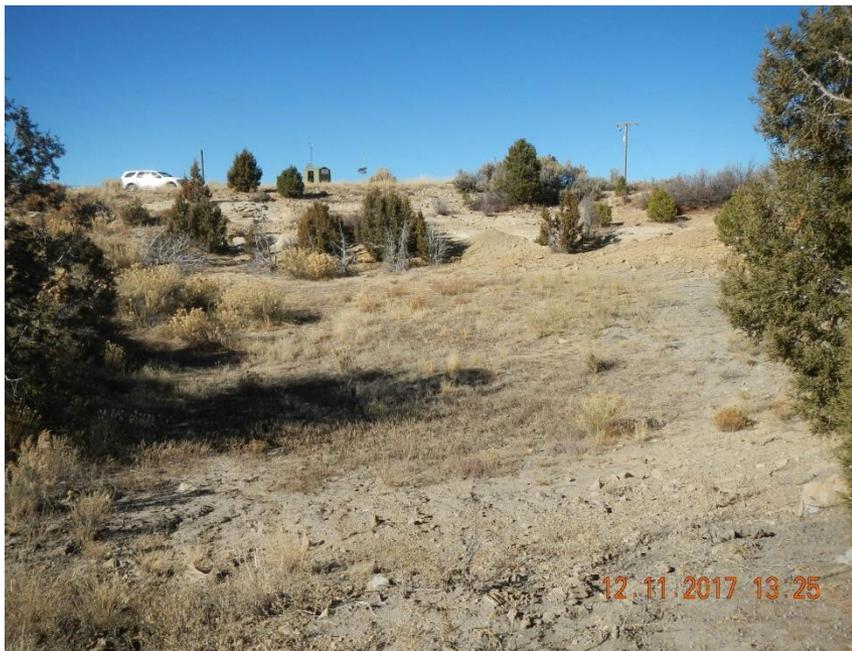
View from pit area towards location.

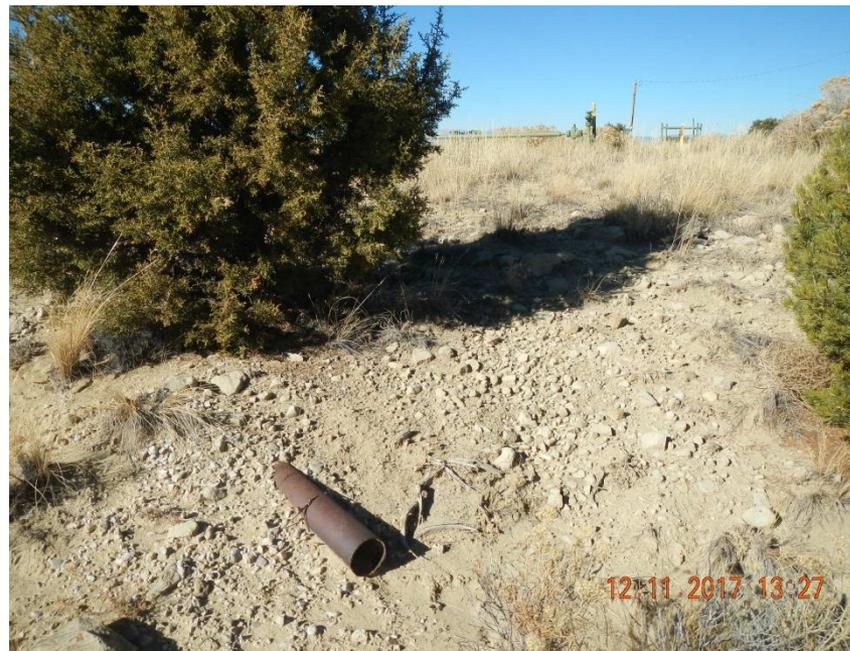
4" steel pipe outlet to pit area. Inlet was not observed during this field inspection.
