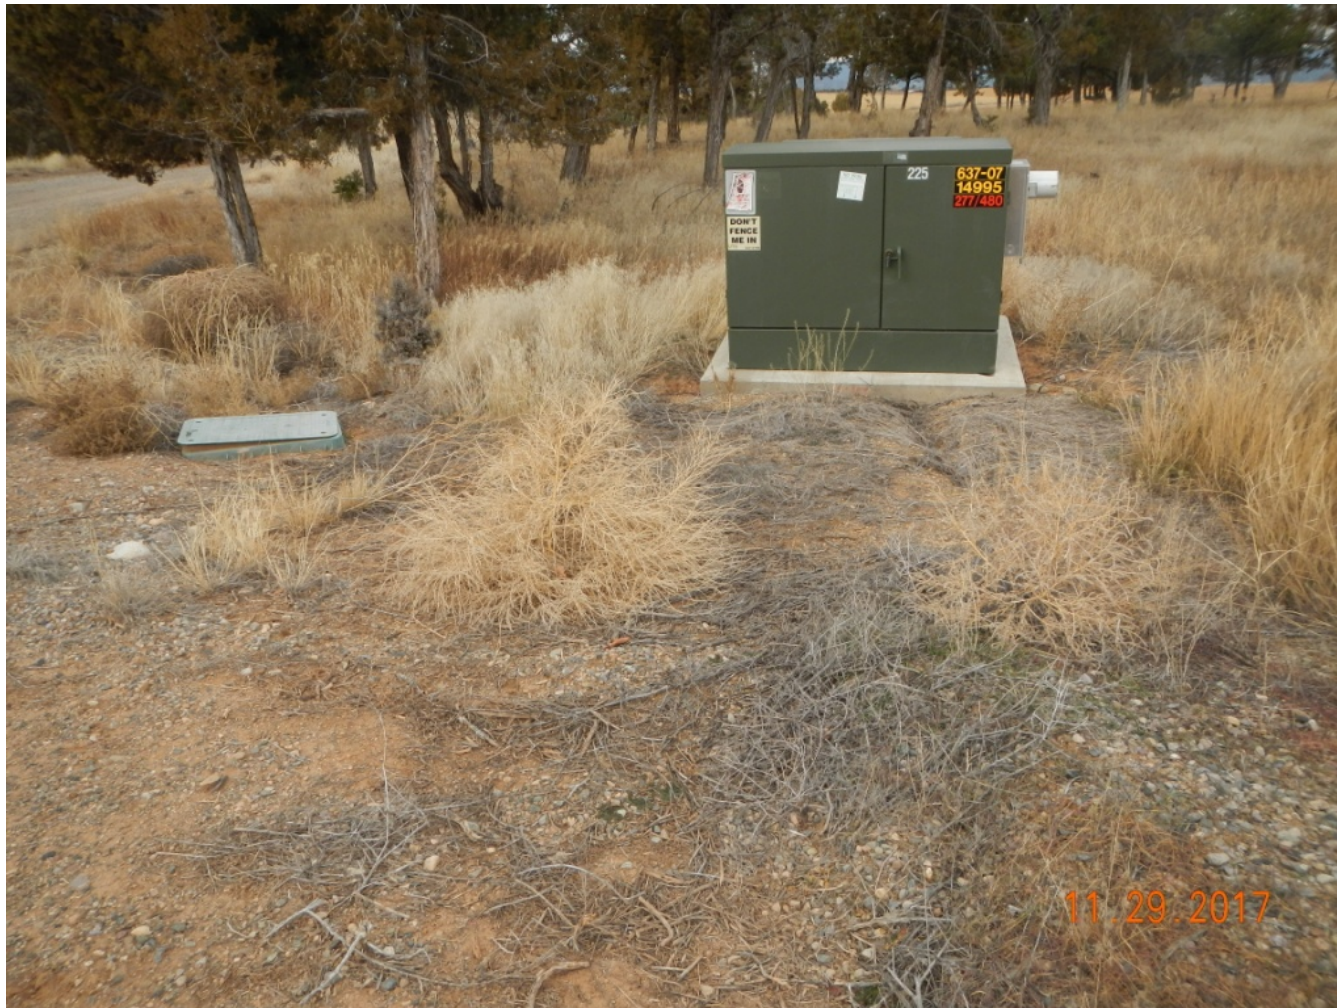
Photo 1. View of area near well pad entrance where debris was removed.

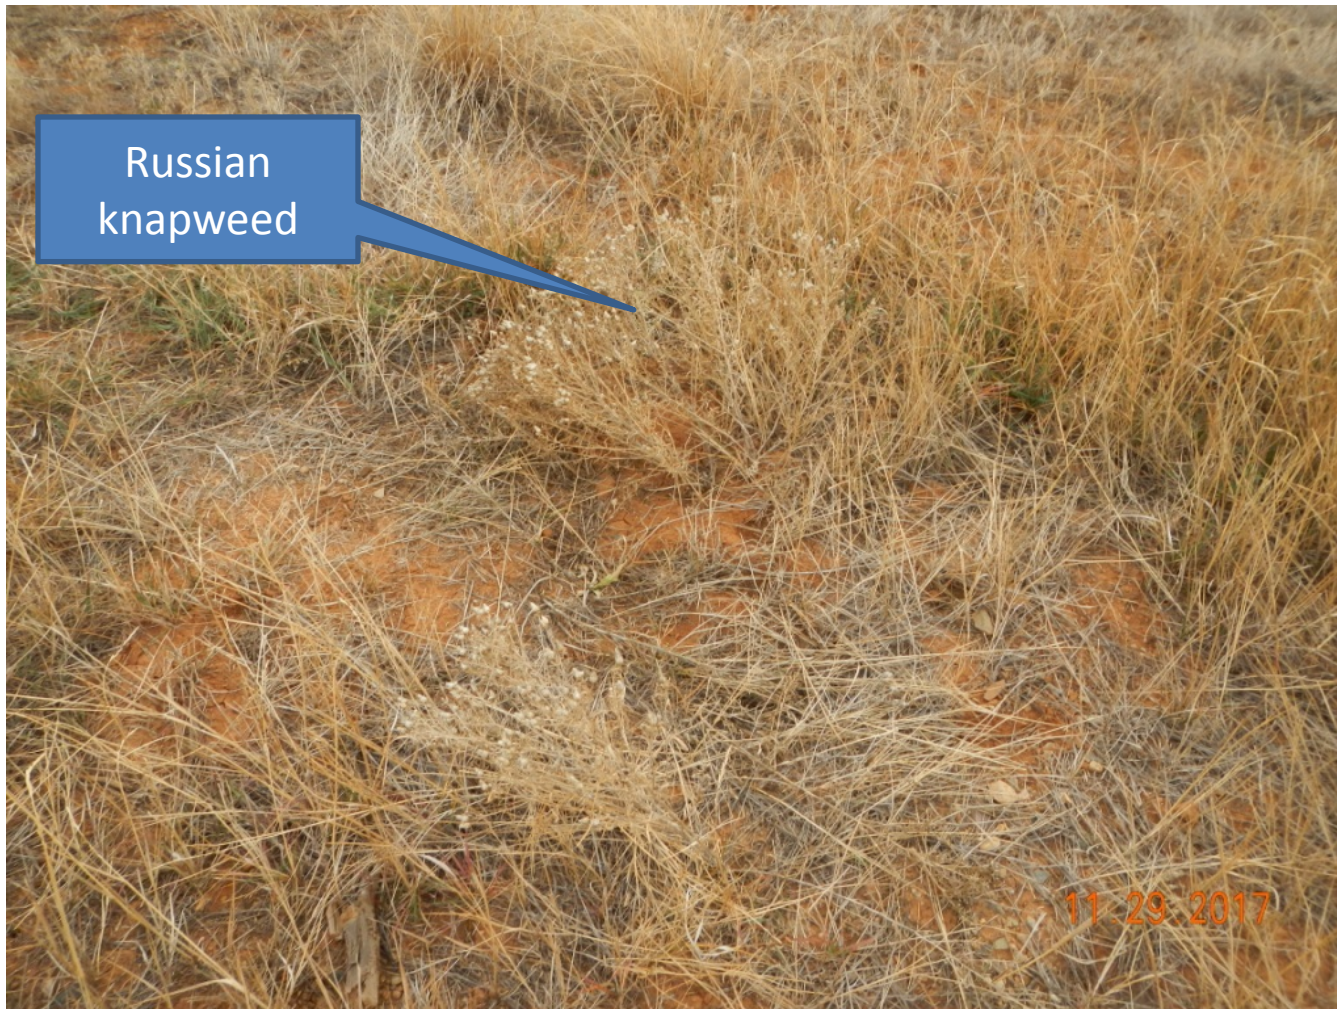
Photo 2. View of Russian knapweeds (*Acroptilon repens*) in the southwestern portion of the project area.

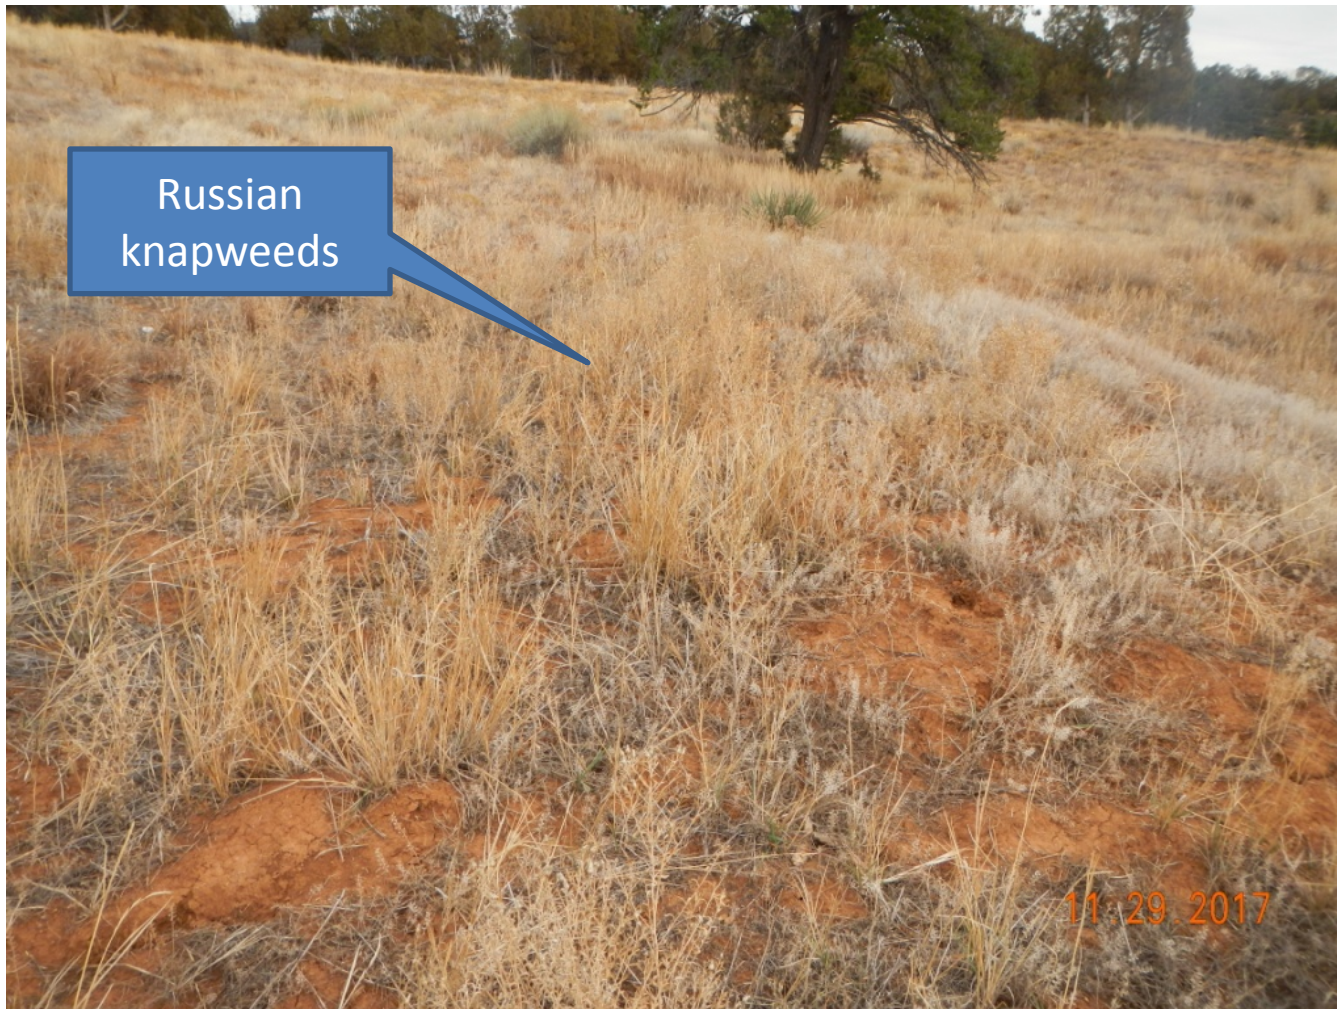
Photo 3. View of Russian knapweeds in the southern portion of the project area.
