Inspection Photos

Location Name: Lorenz Farms 22-13

API #: 05-123-19256

Location ID: 330537

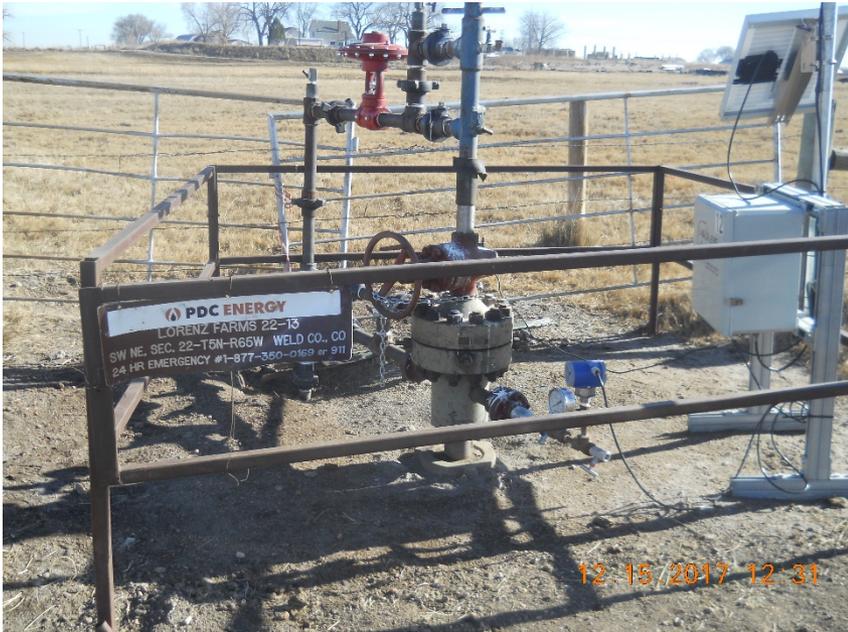
Wellhead looking east

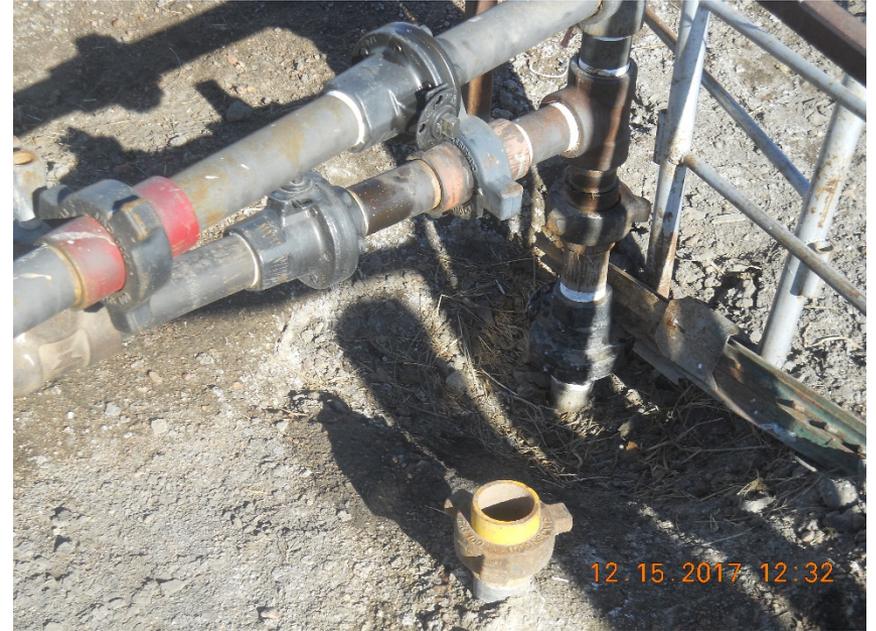
2" Ball valve from surface casing to flowline appears to be leaking. Stained soil under valve

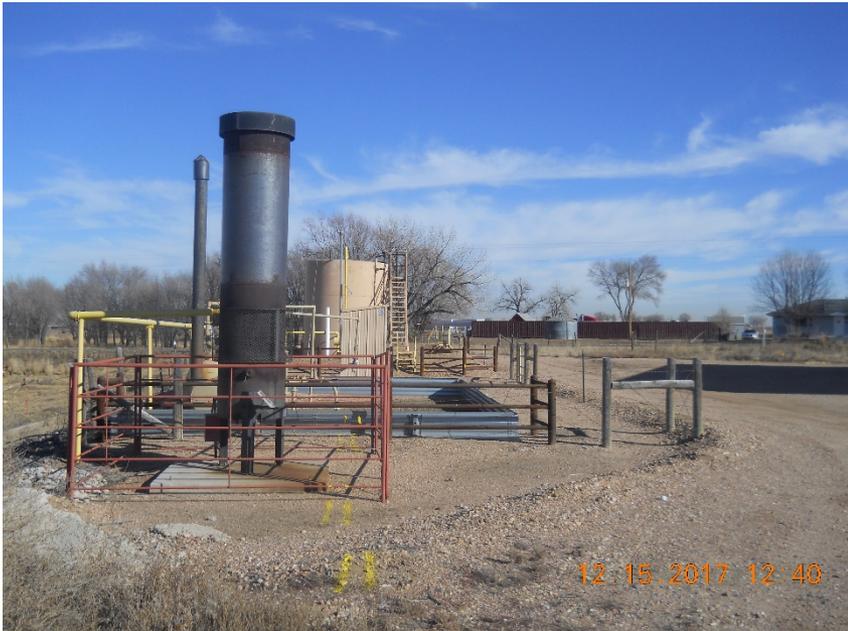
Battery looking east

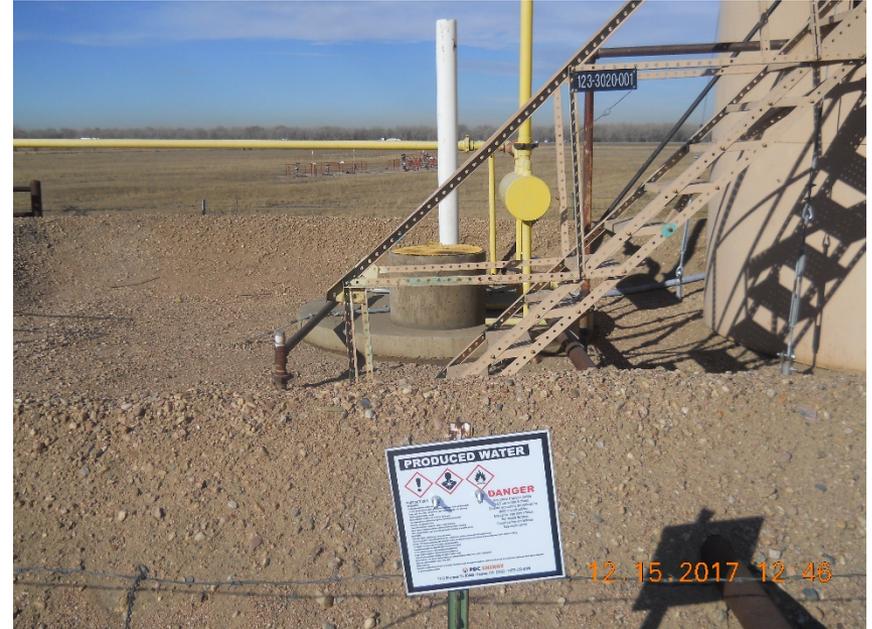
Produced water vault does not have capacity labeled and does not have NFPA placard
