Inspection Photos

Operator: OILFIELD SALVAGE & SERVICE CO -
65550

Location ID: 453292

Inspection Doc. Number: 682502970
Adams County, CO

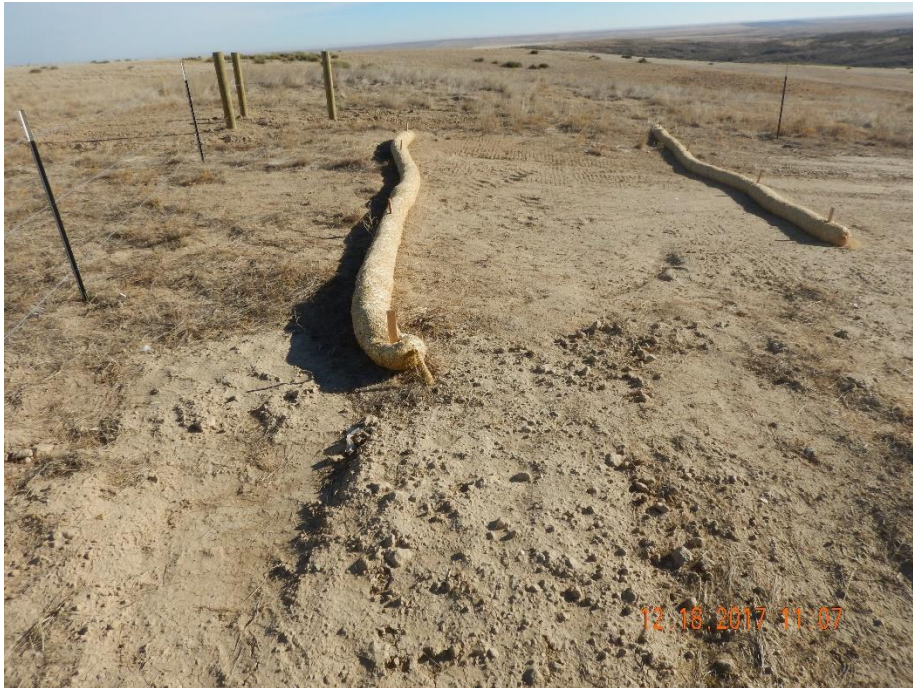
Photo 1: Photo taken from the northwest end of the fenced reclamation area (on slope), facing east. Photo shows straw wattles BMPs have not been installed in accordance to good engineering practices. Previous inspections required operator to perform reclamation and ensure erosion controls are implemented to stabilize the seeded soil. Photo shows the disturbance area appears to have been seeded (striations in soil suggest a no-till seed drill was used), however no erosion/stabilization controls appear to have been implemented to stabilize the seeded soil per the corrective action. This has allowed stormwater degradation to continue on the location.

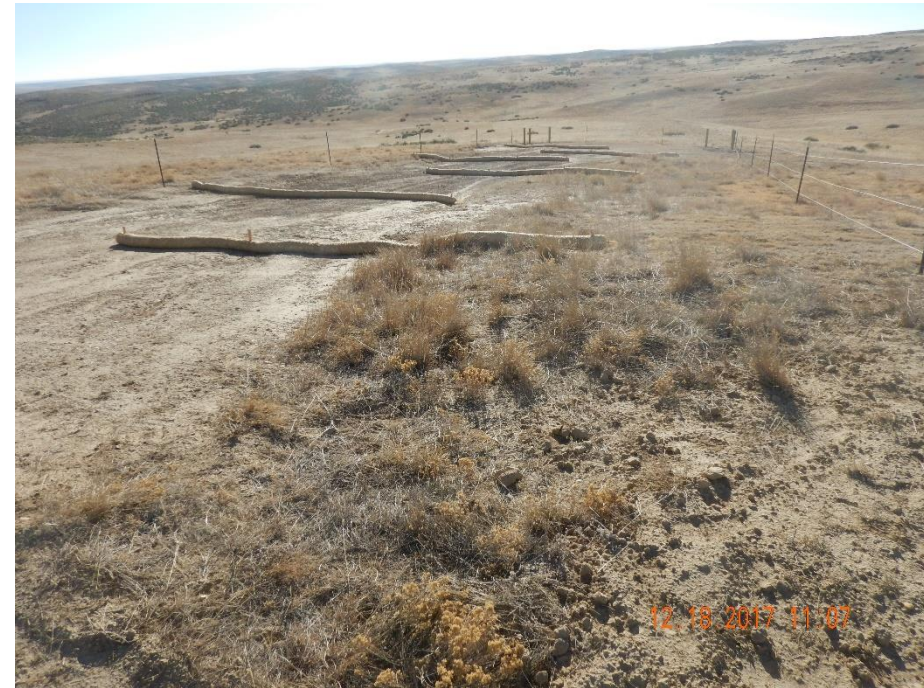
Photo 2: Photo taken from the northwest end of the fenced reclamation area (on slope), facing south. SEE COMMENTS UNDER PHOTO 1

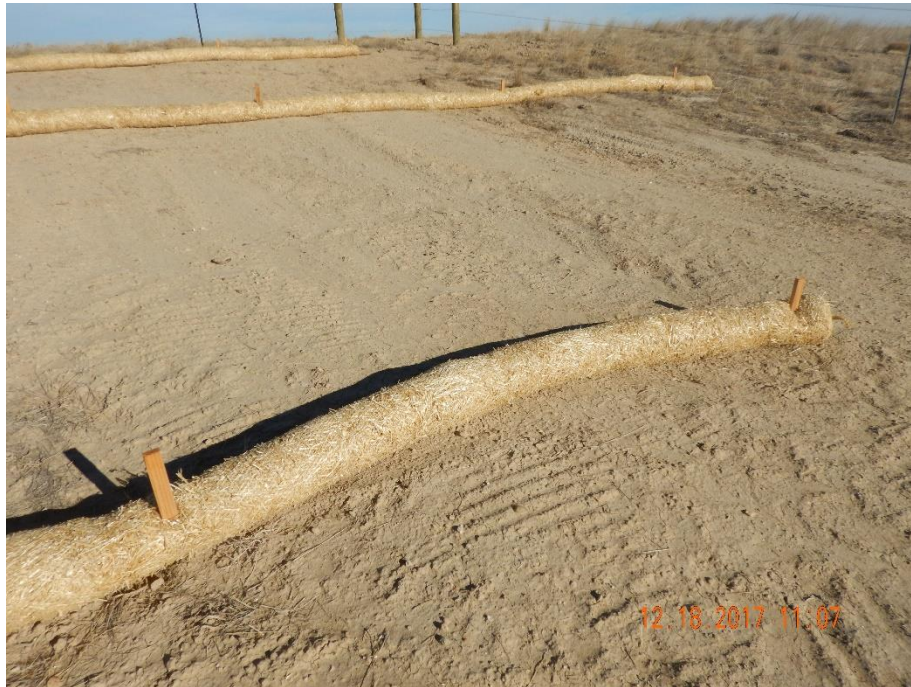
Photo 3: Photo taken from within the disturbance area on the slope, facing northeast. Photo shows straw wattles BMPs have not been installed in accordance to good engineering practices. Photo also shows the disturbance area appears to have been seeded (striations in soil suggest a no-till seed drill was used), however no erosion controls were implemented to stabilize the seeded soil per the corrective action.

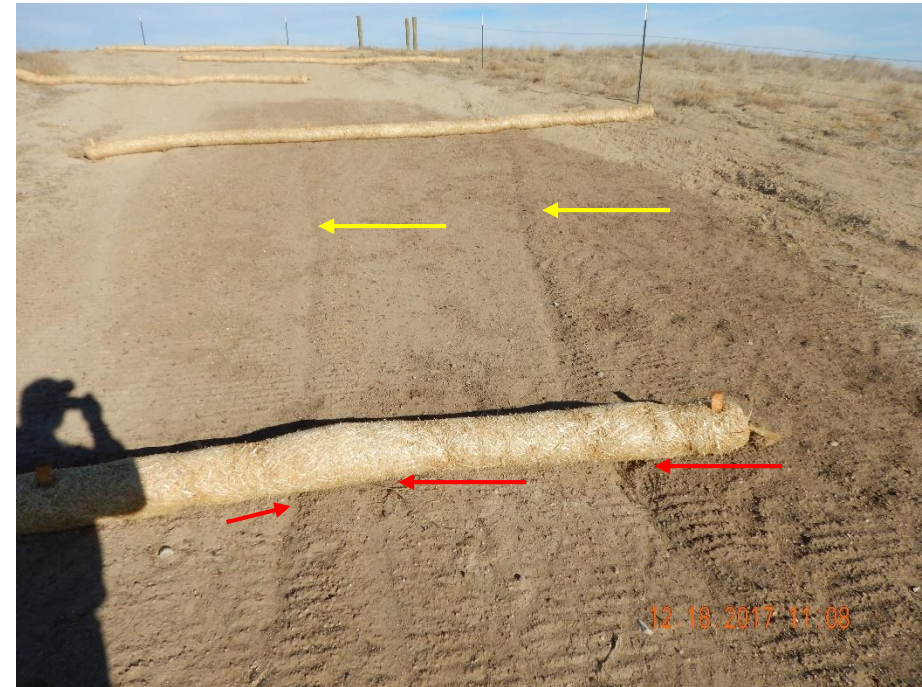
Photo 4: Photo taken from within the disturbance area on the slope, facing northeast. Photo shows that no erosion controls were implemented to stabilize the seeded soil, allowing erosion degradation to continue (yellow arrow). Photo also shows straw wattles BMPs have not been installed in accordance to good engineering practices, and stormwater has cut underneath the BMP (red arrow).

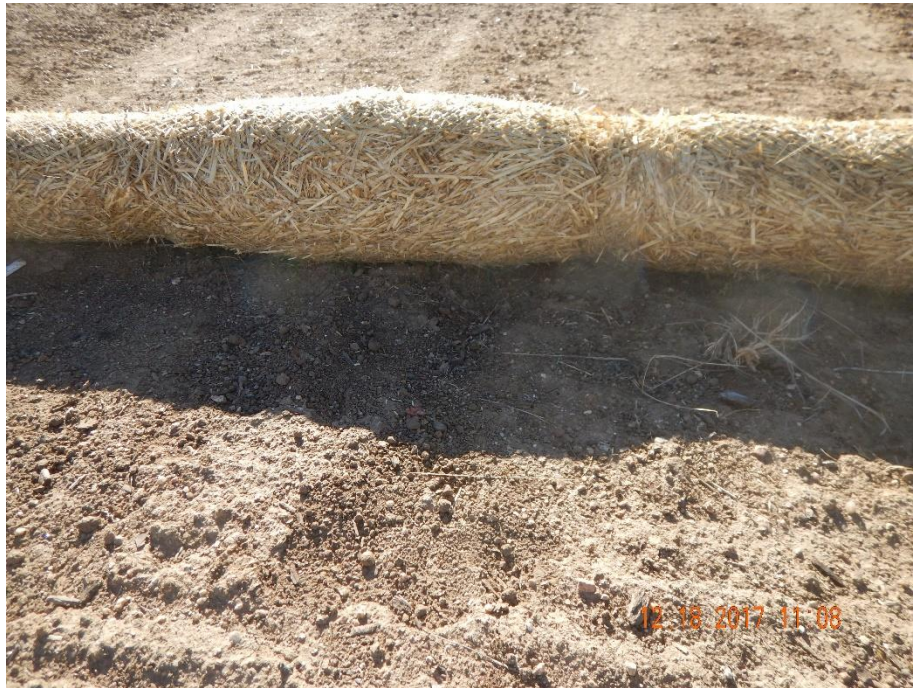
Photo 5: Photo shows straw wattles BMPs have not been installed in accordance to good engineering practices. Straw wattles are a stormwater ponding BMP that is required to be trenched below grade and backfilled in order to work in proper functioning condition.

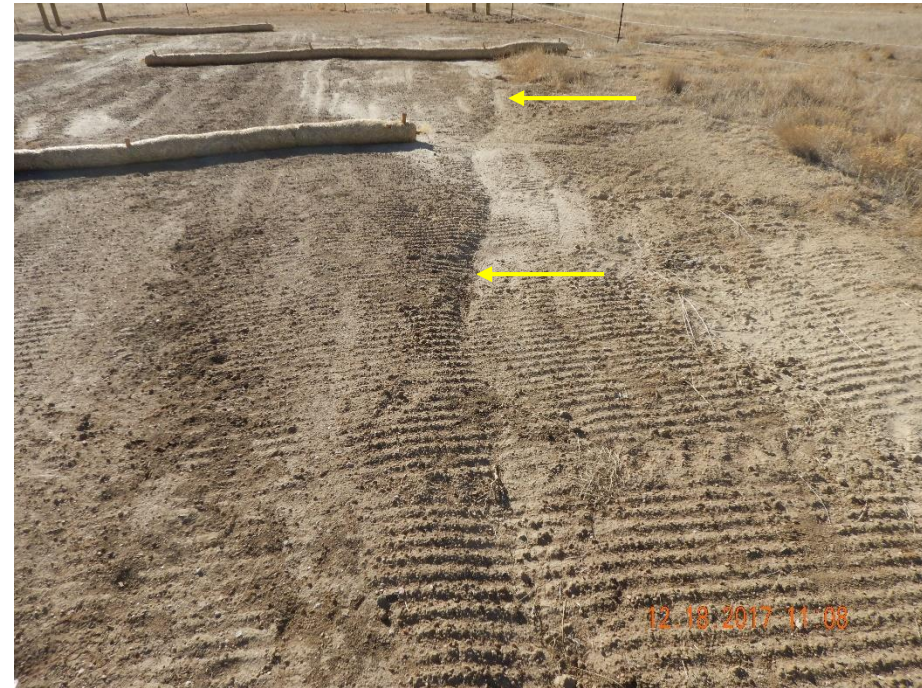
Photo 6: Photo taken from within the disturbance area on the slope, facing south. Photo shows that no erosion controls were implemented to stabilize the seeded soil, allowing erosion degradation to continue (yellow arrow).

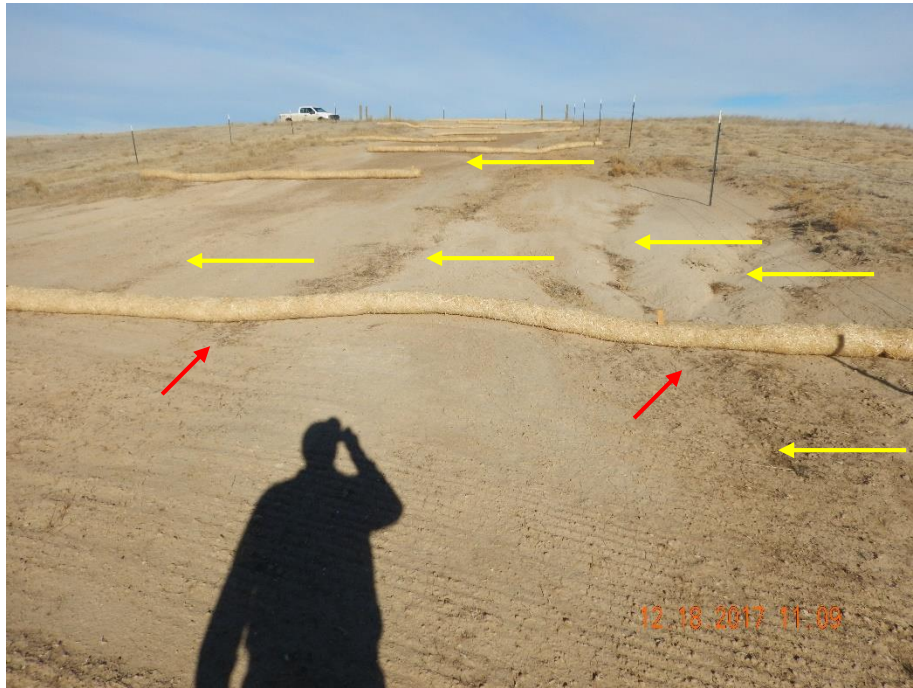
Photo 7: Photo taken from the southern portion of the fenced disturbance, facing north. Photo shows that no erosion controls were implemented to stabilize the seeded soil, allowing erosion degradation to continue (yellow arrow). Photo also shows straw wattles BMPs have not been installed in accordance to good engineering practices, and stormwater has cut underneath the BMP (red arrow).

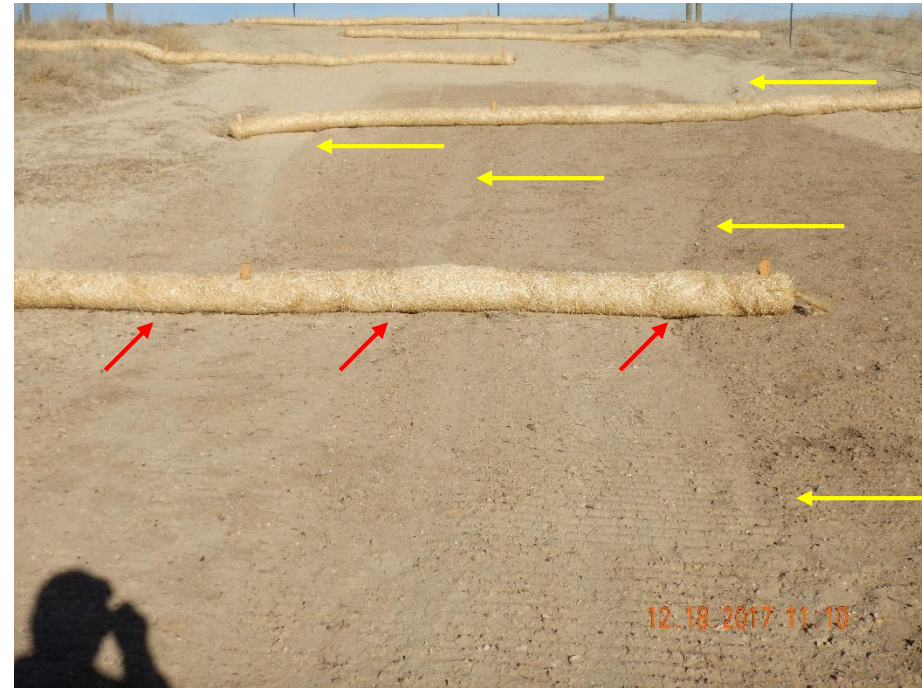
Photo 8: Photo taken from within the disturbance area on the slope, facing north. Photo shows that no erosion controls were implemented to stabilize the seeded soil, allowing erosion degradation to continue (yellow arrow). Photo also shows straw wattles BMPs have not been installed in accordance to good engineering practices, and stormwater has cut underneath the BMP (red arrow).
