Location Name: Magellan #1

API: 05-043-06229

Inspection Date: 12/15/2017

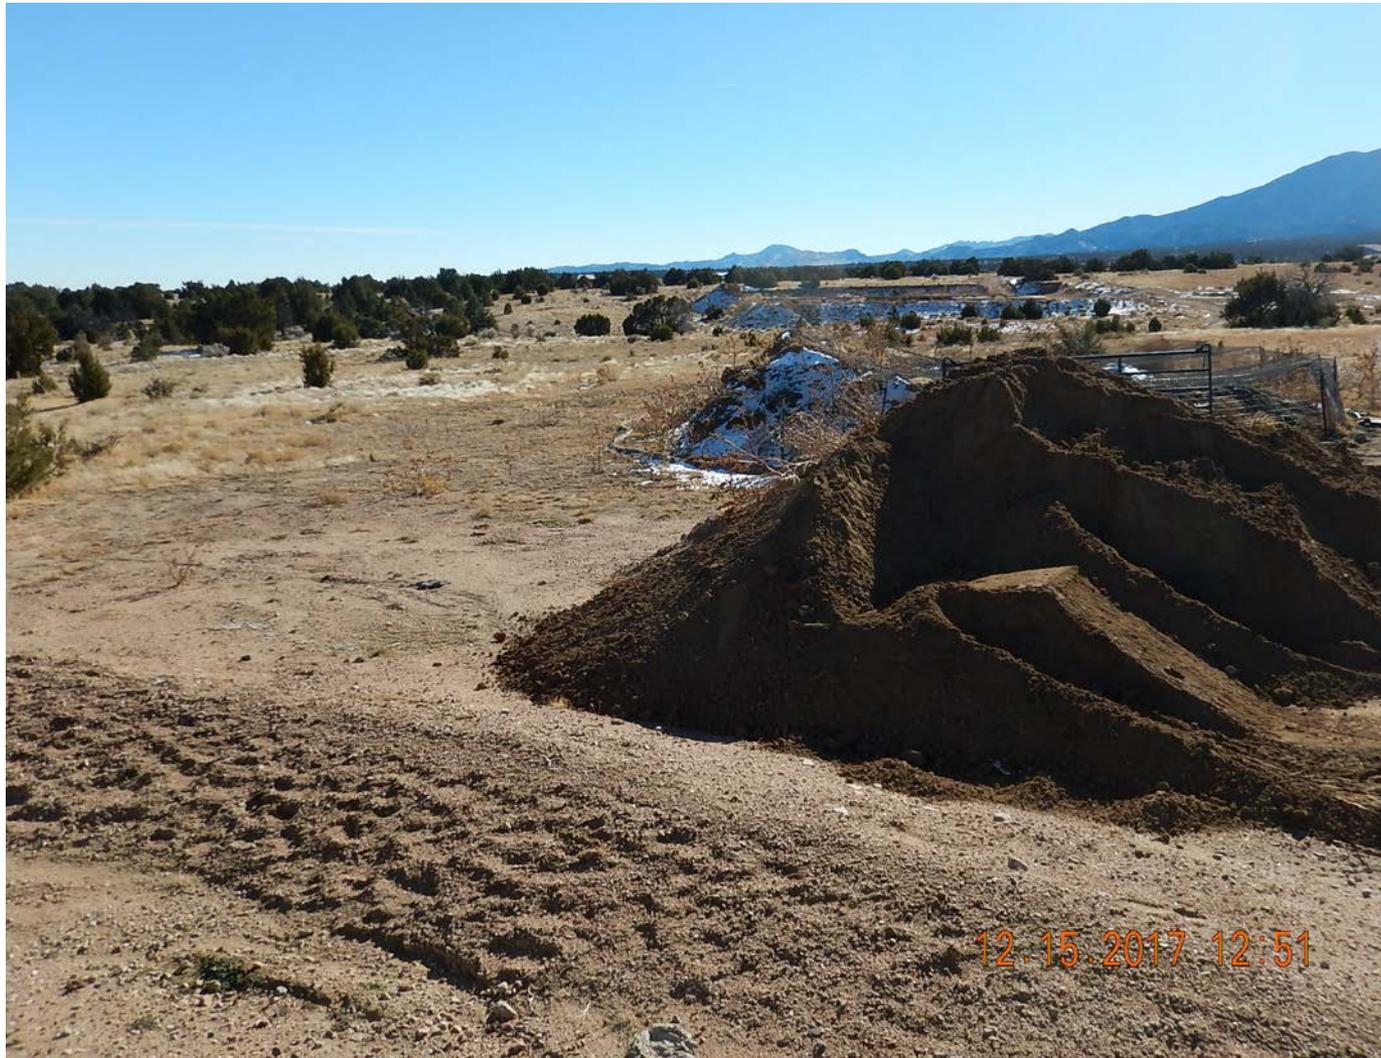
No stormwater BMP's in place to prevent sediment flow off location.

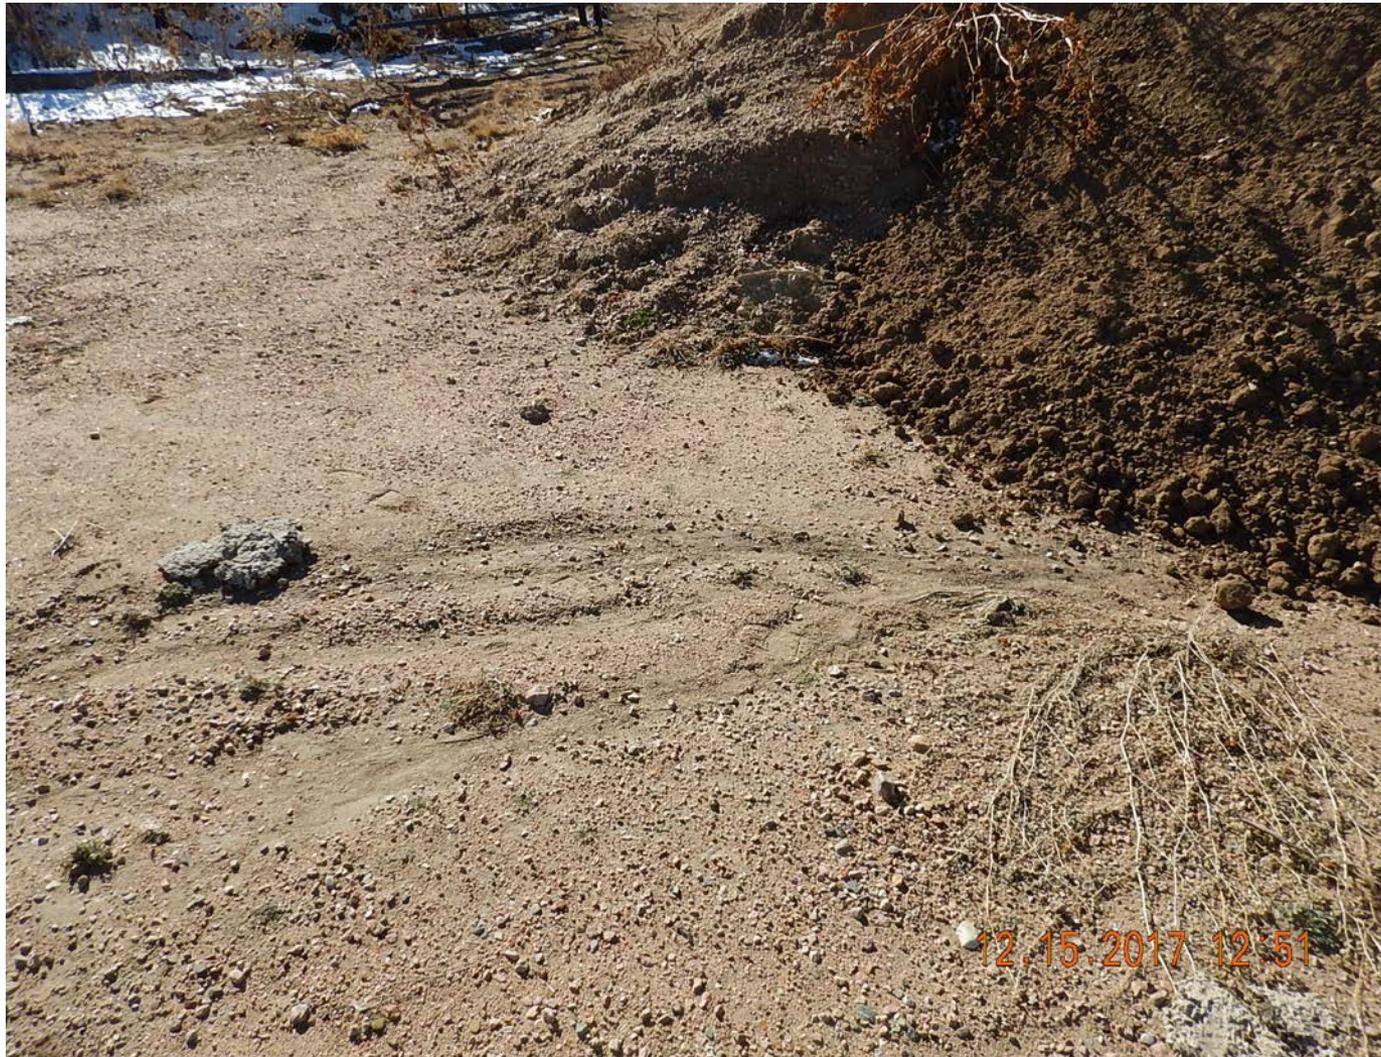
No stormwater BMP's in place to prevent sediment flow off location.

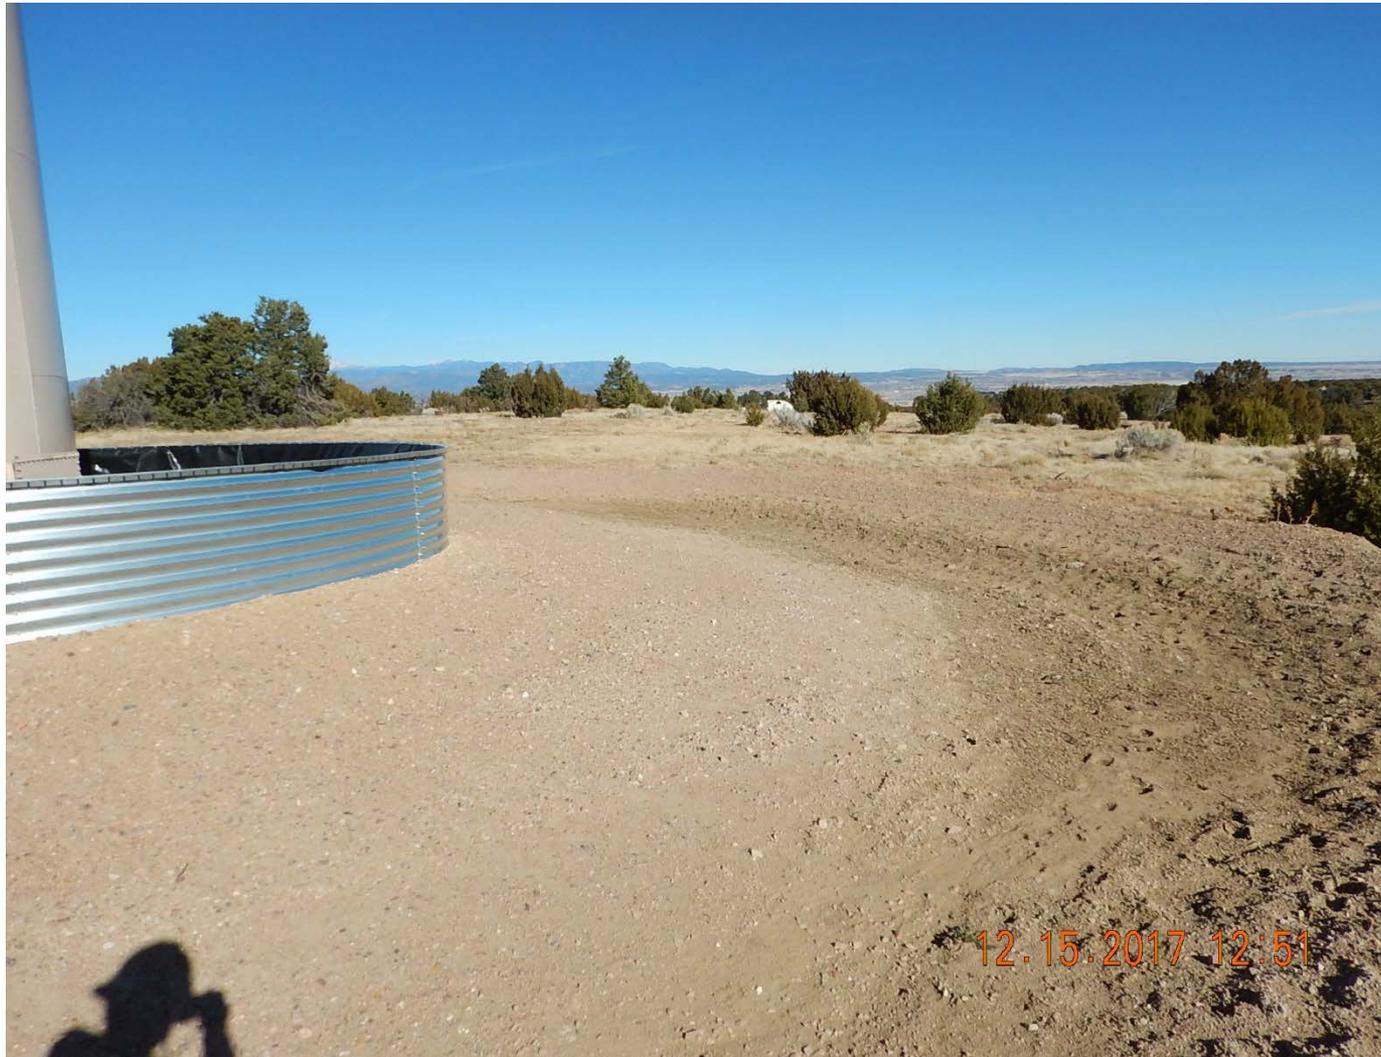
Stormwater BMP's

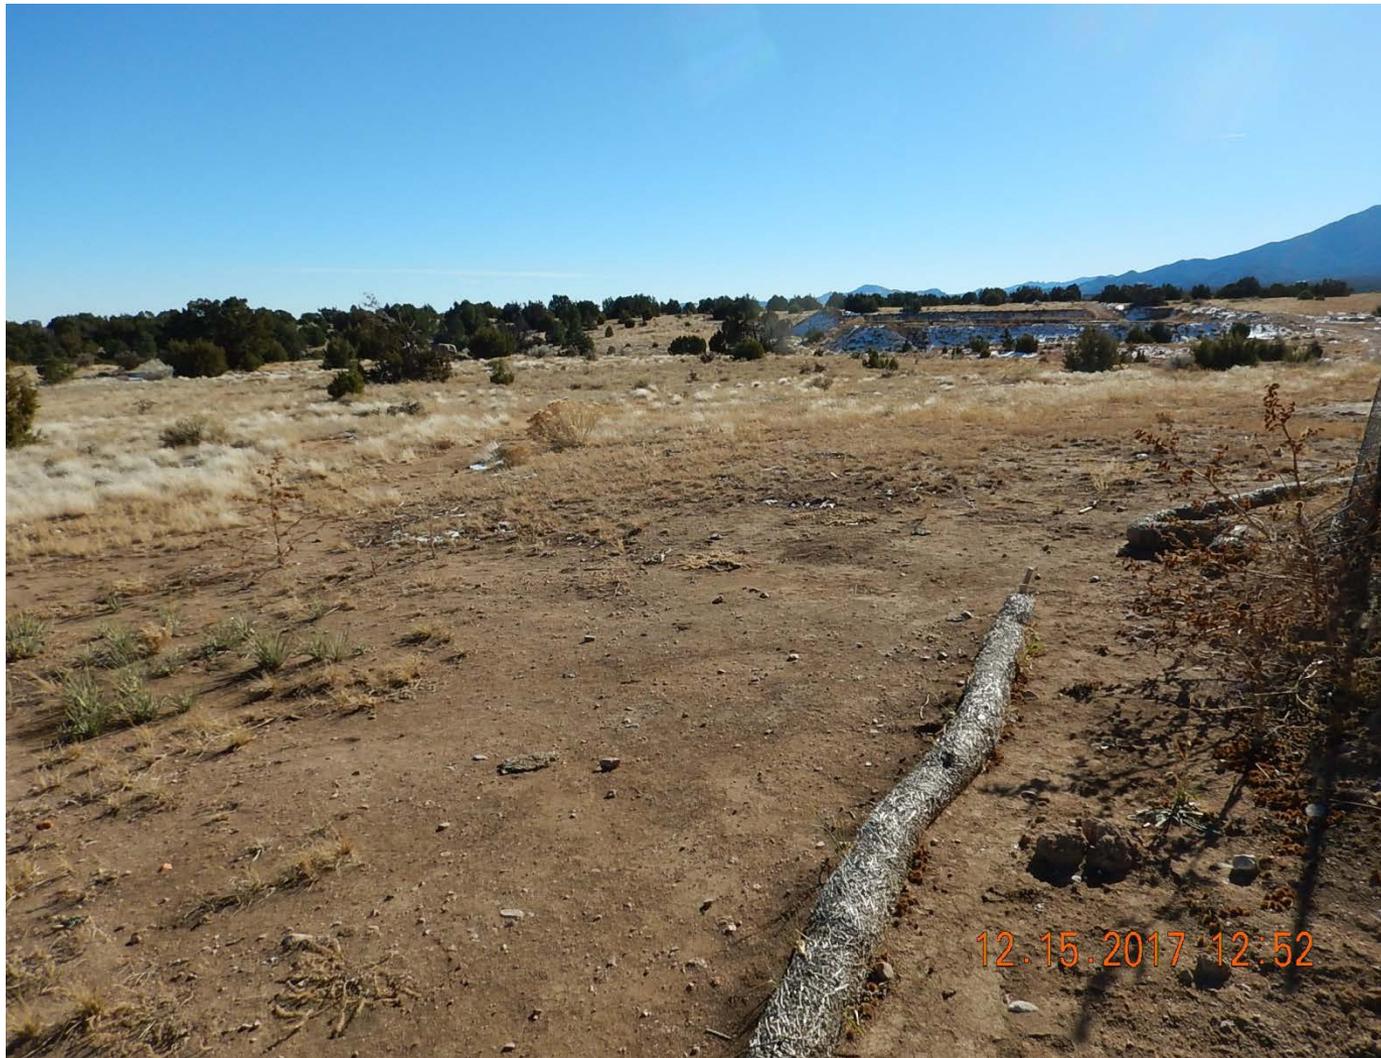
Inadequate stormwater BMP's. Sediment flow off location observed.

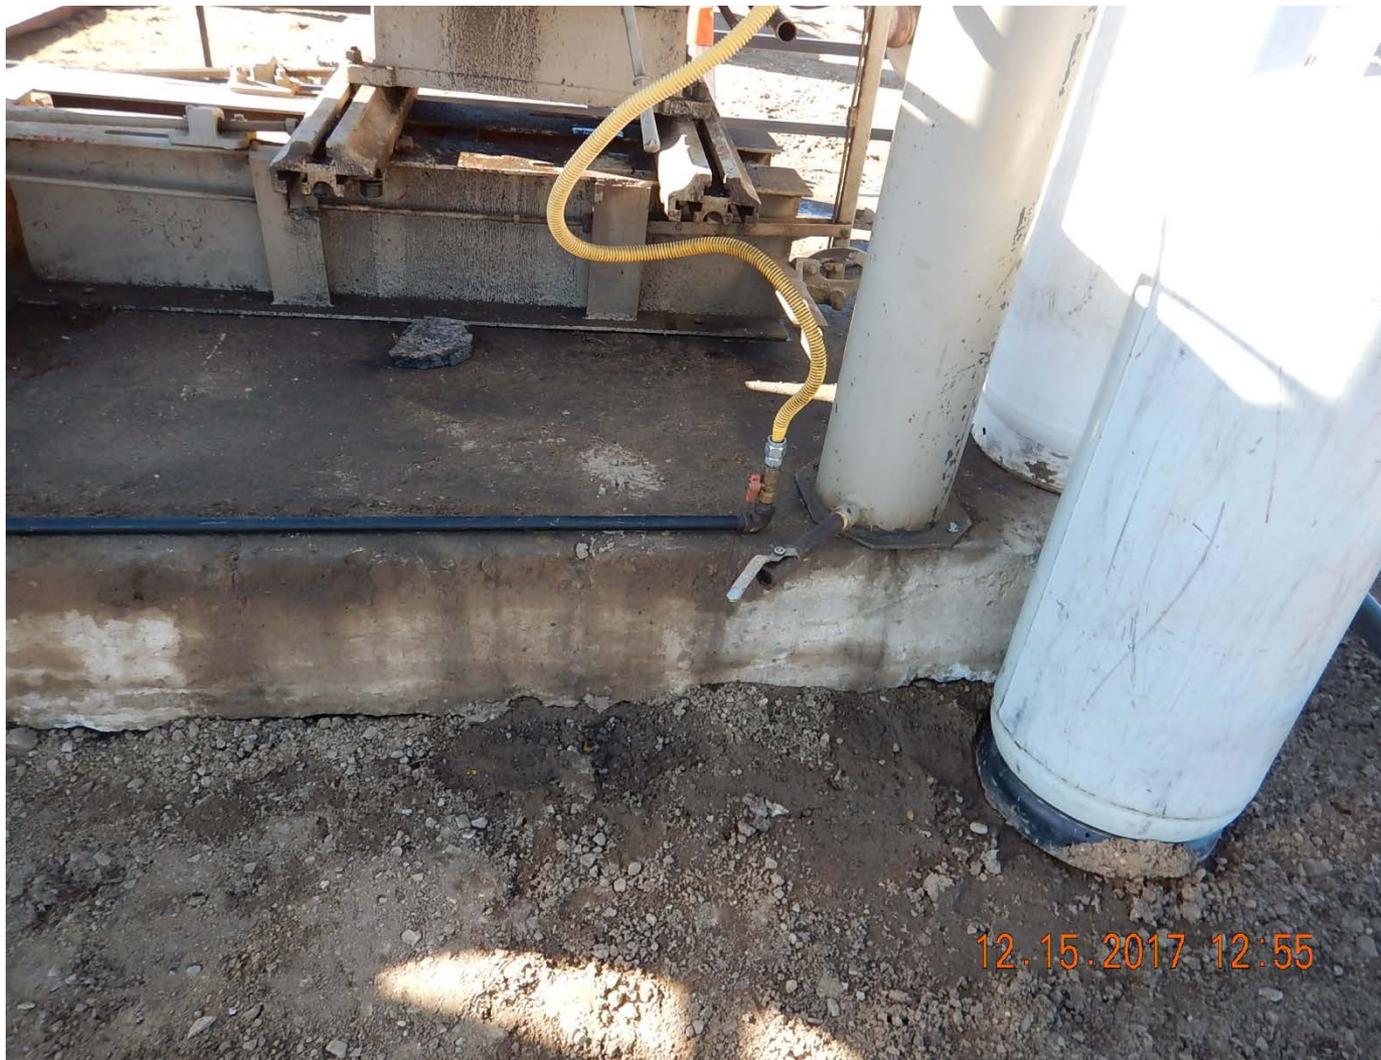
Venting from open valve pictured was observed during inspection.

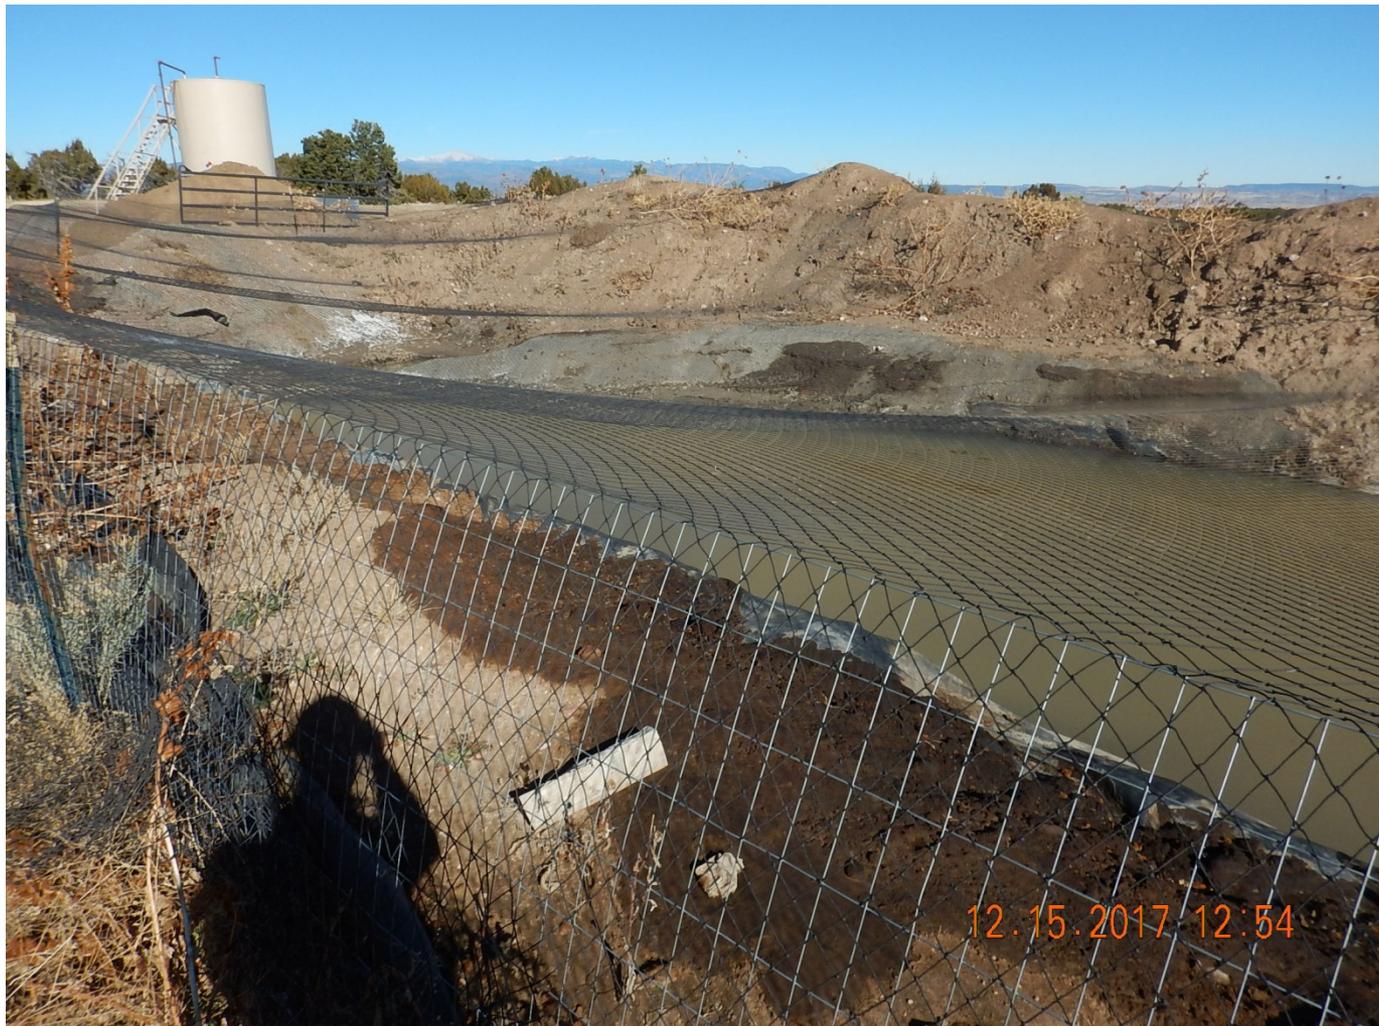
Drilling pit
