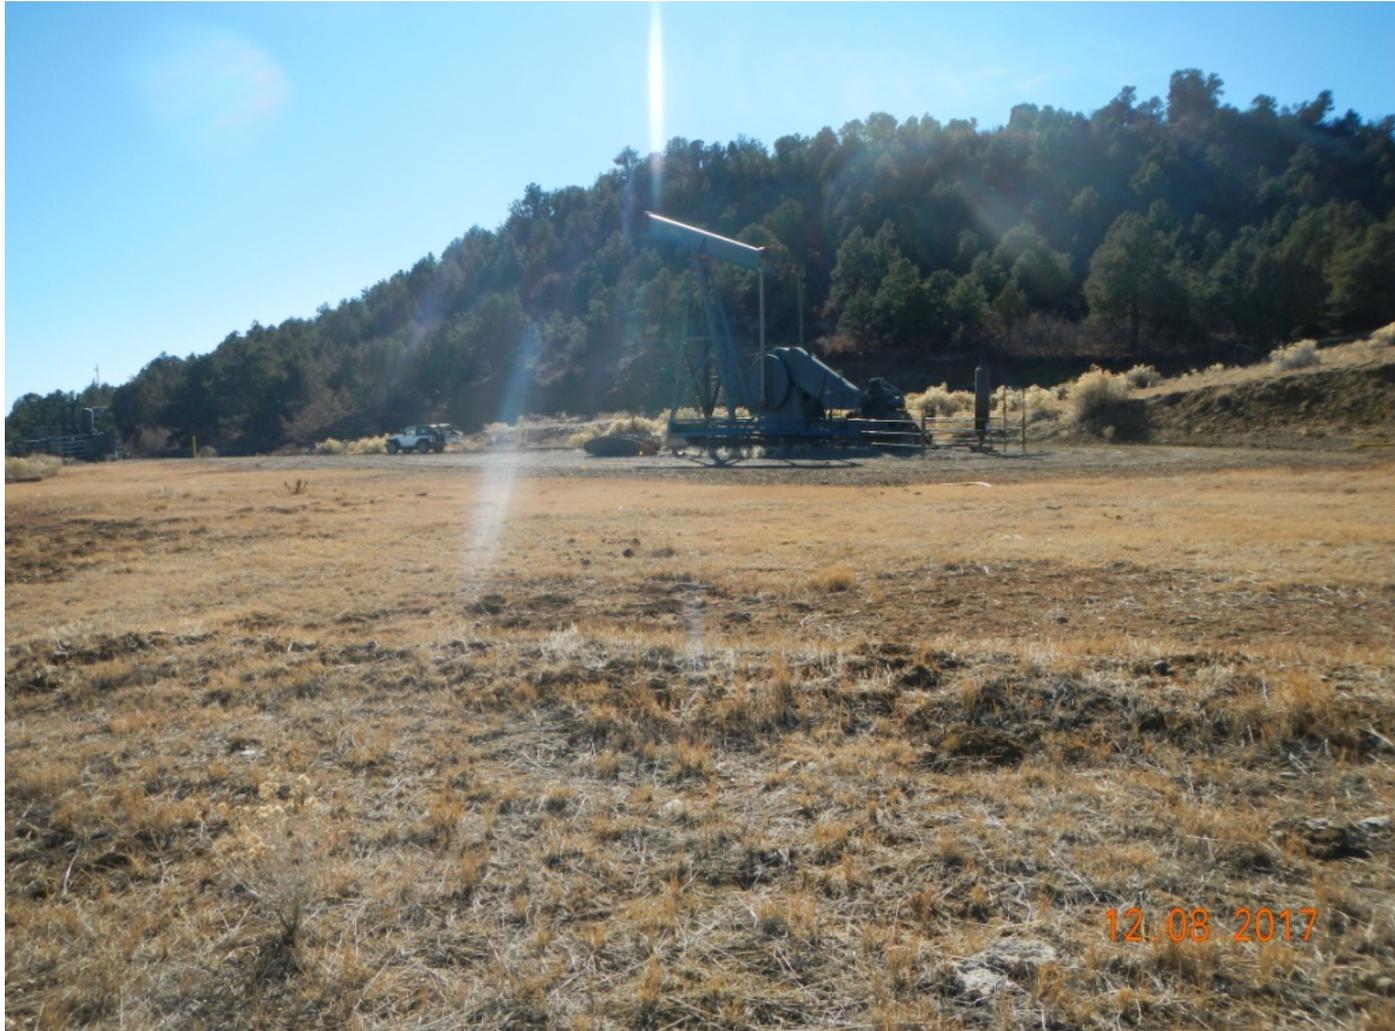
Photo 1. View of the project area from the northern corner facing center.

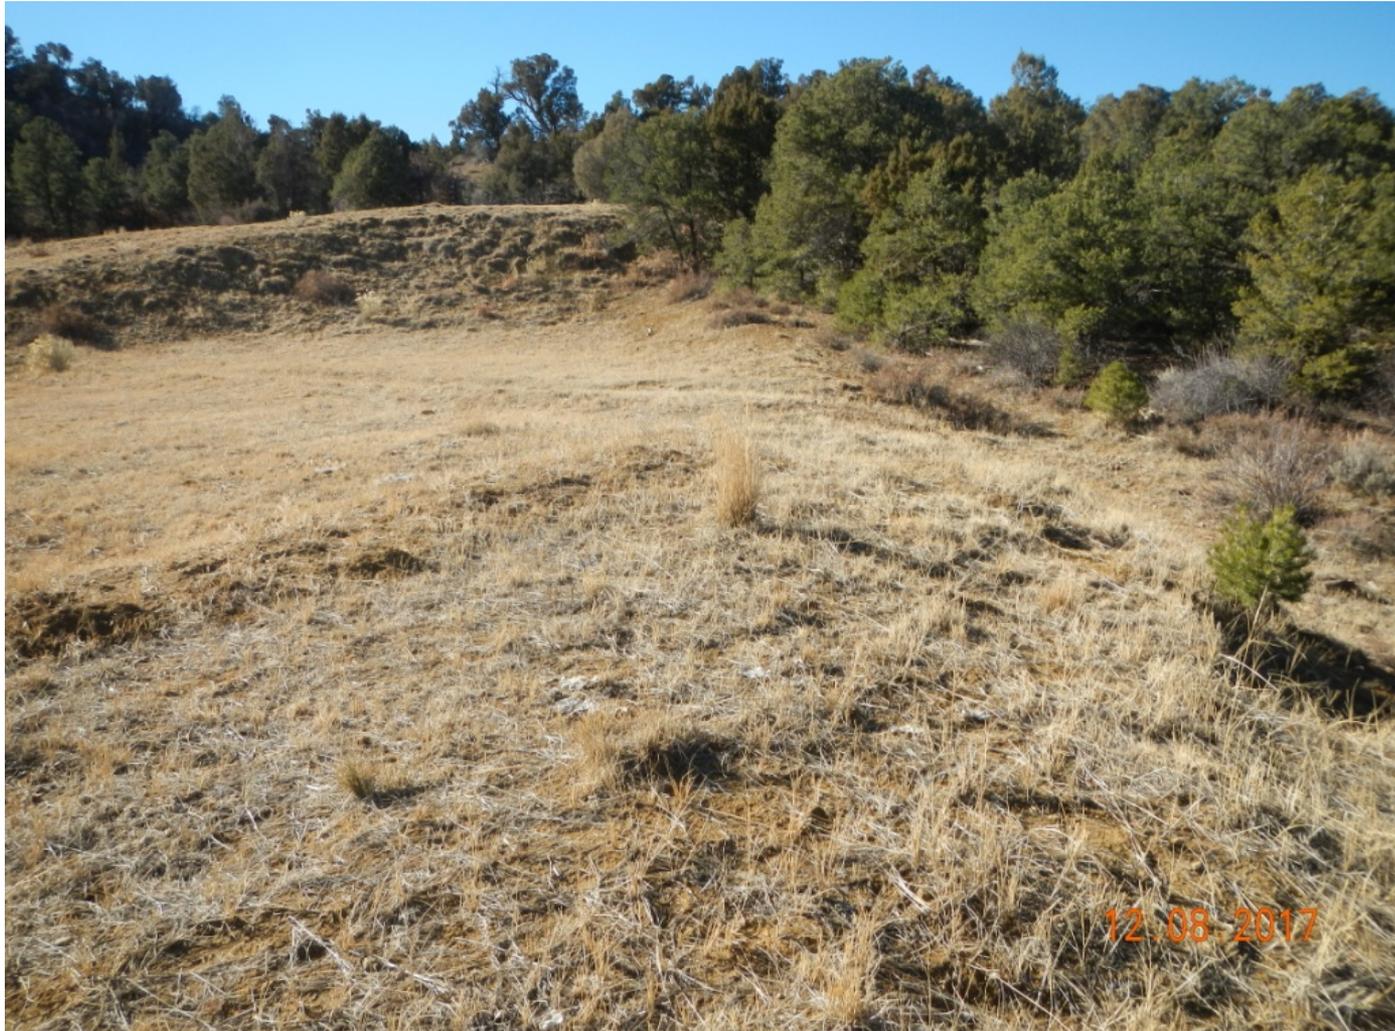
Photo 2. View of the northern portion of the project area from the northern corner facing westward.

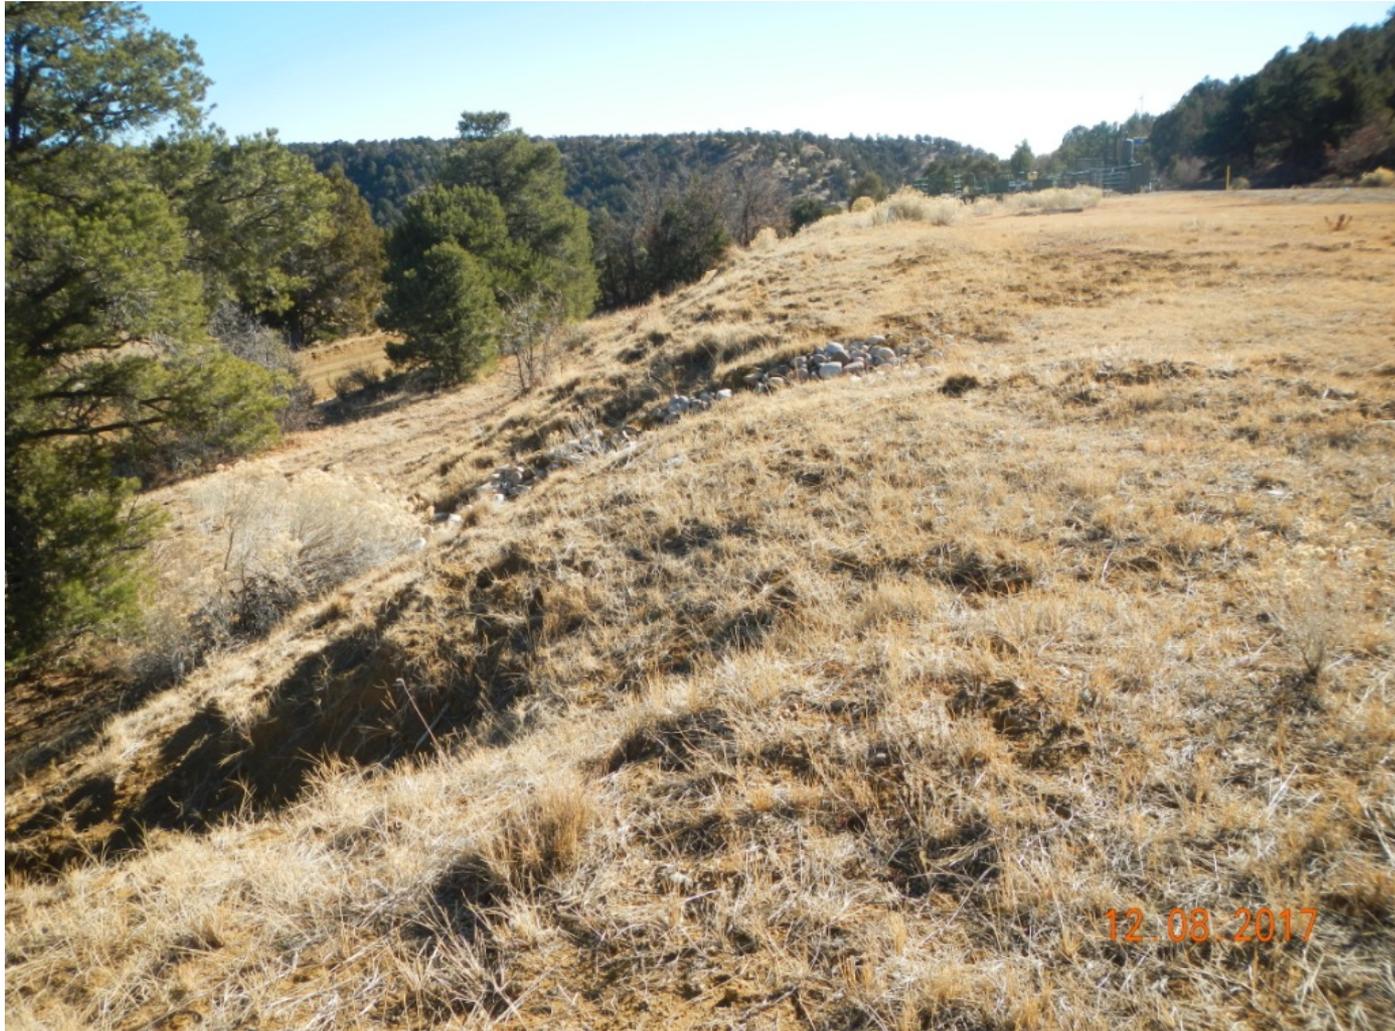
Photo 3. View of the eastern portion of the project area from the northern corner facing southeastward. Revegetation is progressing with grasses and shrubs such as western wheatgrass (*Pascopyrum smithii*) and rubber rabbitbrush (*Chrysothamnus nauseosus*).

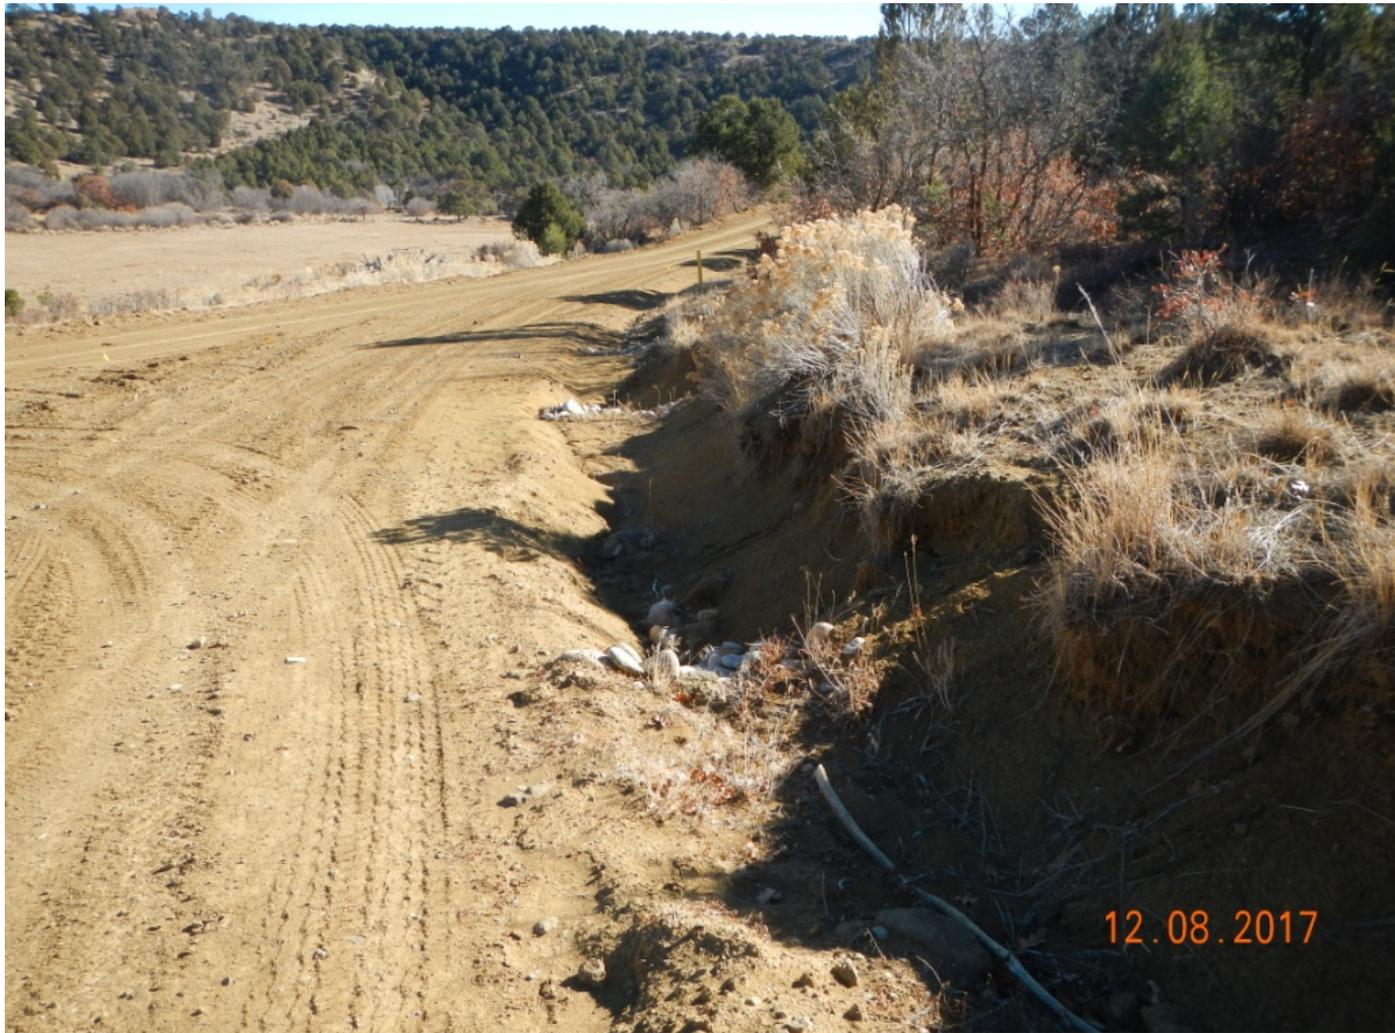
Photo 4. View of check dams along access that are full of sediment and need maintenance.
