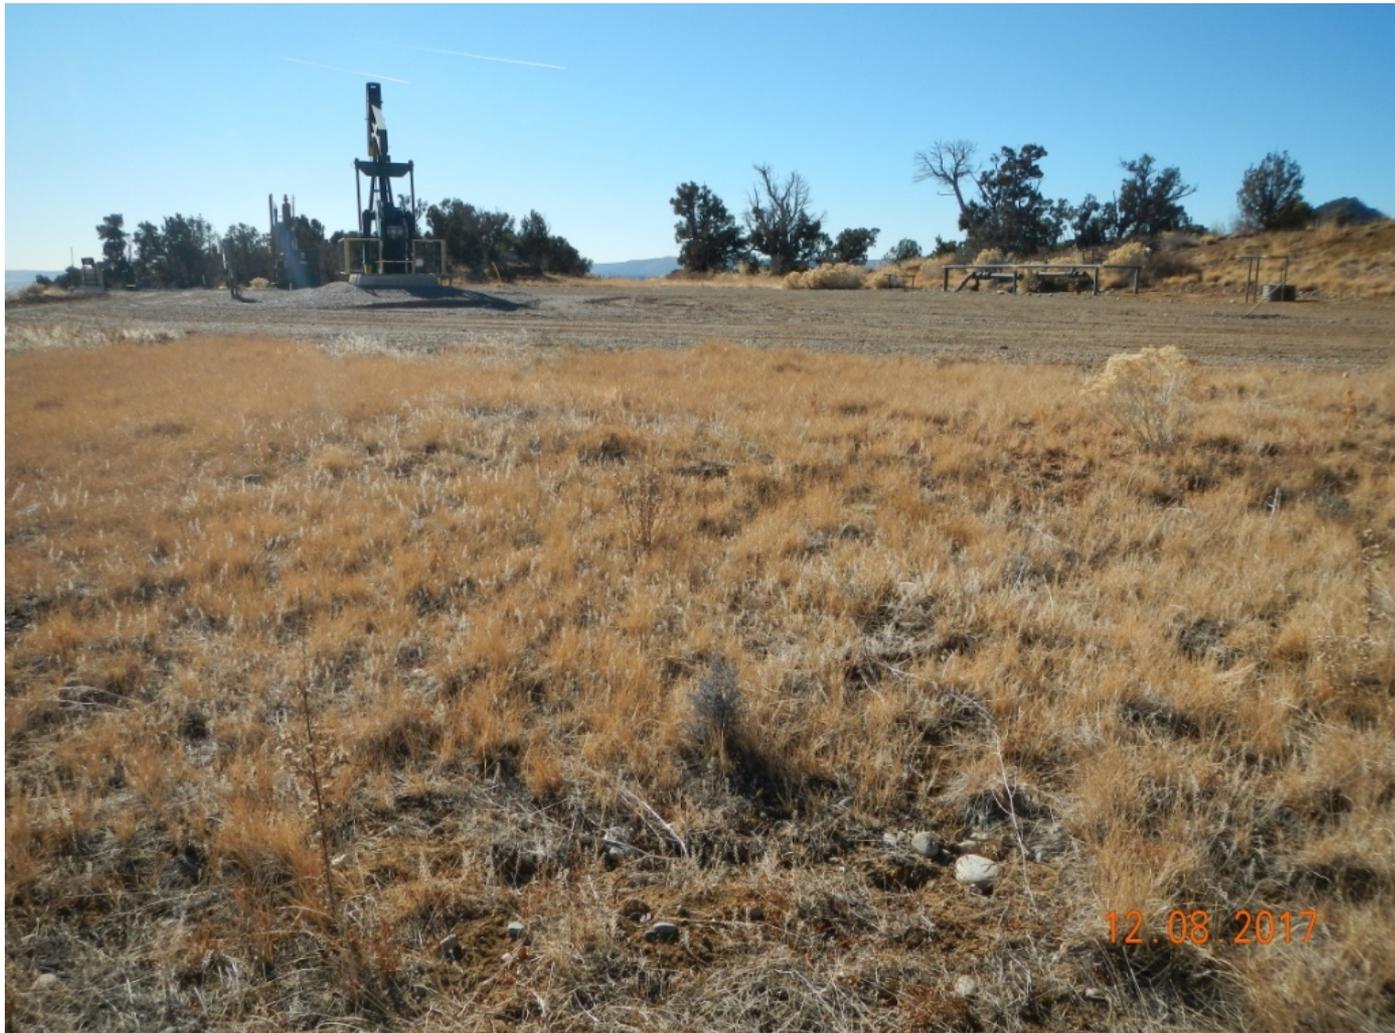
Photo 1. View of the project area from the northeastern corner facing center.

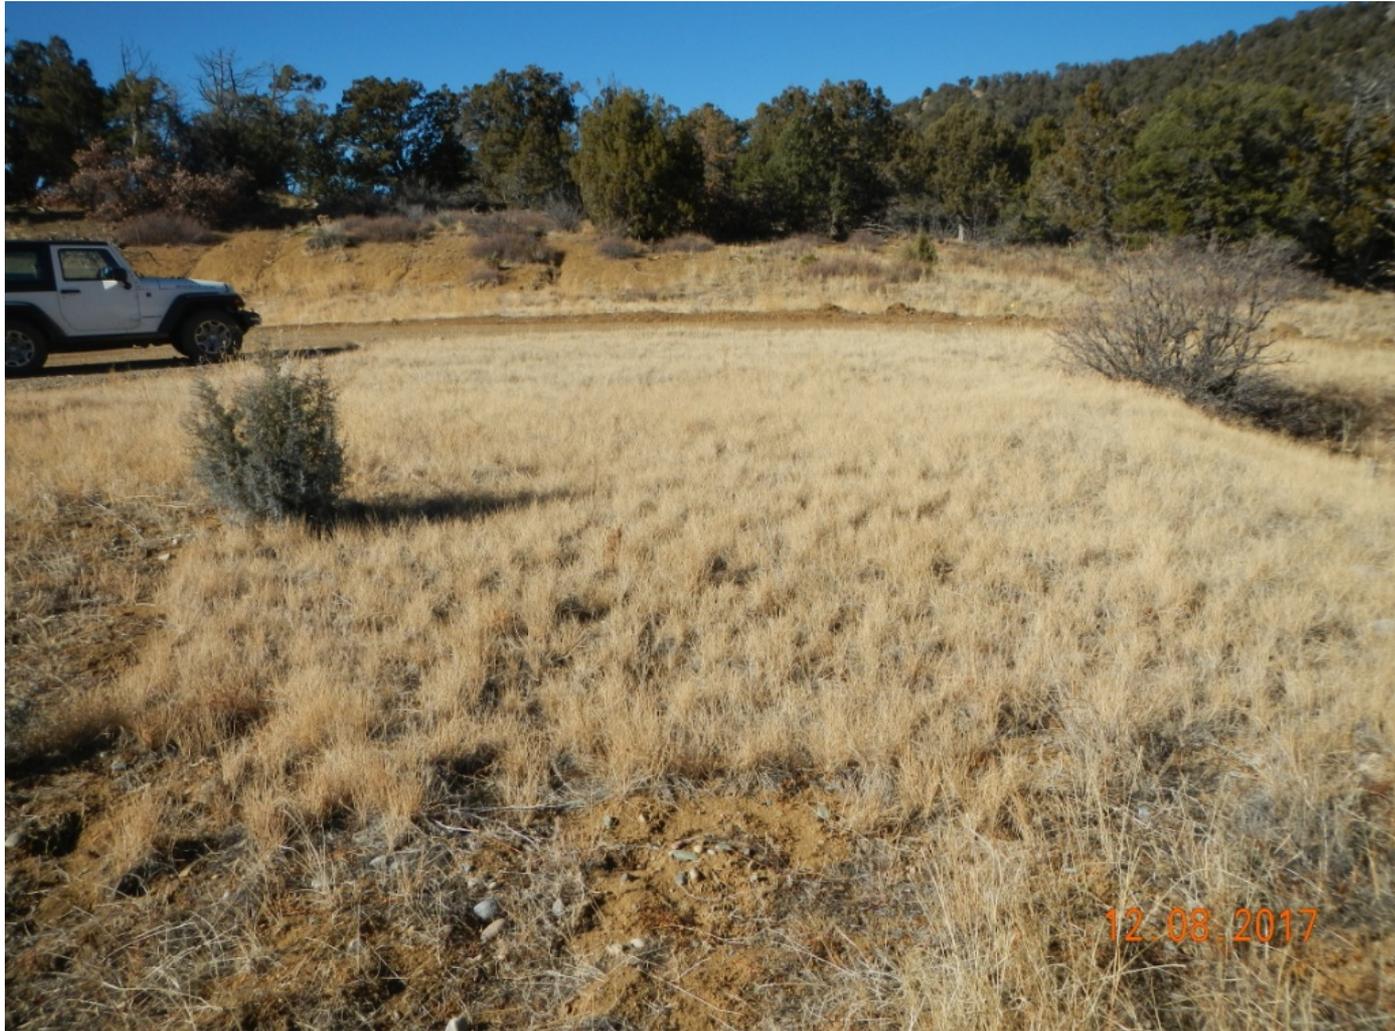
Photo 2. View of the northern portion of the project area from the northeastern corner facing westward.

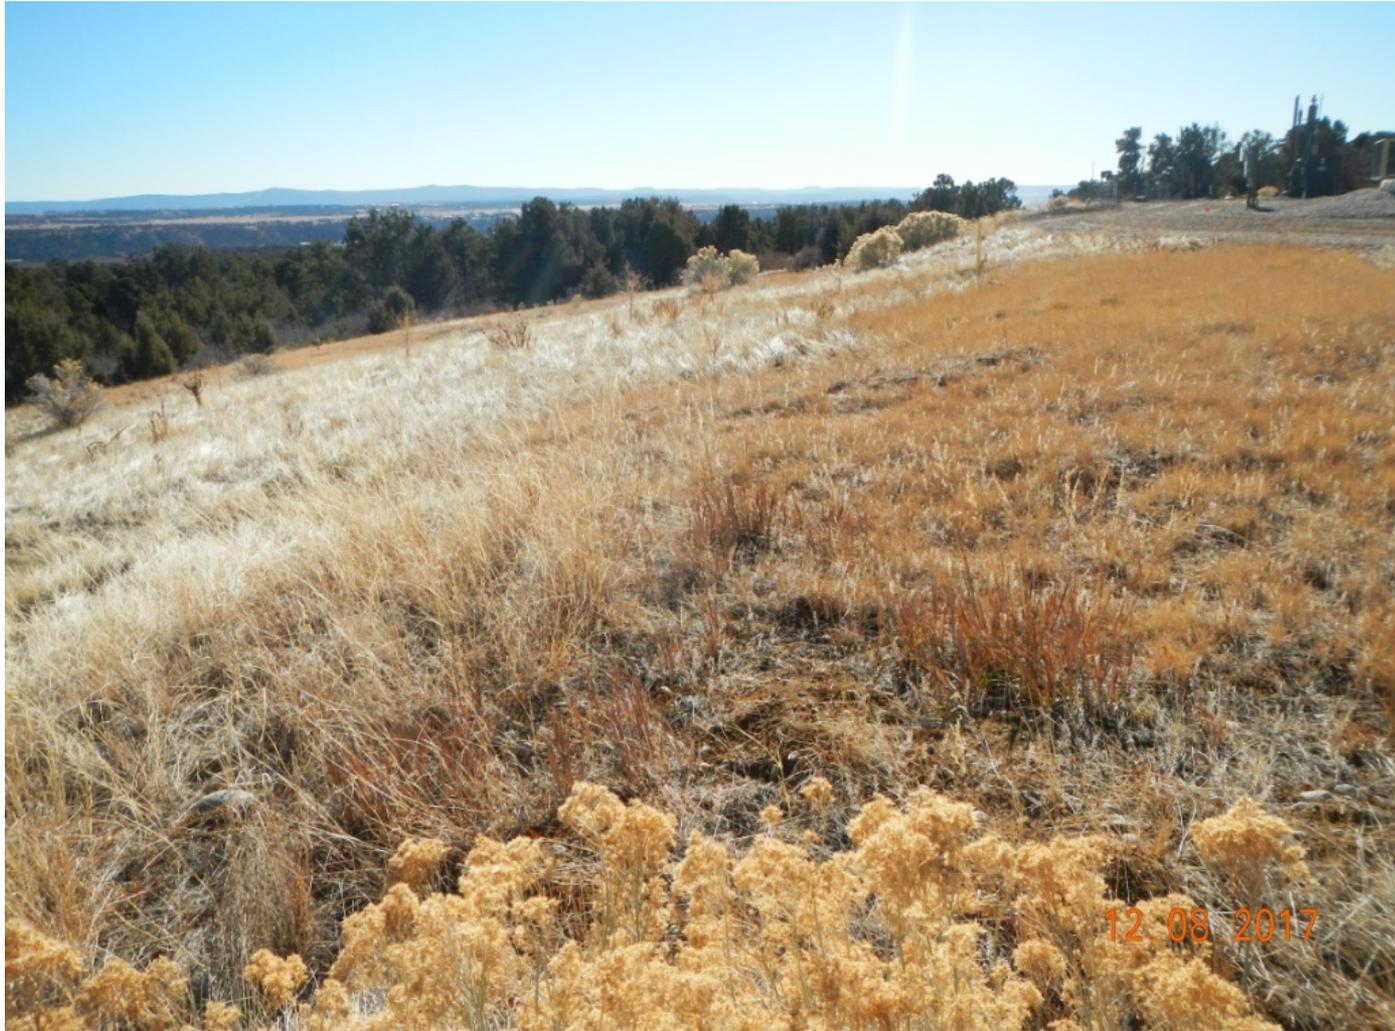
Photo 3. View of the eastern portion of the project area from the northeastern corner facing southeastward. Little soil is present in interim reclamation areas due to dense rocks. Revegetation is progressing in areas with soil.

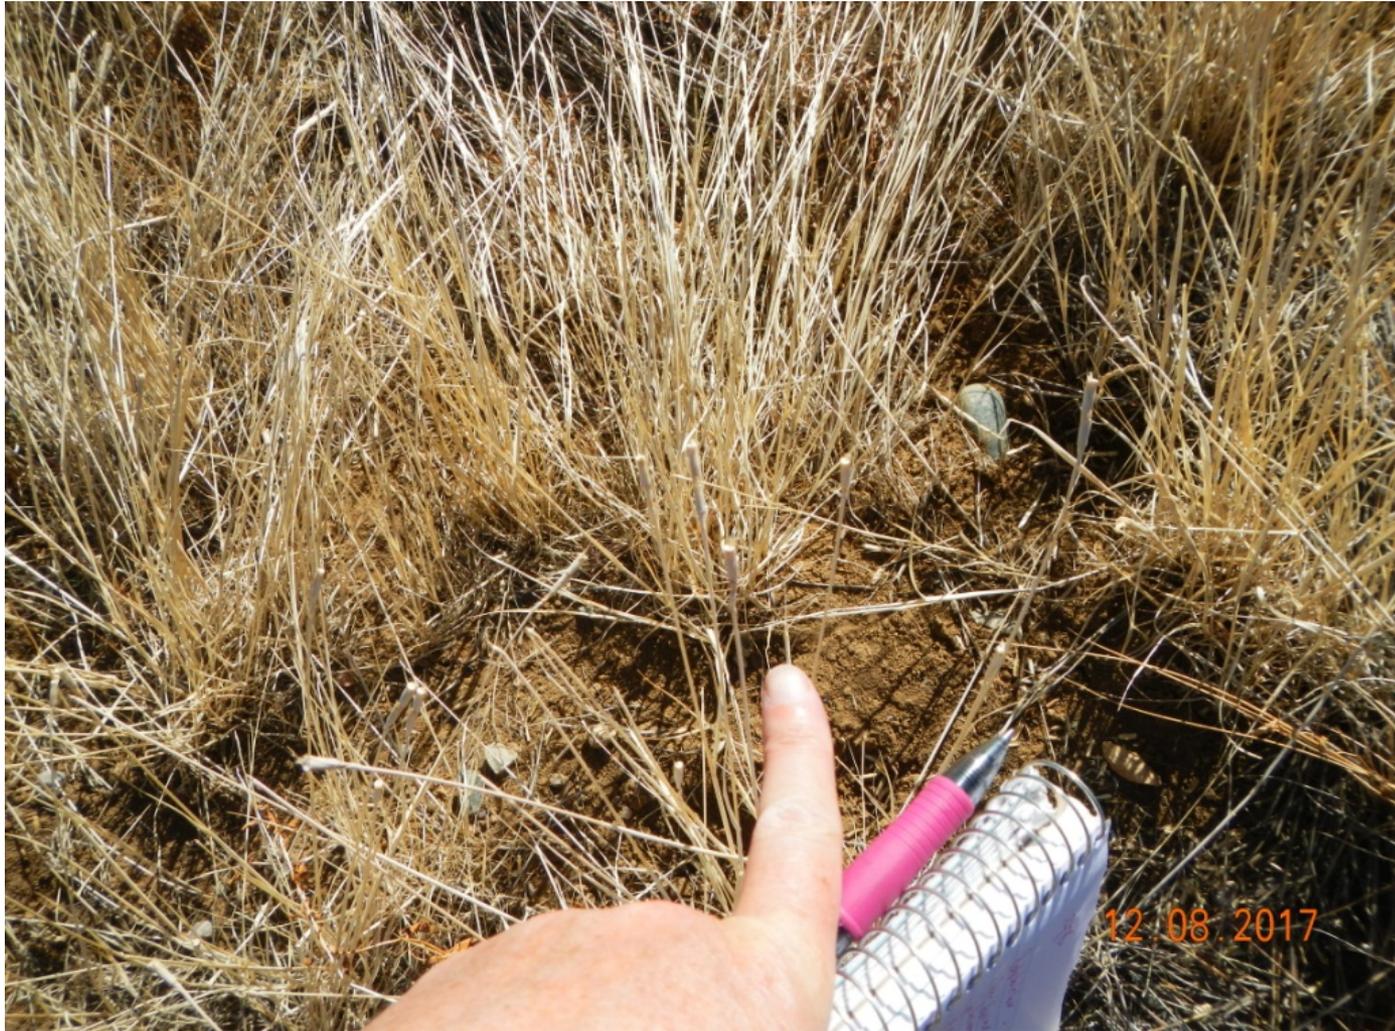
Photo 4. Closeup view of jointed goatgrass (*Aegilops cylindrica*) within the eastern portion of the interim reclamation area. Thousands of individuals from previous growing season observed.

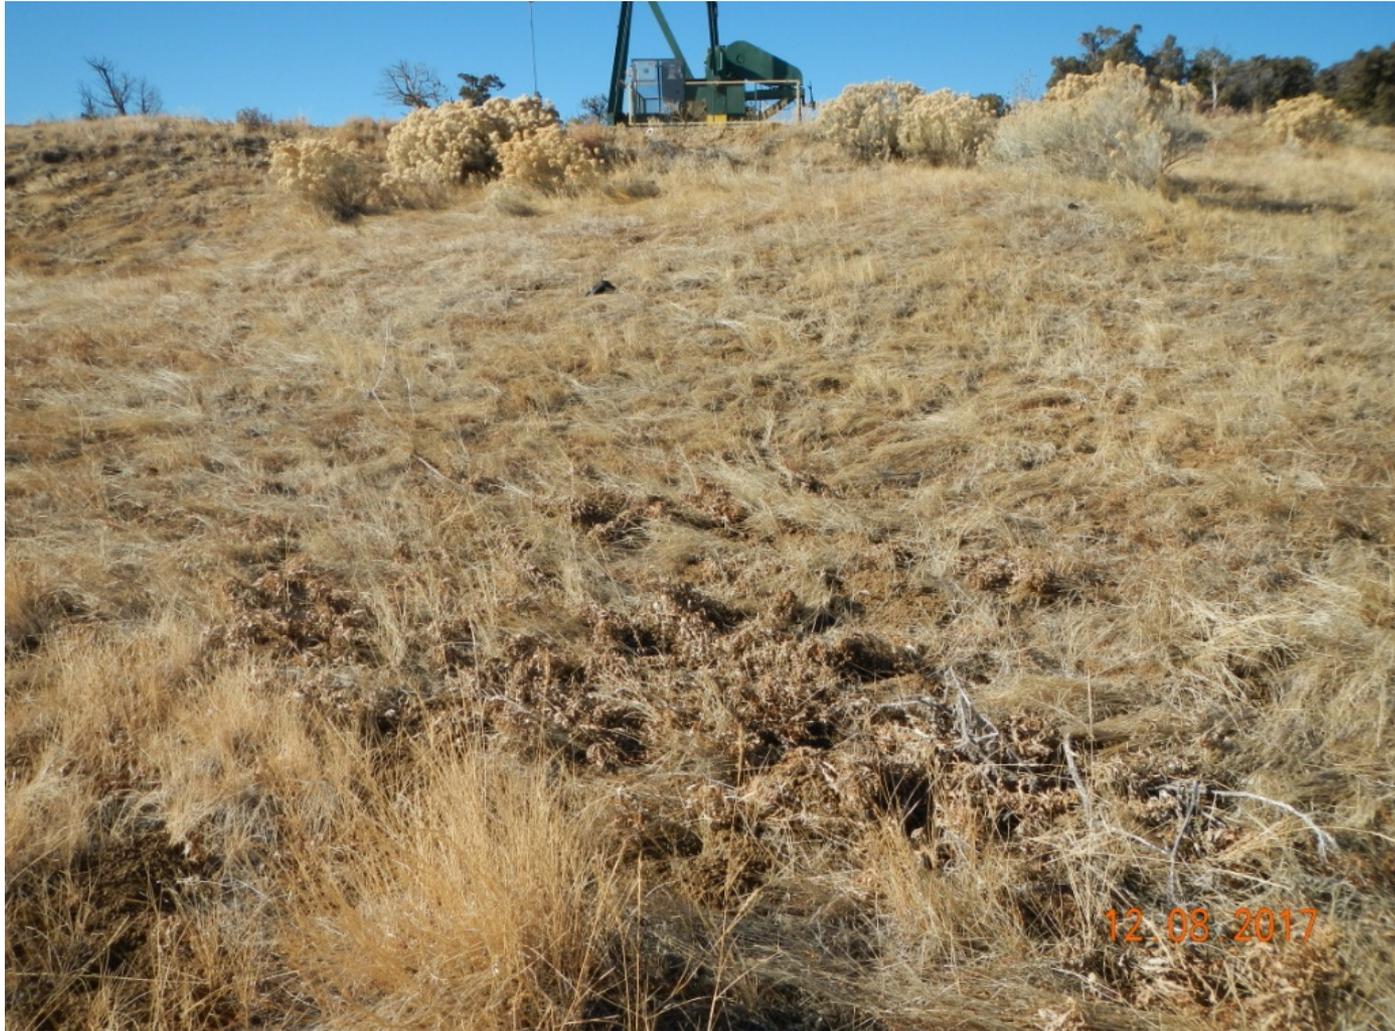
Photo 5. View of approximately 75 Canada thistles (*Cirsium arvense*) within the eastern portion of the project area.
