Inspection Photos 12/20/17
Location Name: Seltzer GU 2-4
API: 05-001-09025

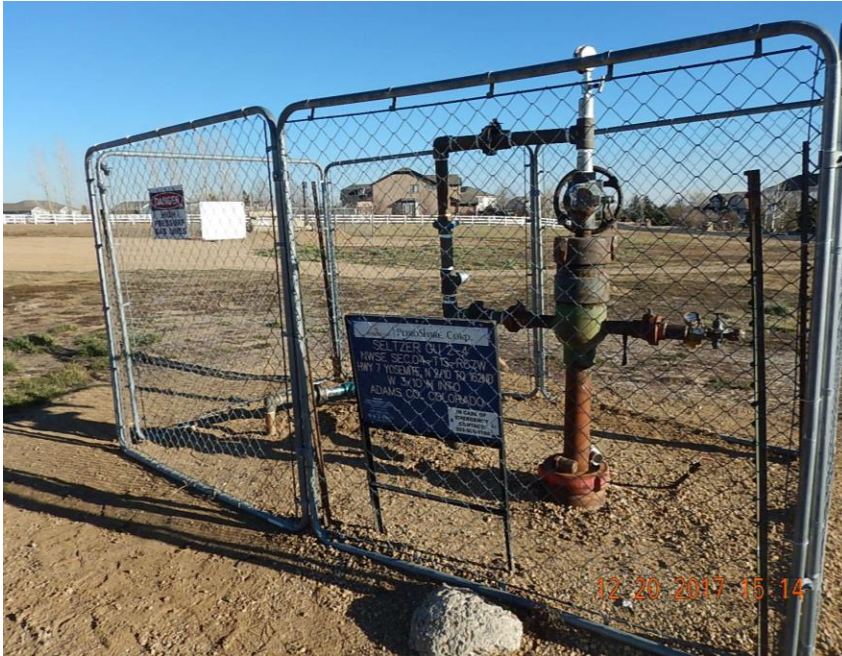
Wellhead and signage

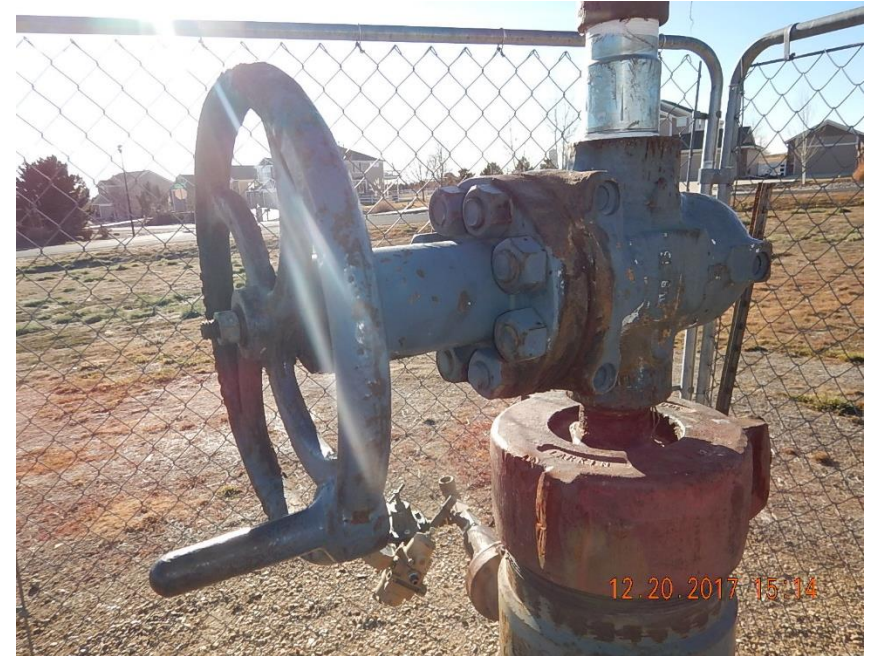
Master Valve – Leak identified at bolt up/ paint removed

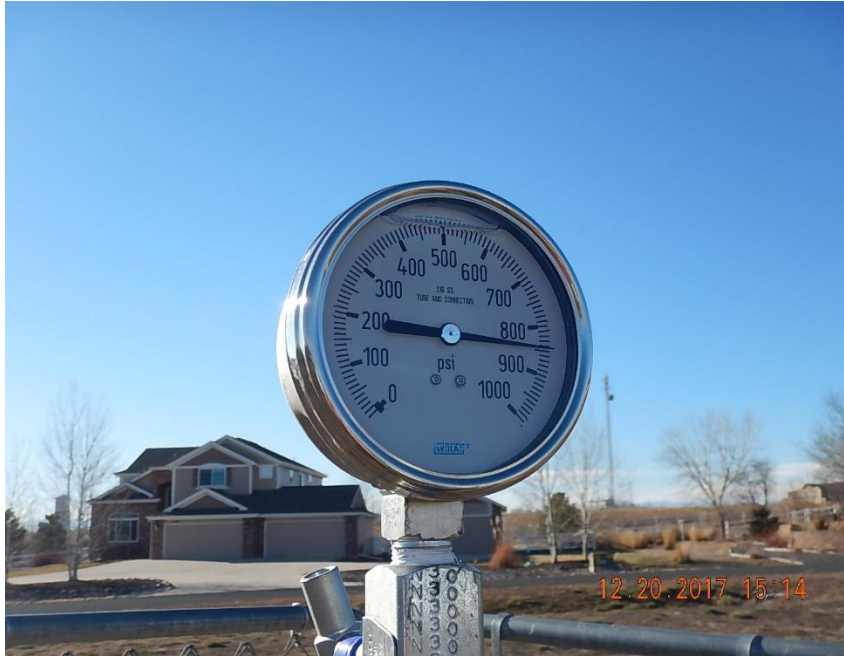
Tubing Gauge showing current pressure

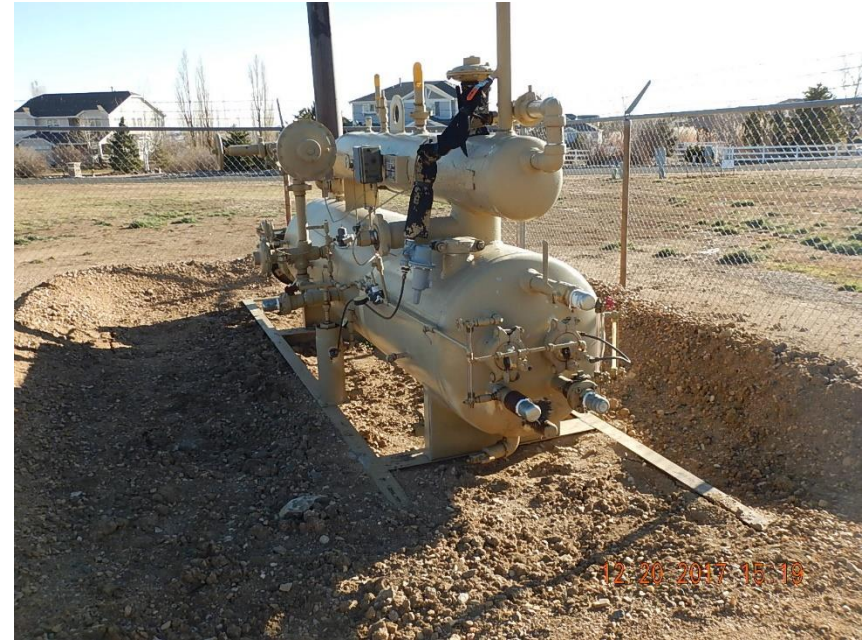
Horizontal separator – Unused equipment

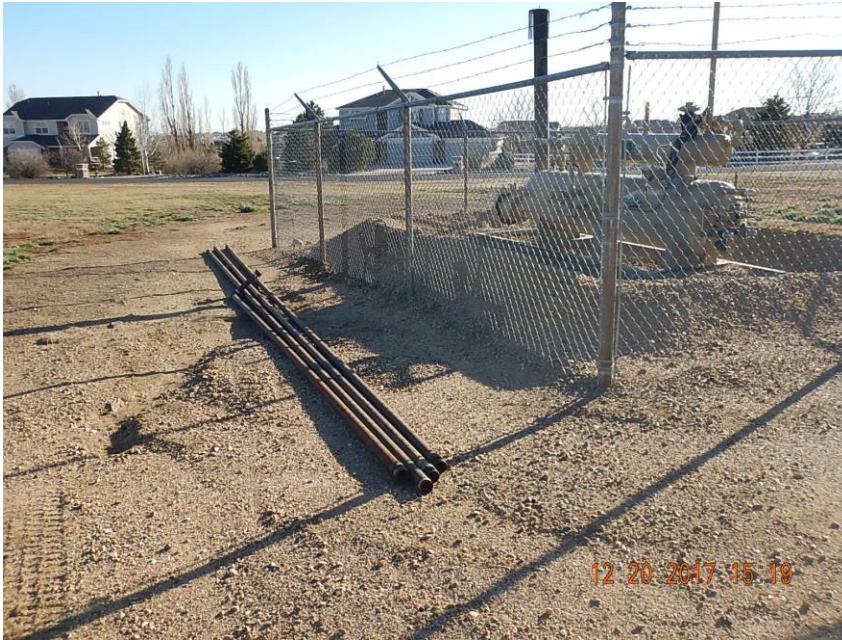
Tubing on North side separator – unused equipment

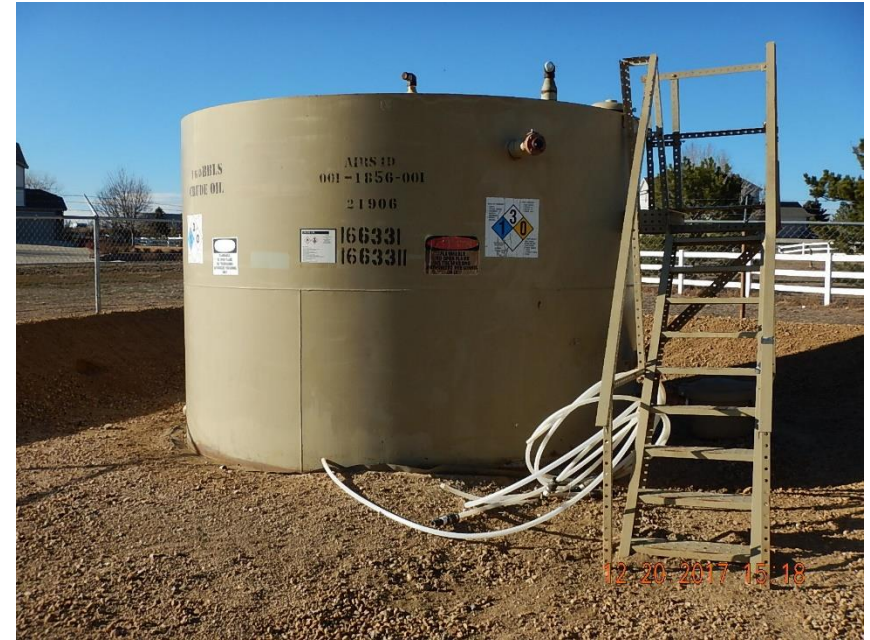
Production tank – unused equipment; poly hose – unused equipment
