Inspection Photos

Location Name: Price-Degenhart 1

API: 05-001-07346

Inspection Date: December 19, 2017

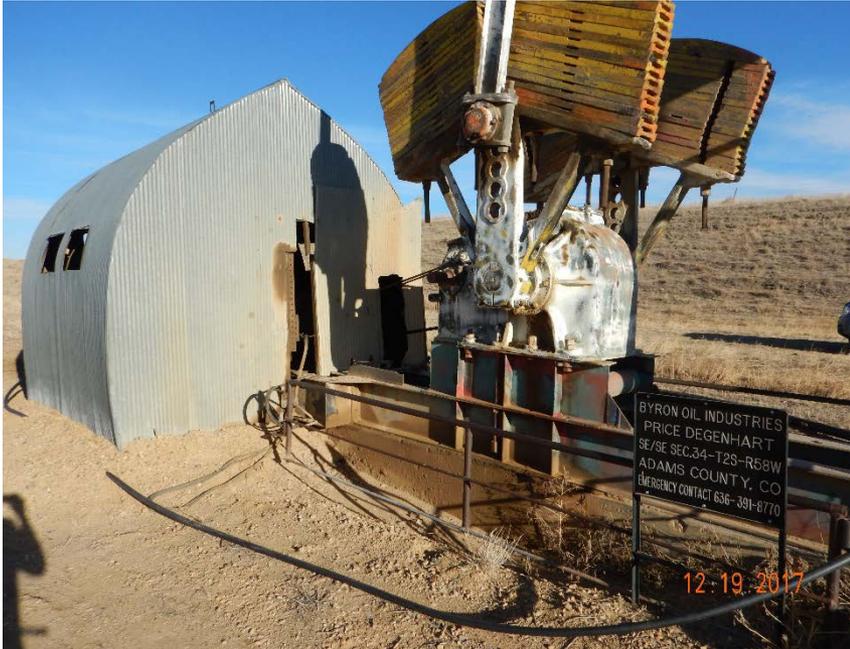
Photo #1 – Well sign with pumping unit and shed.

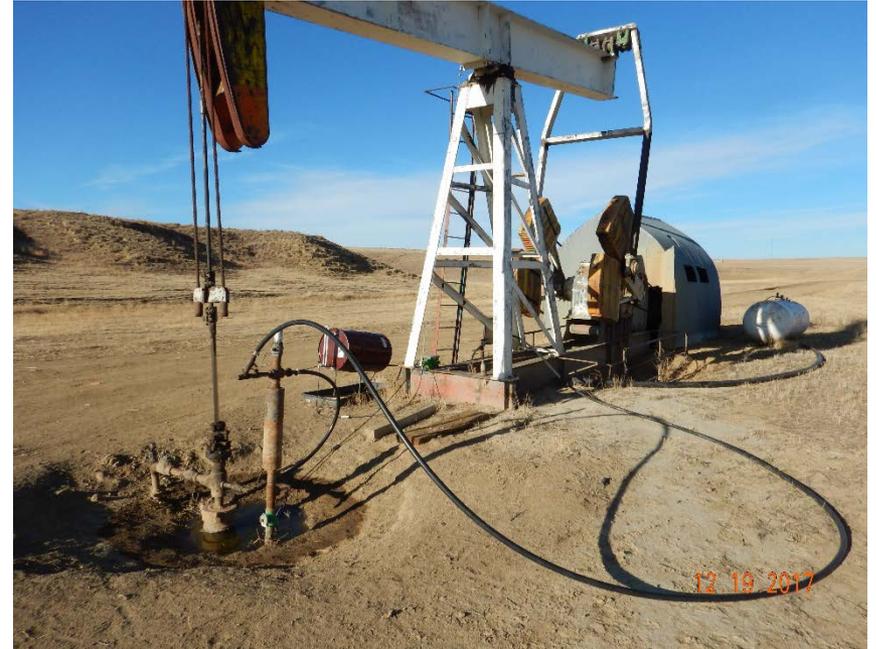
Photo #2 – View of pumping unit from east.

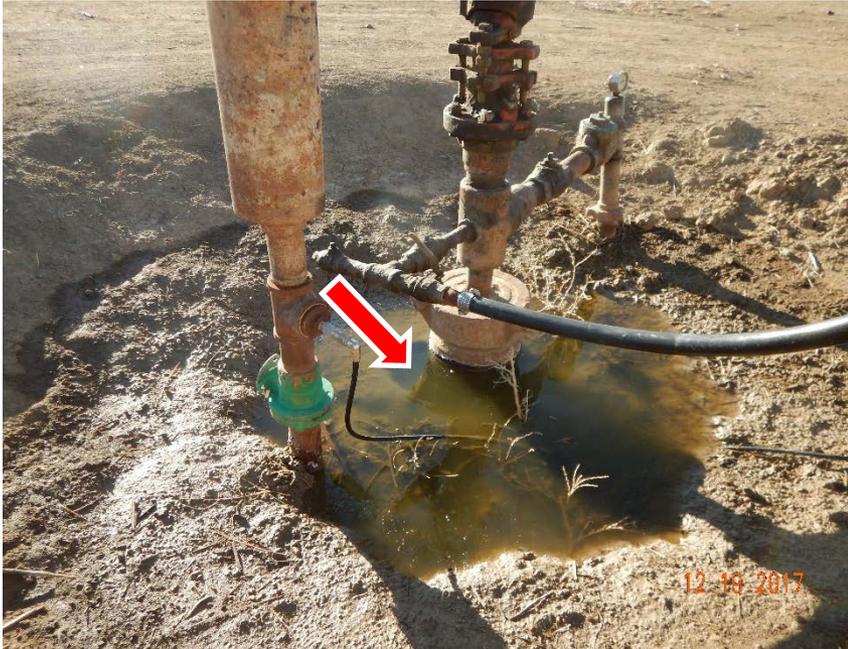
Photo #3 – Pool of water remaining at wellhead has been documented in field inspection reports dating back to June 22, 2017. Periodic bubbling of gas from area beneath wellhead was observed on date of inspection.

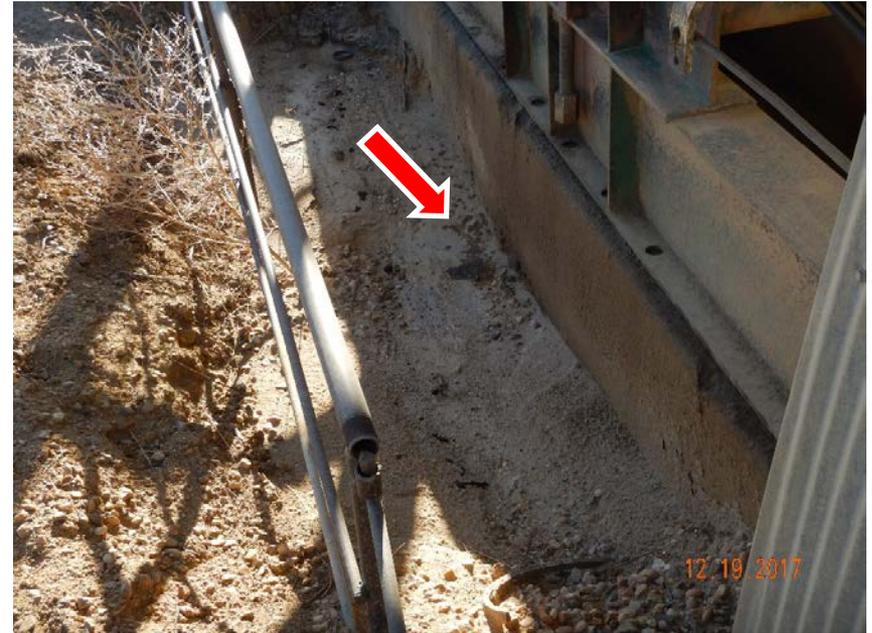
Photo #4 – Localized accumulation of lube oil underlying northeast side of pump jack after oily waste had been removed by operator in response to previous FIRs.

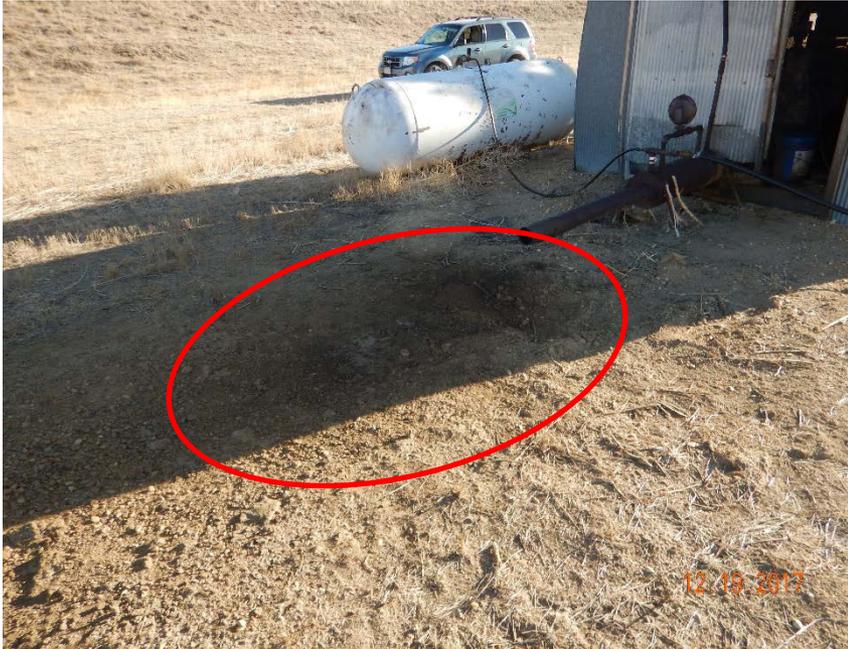
Photo #5 - Localized accumulation of blow-through motor oil underlying muffler at NW end of pump jack after oily waste had been removed by operator in response to previous FIRs.

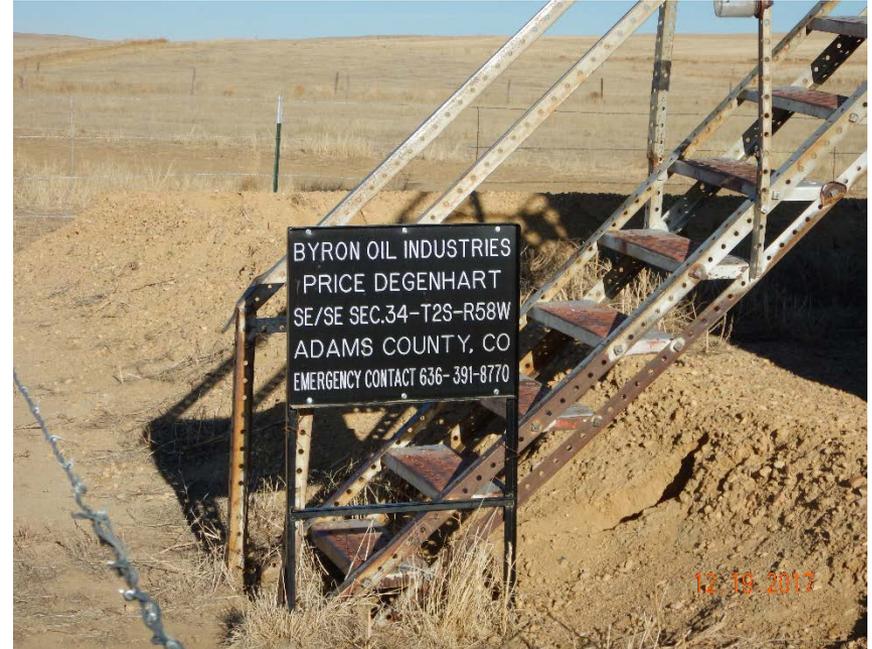
Photo #6 – Battery sign.

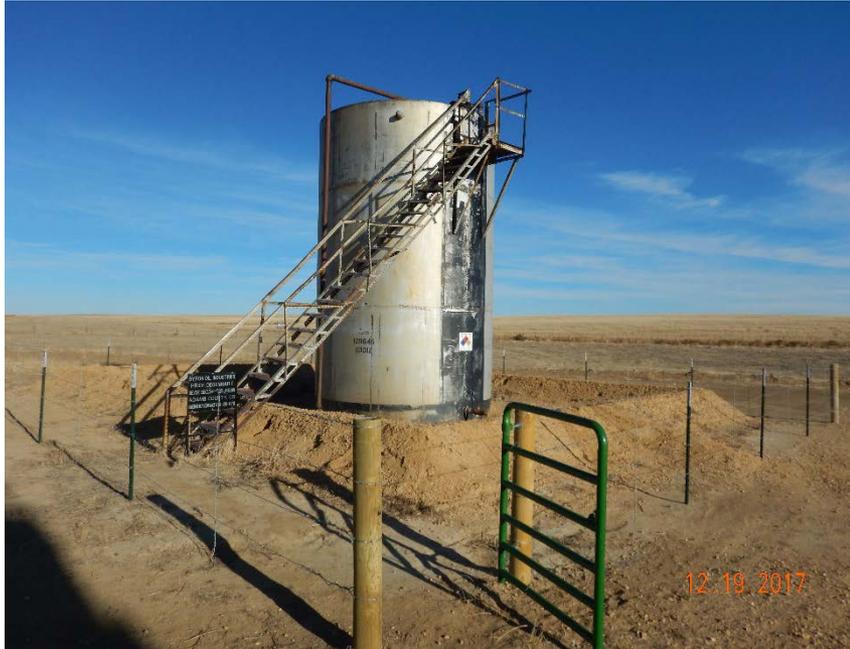
Photo #7 – Barbed wire fence has been installed around crude oil AST. Berm had been repaired in response to previous FIRs.

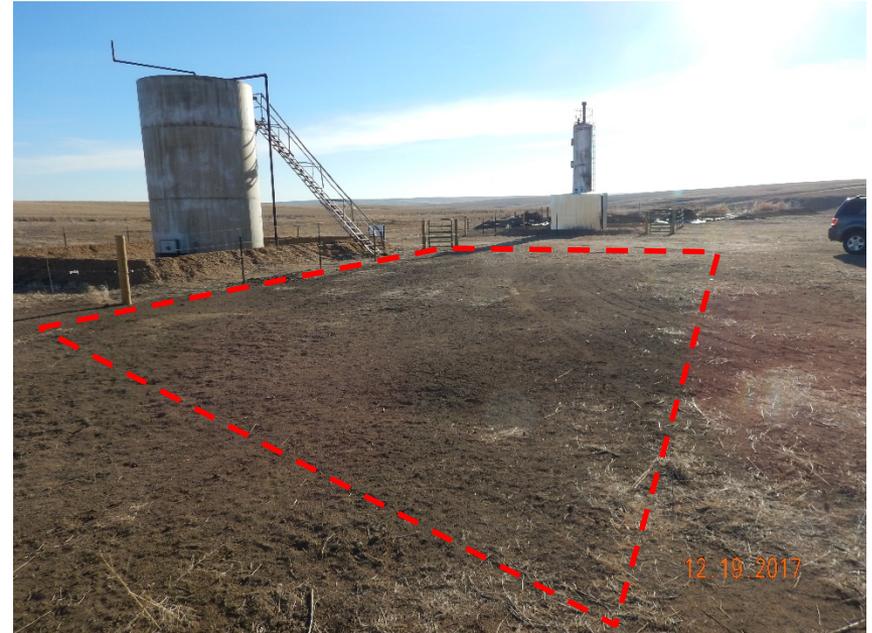
Photo #8 - Modular, steel ASTs had been removed from area west of 300 bbl crude oil AST prior to inspection date, view from NW.

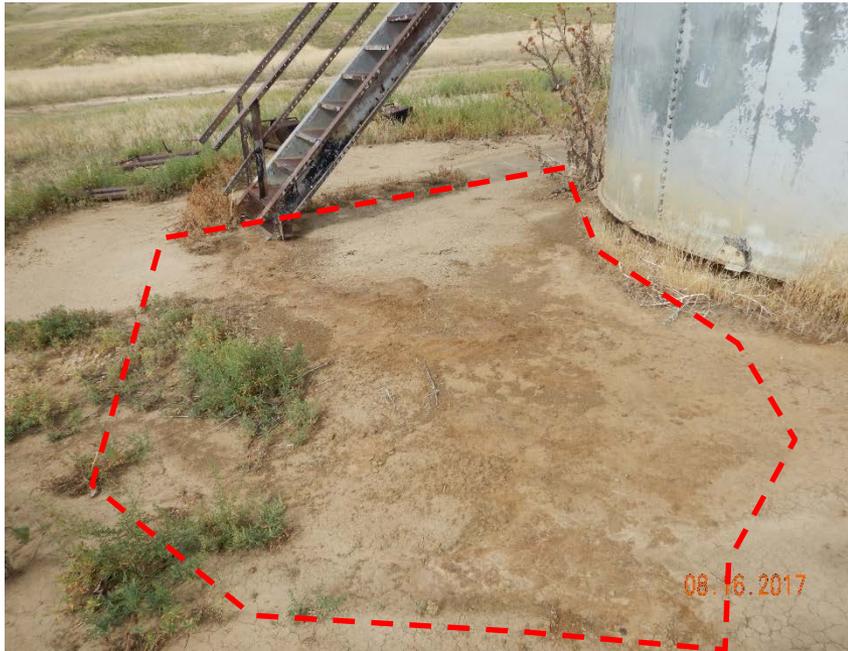
Photo #9 – Photo from **AUGUST 16, 2017** illustrates historical accumulation of oily waste underlying area south of modular steel ASTs, which were removed prior to 12/19/2017 FIR. No visual evidence remains of these impacts as of 12/19/2017.

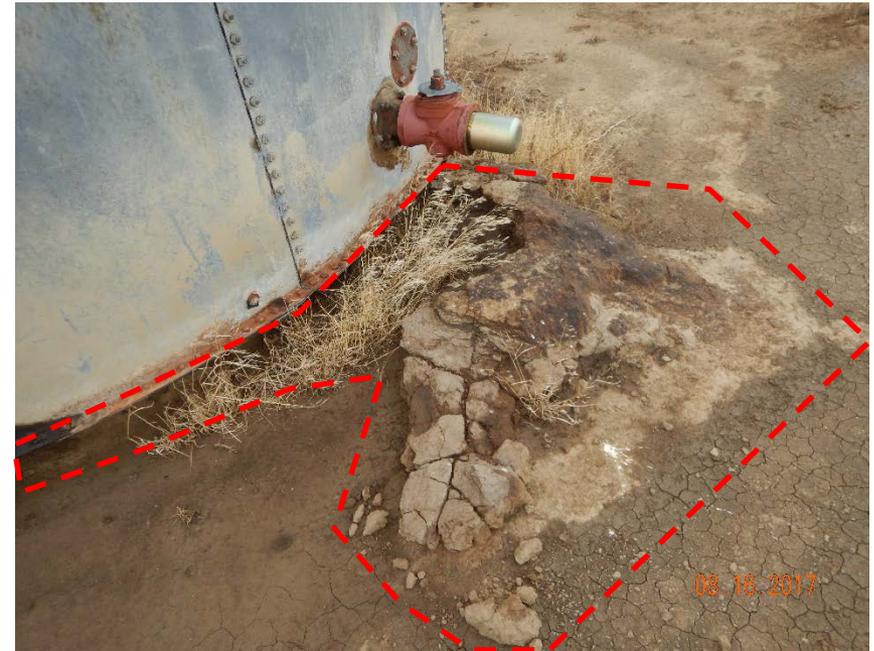
Photo #10 - Photo from **AUGUST 16, 2017** illustrates historical accumulation of oily waste underlying modular steel ASTs, which were removed prior to 12/19/2017 FIR. No visual evidence remains of these impacts as of 12/19/2017.

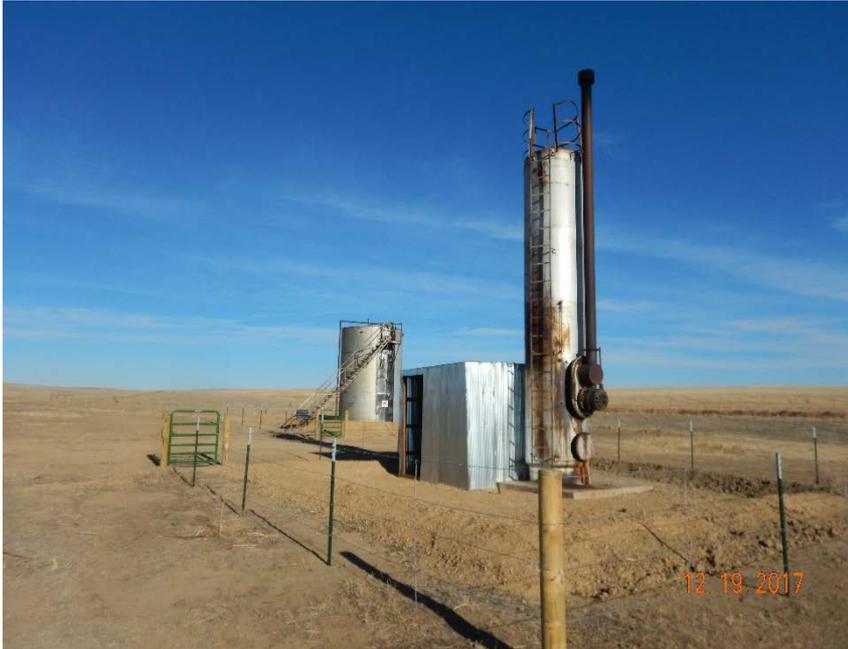
Photo #11 – View of vertical heater treater (VHT) with recently-installed fence and shed from SW corner.

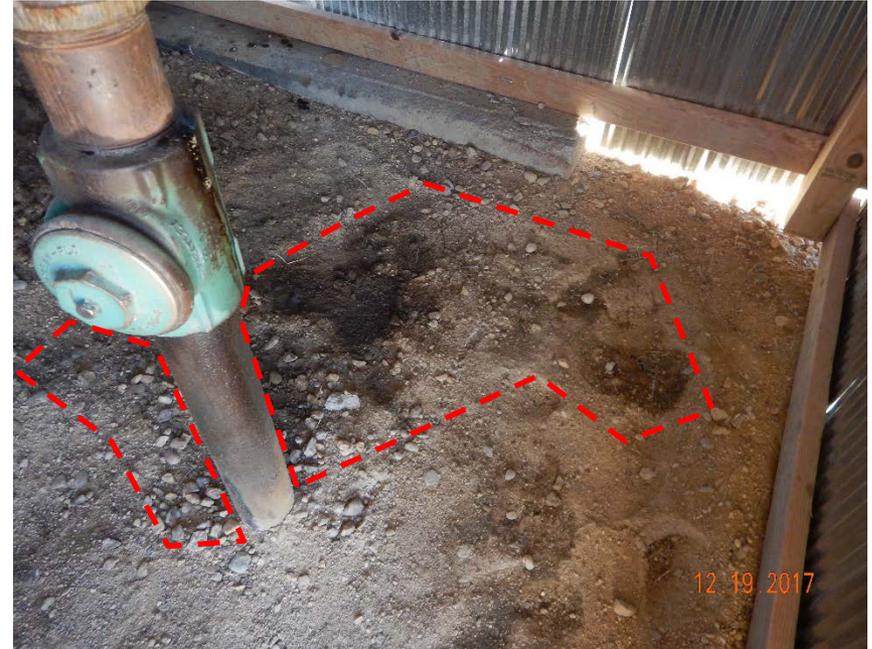
Photo #12 – Localized accumulation of oily waste inside of VHT shed.

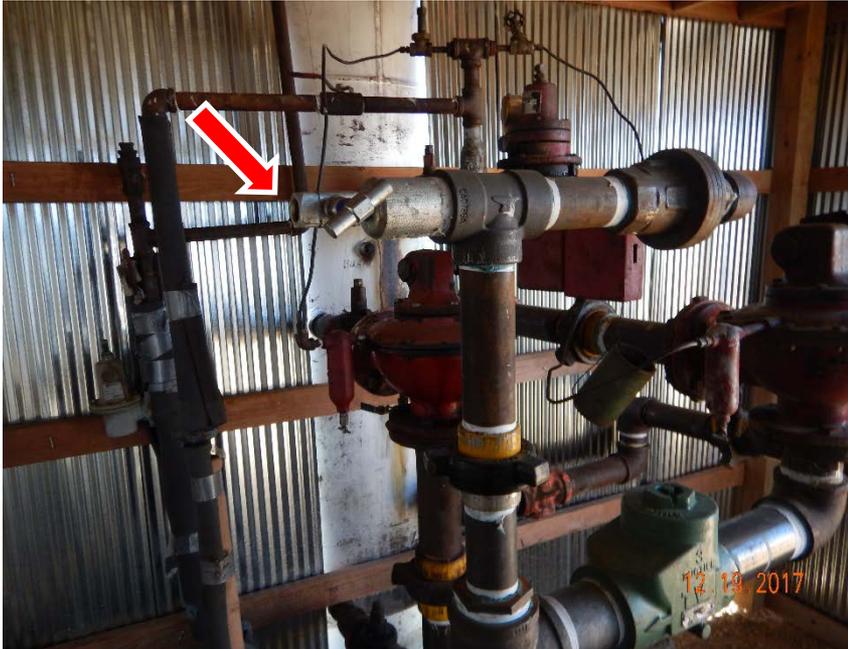
Photo #13 – View of valve that was most likely source of audible gas leak that was observed on inspection date. COGCC Inspector’s personal four-gas meter detected measurable concentrations of H_2S inside of VHT shed.

Operator’s pumper was notified of leak on 12/20/2017.

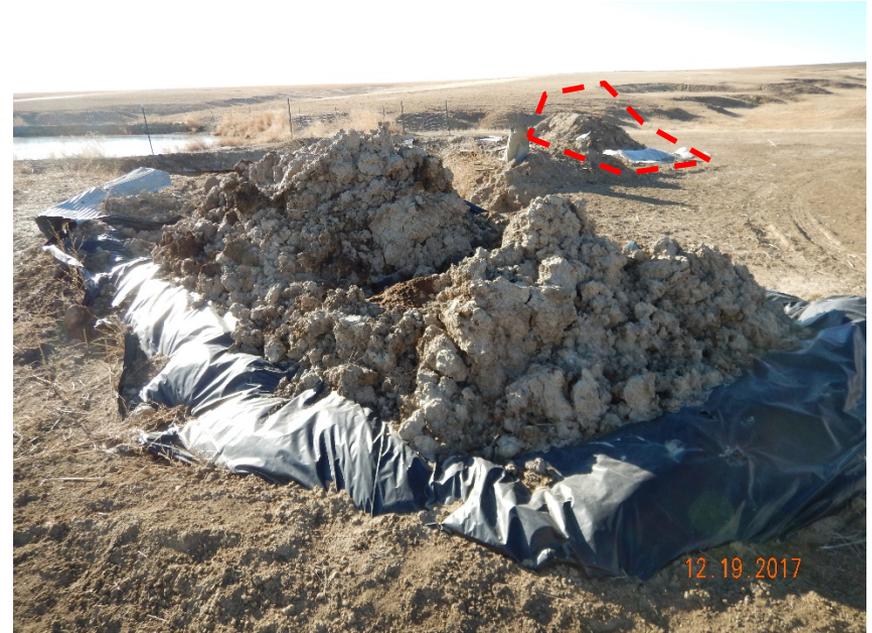
Photo #14 – Stockpiles of oily waste with debris located at NE and NW (background) corners of excavated skim pit. Note corrugated metal debris present inside of stockpiles and excavation.

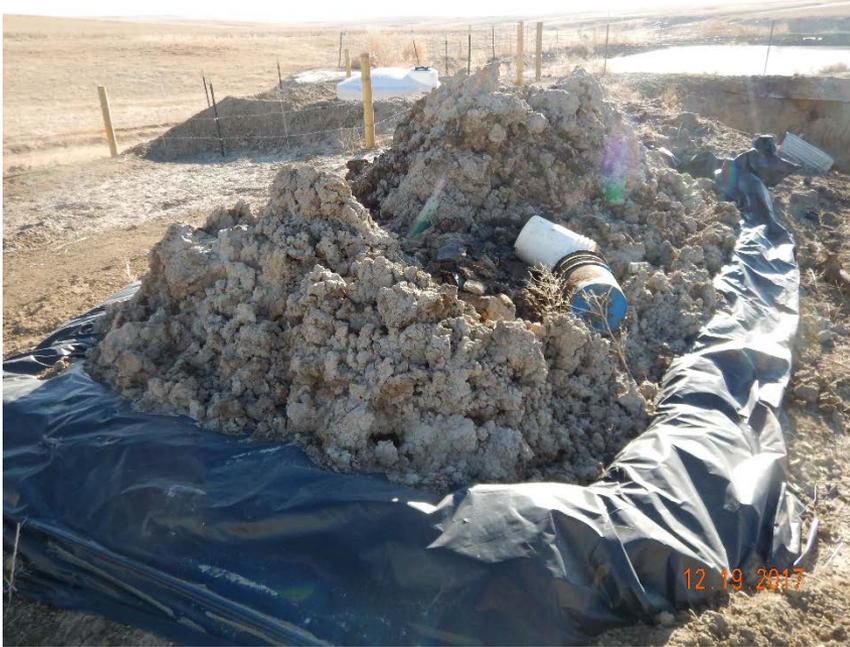
Photo #15 – View of NW lined stockpile of oily waste and debris. Note fenced skim tank with earthen berm in background.

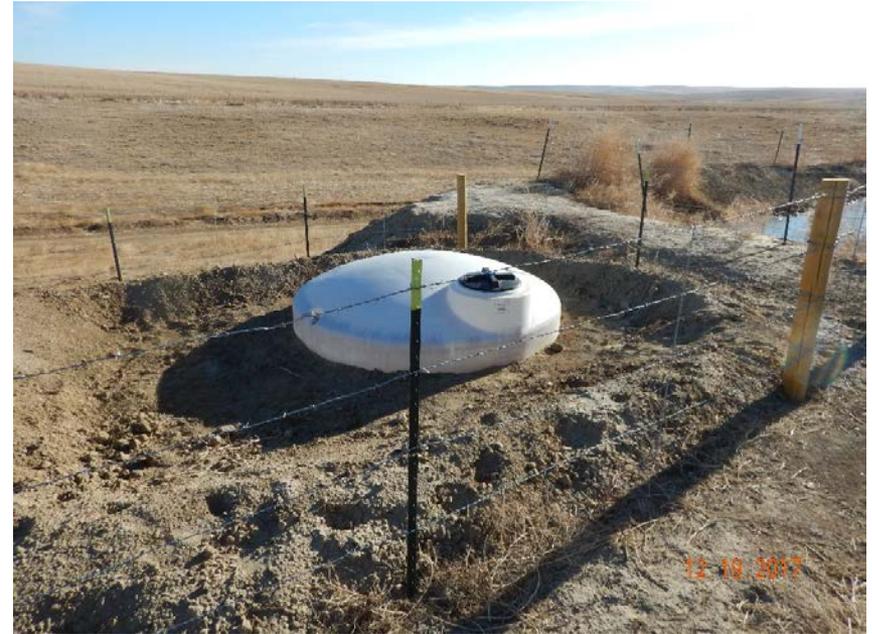
Photo #16 – View of skim tank from west. Tank lacked required volume/content labels and NFPA placard on inspection date.

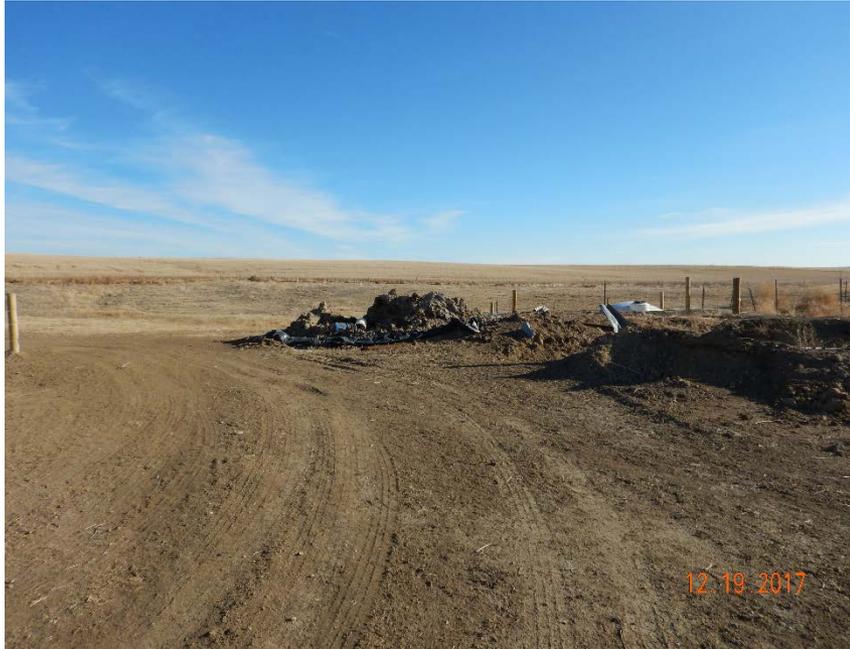
Photo #17 – View of junk and debris north of produced water pit.

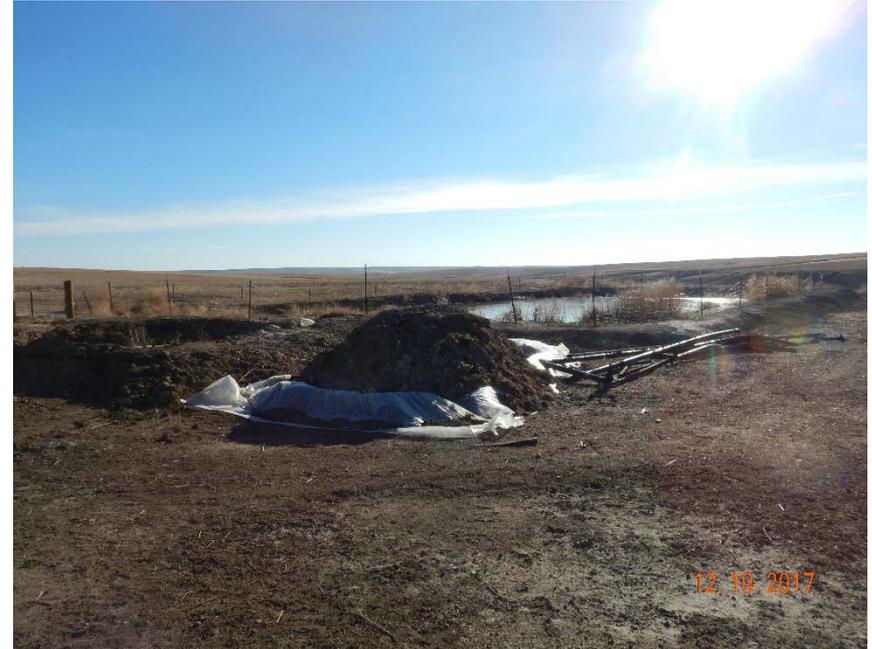
Photo #18 – View of lined oily waste stockpile and junk pipe/flowlines NW of pit.

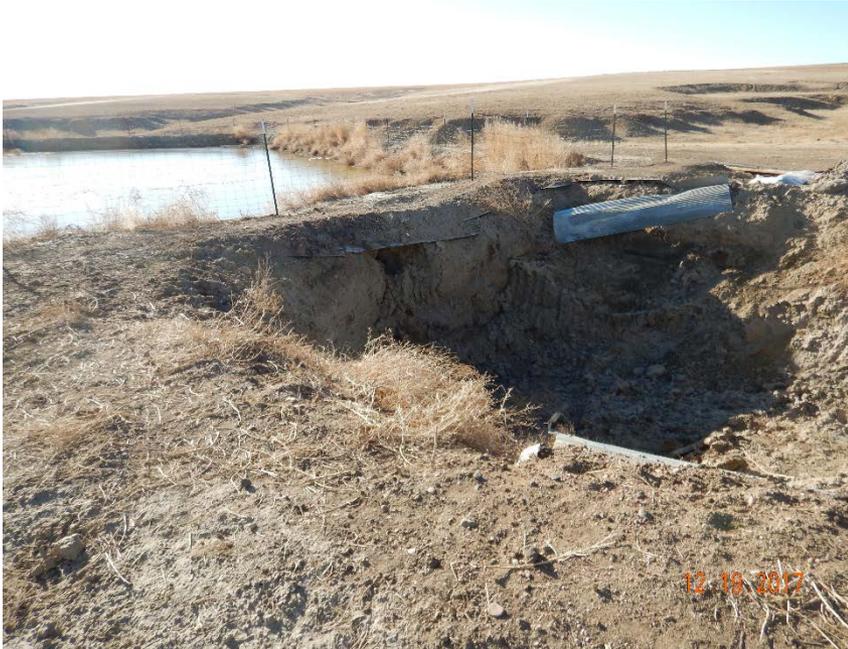
Photo #19 – Junk corrugated metal and wood debris inside of former skim pit excavation (1).

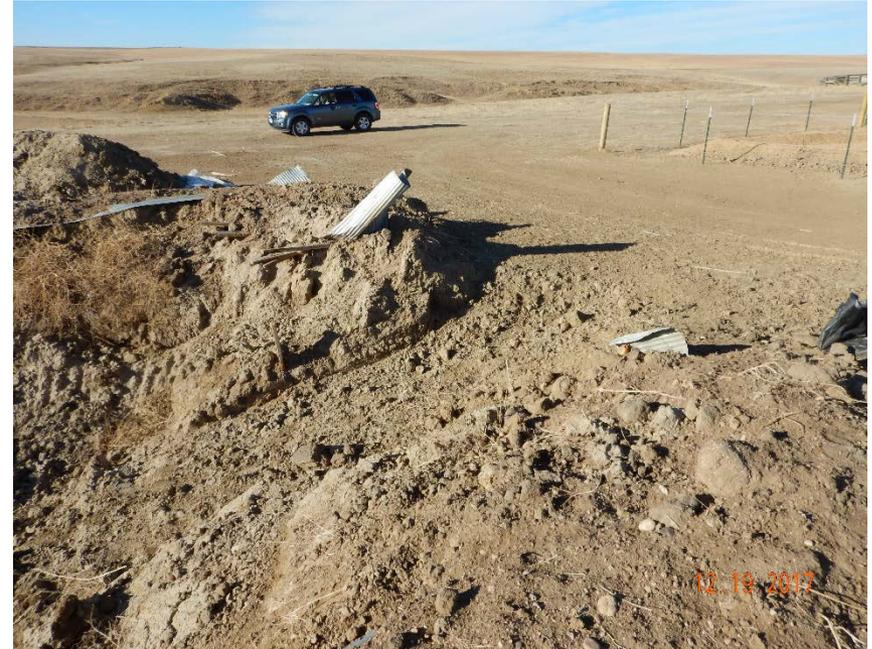
Photo #20 - Junk corrugated metal and wood debris inside of former skim pit excavation (2).

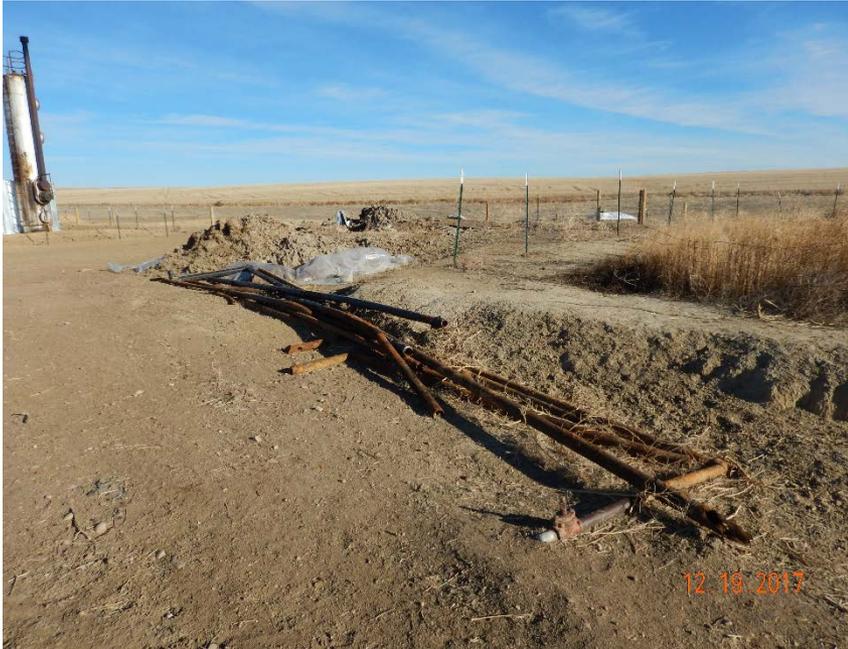
Photo #21 – Junk pipe/flowlines located NW of produced water pit.

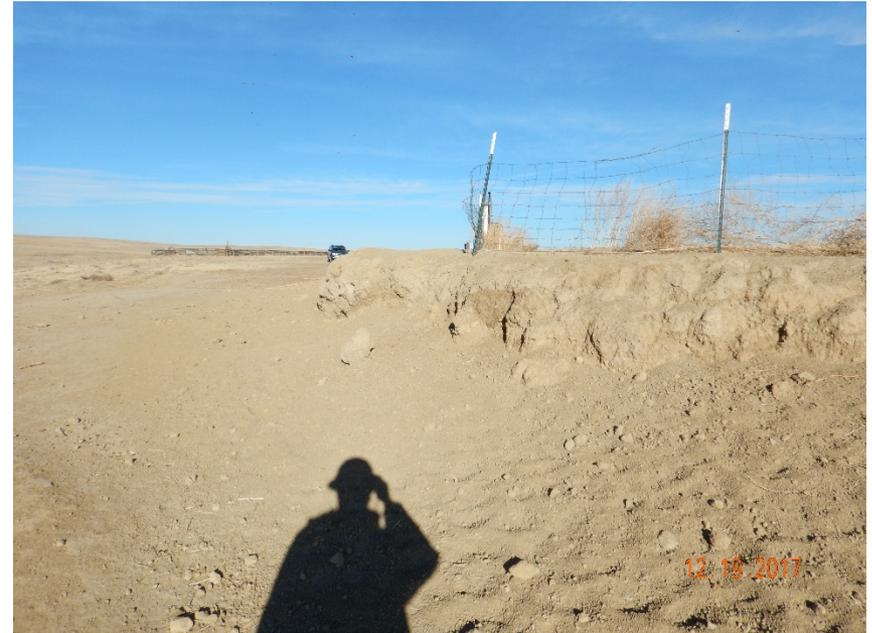
Photo #22 – View of eroded produced water pit berms, looking NW.

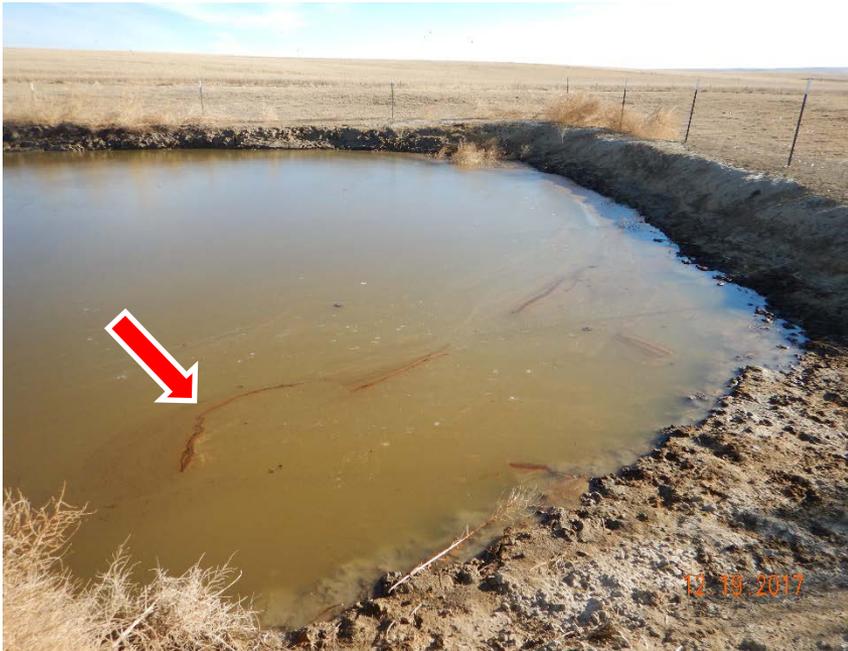
Photo #23 – Trace amount ($\ll 1\%$) of free-phase hydrocarbons remained on produced water pit on inspection date.

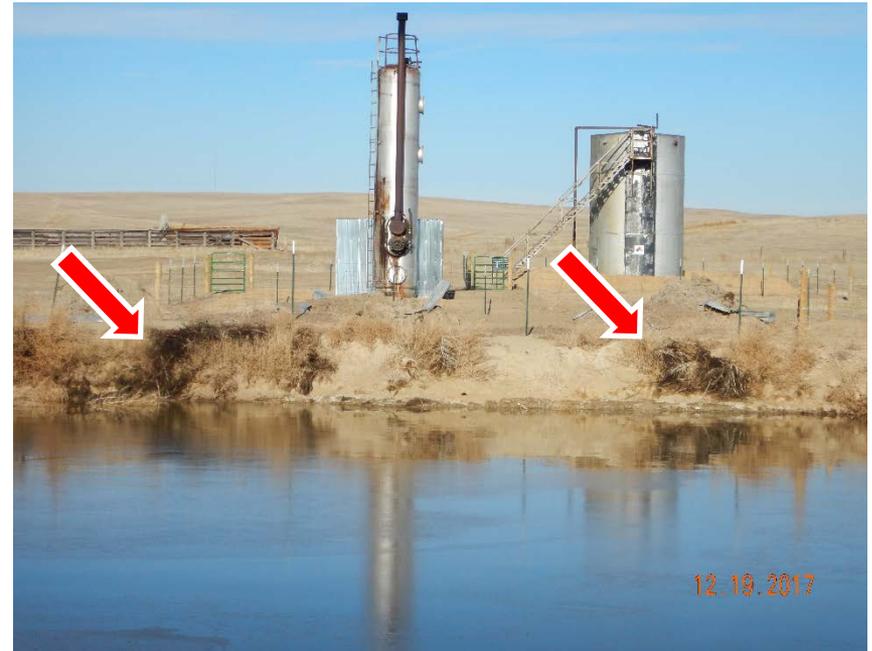
Photo #24 – View of oil-stained soil and vegetation inside of northern pit berm (from South).
