Interim Reclamation Inspection

December 18, 2017

Operator: CRESTONE PEAK RESOURCES OPERATING LLC- #10633

Location ID: 435070

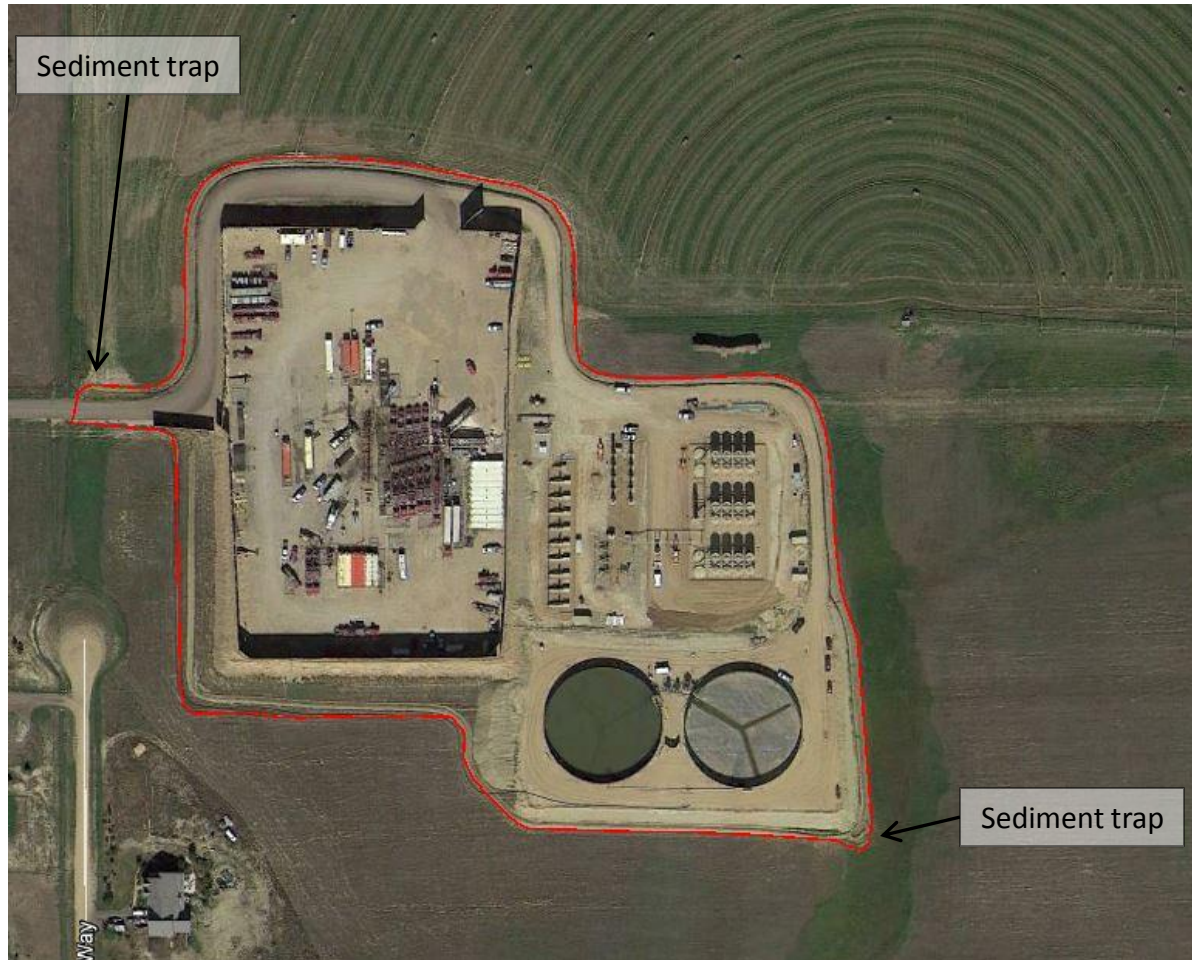
Google Earth aerial imagery from October 6, 2014 during drilling operations illustrates the total disturbance to be approximately 13.70 acres. This location is not in compliance with the approved Form 2A for the permitted disturbance area.

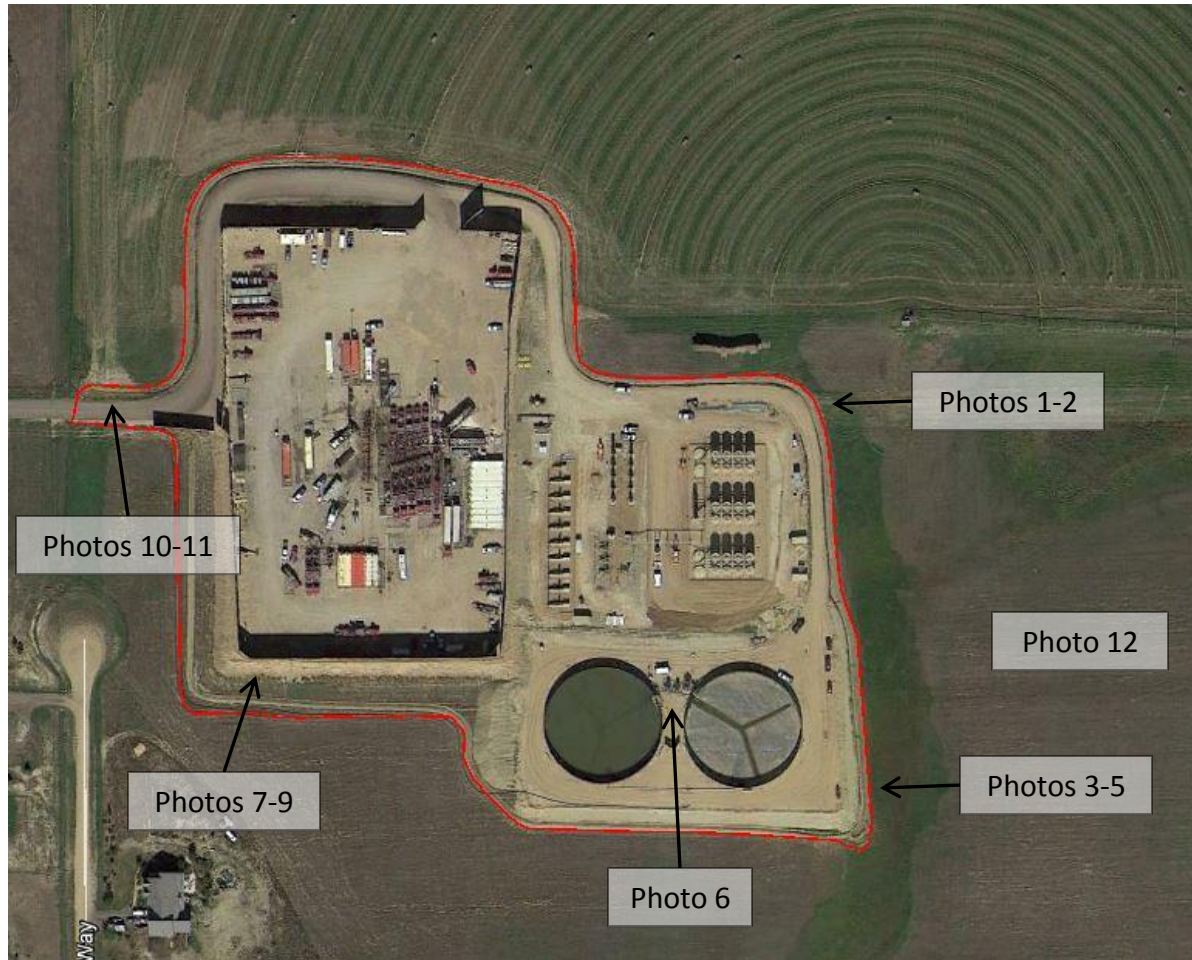
Photo reference points taken from the approximate photo location during the December 18, 2017 inspection.

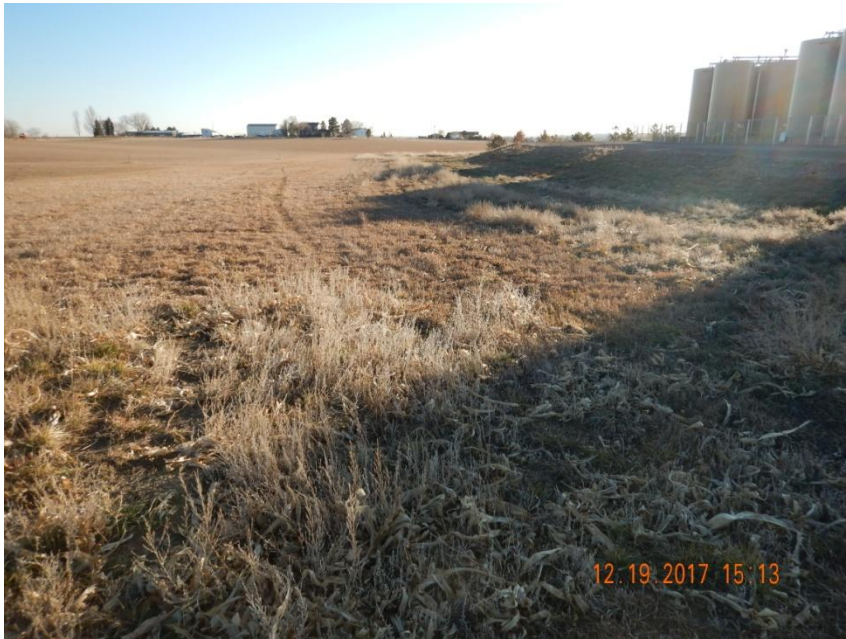
Photo 1. Photo taken from the eastern location, facing South. Interim reclamation areas are not reflective of reference area vegetative levels. Kochia (*Kochia scoparia*) is the dominate vegetative growth throughout the southern interim reclamation area. Some portions appear to be mowed while other portions have not been controlled.

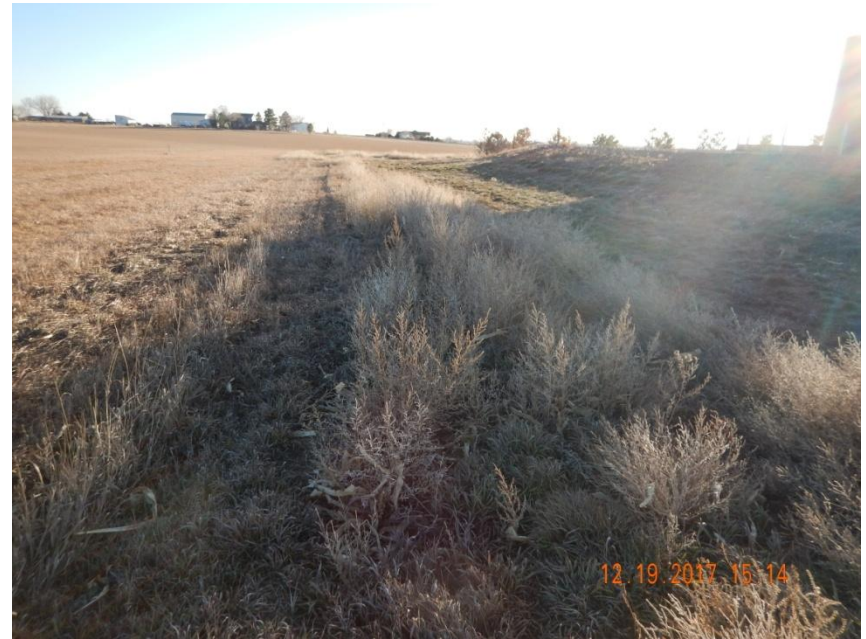
Photo 2. Photo taken from the eastern location, facing South. See comments under Photo 1.

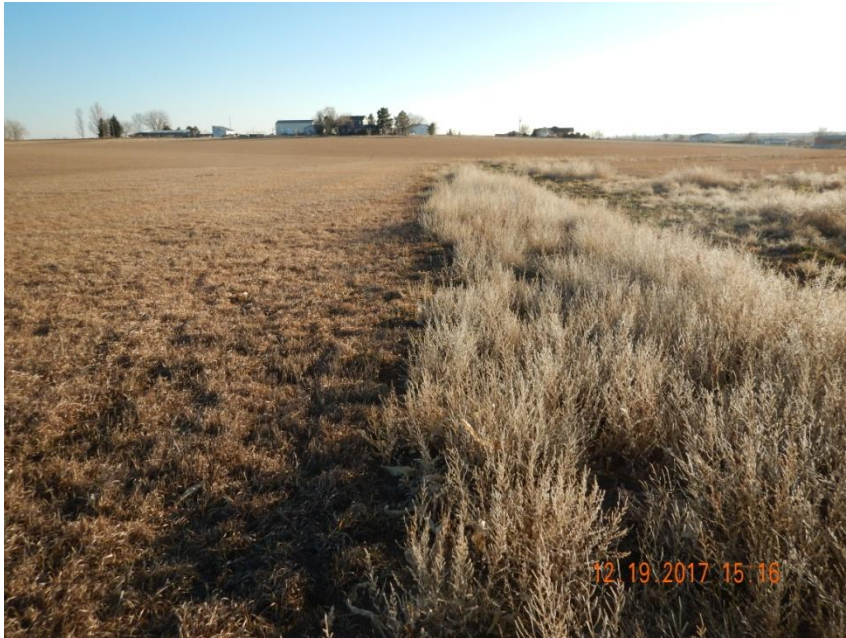
Photo 3. Photo taken from the southeastern location, facing South. See comments under Photo 1.

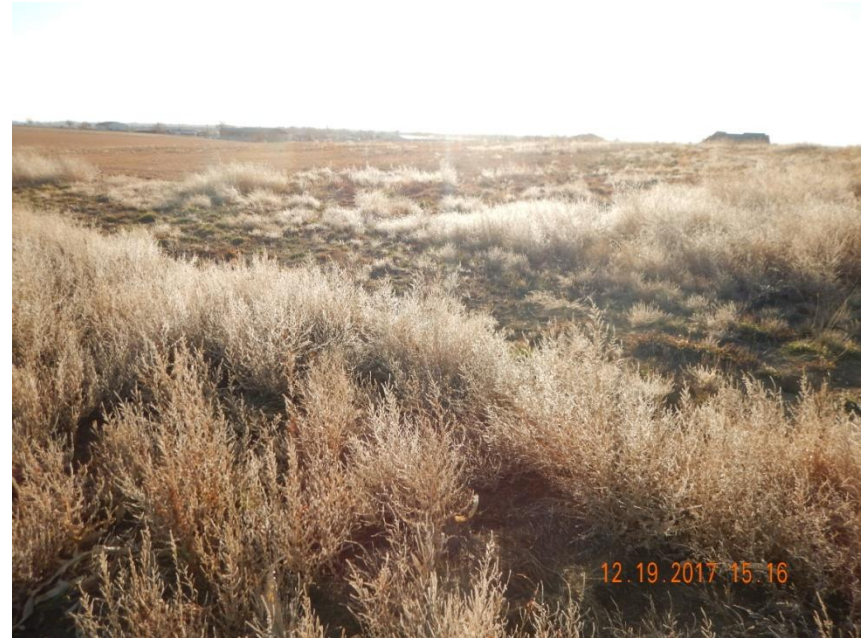
Photo 4. Photo taken from the southeastern location, facing Southwest. See comments under Photo 1.

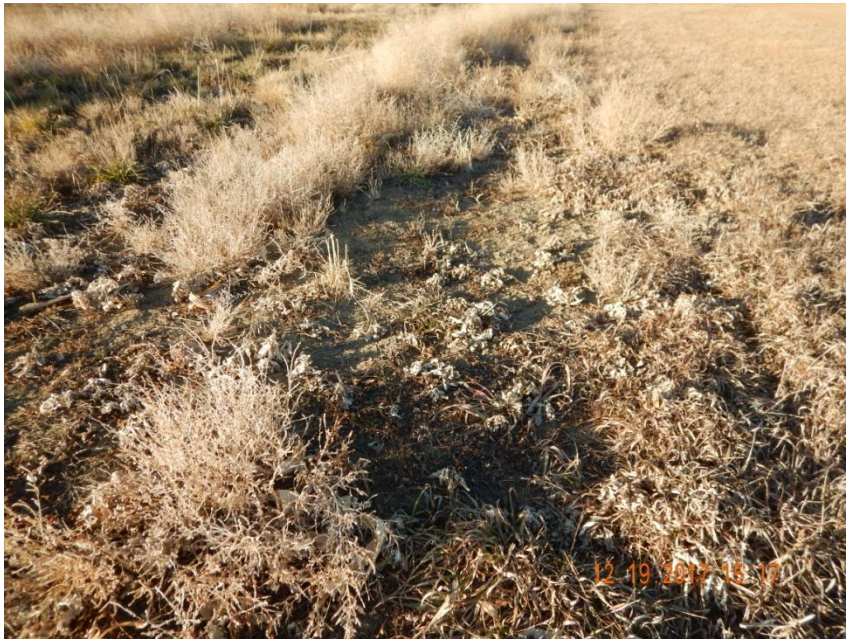
Photo 5. Photo taken from the southeastern location, facing North. Photo illustrates Canada thistle (*Cirsium arvense*) growth which is a List B Colorado noxious weed.

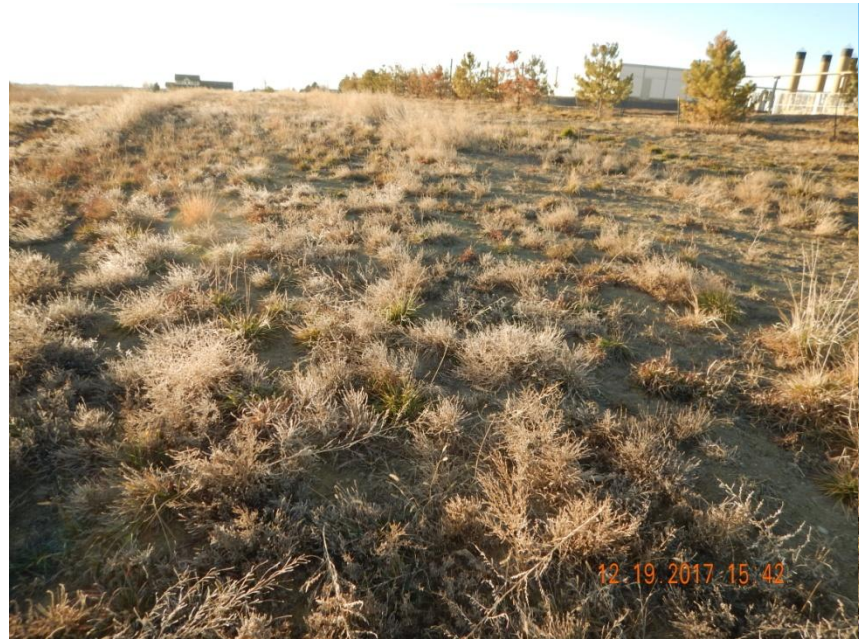
Photo 6. Photo taken from the southern location, facing West. See comments under Photo 1.

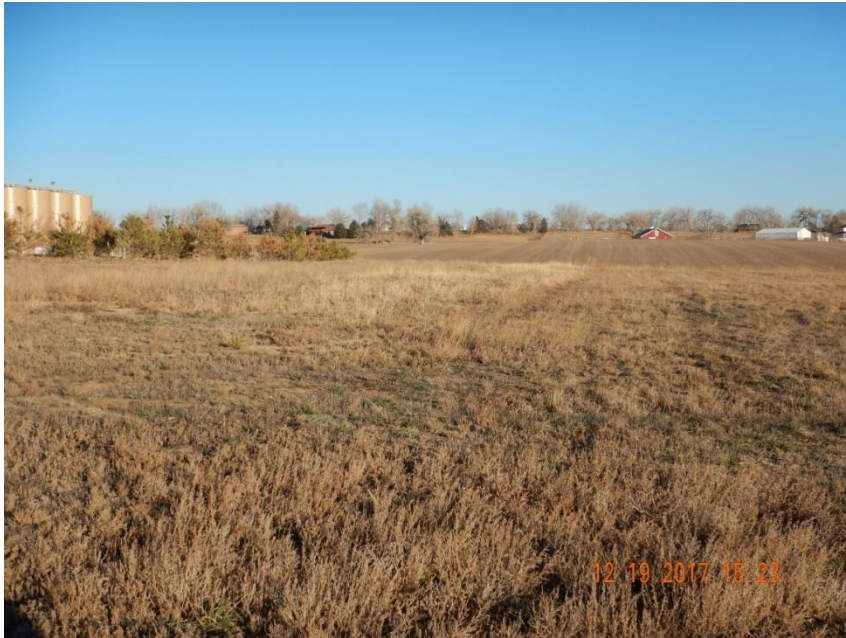
Photo 7. Photo taken from the southwestern location, facing East. See comments under Photo 1.

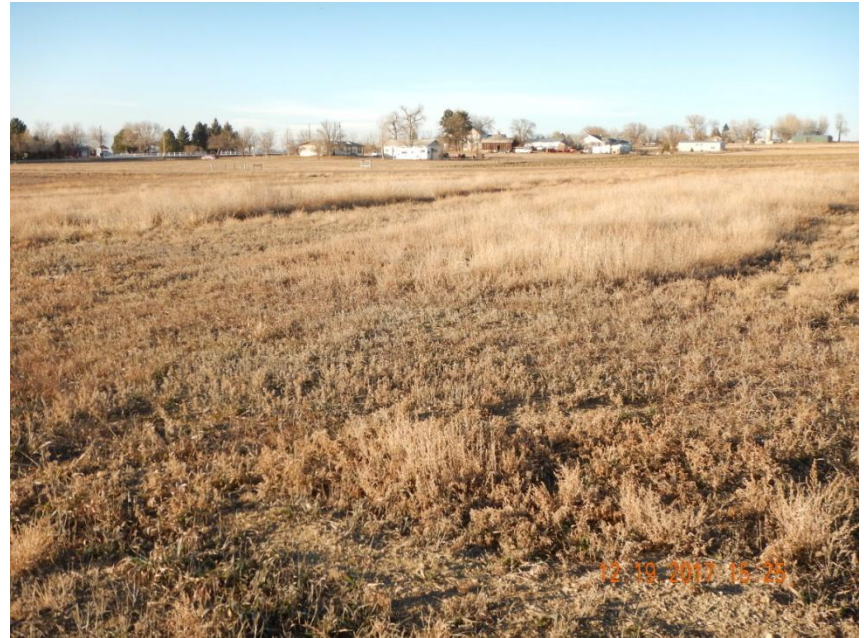
Photo 8. Photo taken from the southwestern location, facing Northwest. See comments under Photo 1.

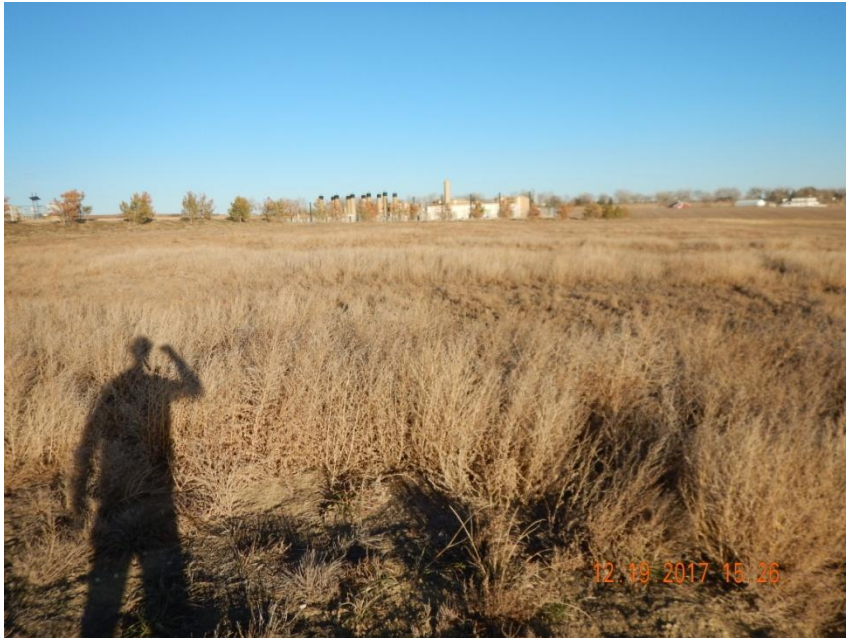
Photo 9. Photo taken from the western location, facing East. See comments under Photo 1.

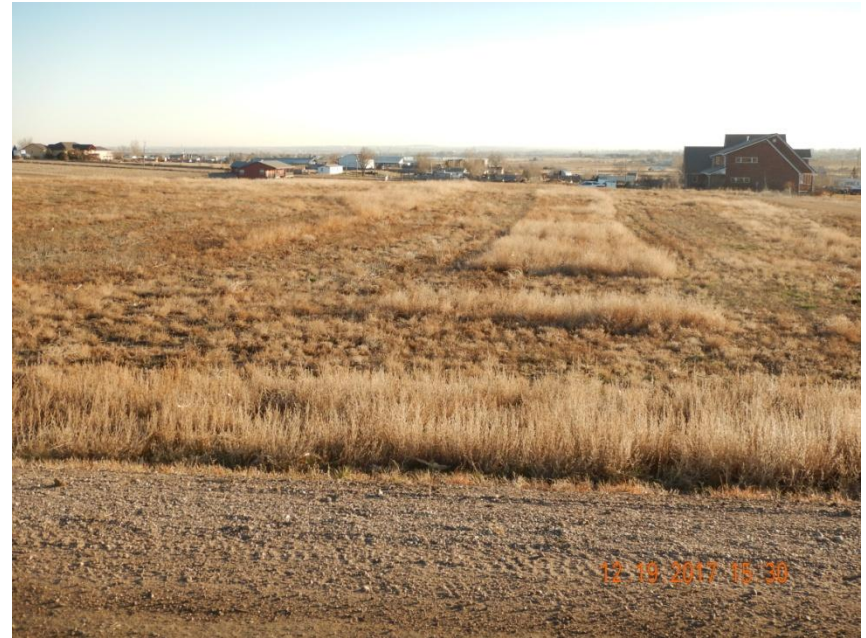
Photo 10. Photo taken from the western access road, facing South. See comments under Photo 1.

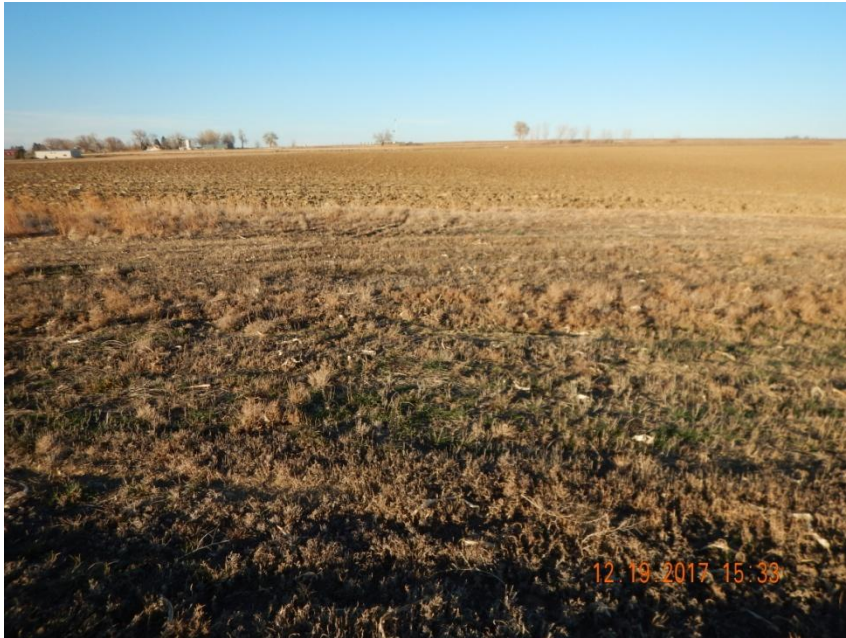
Photo 11. Photo taken from the western access road, facing North. The northern interim reclamation area is currently tilled so an assessment could not be performed.

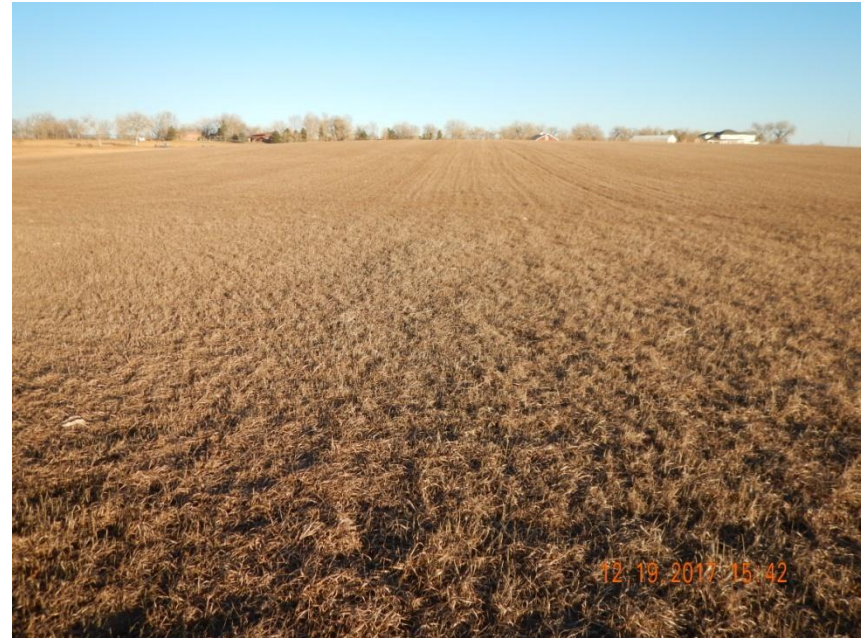
Photo 12. Reference photo taken east of the location, facing East. Reference areas mainly consist on Brome species which is not reflective of interim reclamation areas.
