# Inspection Photos

Operator: NOBLE ENERGY INC - 100322

Location ID: 326752

Inspection Doc. Number: 682503009

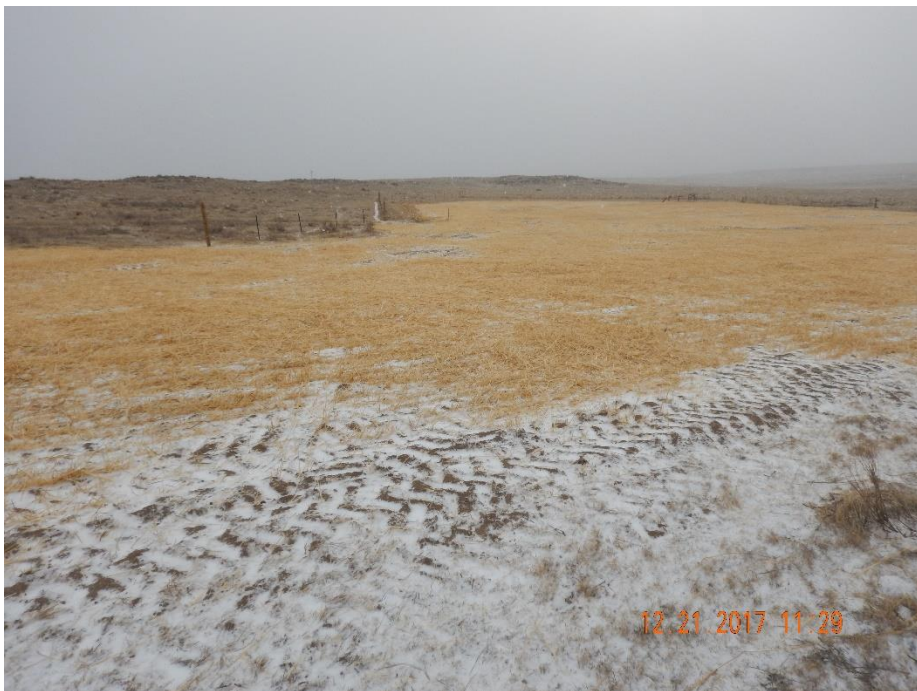
**Photo 1:** Photo taken from the northeast end of the location, facing south. Photo shows additional reclamation appear to have been conducted. Location appears to have been seeded, and crimped with straw mulch for stabilization.

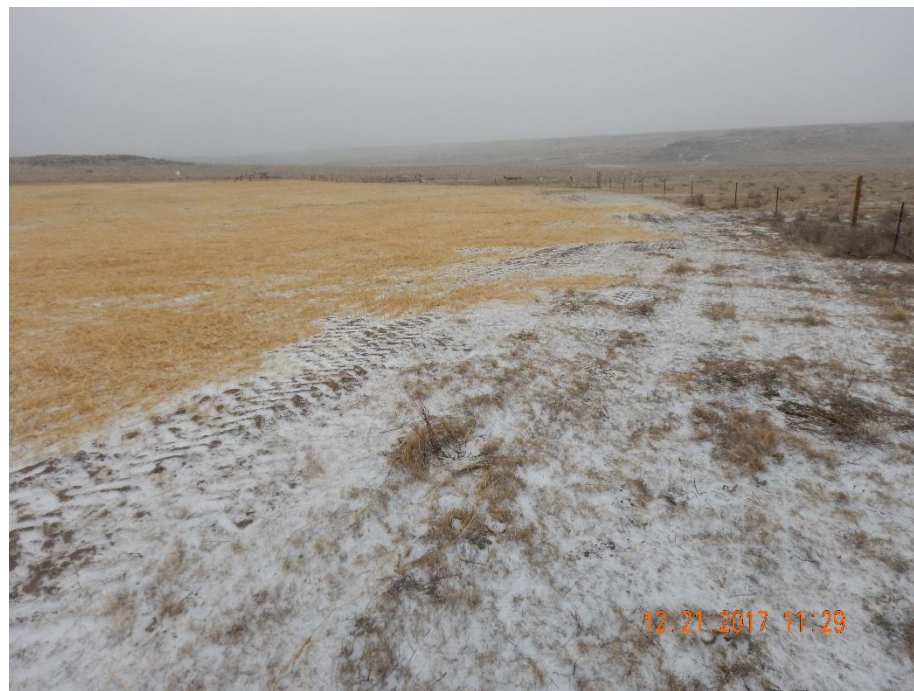
**Photo 2:** Photo taken from the northeast end of the location, facing southwest. Photo shows additional reclamation appear to have been conducted. Location appears to have been seeded, and crimped with straw mulch for stabilization.

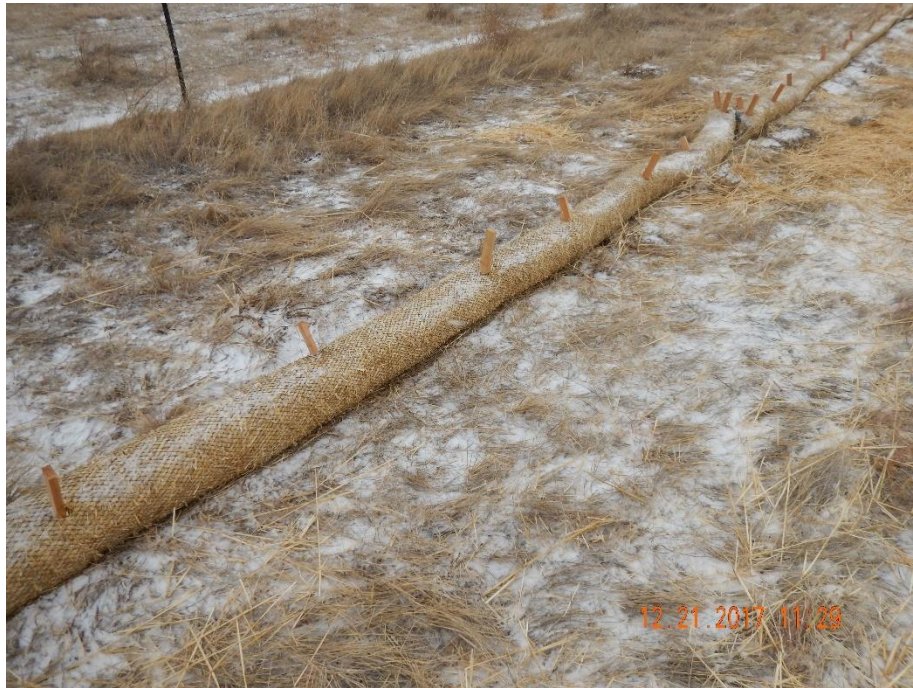
**Photo 3:** Photo of straw wattle used as a stormwater ponding BMP along the eastern perimeter of the location. Photo shows that wattle does not appear to have been installed with good engineering practices. Wattle does not appear to be sufficiently trenched and back-filled

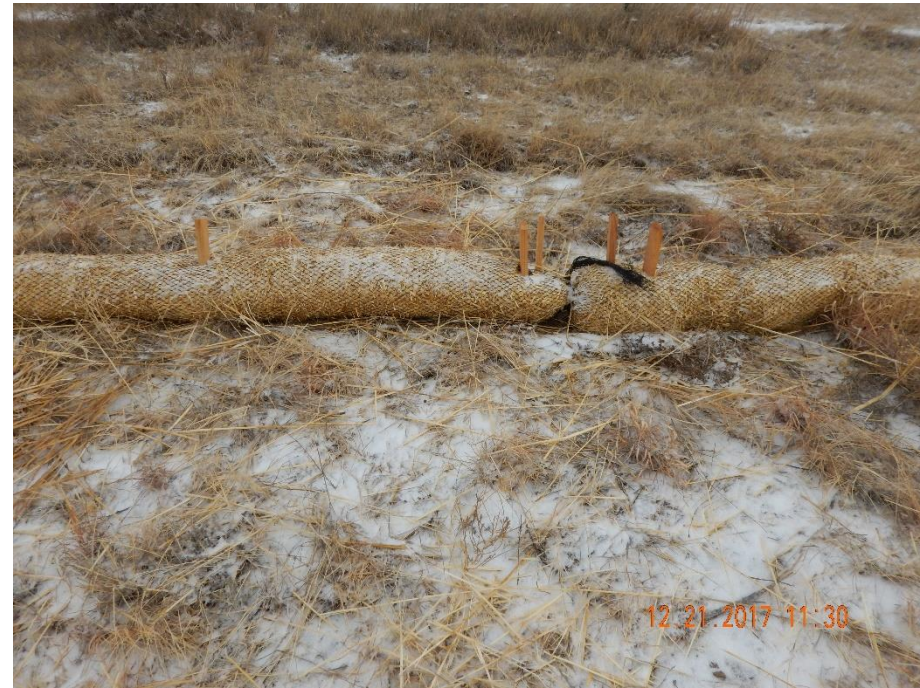
**Photo 4:** Photo of straw wattle used as a stormwater ponding BMP along the eastern perimeter of the location. Photo shows that wattle does not appear to have been installed with good engineering practices. Wattle does not appear to be sufficiently trenched and back-filled

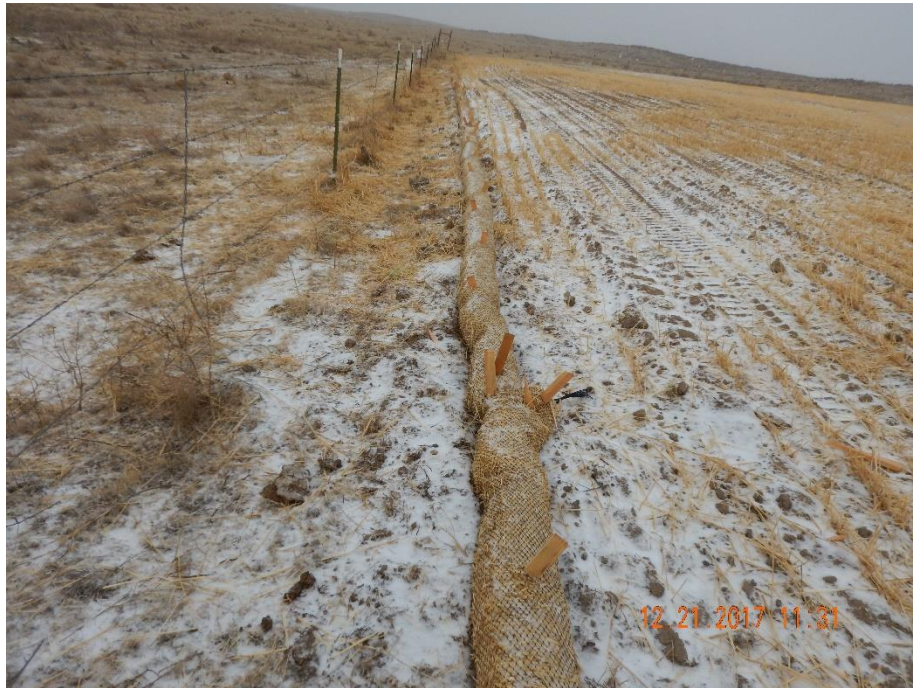
**Photo 5:** Photo of straw wattle used as a stormwater ponding BMP along the western perimeter of the location. Photo shows that wattle does not appear to have been installed with good engineering practices. Wattle does not appear to be sufficiently trenched and back-filled

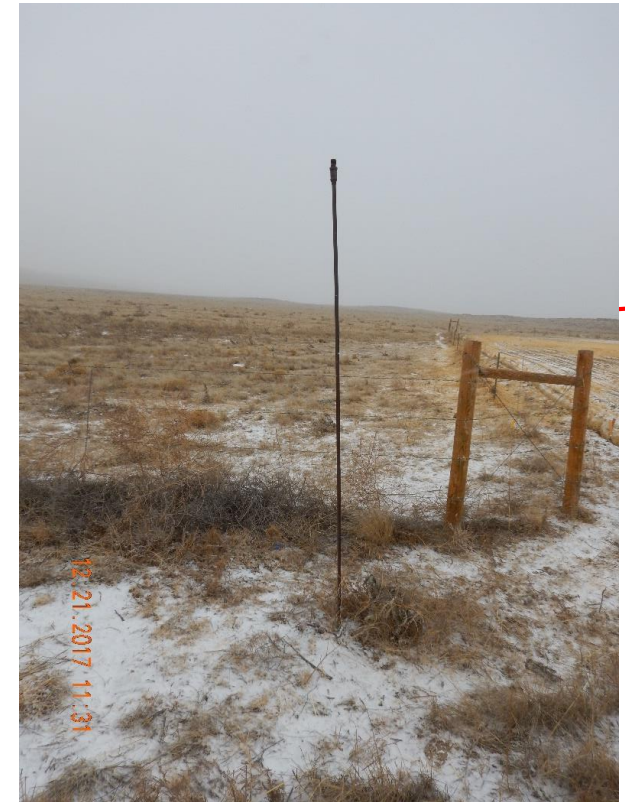
**Photo 6:** Photo taken from the west end of the location, facing north. Photo shows what appears to be a rod sticking out of the ground. This is unused equipment and requires removal.

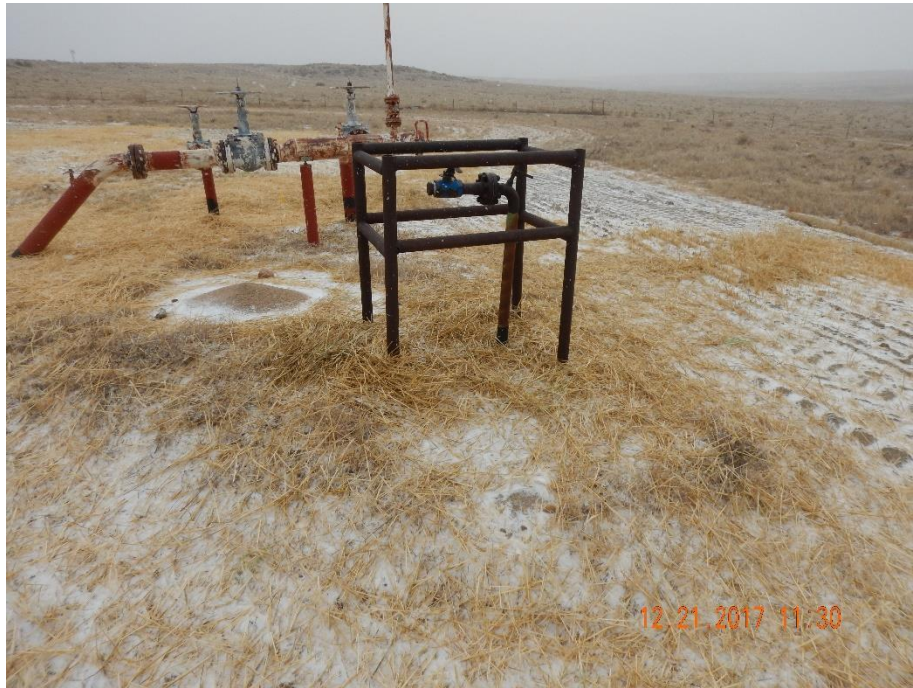
**Photo 7:** Photo taken from the well location, facing south. Photo shows pipe equipment remaining on location. Pipe riser in brown cage appears to be an abandoned gathering riser.

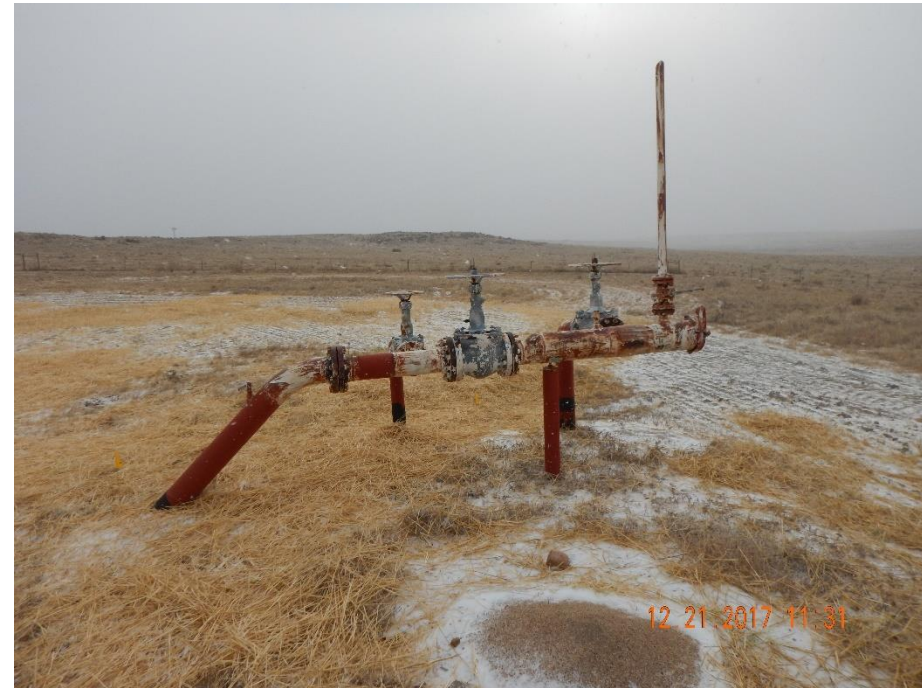
**Photo 8:** Photo taken from the well location, facing south. Photo shows pipe equipment remaining on location.

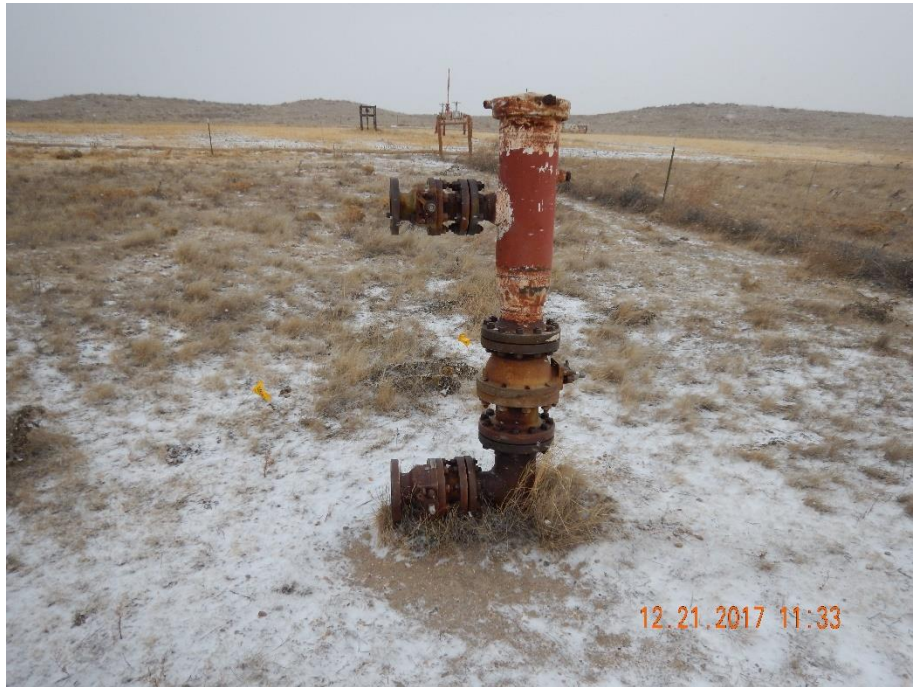
**Photo 9:** Photos 9- 12 were taken from what appears where a historic pit and facilities were located, immediately west of the current fenced reclamation area, facing east. Photo shows pipe equipment remaining.

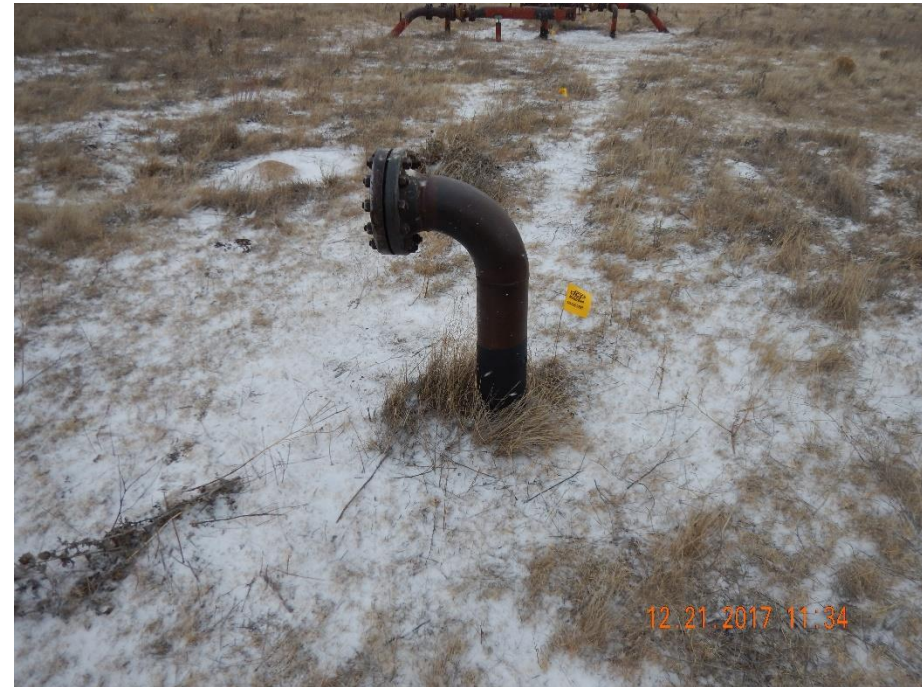
**Photo 12:** Flags seen in area of pipe risers labeled with DCP's information.

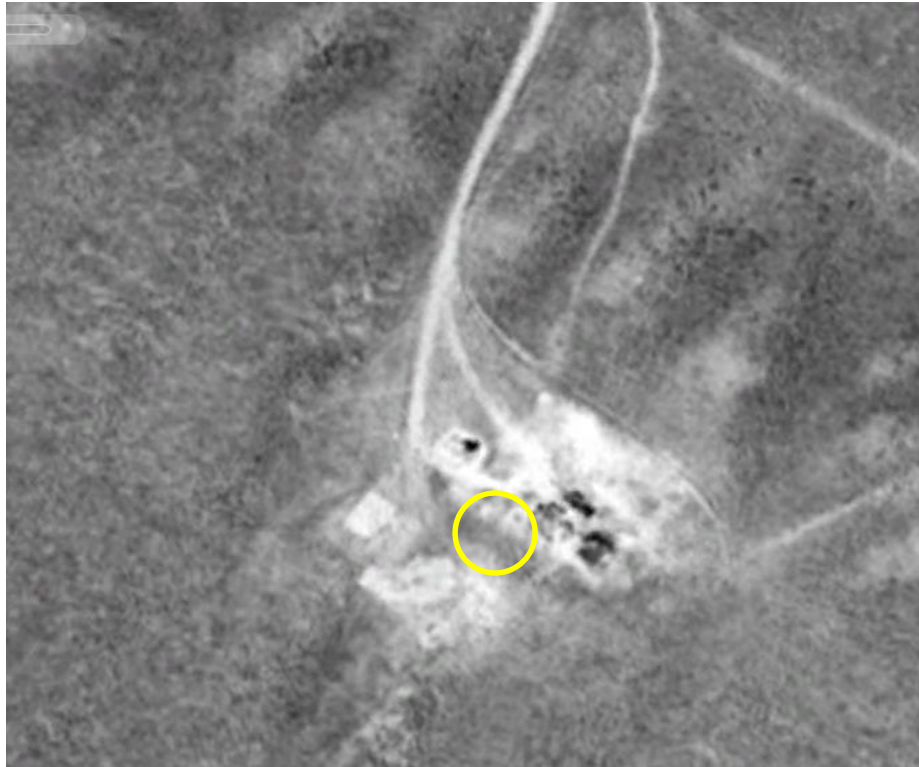
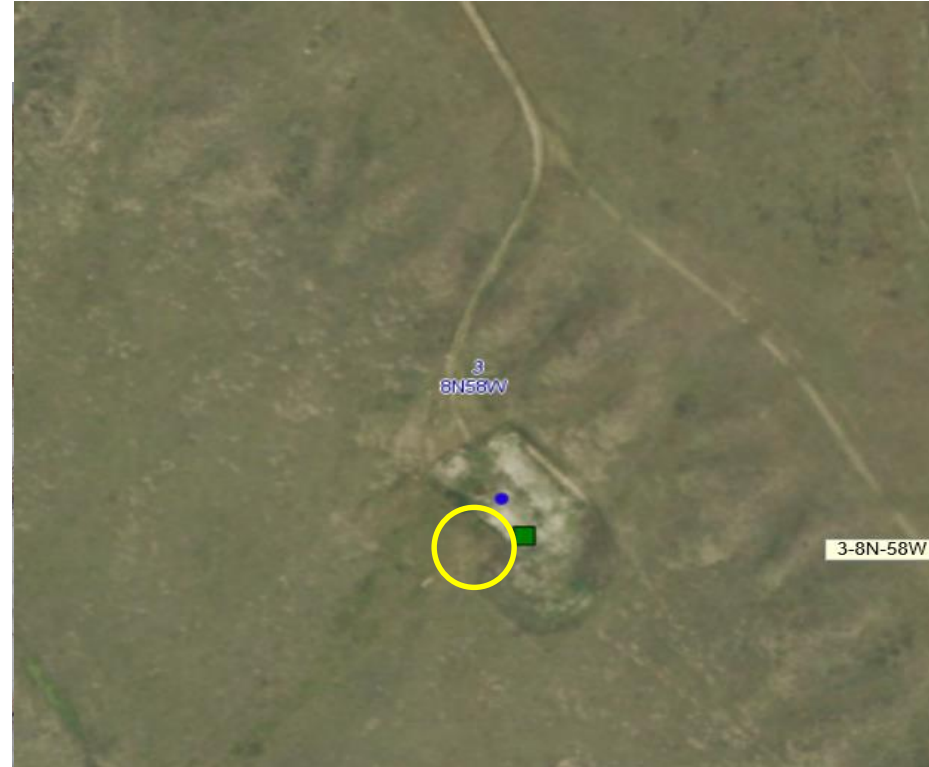
**Photo 13:** Historic aerial imagery (1999) seen on the left compared to current available aerial imagery (2015). Yellow circle indicates approximate areas where pipe equipment (seen in photos 9-12) remain.

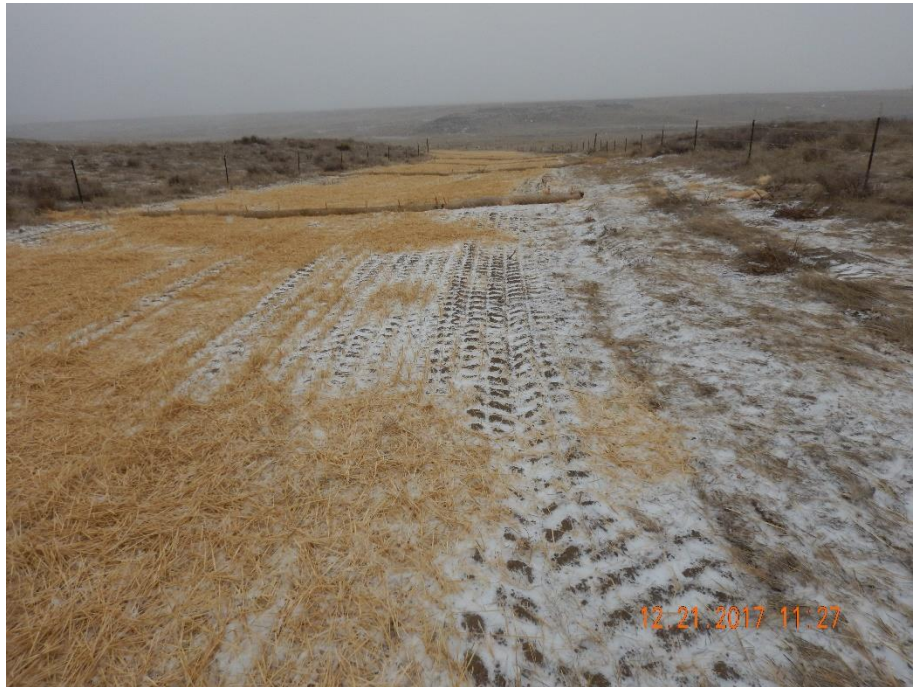
**Photo 14:** Photo taken from the access road, northeast of the well location, facing southwest. Photo shows areas of the access road that appear to have had additional reclamation work conducted.

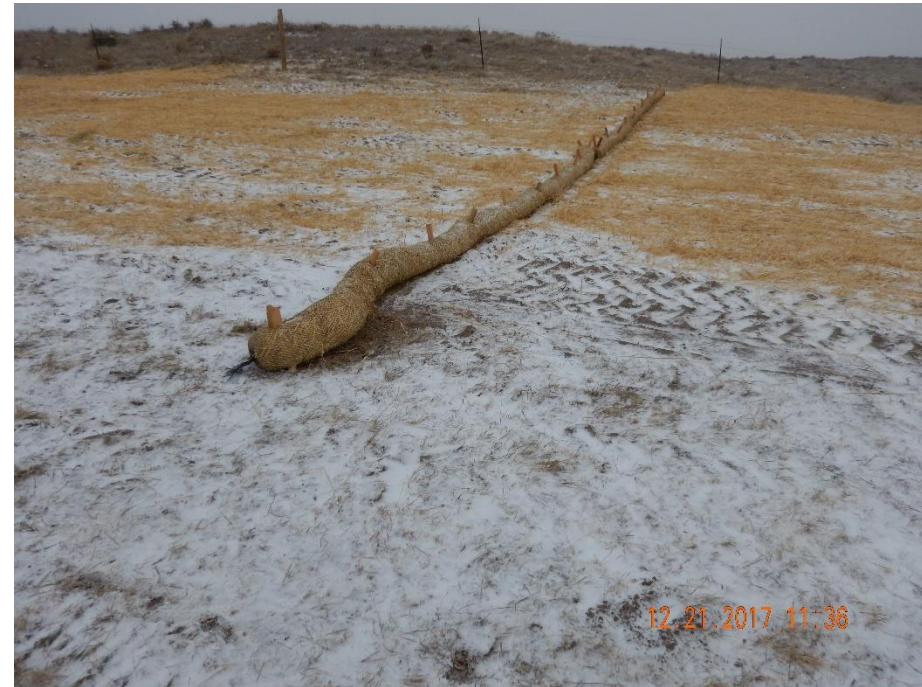
**Photo 15:** Photo of straw wattle BMP at the access road. Photo shows that wattle does not appear to have been installed with good engineering practices. Wattle does not appear to be sufficiently trenched and back-filled

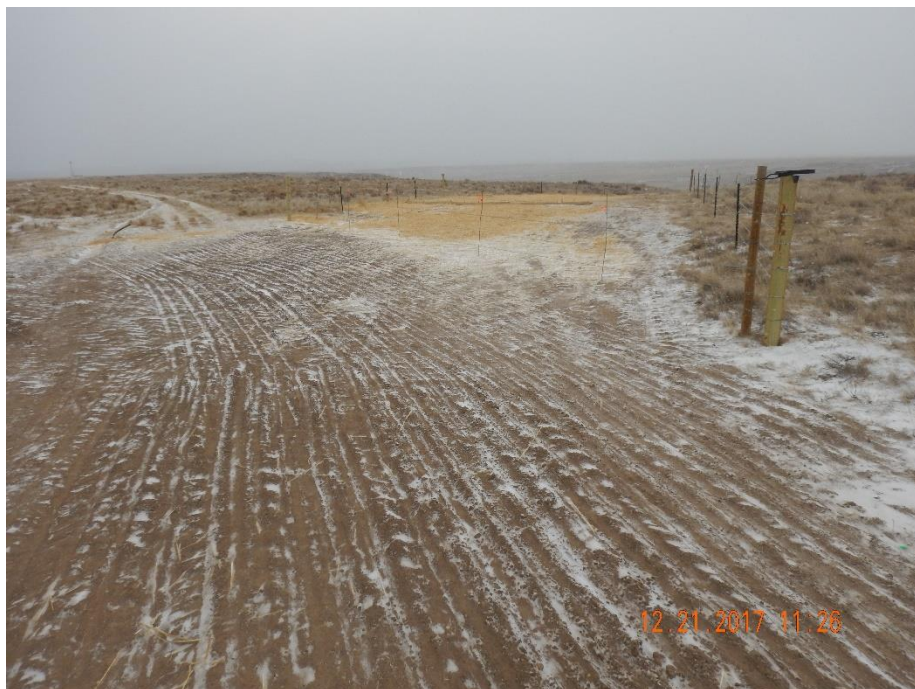
**Photo 16:** Photo taken from access road, northeast of the location. Photo at point where access road turns to the northwest. Photo shows operator appears to have only reclaimed a portion of the access road, leaving ~1/2 mile un reclaimed.

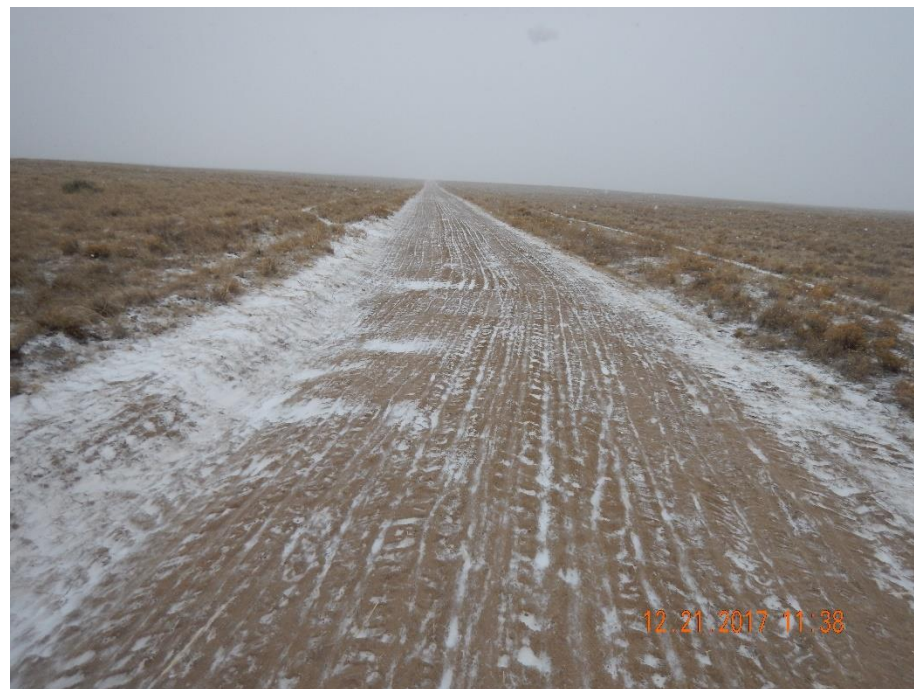
**Photo 17:** Photo taken from the access road, facing north. Photo shows portions of access road left unclaimed.

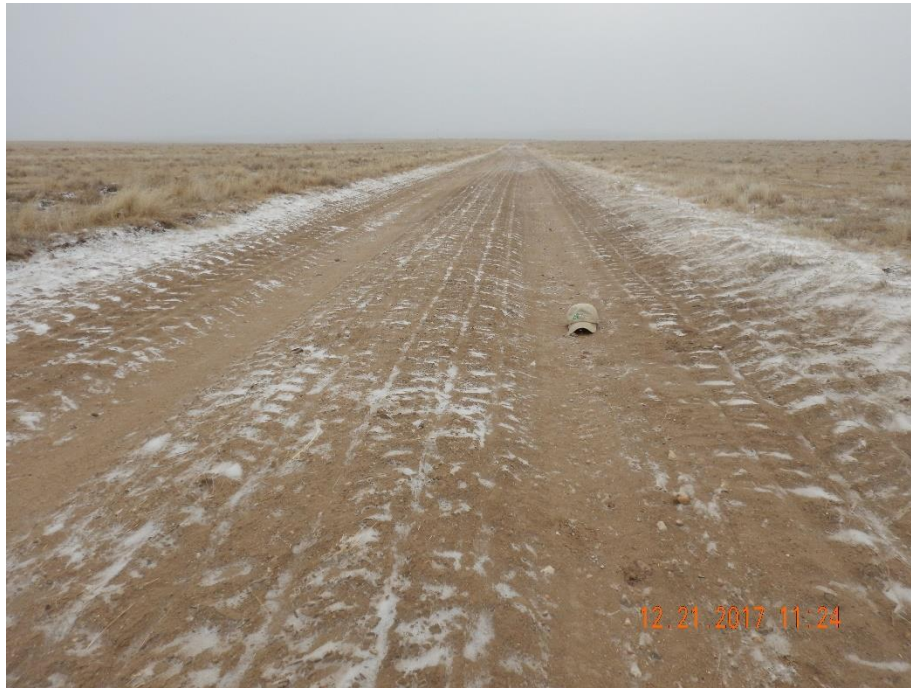
**Photo 18:** Photo taken from the access road, facing north. Photo shows portions of access road left unclaimed. Hat in photo for reference to show ruts remains.

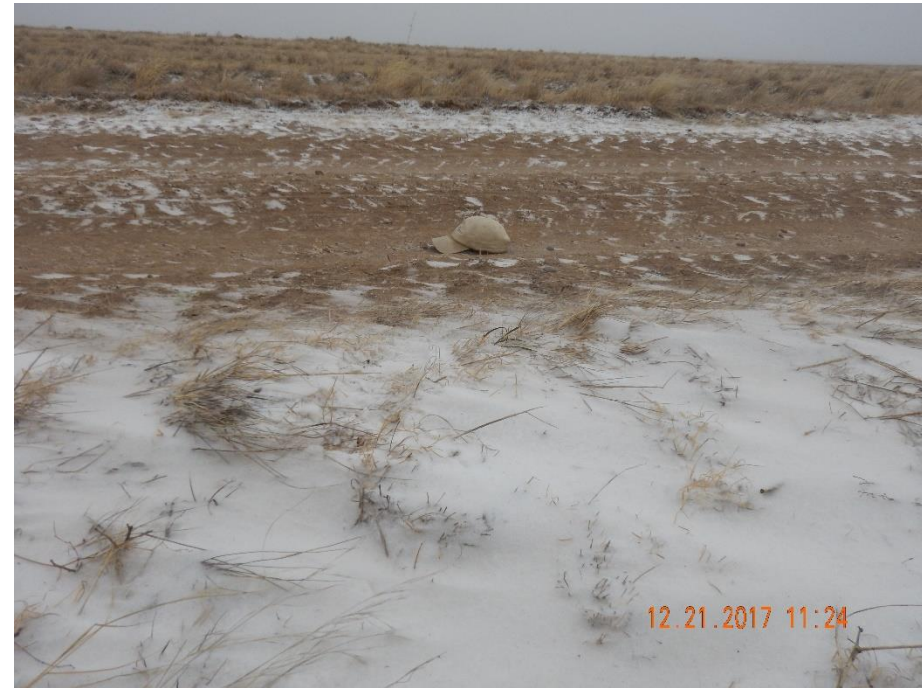
**Photo 19:** Photo taken from the access road, facing east. Photo shows portions of access road left unclaimed. Hat in photo for reference to show ruts remains.

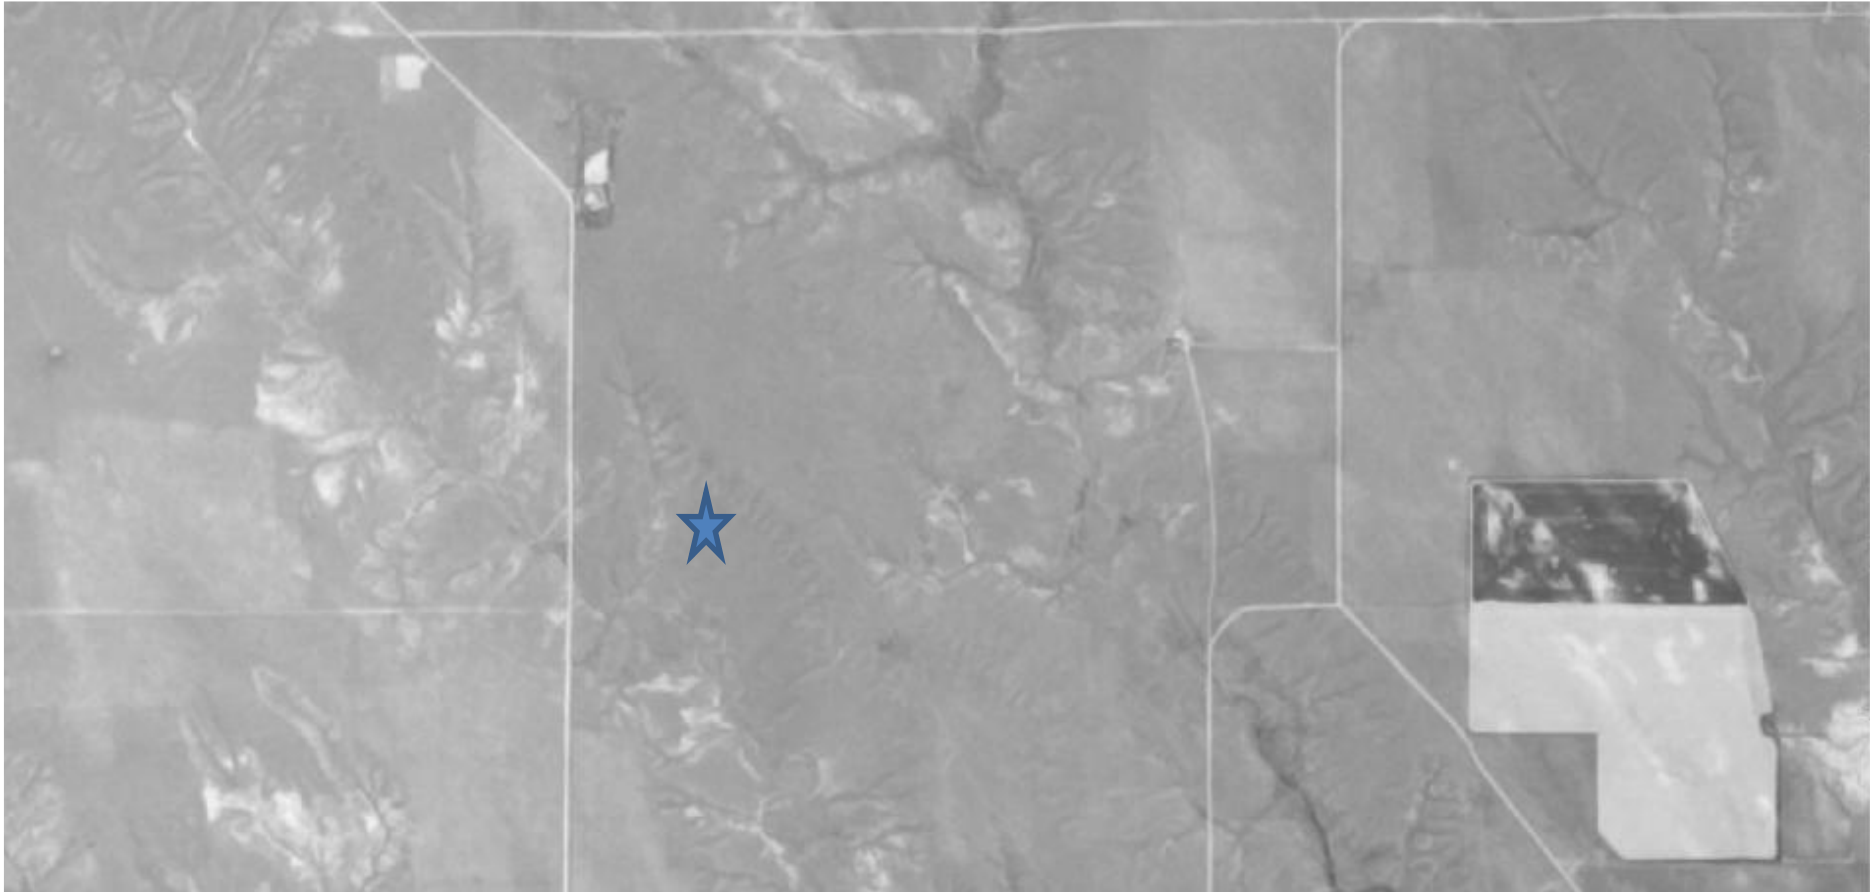
**Photo 20:** May 1985 aerial imagery. Star indicates location of the well. Well was spud 9/21/1987. Photo shows location and access road pre O&G disturbance. Photo shows access road had not been pre-existing.

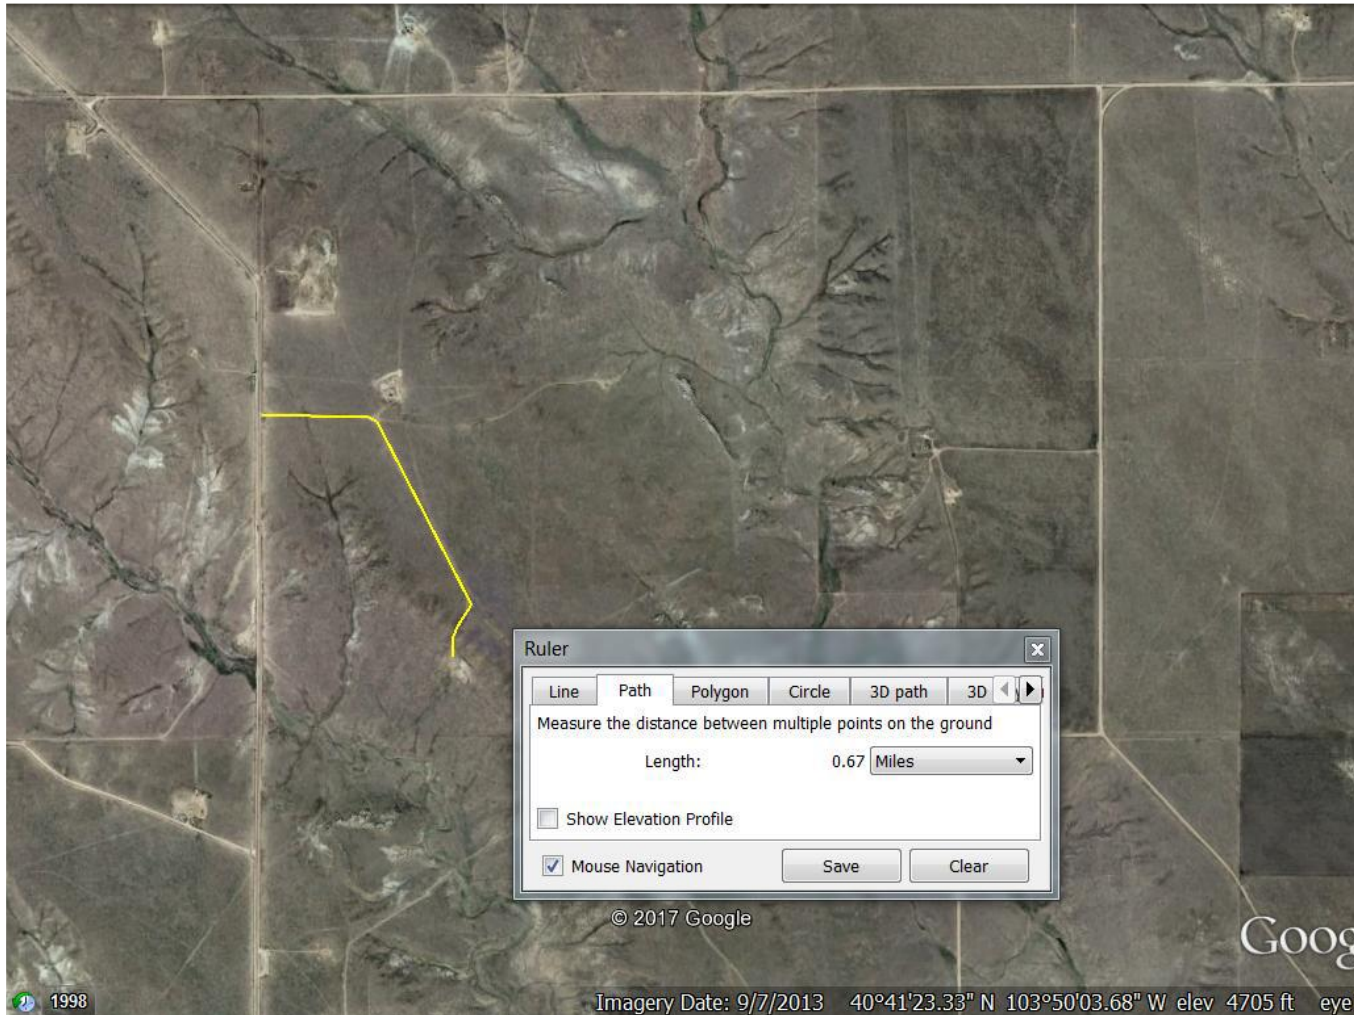
**Photo 21:** Most current available aerial imagery (2013). Photo shows ~0.6 miles of access road that requires reclamation
