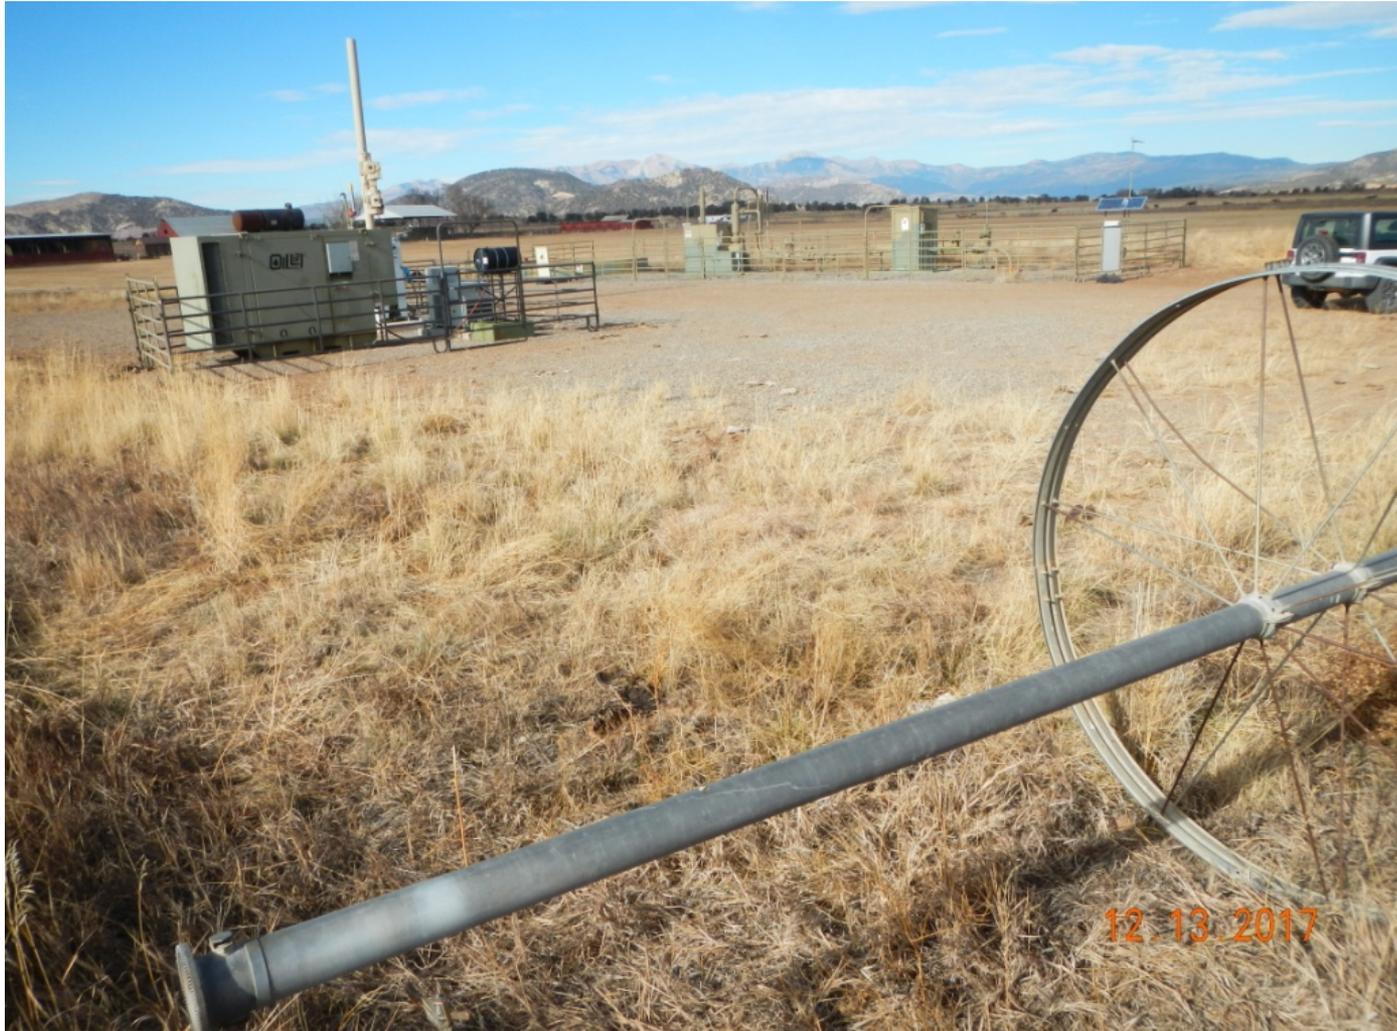
Photo 1. View of the project area from the southeastern corner facing center.

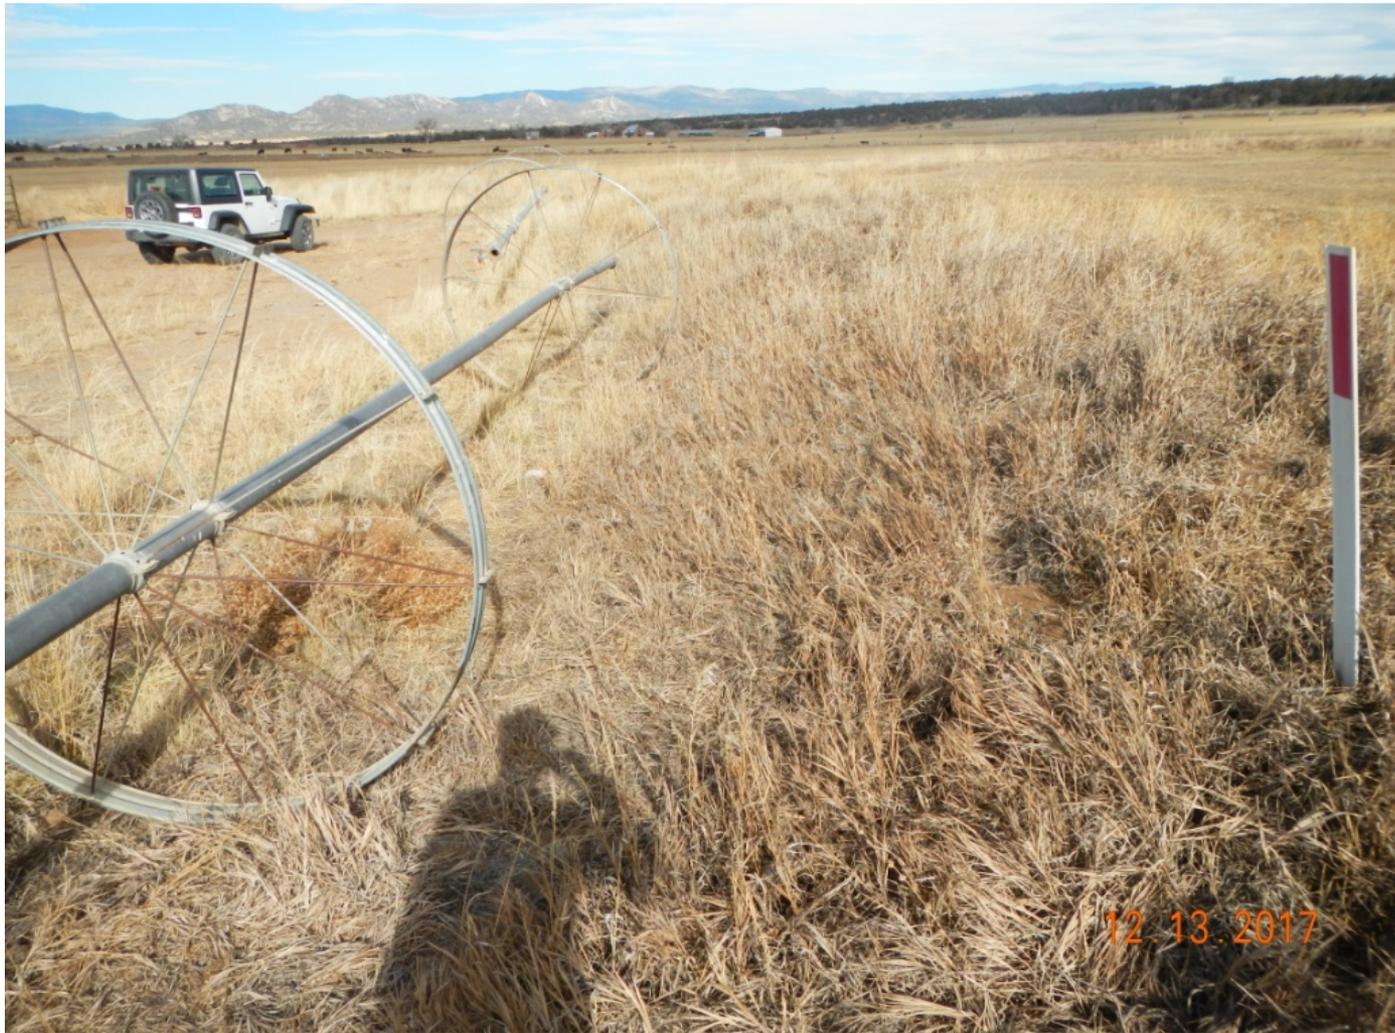
Photo 2. View of the eastern portion of the project area from the southeastern corner facing northward. Revegetation is progressing with dropseed (*Sporobolus* sp.) and smooth brome (*Bromus inermis*).

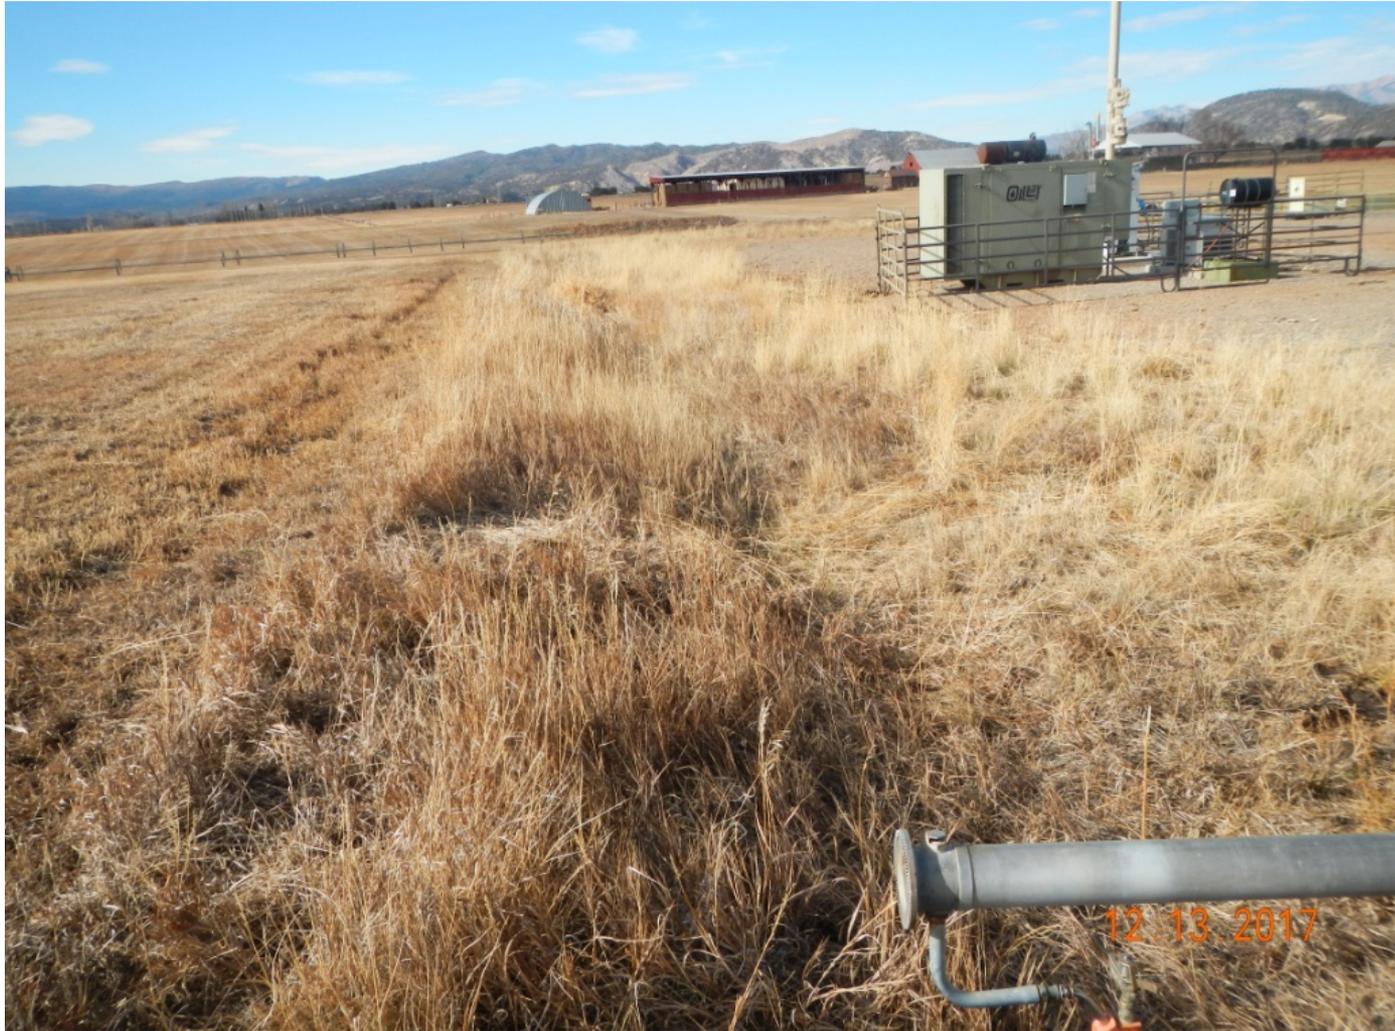
Photo 3. View of the southern portion of the project area from the southeastern corner facing westward.

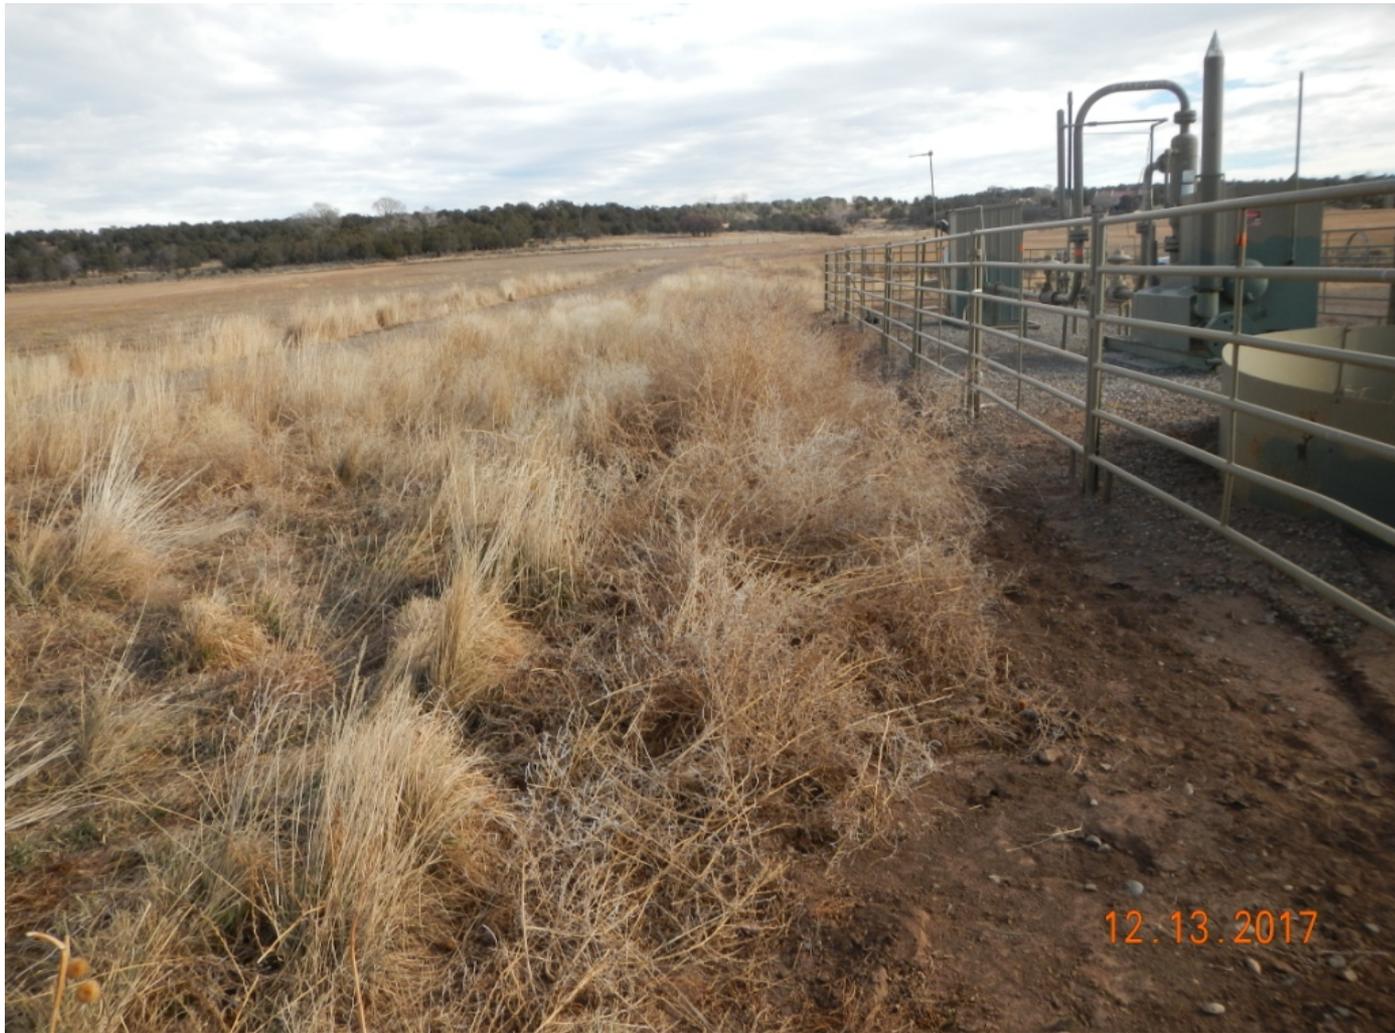
Photo 4. View of the northern portion of the project area from the northwestern corner facing eastward. Dried kochia debris lines this portion of the project area.

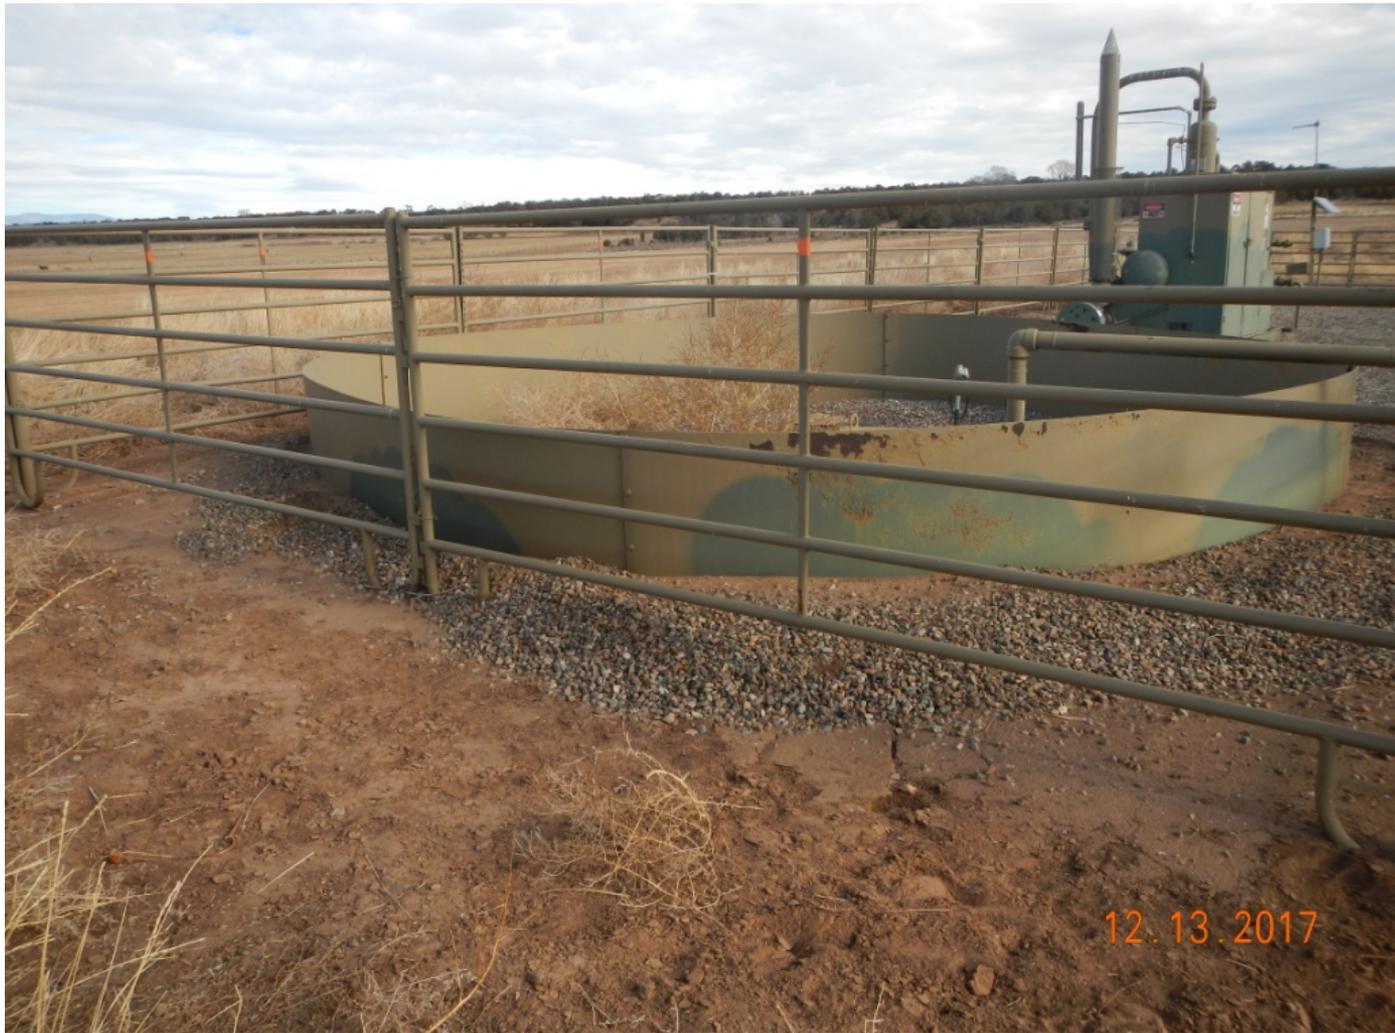
Photo 5. View of kochia debris around fired equipment, and blowing within the project area.
