December 20, 2017

COLORADO
Oil & Gas Conservation
Commission
Department of Natural Resources

Inspection Photos: Caerus KM Loc#423633

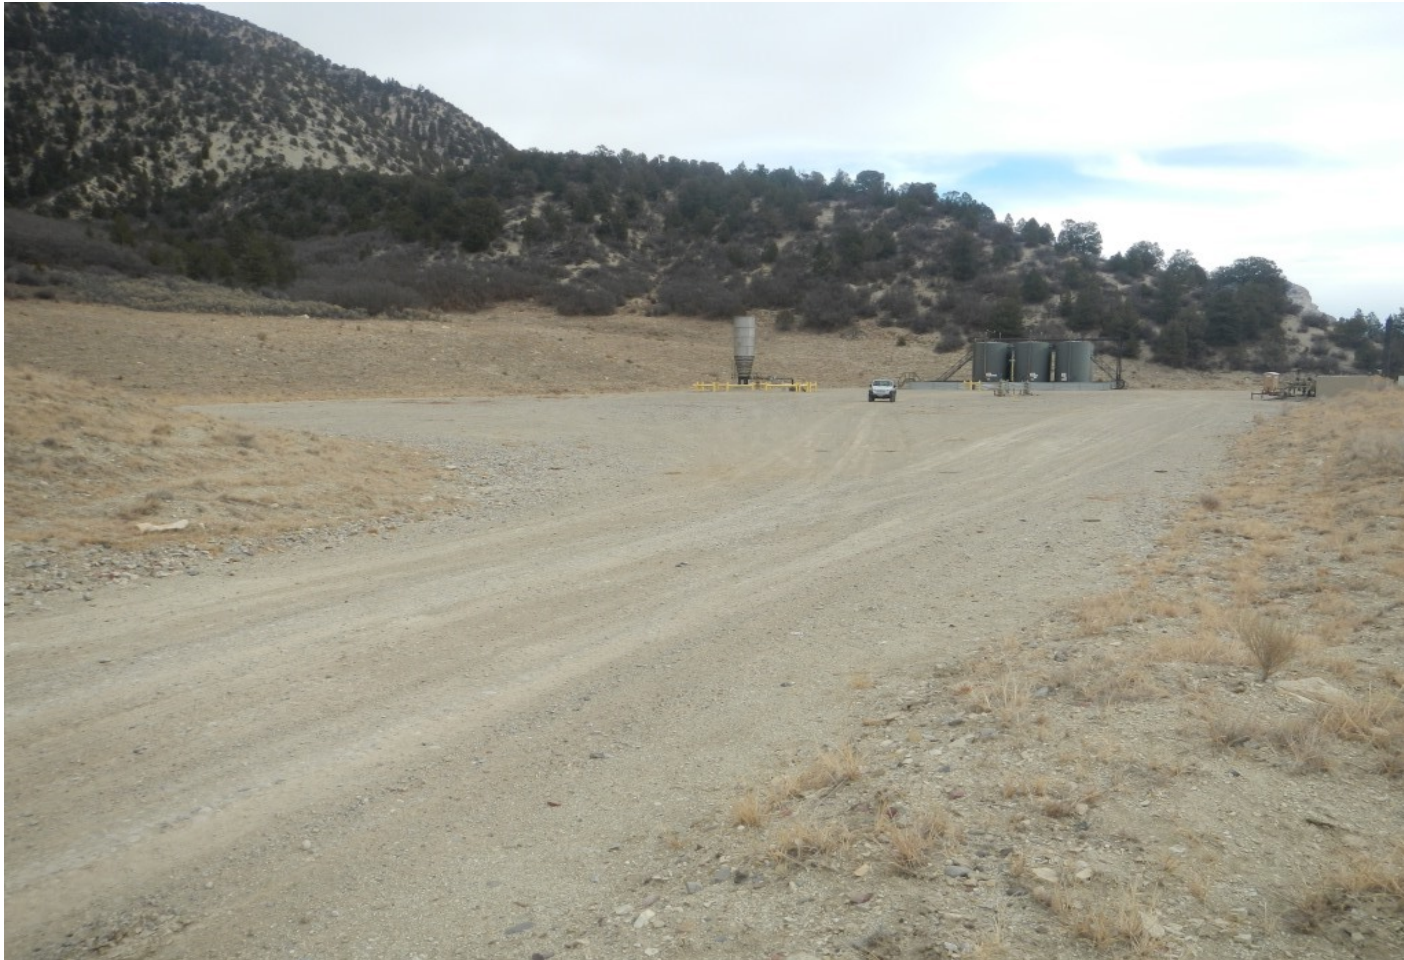
Photo#1:
Overview of Location from Entry to East.

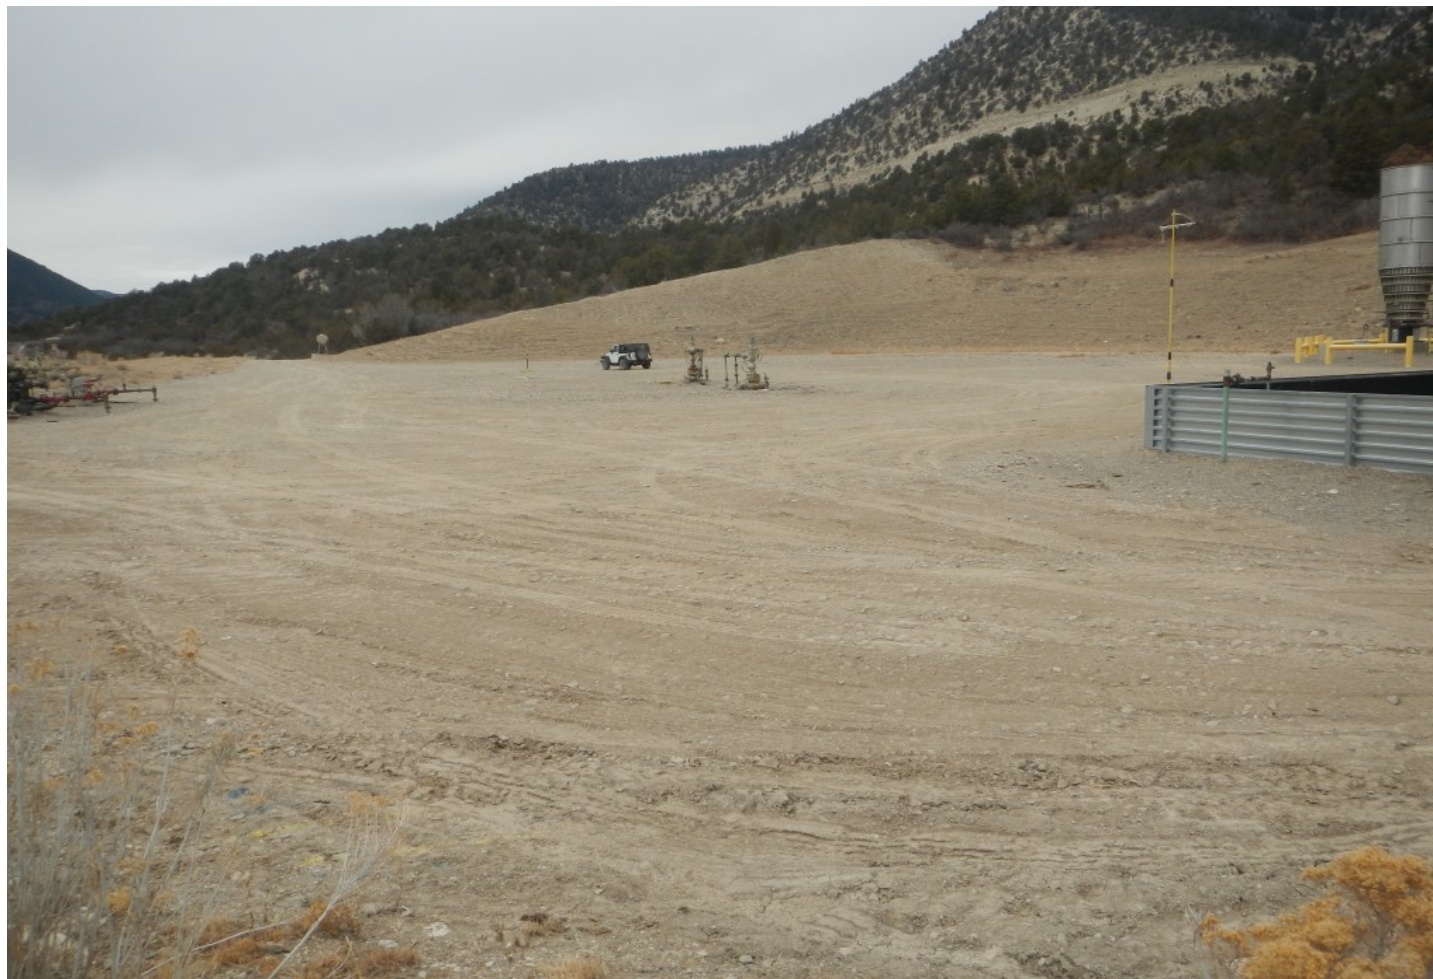
Photo#2:
Overview of Location to Northwest.

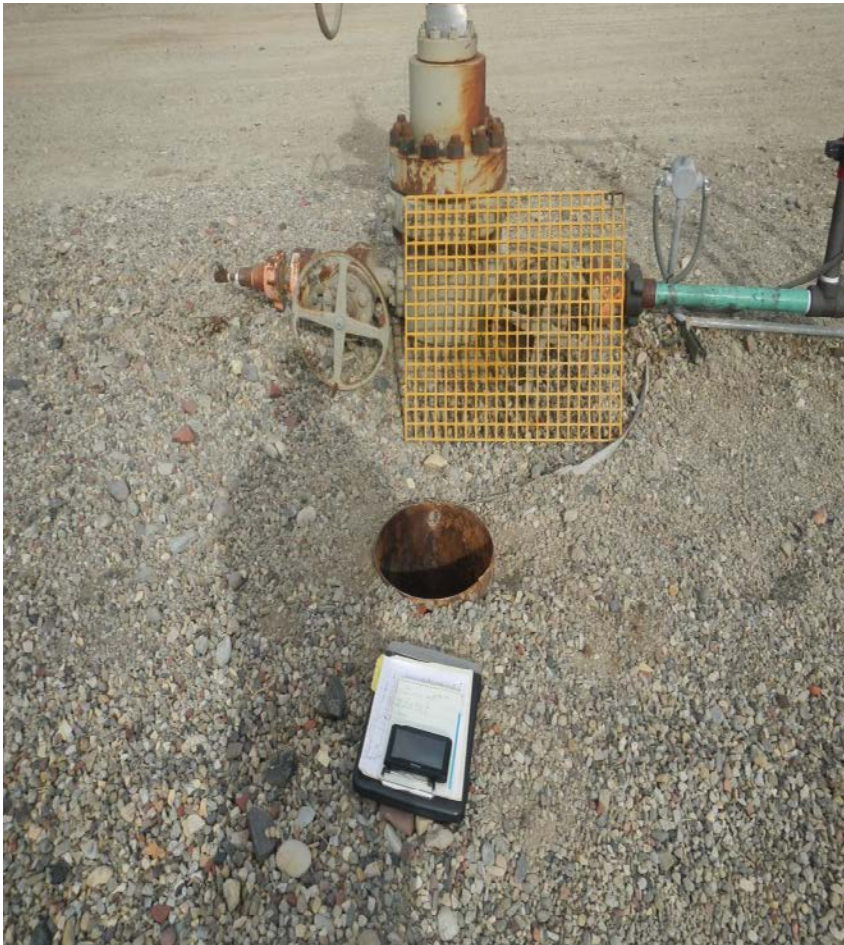
Photo#3:

What appears to be open Rat Hole is positioned immediately South of Well API#045-20790, covered with square of light plastic grating.

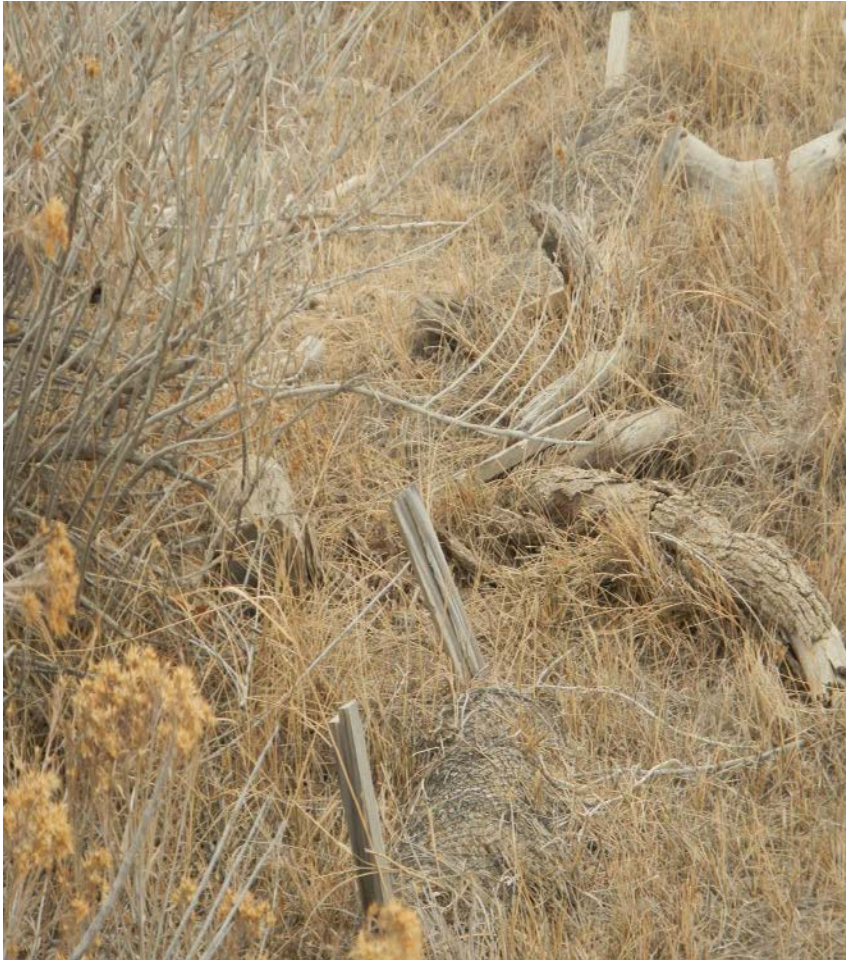
Photo#5:

Wattles at base of Fill Slope have become Debris .
