**Inspection Photos**  
**Location Name: Dunbar #1**  
**API: 05-123-23247**

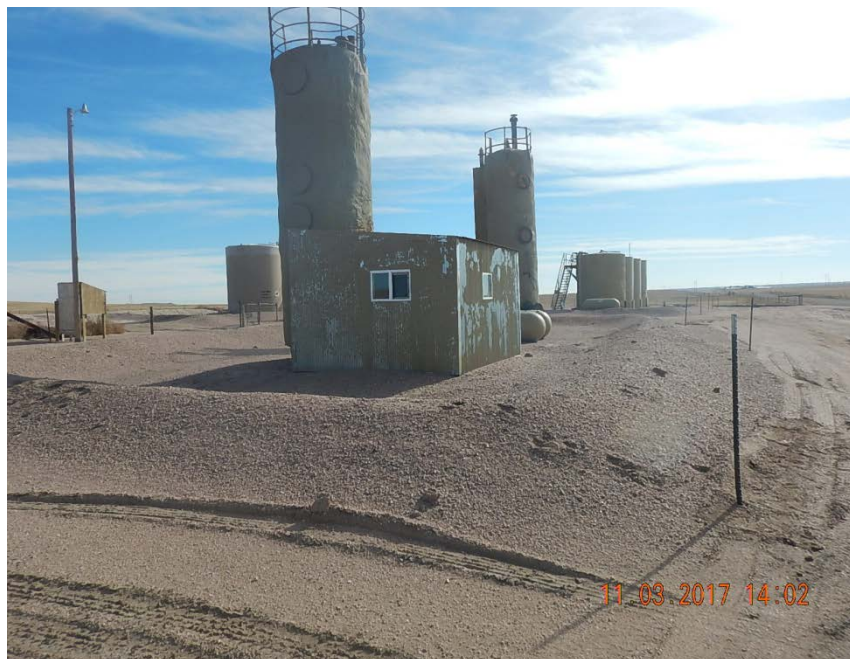
**Photo 1: Location, looking SE**

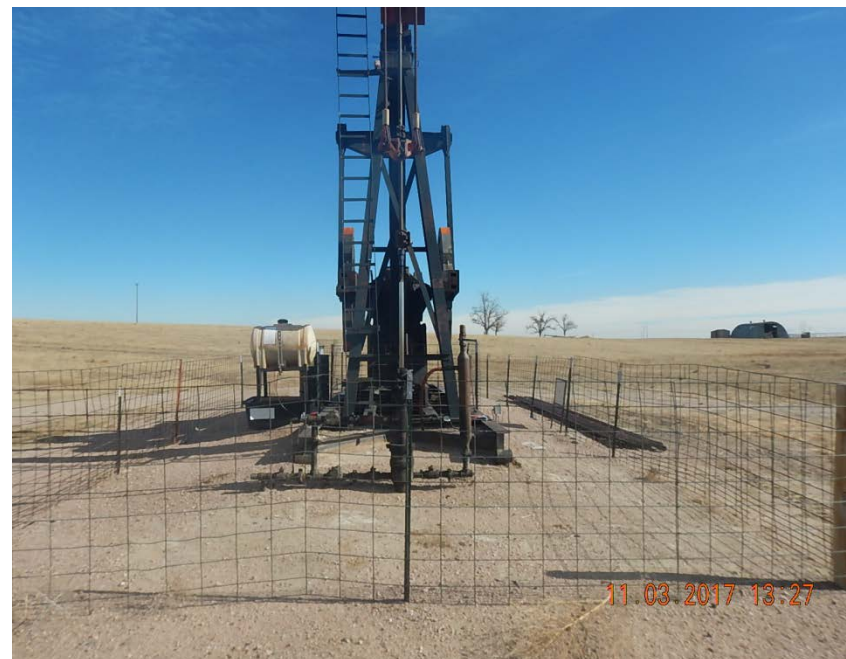
**Photo 2: Wellhead, looking E**
