Inspection Photos

Operator: DENVER EAST MACHINERY COMPANY
- 24040

Location ID: 390528

Inspection Doc. Number: 682503018
Logan County, CO

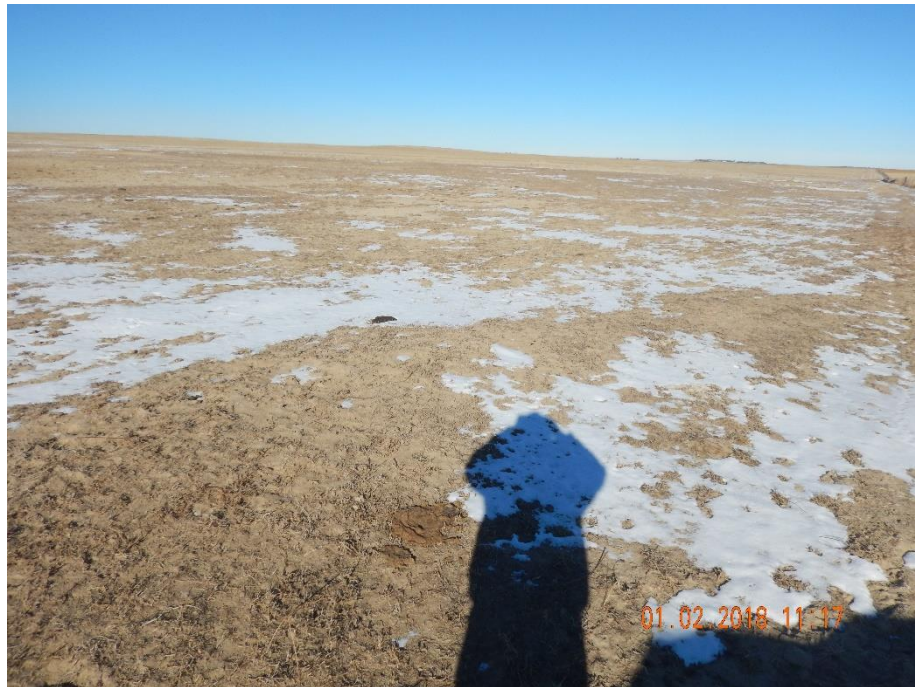
Photo 1: Photo taken from the southeast end of the location, facing northwest.

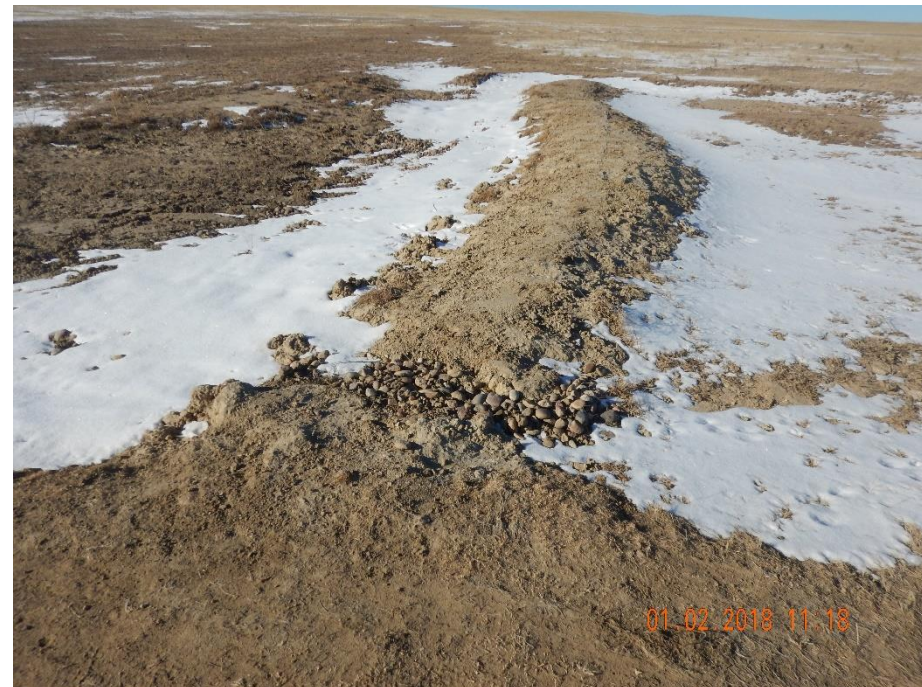
Photo 2: Photo taken from the east end of the location, facing west. Photo show additional rock armoring has been used to repair the degradation within the stormwater berm.

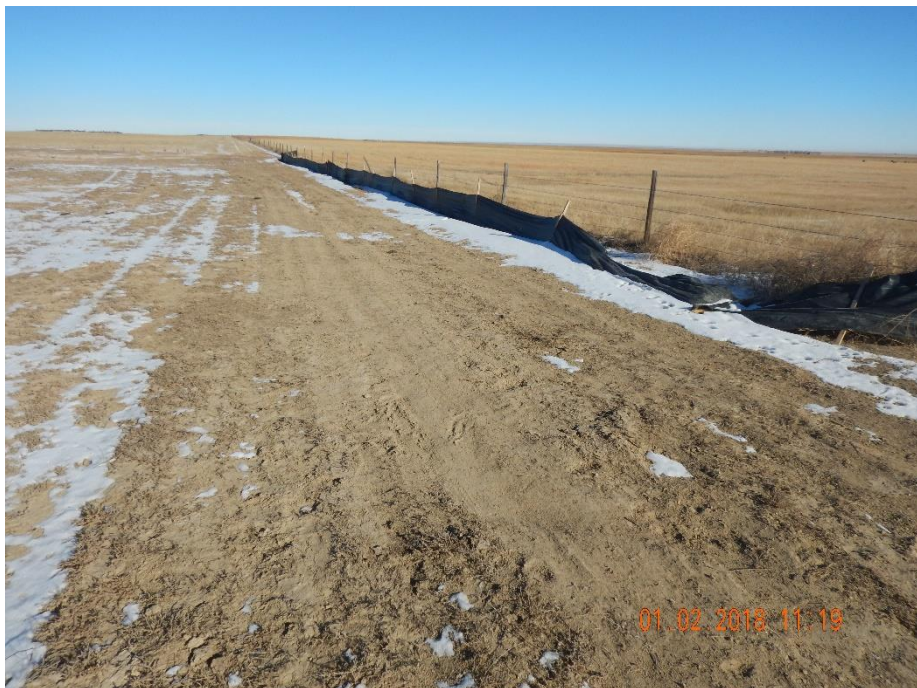
Photo 3: Photo taken from the northeast end of the location, facing northeast. Photo shows that the silt fence appears to have been repaired, however areas of the fence already appear to be in disrepair. Advise maintenance before further damage.

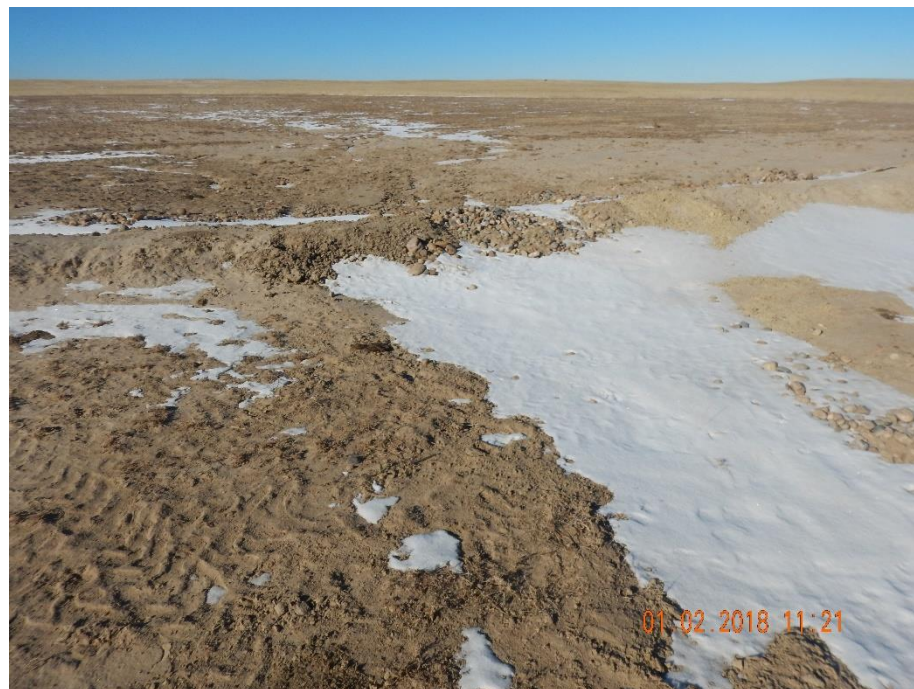
Photo 4: Photo taken from the north end of the location, facing west. Photo show additional rock armoring has been used to repair the degradation within the stormwater berm.

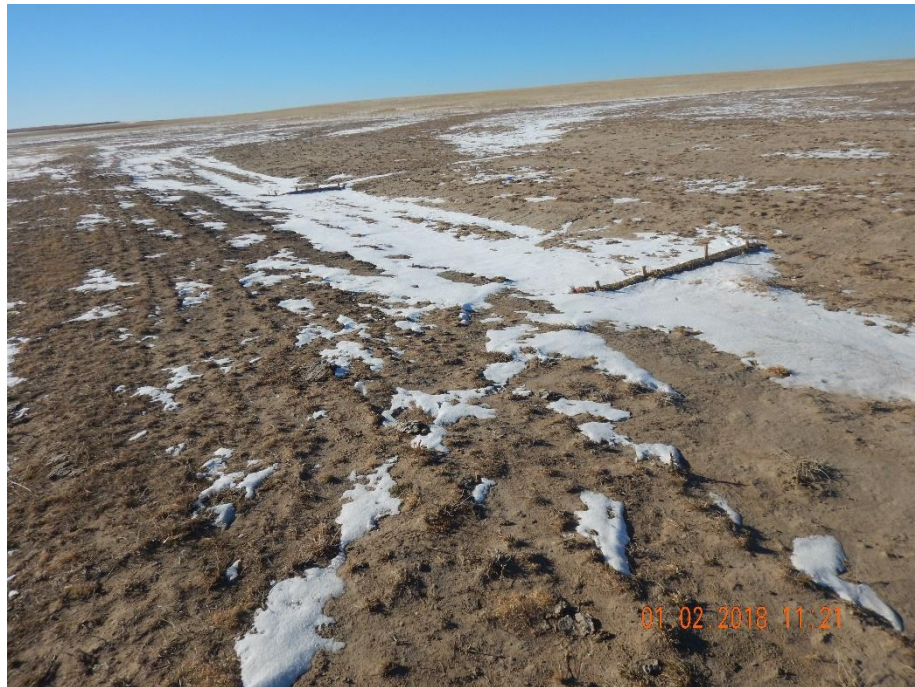
Photo 5: Photo taken from the northwest end of the location, facing southwest. Photo shows straw wattle BMPs have been repaired.

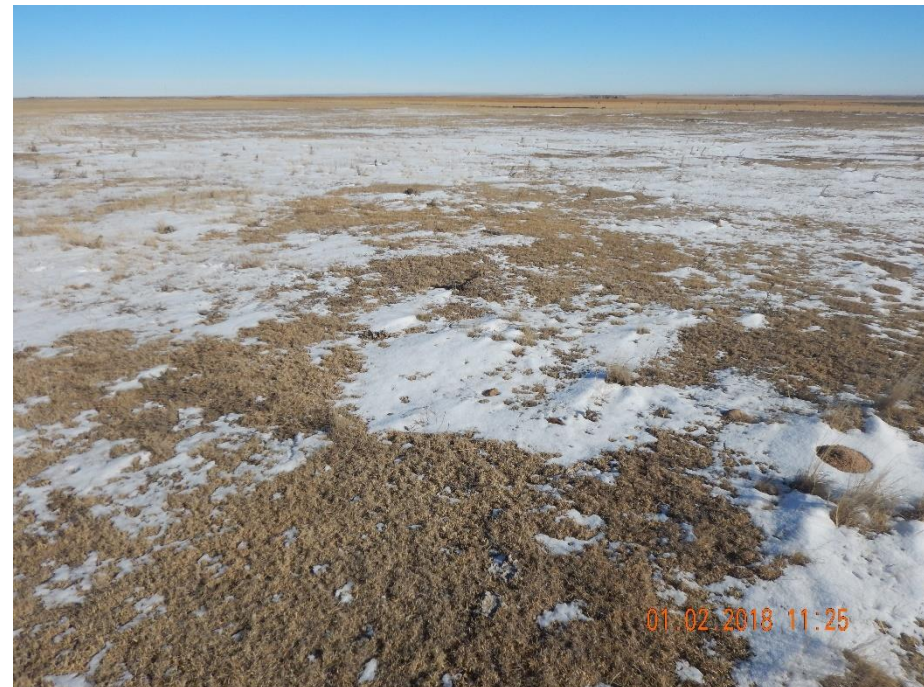
Photo 6: Photo taken from the west end of the location, facing northeast.

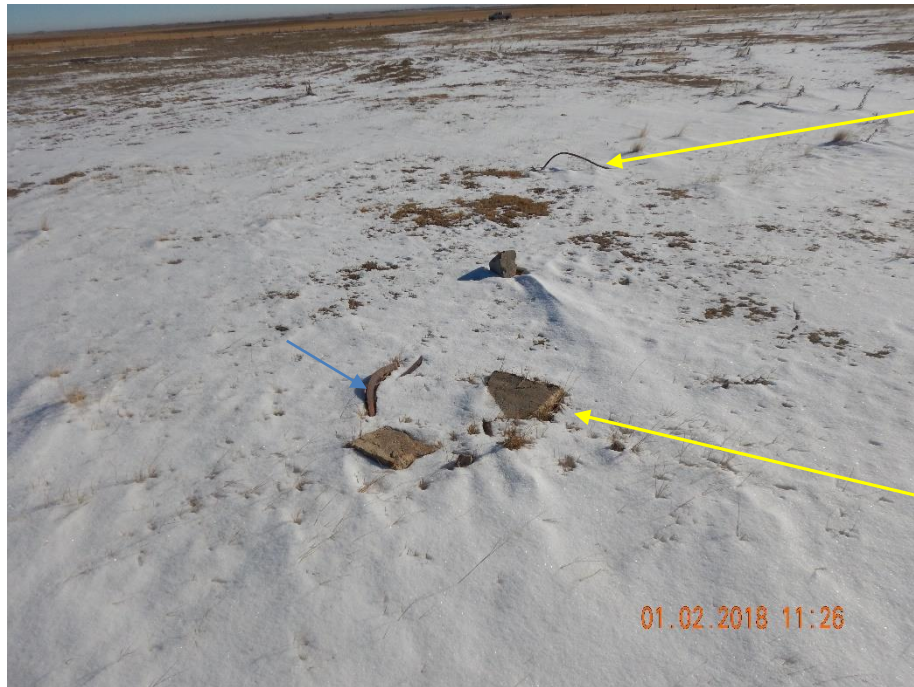
Photo 7: Photo taken from the southwest area of the disturbance, and the well location, facing northeast. Inspection #682501119 and inspection #682502721 identified and documented this debris and required its removal. Refer to photos 9-11 in inspection 682501119 and photo 23 in inspection #682502721. Photo shows debris has not been removed per the corrective action.

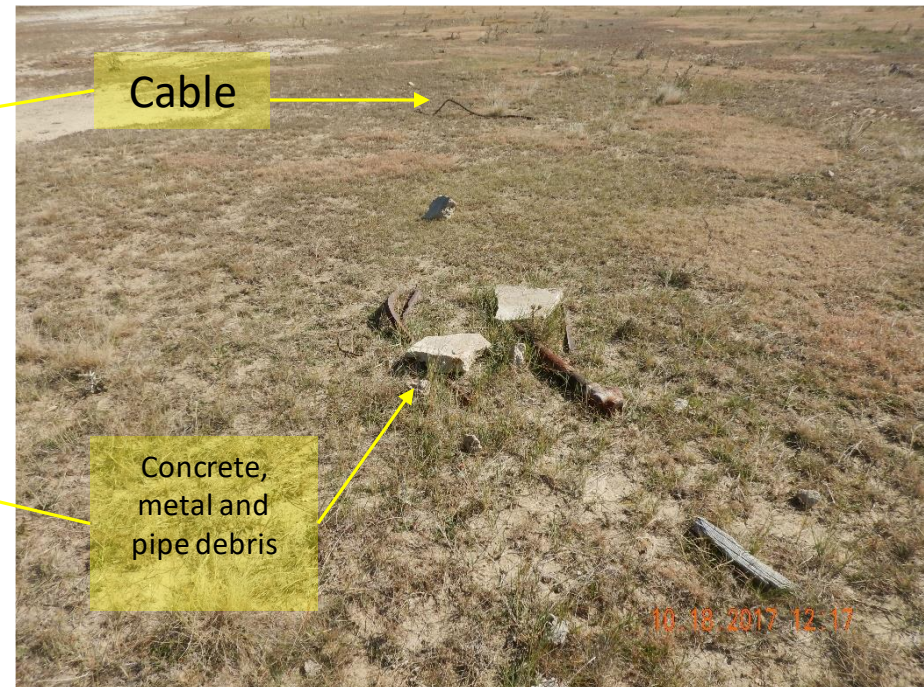
Photo 8: Photo from inspection #682502721 (#23) dated 10/18/2017.

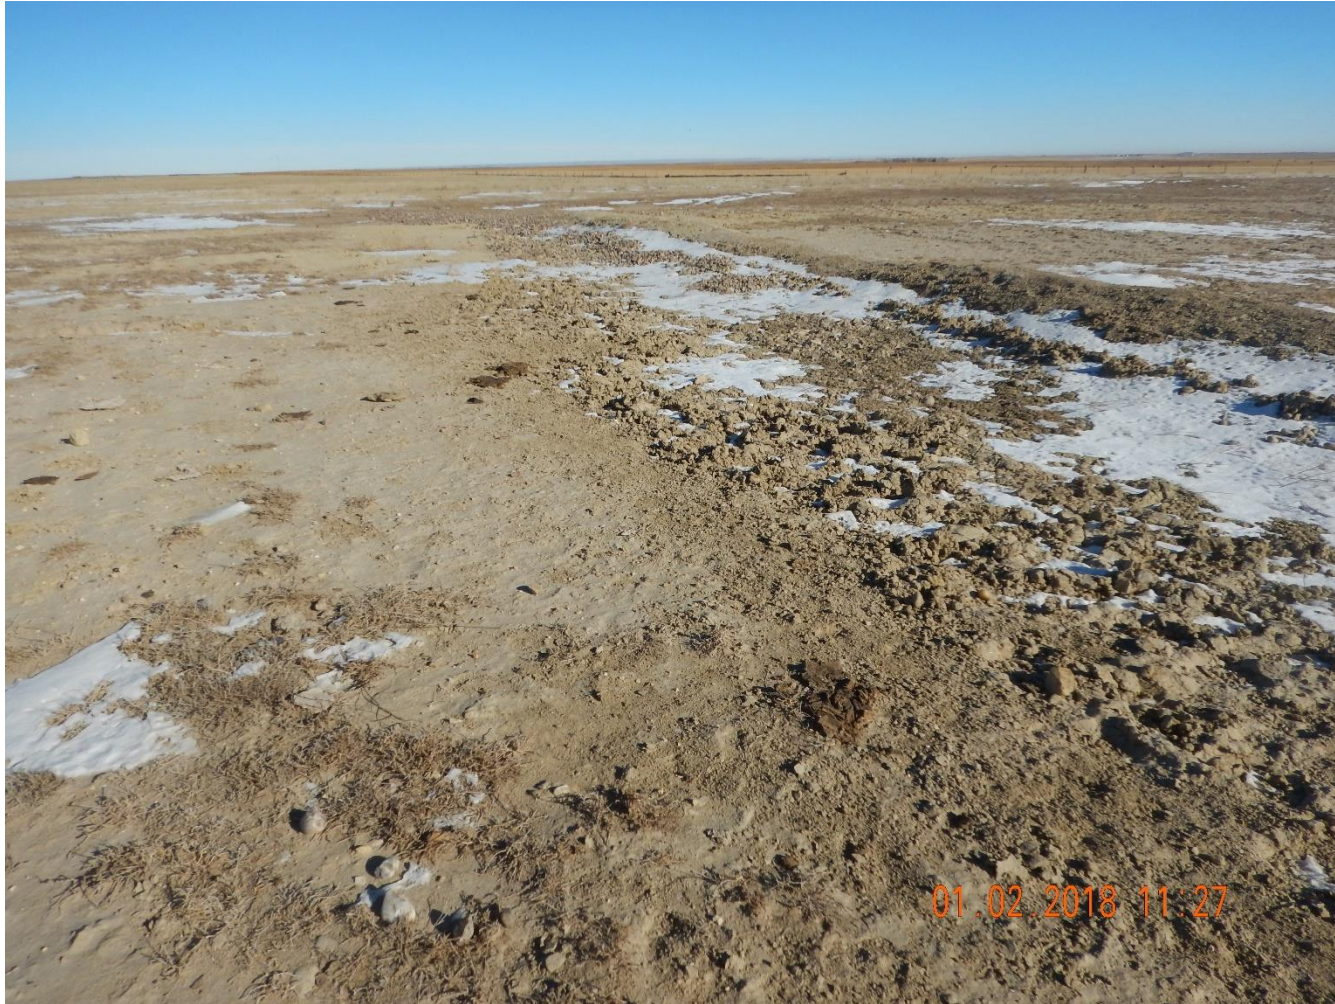
Photo 9: Photo taken from the south end of the location, facing north. Photo shows maintenance appears to have been conducted at the berm BMP.
