Final Reclamation Inspection

Operator: ANADARKO E&P ONSHORE LLC - 2800

API: 05-123-31811

Inspection Photos
Location Name: HOBART #8-67-1-11
API: 05-123-31811

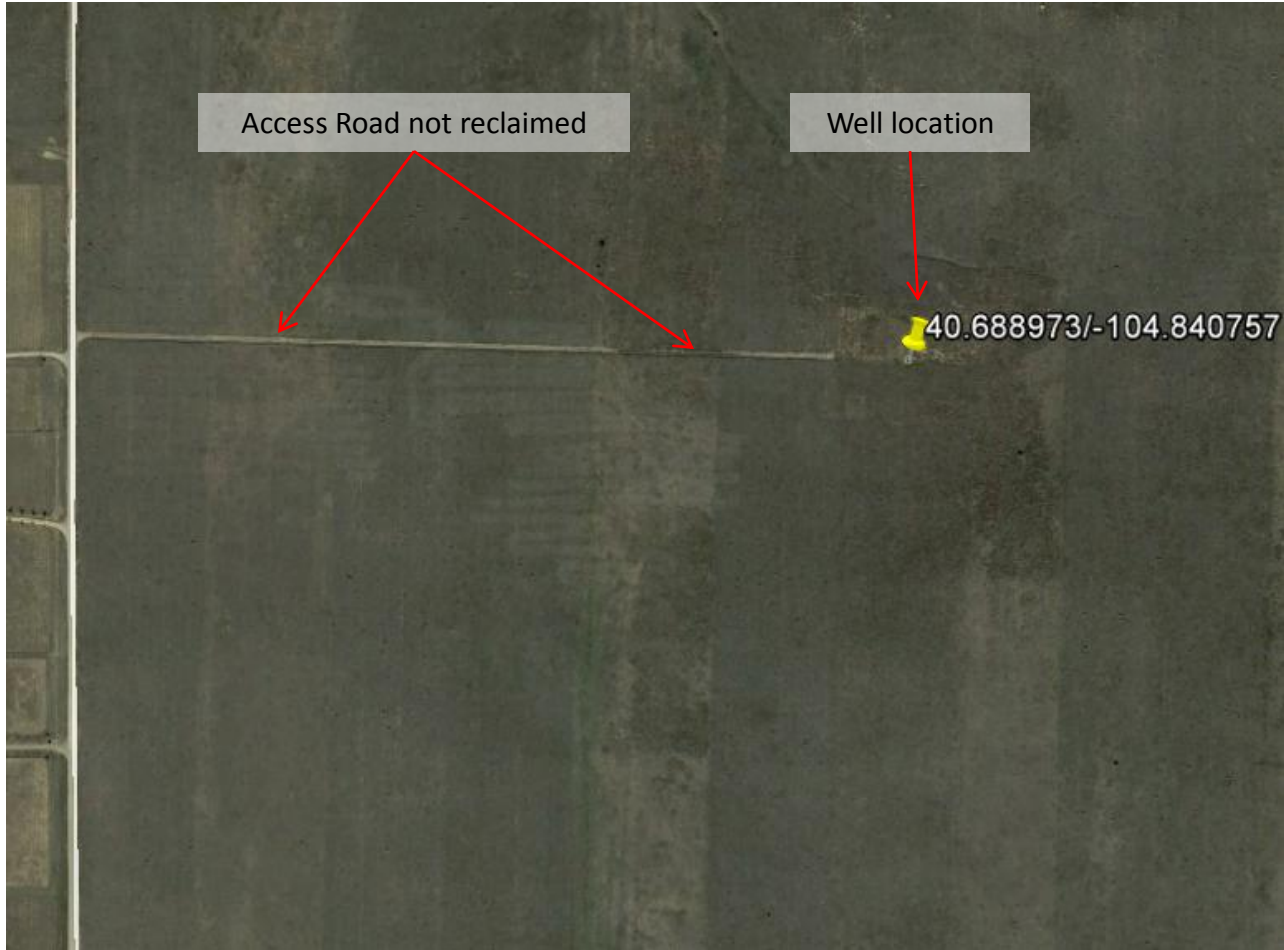
Google Earth imagery taken on October 14, 2017 illustrating the access road that has not been reclaimed per Rule 1004 standards- refer to Photo 6 . Well location appears to meet Rule 1004 standards- refer to Photos 1-4.

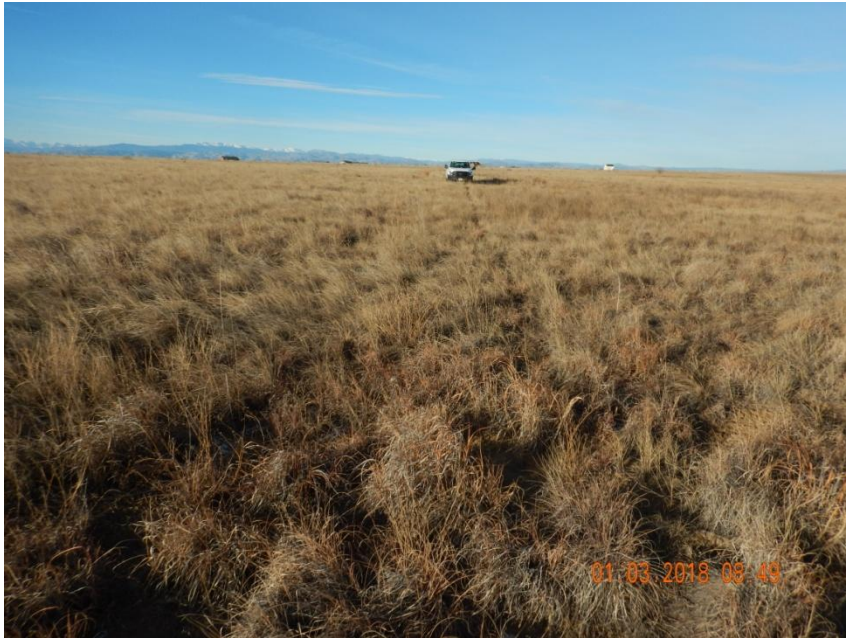
Photo 1. Photo taken from the approximate center of location, facing West. Well location appears reflective of reference area vegetative levels.

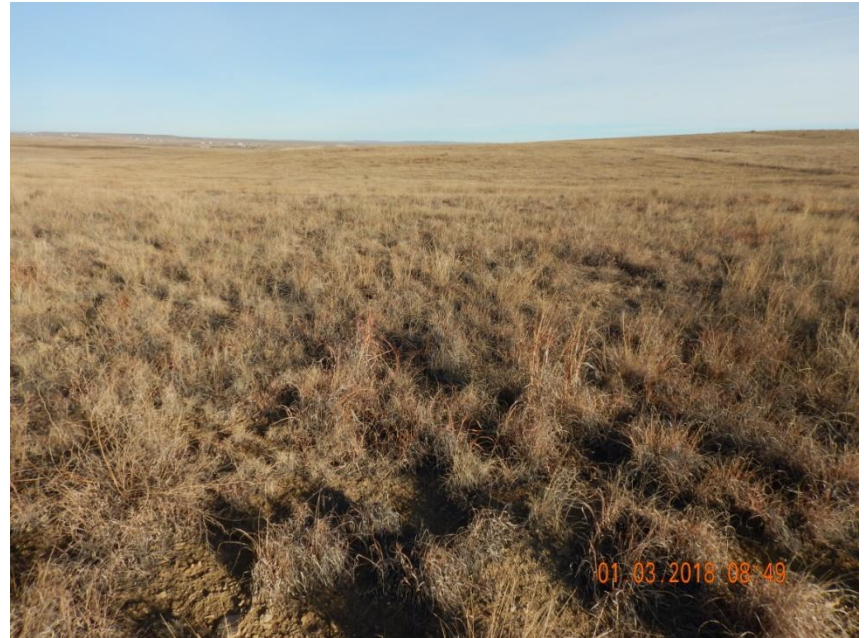
Photo 2. Photo taken from the approximate center of location, facing North. See comments under Photo 1.

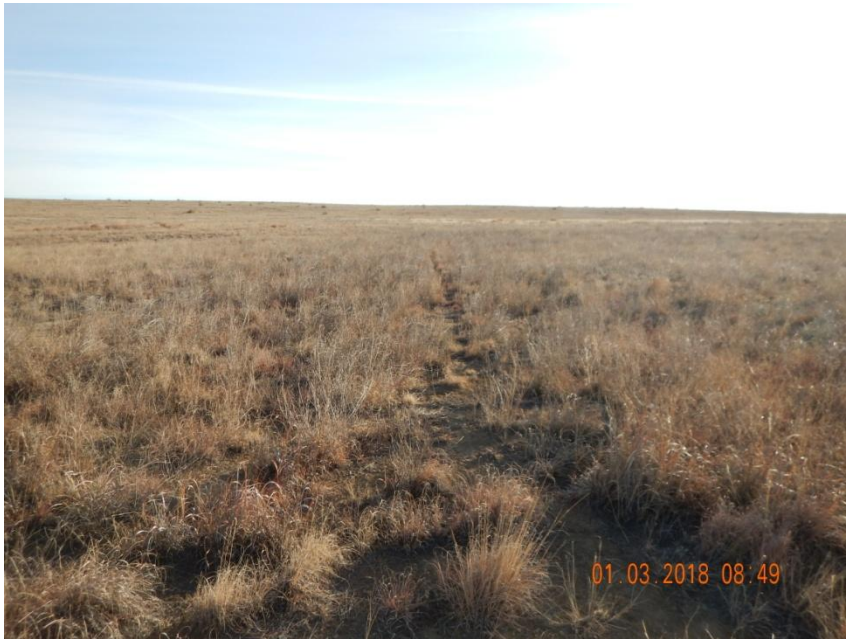
Photo 3. Photo taken from the approximate center of location, facing East. See comments under Photo 1.

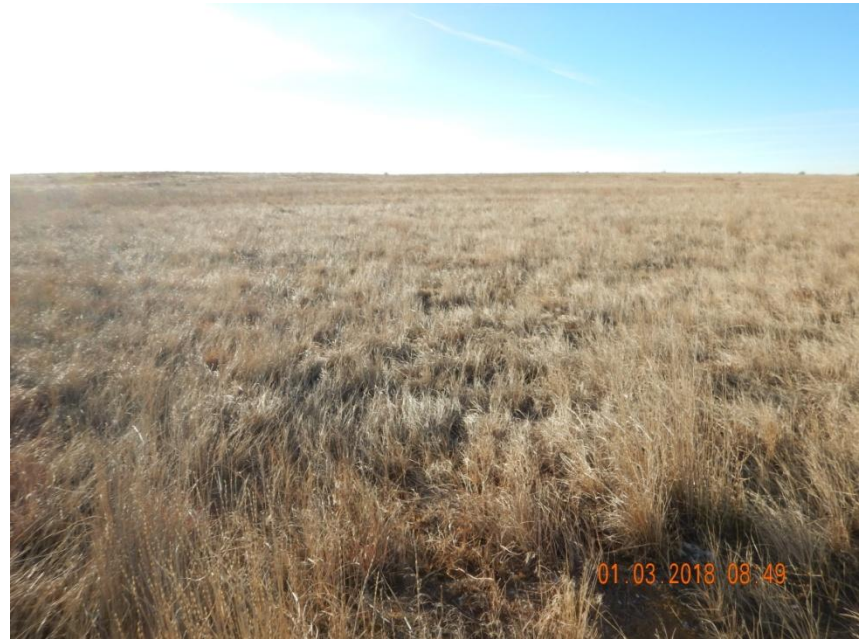
Photo 4. Photo taken from the approximate center of location, facing South. See comments under Photo 1.

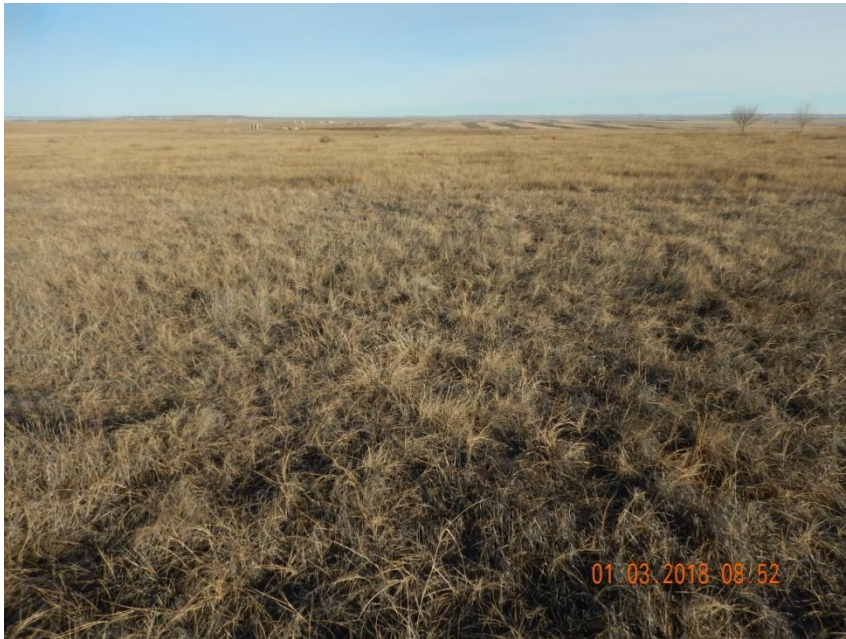
Photo 5. Reference photo taken northwest of the location, facing North. See comments under Photo 1.

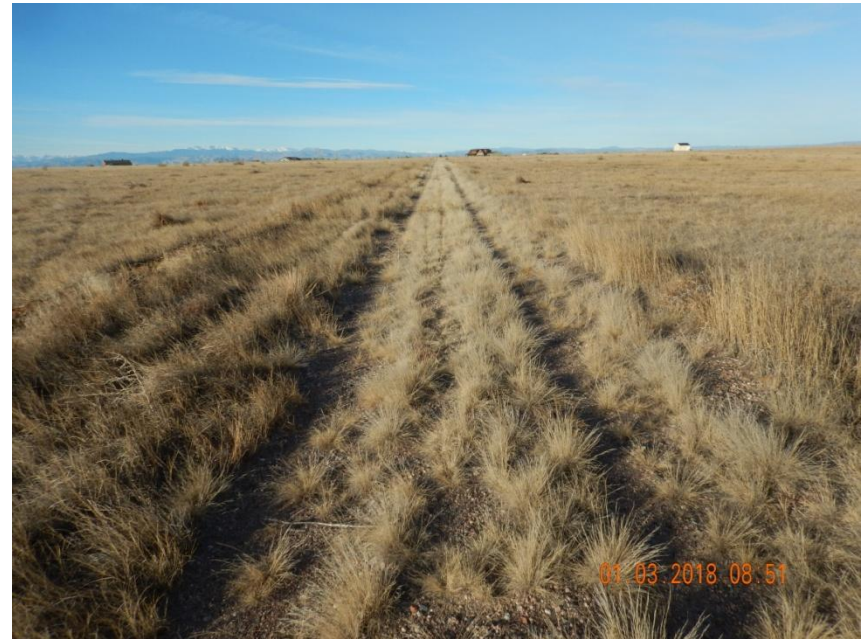
Photo 6. Photo taken from a portion of the access road, facing West. Gravel remains on access road and access road has not been contoured to match the surrounding landscape per Rule 1004 standards.
