Inspection Photos
Location Name: McIntyre 1-3 ST
API: 05-081-06608

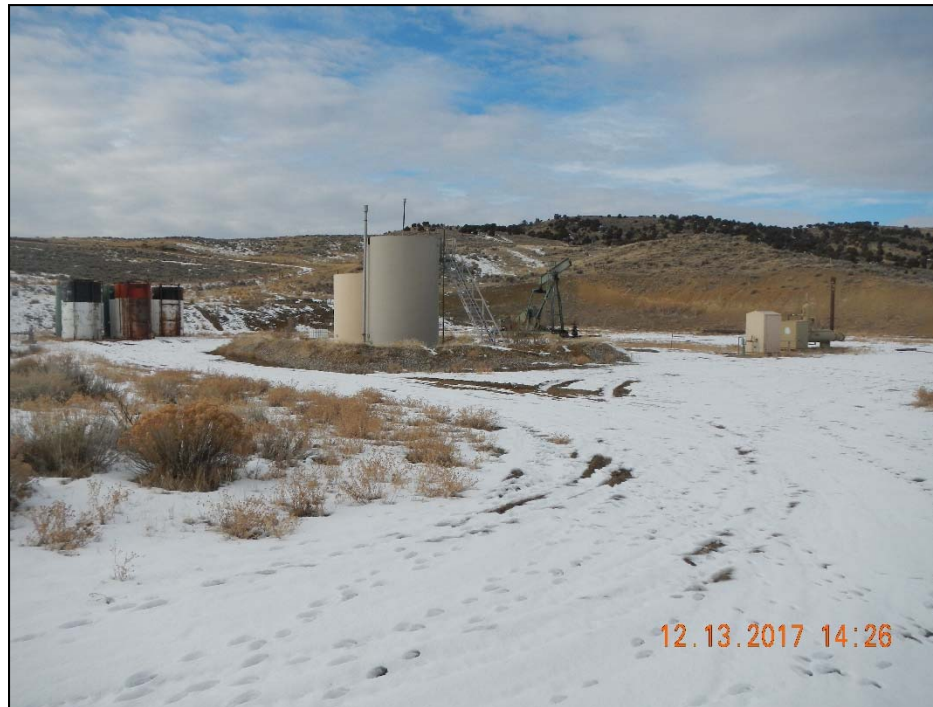
Photo 1. Overview of location taken at entrance facing northeast.

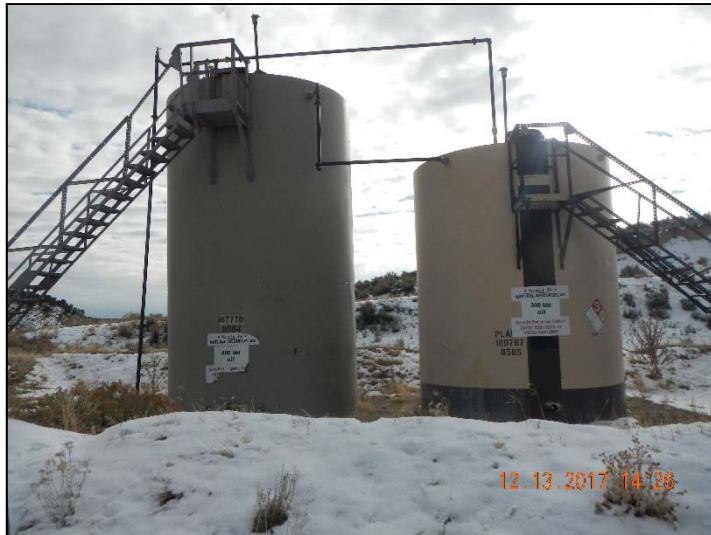
Photo 2. Vegetation, annual, and noxious weeds on and in berm.

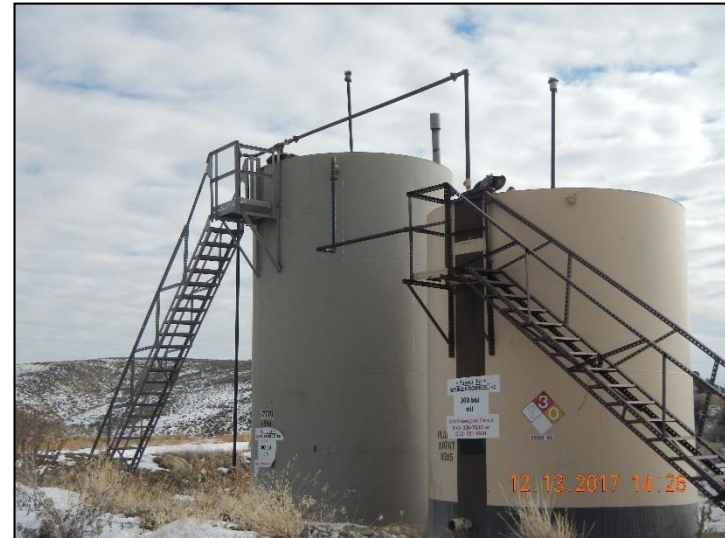
Photo 3. Gauge hatch on 300 bbl tank in foreground is open.

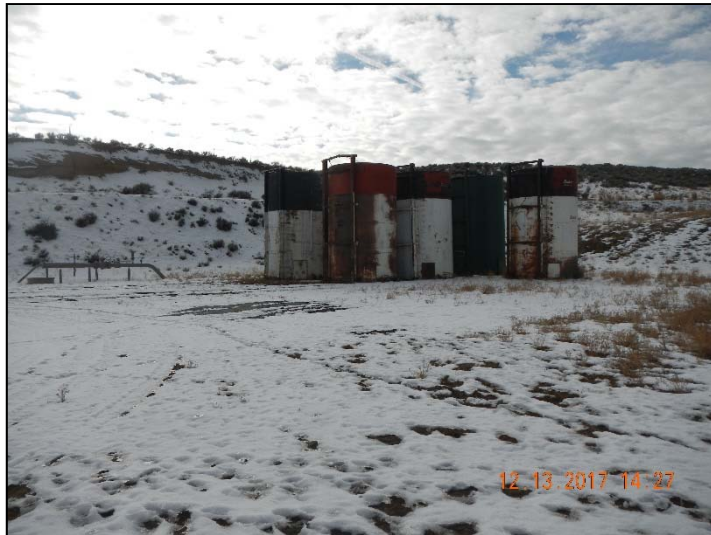
**Photo 4. 7 frack tanks each with fluid in them.
Stored on location with no secondary
containment.**

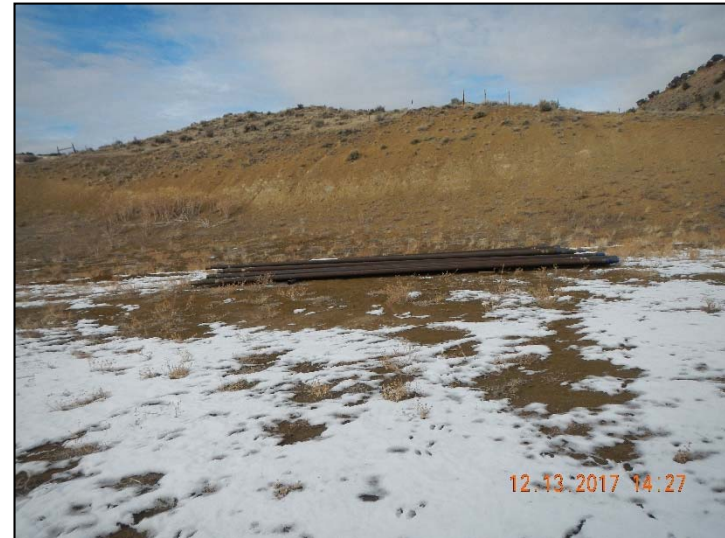
**Photo 5. Equipment stored on location. Rills coming
onto location.**

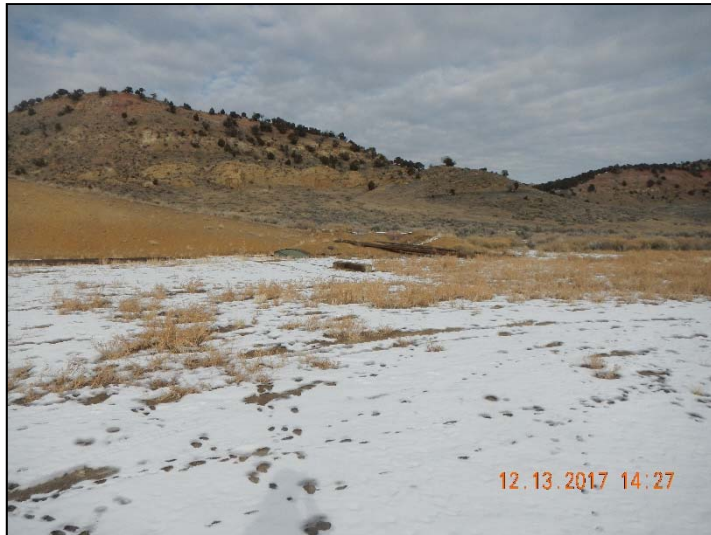
Photo 6. Equipment stored on location.

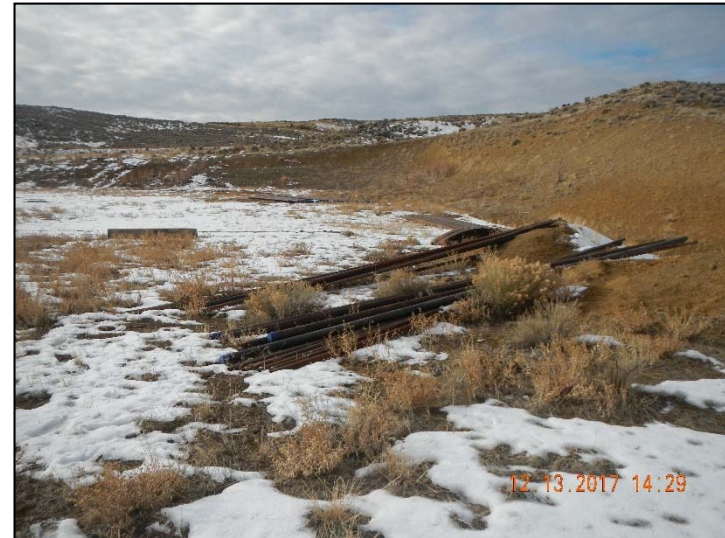
Photo 7. Equipment stored on location.

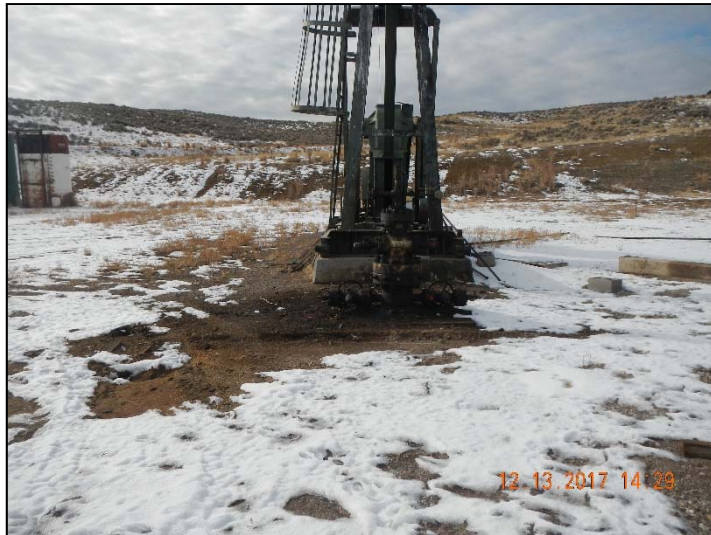
Photo 8. Stained soil at wellhead.

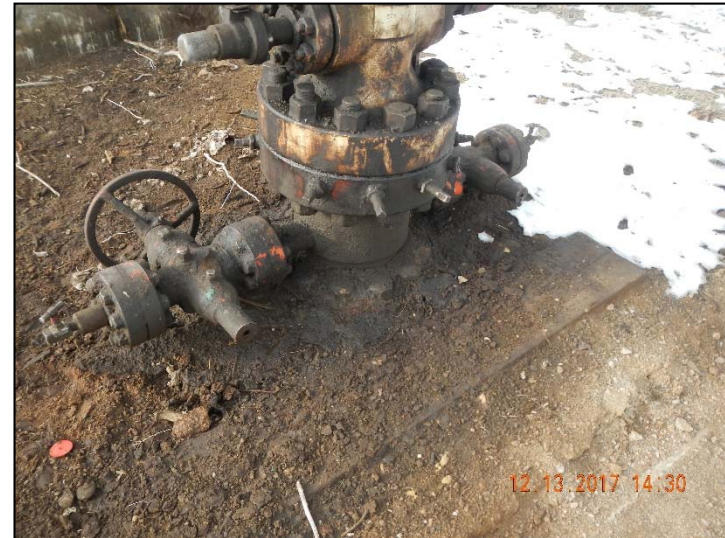
Photo 9. Close-up of stained soil at wellhead.

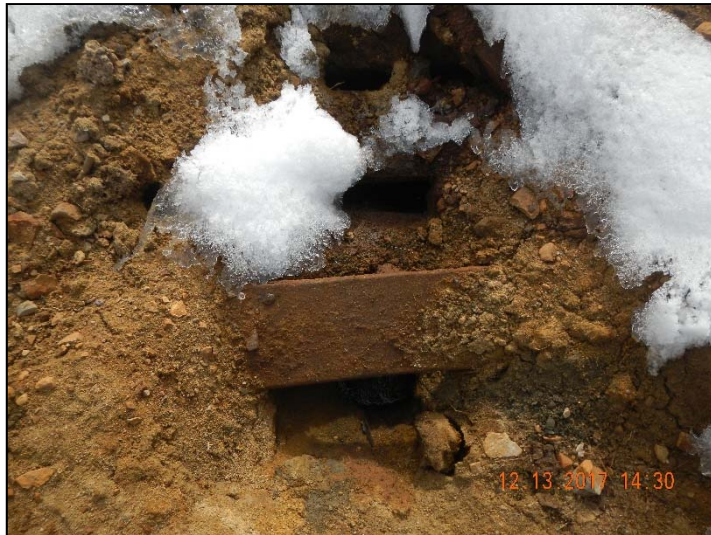
Photo 10. Rathole covered with wooden slats with fluid present.

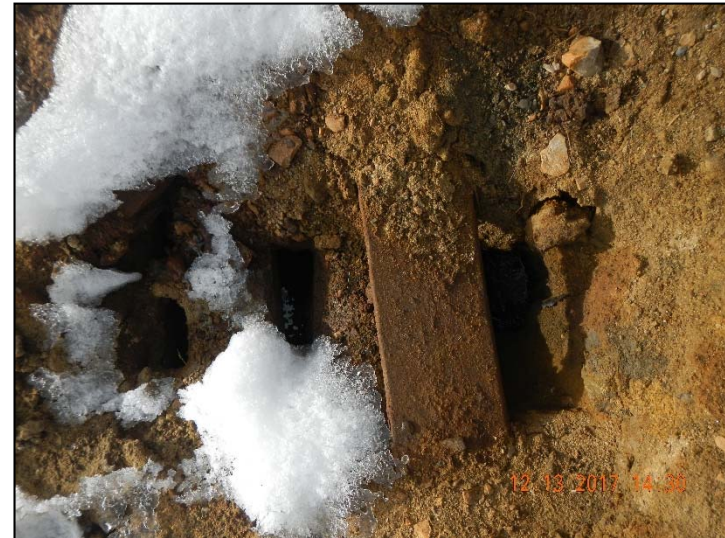
Photo 11. Close-up of rathole fluid.

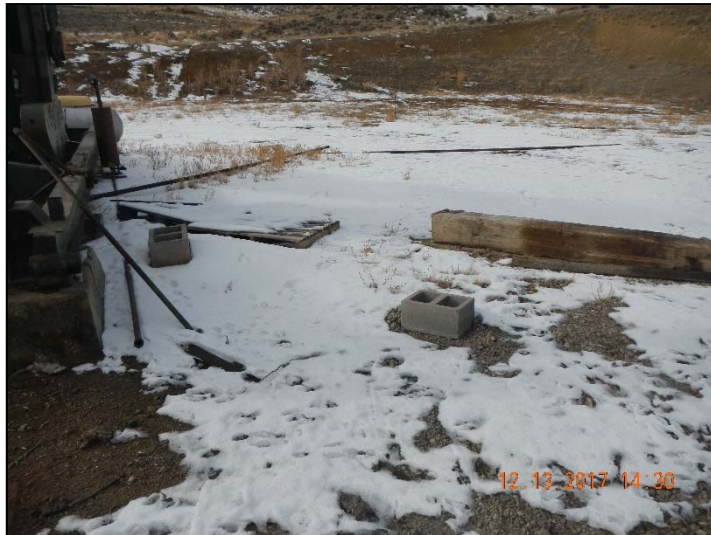
Photo 12. Debris on location.

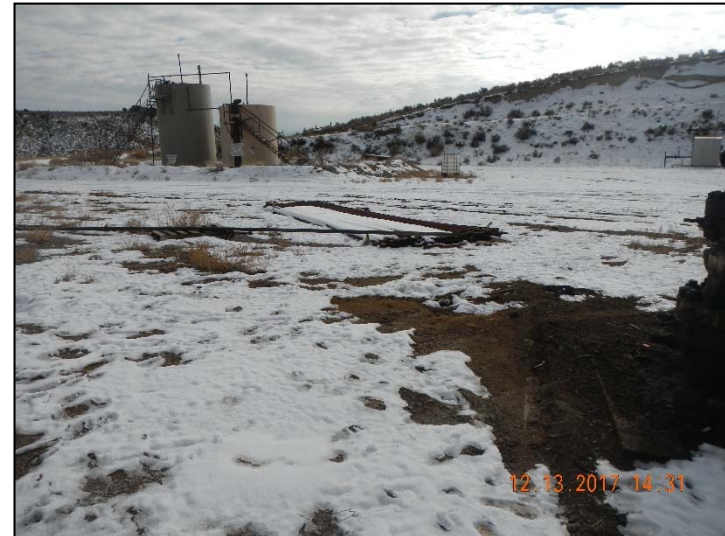
Photo 13. Debris on location.
