Final Reclamation Inspection

January 3, 2018

Operator: CHESAPEAKE OPERATING LLC- 16660

API: 05-123-34627

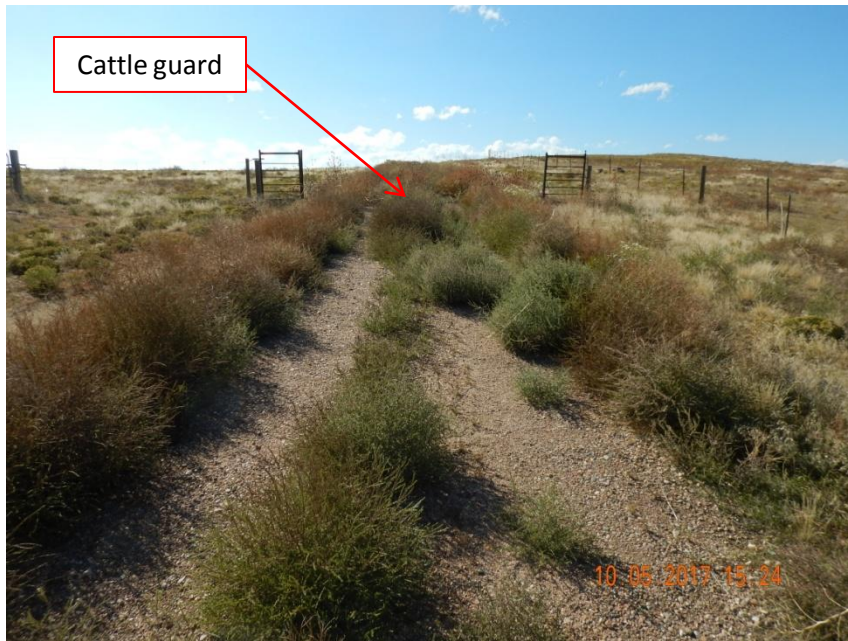
Photo 1. Photo taken from the start of the access road off CR 94, facing West on October 5, 2017. Russian thistle growing throughout the access road portions of the road; gravel on access road; access road has not been contoured or seeded.

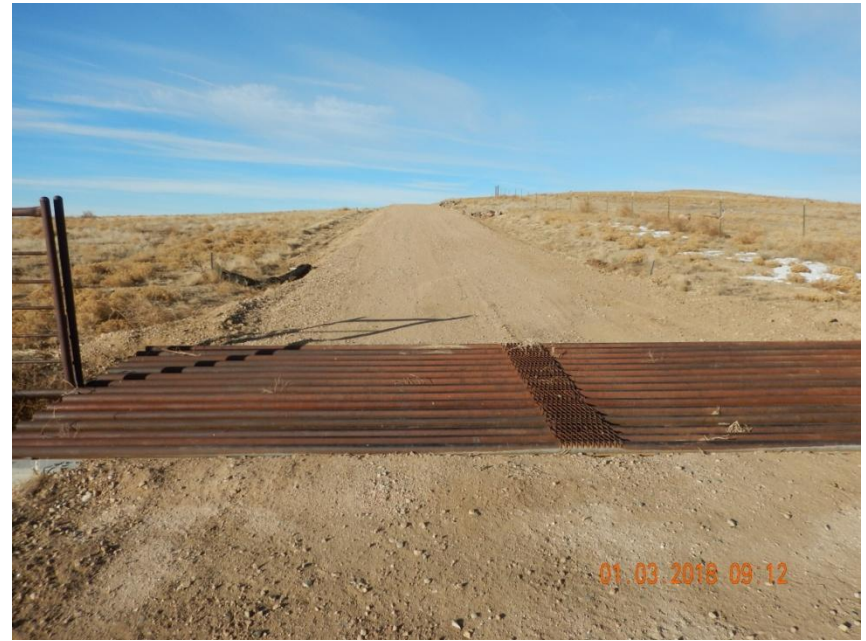
Photo 2. Photo taken from the same location as Photo 1, facing West on January 3, 2018. Operator has removed Russian thistle from the access road.

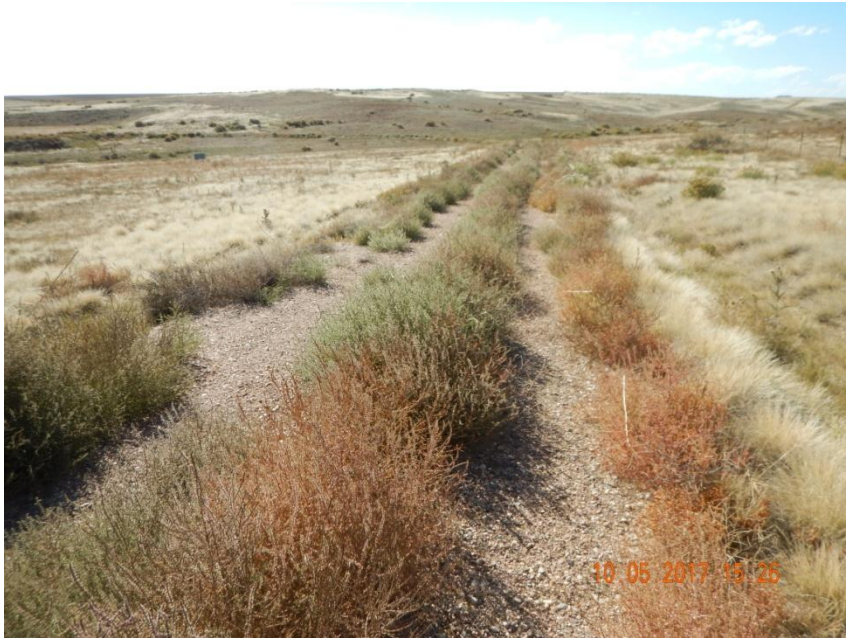
Photo 3. Photo taken along a portion of the access road, facing West on October 5, 2017. See comments under Photo 1.

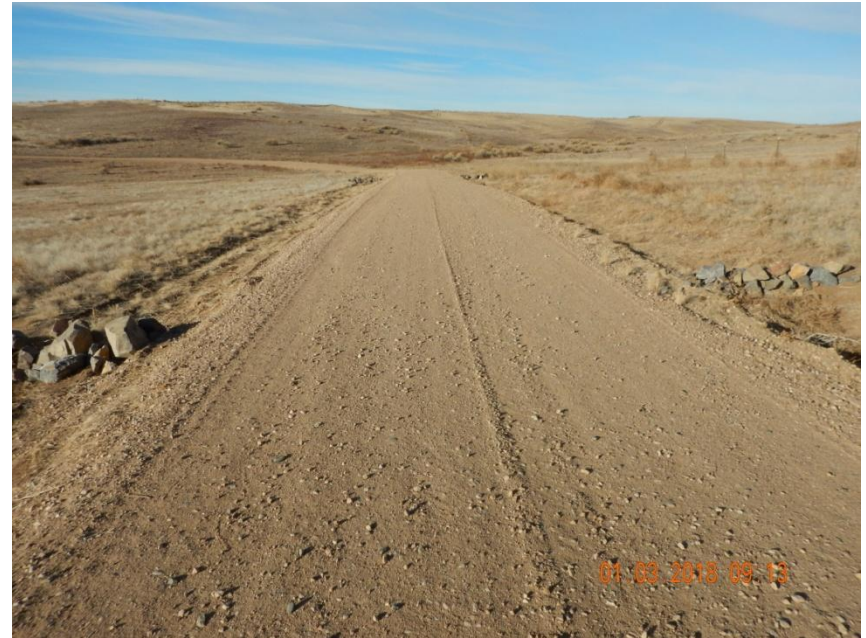
Photo 4. Photo taken from the same location as Photo 3, facing West on January 3, 2018. See comments under Photo 2.

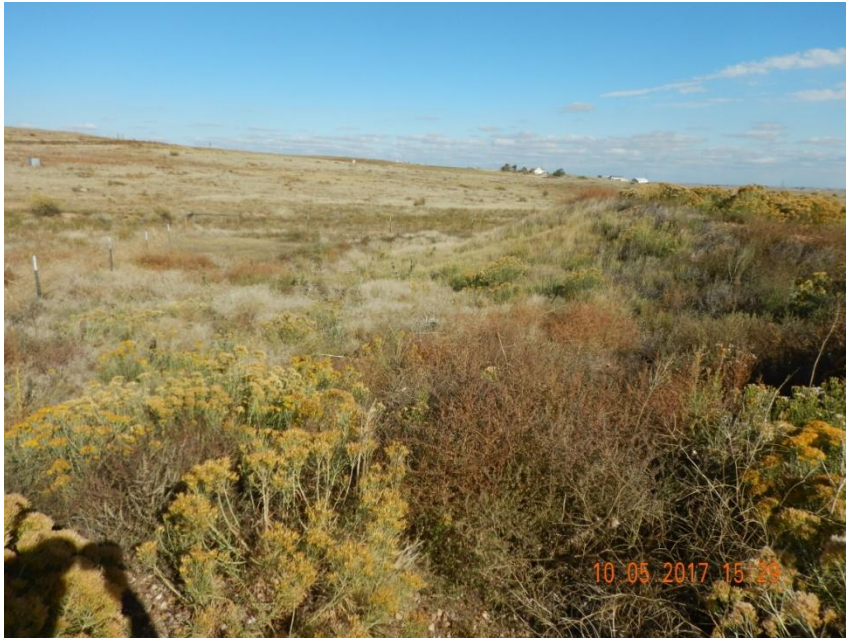
Photo 5. Photo taken from the northern location, facing East on October 5, 2017. Photo illustrates the location has not been contoured to the surrounding landscape and the perimeter fence around the entire location remains.

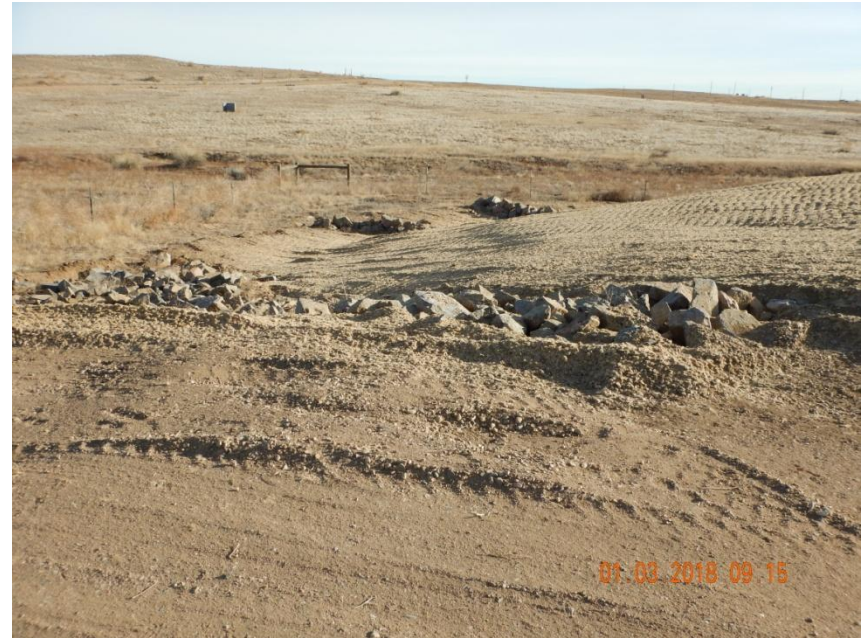
Photo 6. Photo taken from the same location as Photo 5, facing East on January 3, 2018. Operator has installed stormwater BMPs along the perimeter of the location and has brush hogged the location.

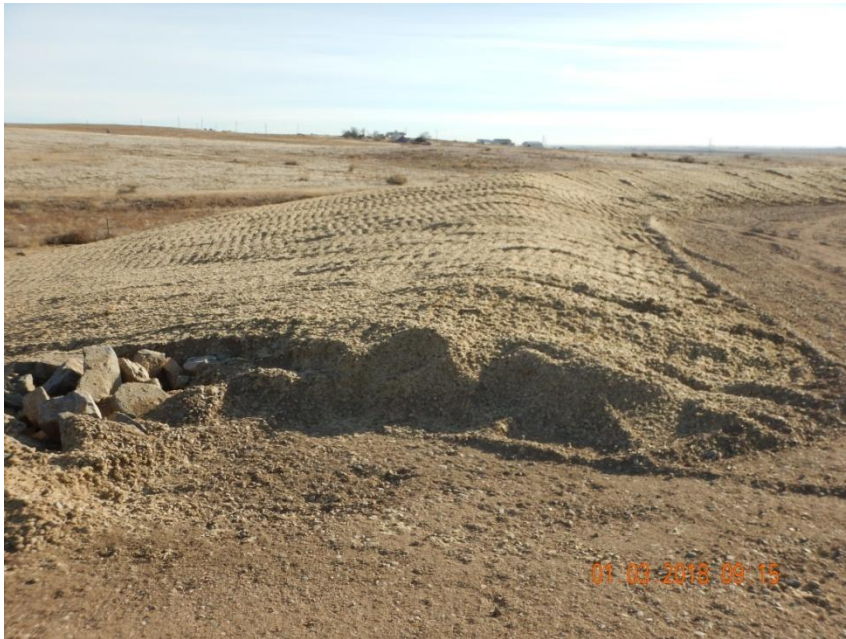
Photo 7. Photo taken from the northern location, facing East on January 3, 2018. Operator appears to have constructed a berm around the northern and eastern well pad perimeter. Fill slope has been tracked with equipment and hydromulched.

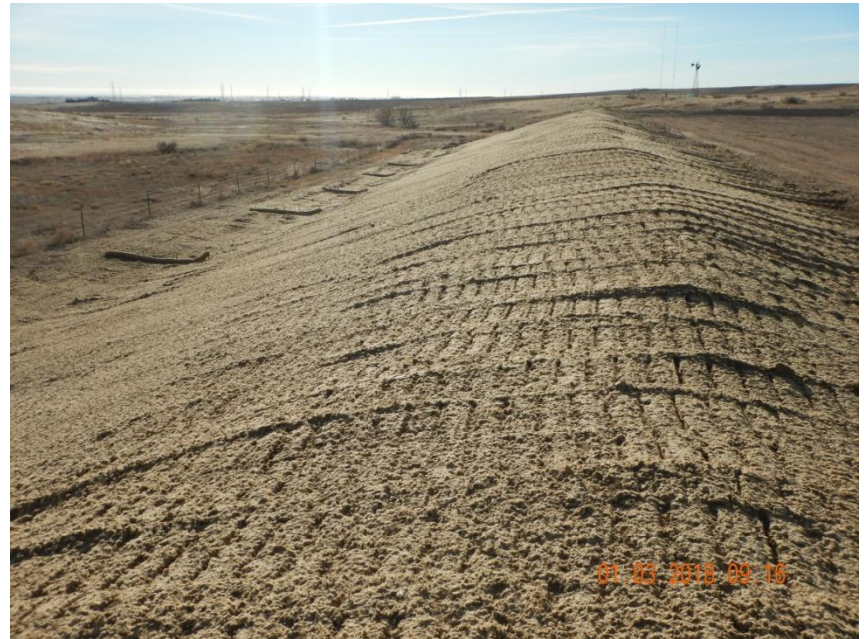
Photo 8. Photo taken from the northeastern location, facing South on January 3, 2018. See comments under Photo 6 & 7.

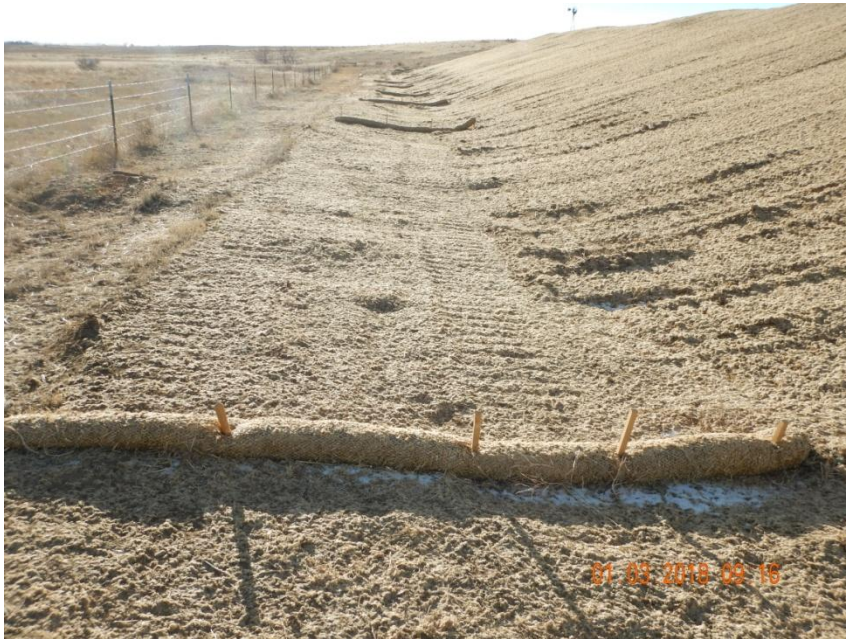
Photo 9. Photo taken from the eastern location, facing South on January 3, 2018. Operator has installed straw wattles as check dams which have not been properly installed. Wattles have not been properly trenched and backfilled.

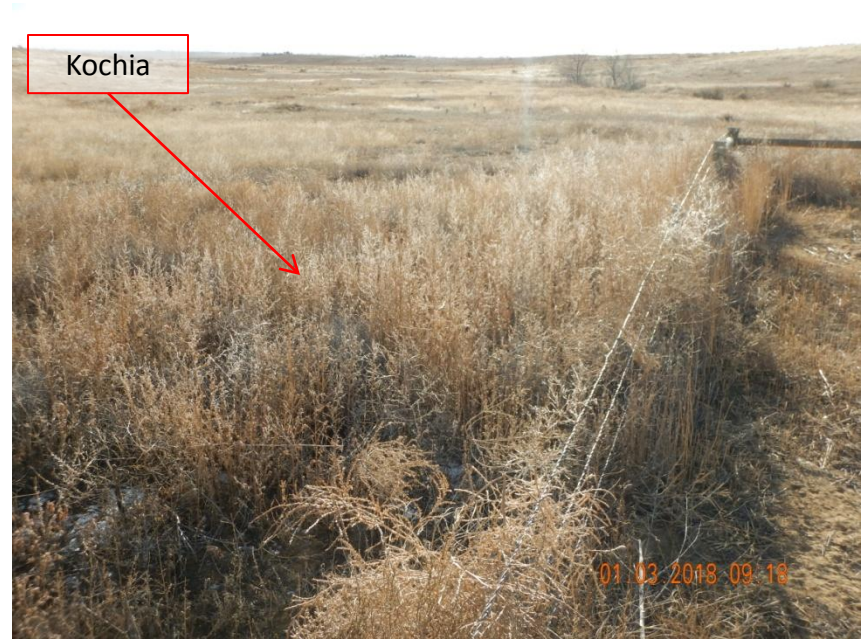
Photo 10. Photo taken from the southeast location, facing South on January 3, 2018. Appears Kochia has spread off location onto the adjacent lands.

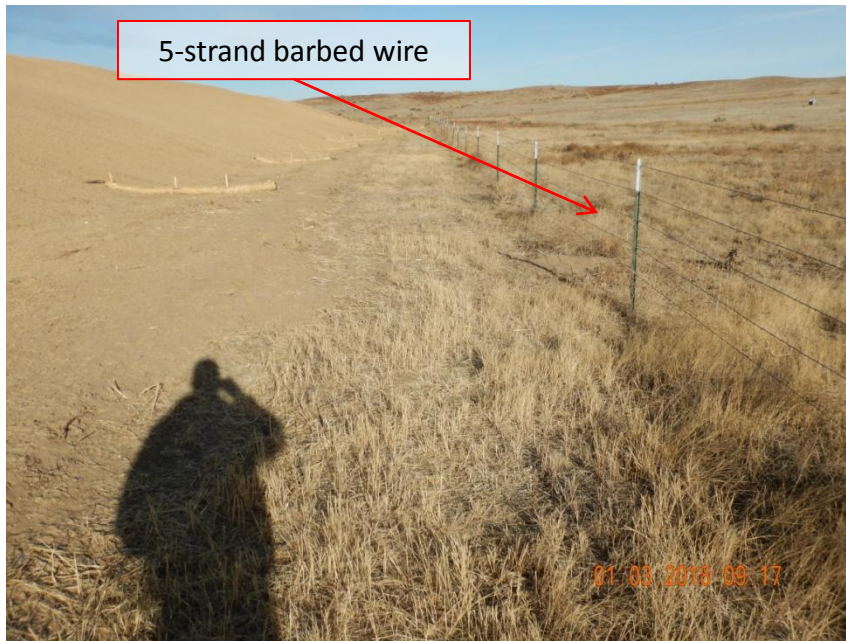
Photo 11. Photo taken from the southeast location, facing North on January 3, 2018. This photo illustrates 5-strand barbed wire. The following photo will illustrate the amount of sediment discharge from the location.

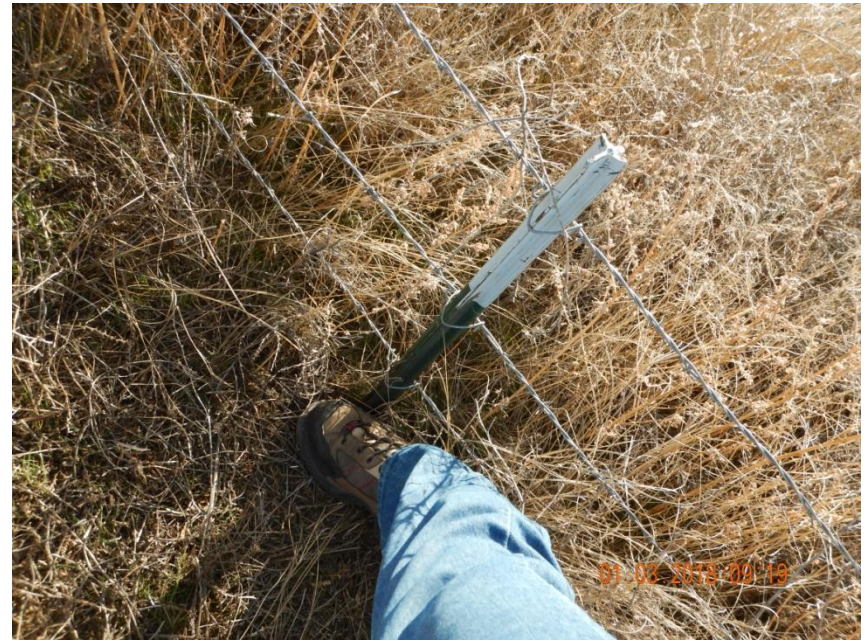
Photo 12. Close-up photo taken from the southeast location. This photo illustrates how much sediment has discharged from location. Only 3 strands of barbed wire and half the t-post are visible.

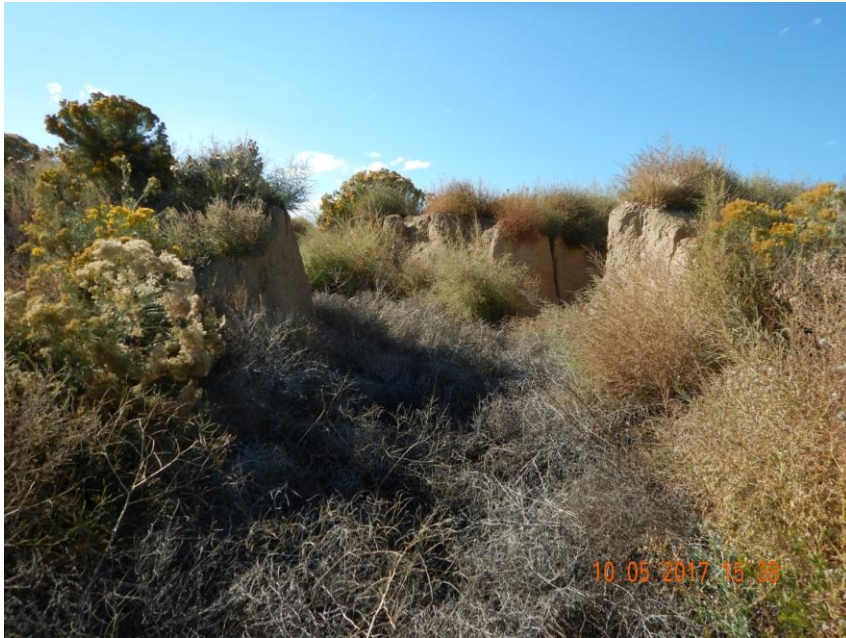
Photo 13. Photo taken from the southeastern location, facing Northwest on October 5, 2017. Gully erosion- 6 feet in depth- observed throughout the southeastern well pad location.

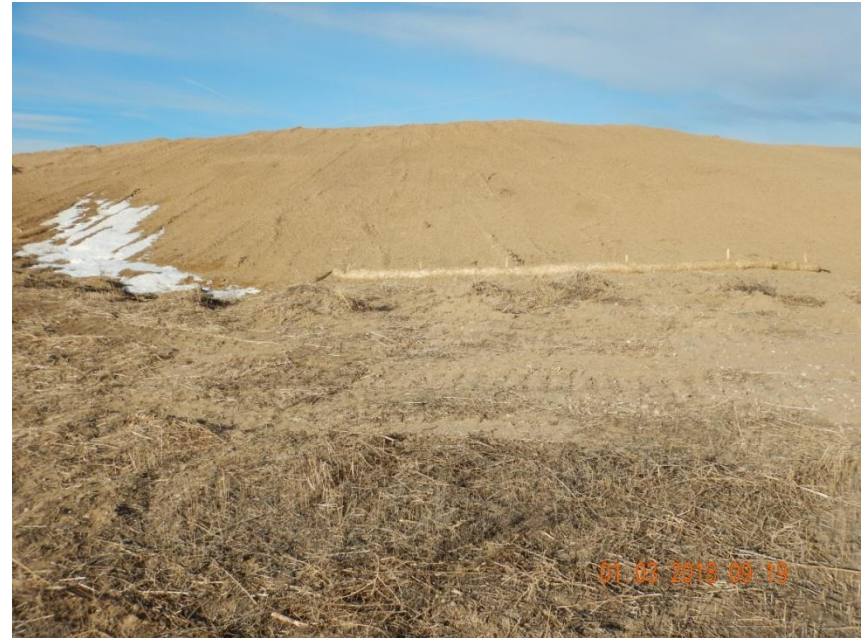
Photo 14. Photo taken from the same location as Photo 12, facing Northwest on January 3, 2018. Operator has repaired gully erosion. There was no observed stabilized outlet installed for stormwater management.

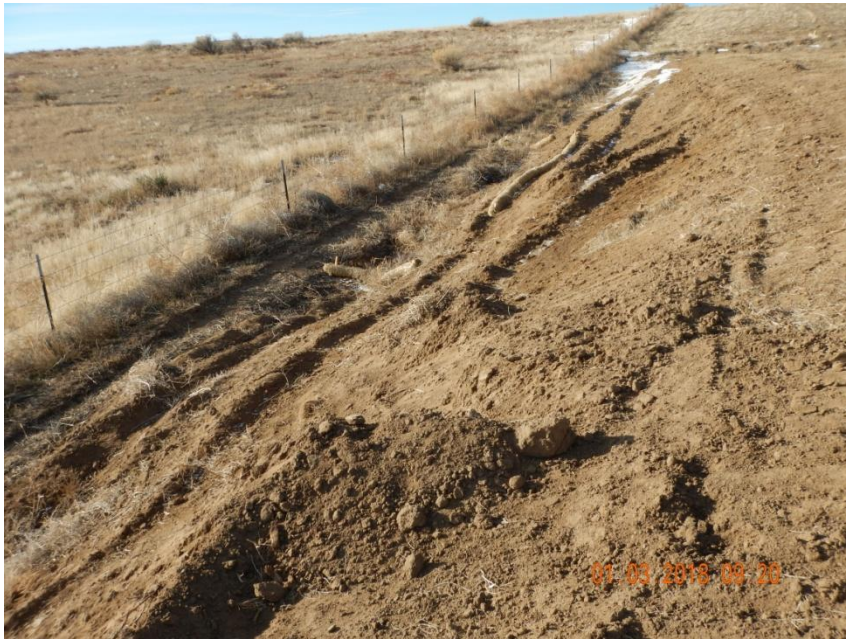
Photo 15. Photo taken from the southeastern location, facing West on January 3, 2018. Fill slope of what appears to be topsoil has not been properly stabilized. Straw wattles have not been properly installed.

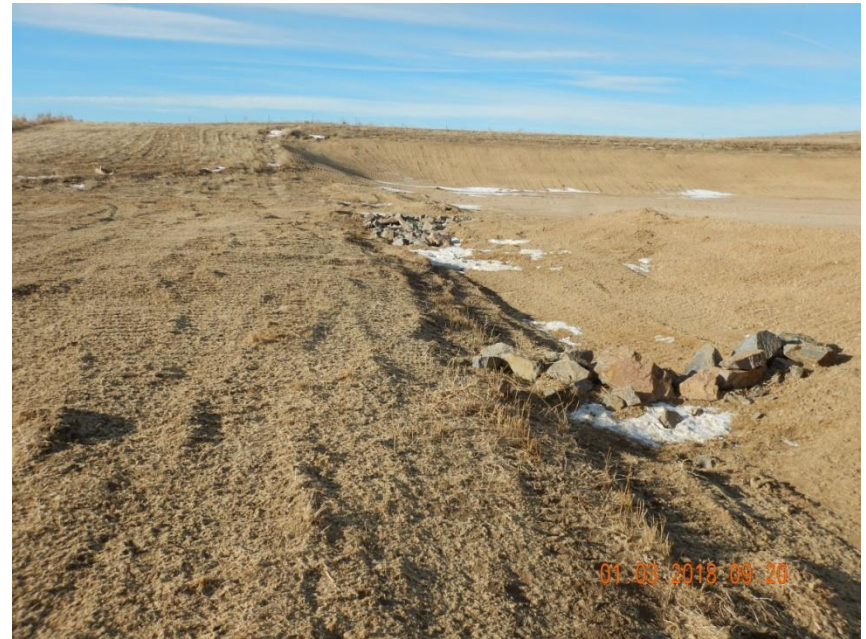
Photo 16. Photo taken from the southern location, facing West on January 3, 2018. Operator has installed stormwater BMPs.

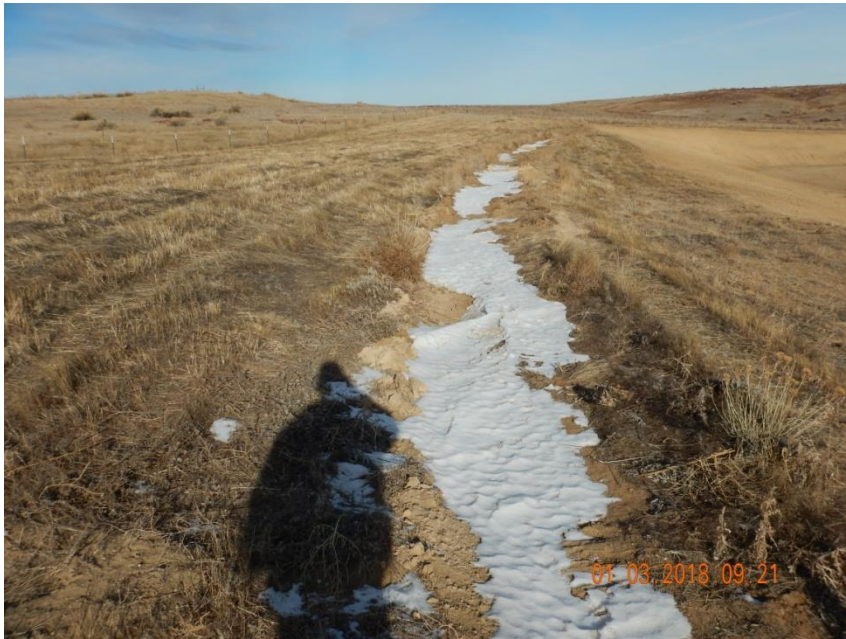
Photo 17. Photo taken from the southwestern location, facing North on January 3, 2018. Operator has installed a ditch in conjunction with check dams. Check dams are straw wattles which have not been properly installed.

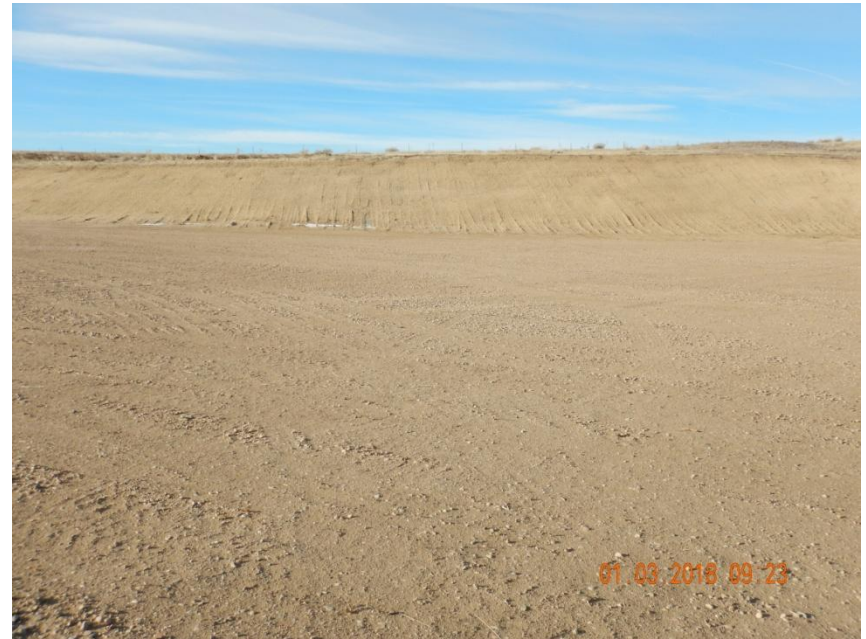
Photo 18. Photo taken from the approximate central well pad, facing West on January 3, 2018. Operator has tracked the cut slopes with equipment and hydromulched.

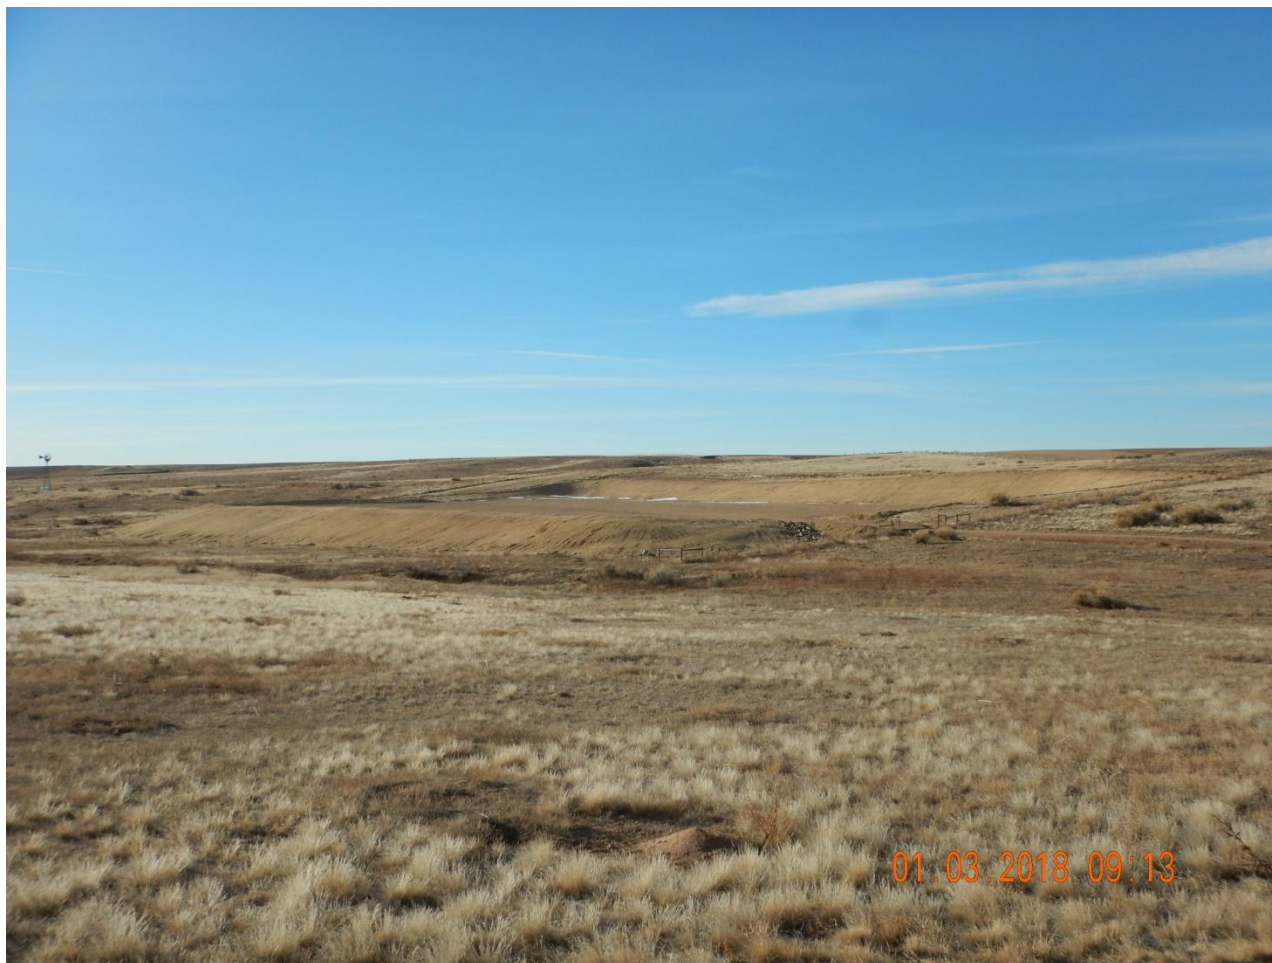
Photo 19. Photo taken from the main access road, facing Southwest on January 3, 2018. This is an overview photo of the location.
