COLORADO
Oil & Gas Conservation
Commission
Department of Natural Resources

Inspection Photos: Encana PA Standard Shale API#045-06913

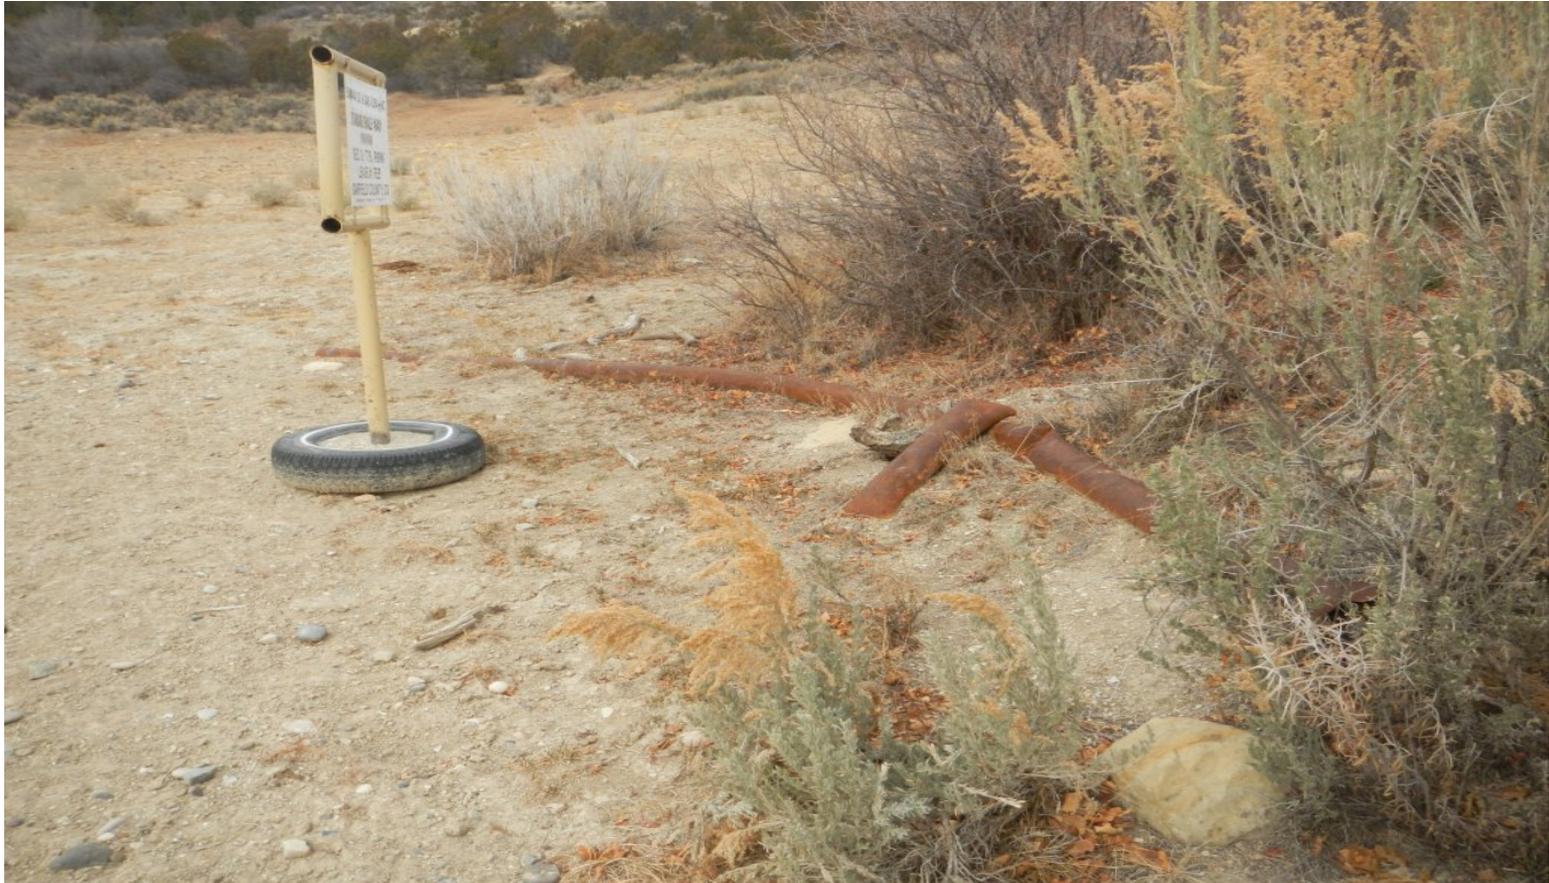
Photo#1:
View of Entry into Location; some Debris remains.

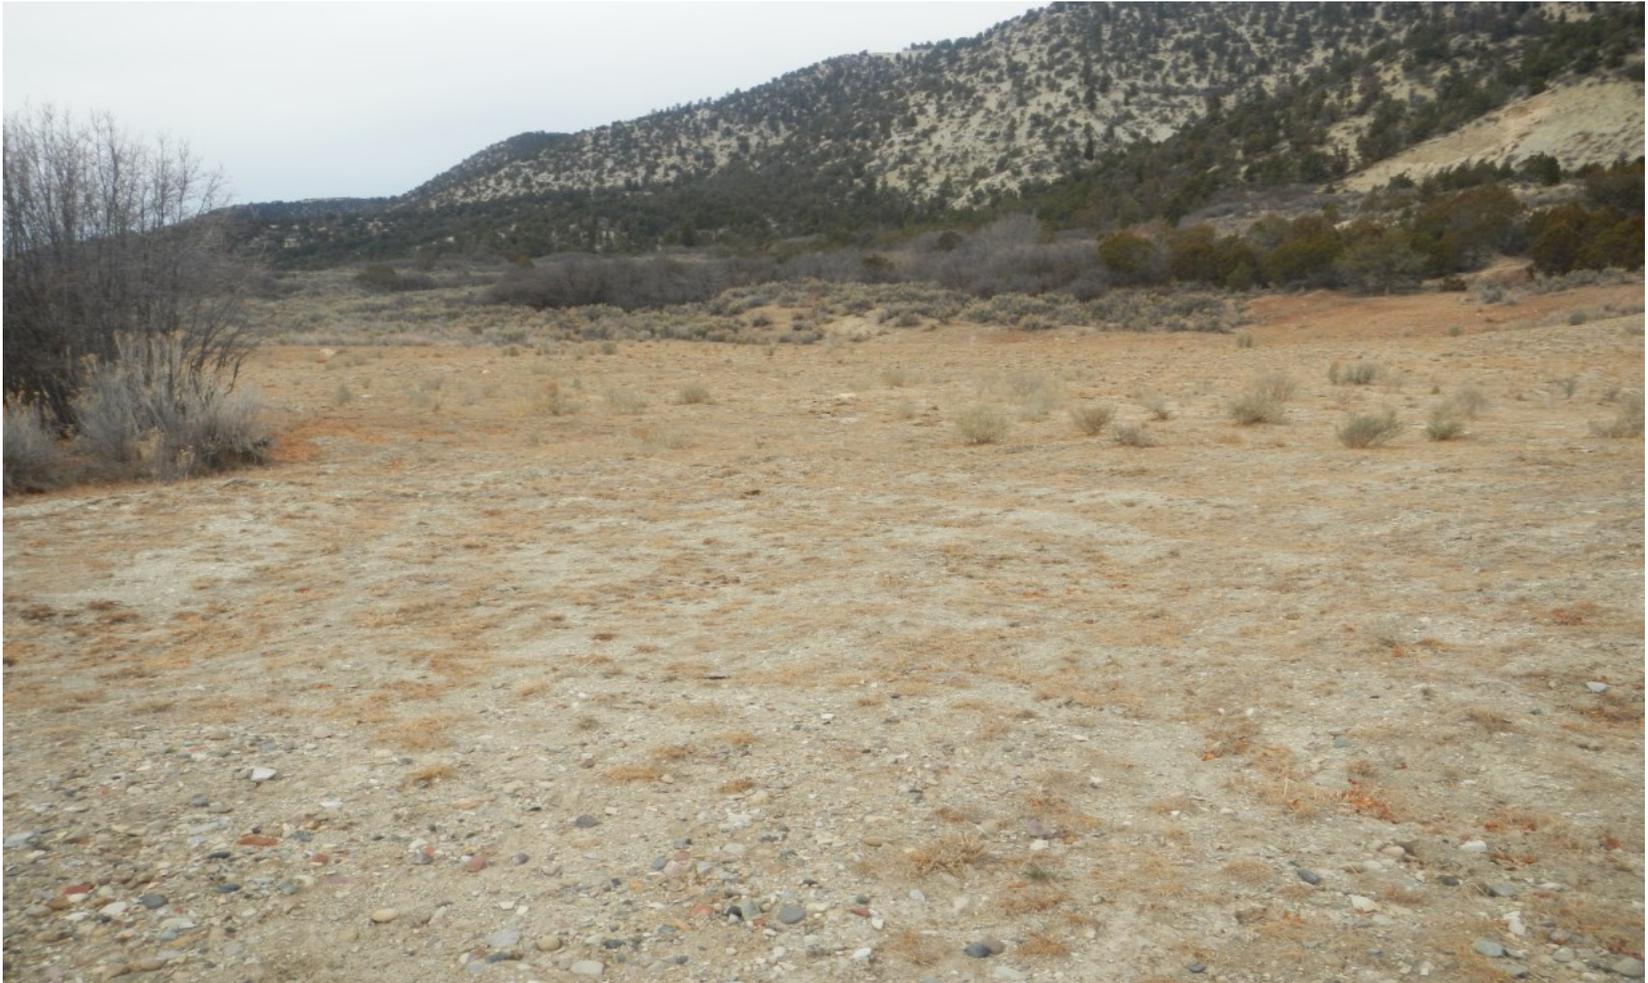
Photo#2:

Overview of Location to Northwest; Vegetation is not yet to the 80% of Reference Requirement.

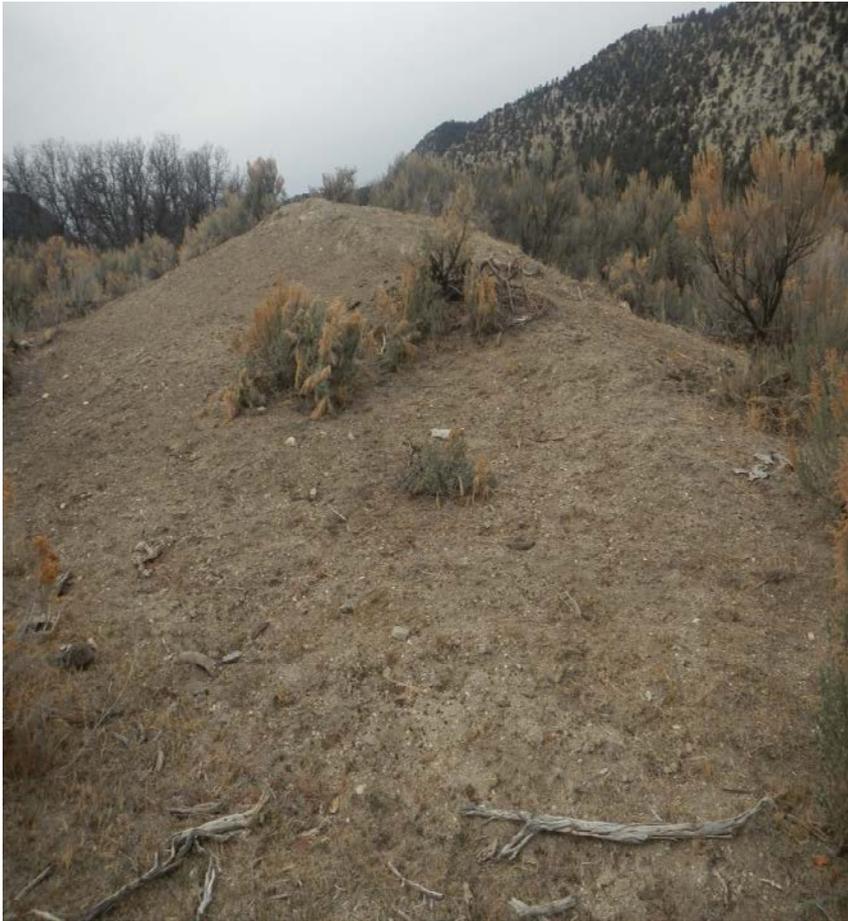
Photo#3:

What appears to be Stockpiled Soil at SW Corner (edge) of Location was not incorporated into recontouring of Site.
