# Inspection Photos

Operator: LEGADO DJ, LLC - 200039

Location ID: 388436

Inspection Doc. Number: 682503022

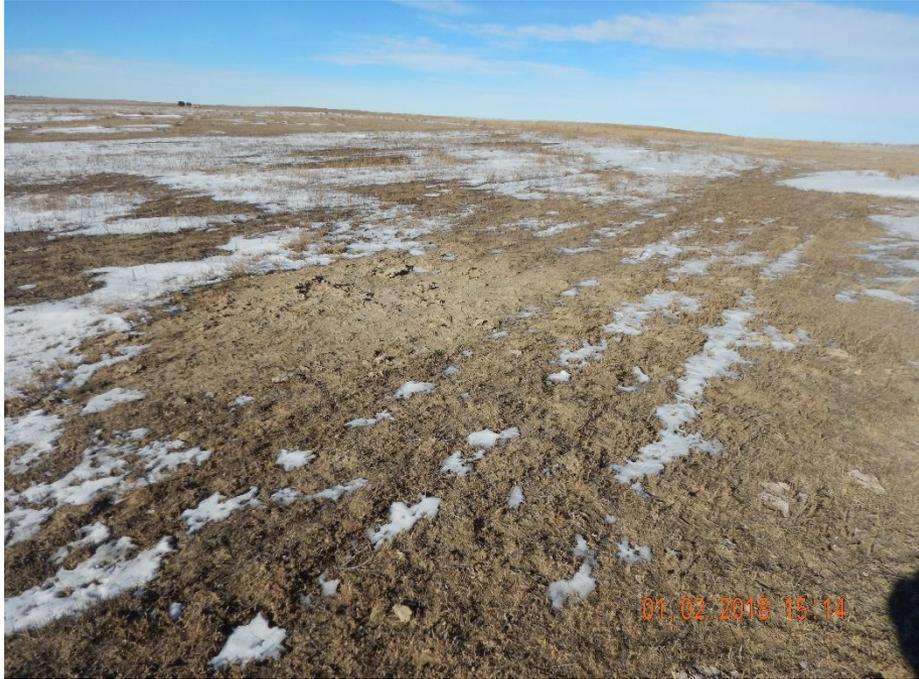
**Photo 1:** Photo taken from the west end of the location, facing north. Photo shows large area of the location that have not achieved uniform, desirable perennial vegetative cover, and remains predominantly exposed soil.

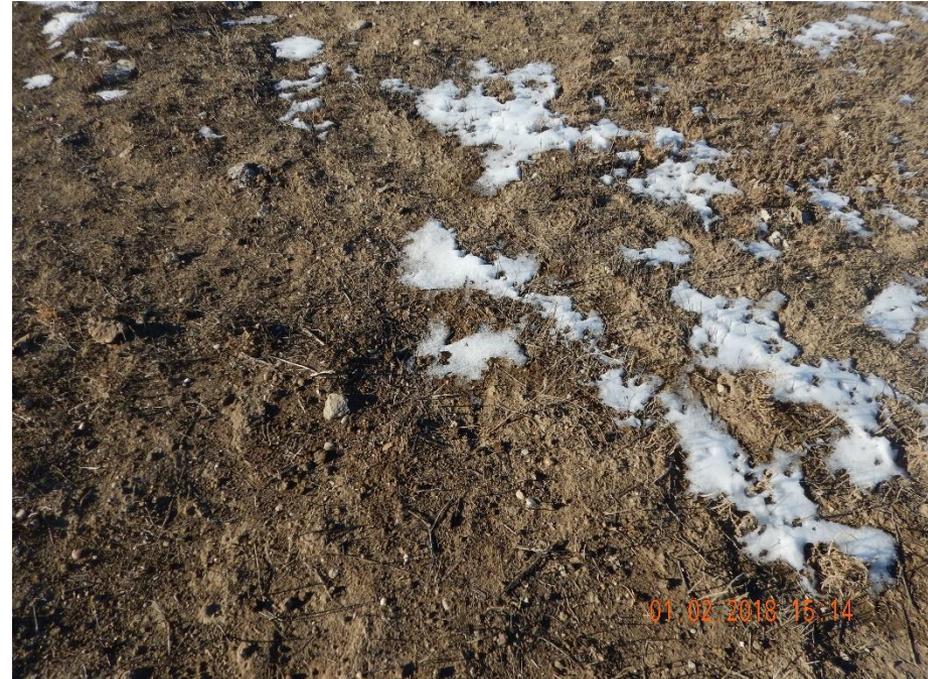
**Photo 2:** Photo taken from the west end of the location. Photo shows areas of the location where vegetation has not established, and remain predominantly exposed soil.

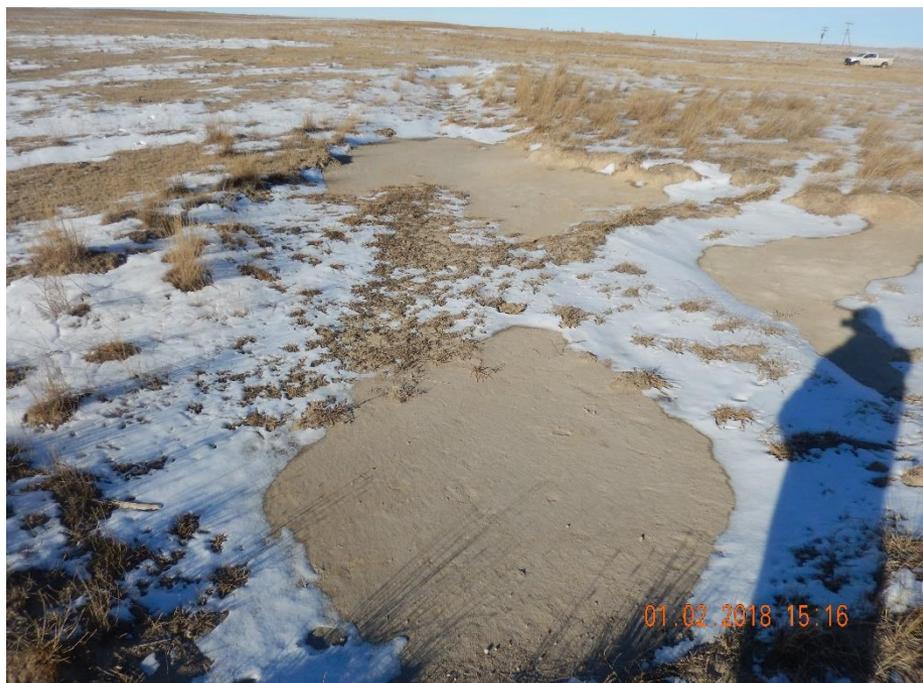
**Photo 3:** Photo taken from the southwest corner of what appears to have been the former pit location, facing north. Photo shows areas of the pit where vegetation has failed to establish. Remediation may be required due to potential salinity concerns.

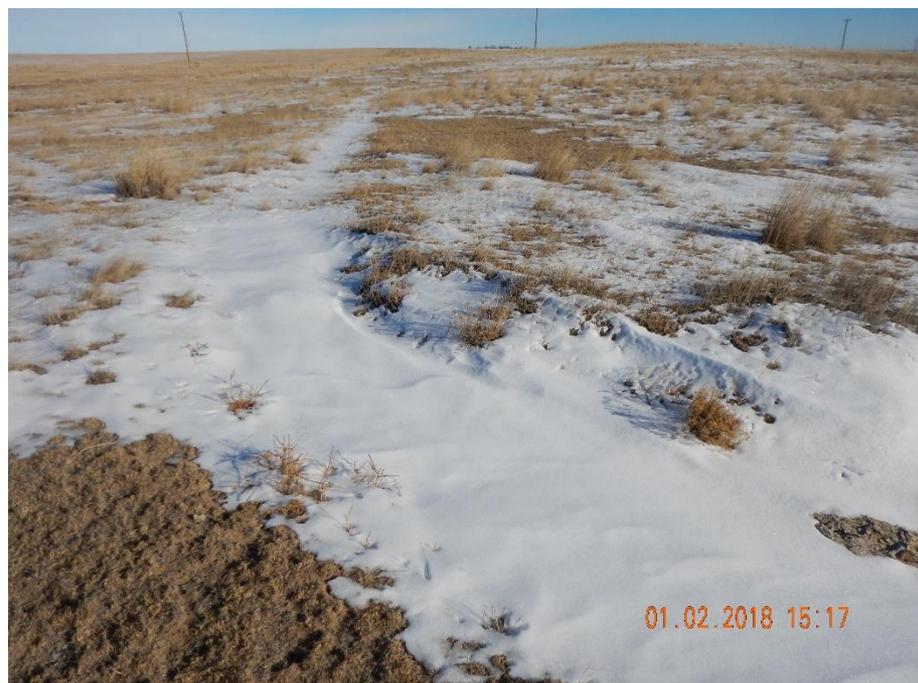
**Photo 4:** Photo taken from the northwest corner of what appears to have been the former pit location, facing east. Photo shows areas of the pit where vegetation has failed to establish. Remediation may be required due to potential salinity concerns.

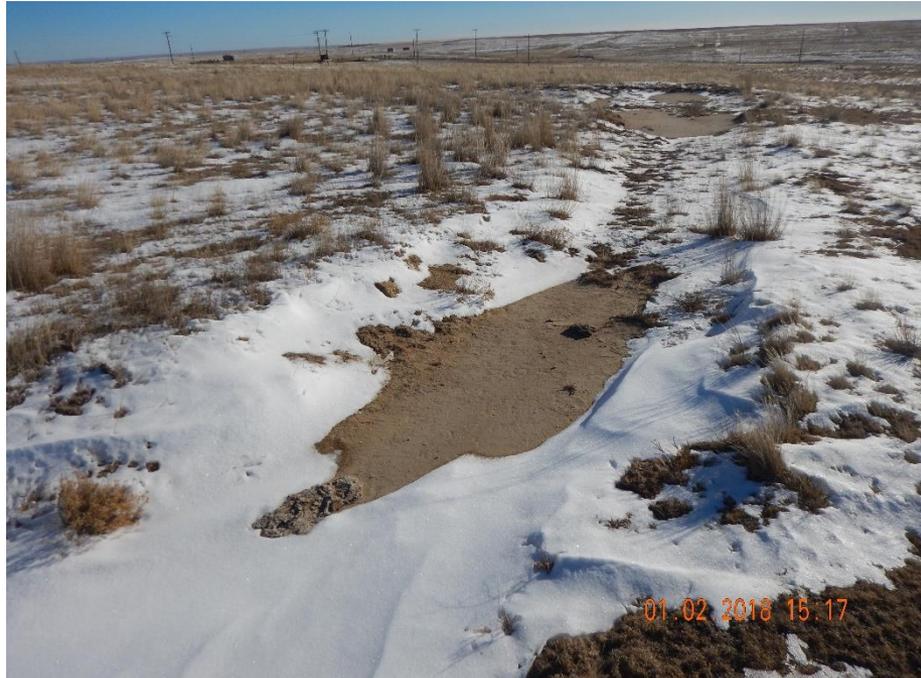
**Photo 5:** Photo taken from the northwest corner of what appears to have been the former pit location, facing south. Photo shows areas of the pit where vegetation has failed to establish. Remediation may be required due to potential salinity concerns.

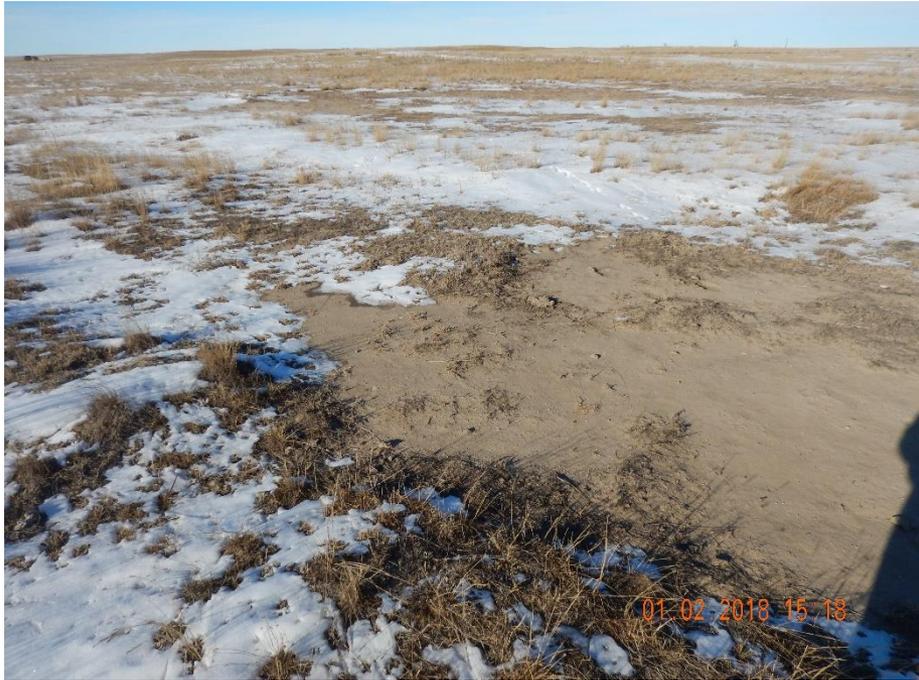
**Photo 7:** Photo taken from the southern end of the location, facing north. Location does not meet reclamation standards. Photo shows large areas of the location that have not achieved uniform, desirable perennial vegetative standards, and remains predominantly exposed soil.

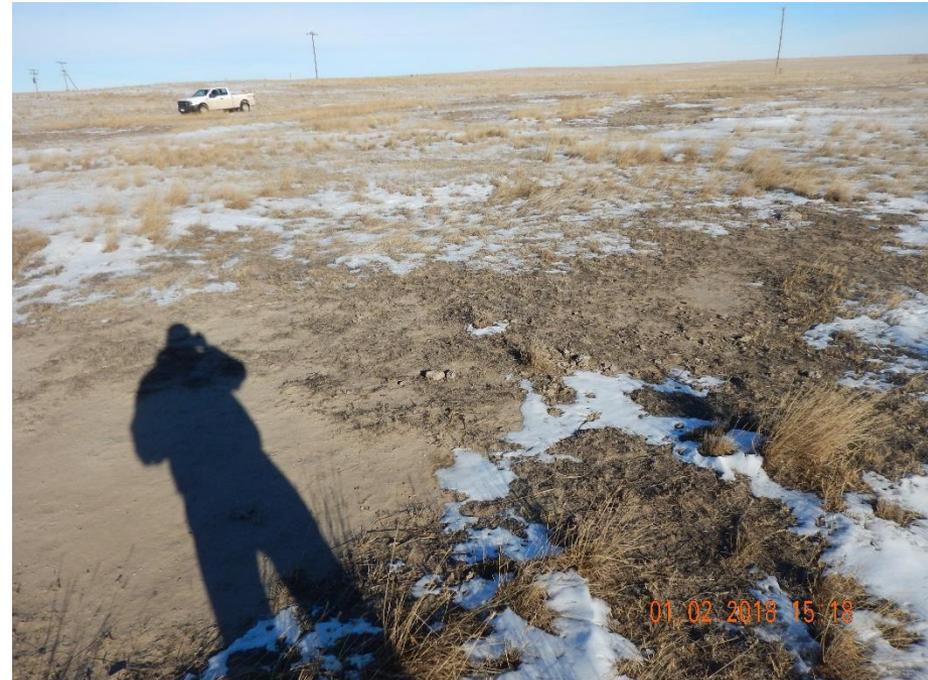
**Photo 8:** Photo taken from the southern end of the location, facing east. Location does not meet reclamation standards. Photo shows large areas of the location that have not achieved uniform, desirable perennial vegetative standards, and remains predominantly exposed soil.

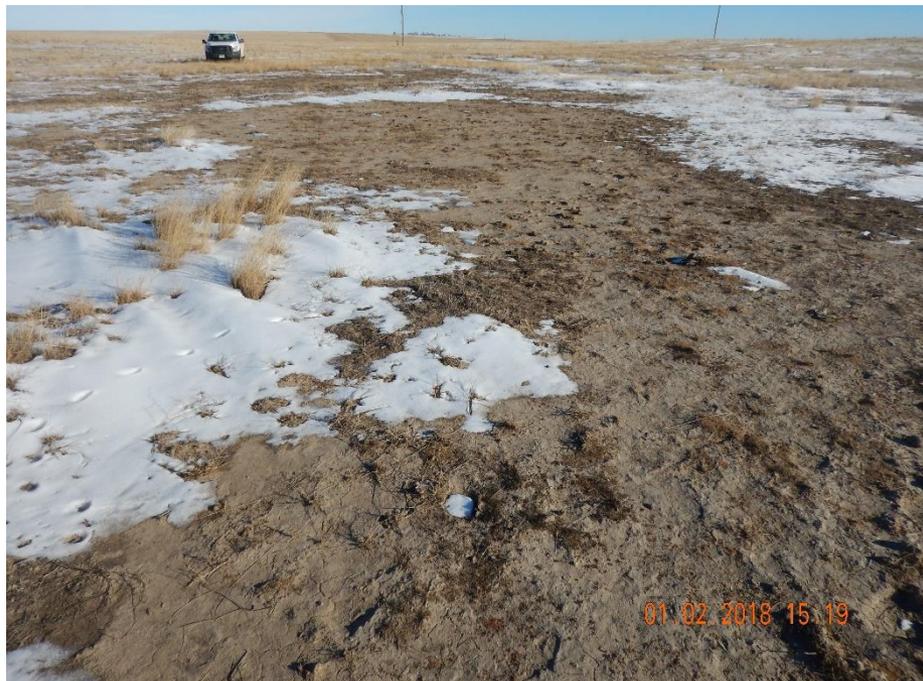
**Photo 9:** Photo taken from the western end of the location, facing east. See comments under photo 7

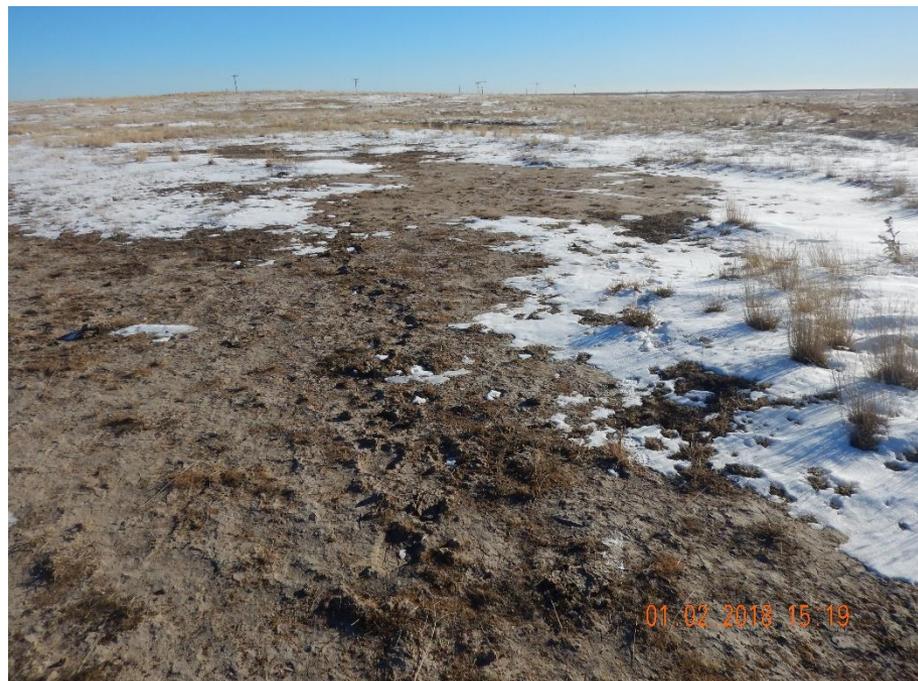
**Photo 10:** Photo taken from the northwestern end of the location, facing south. See comments under photo 7

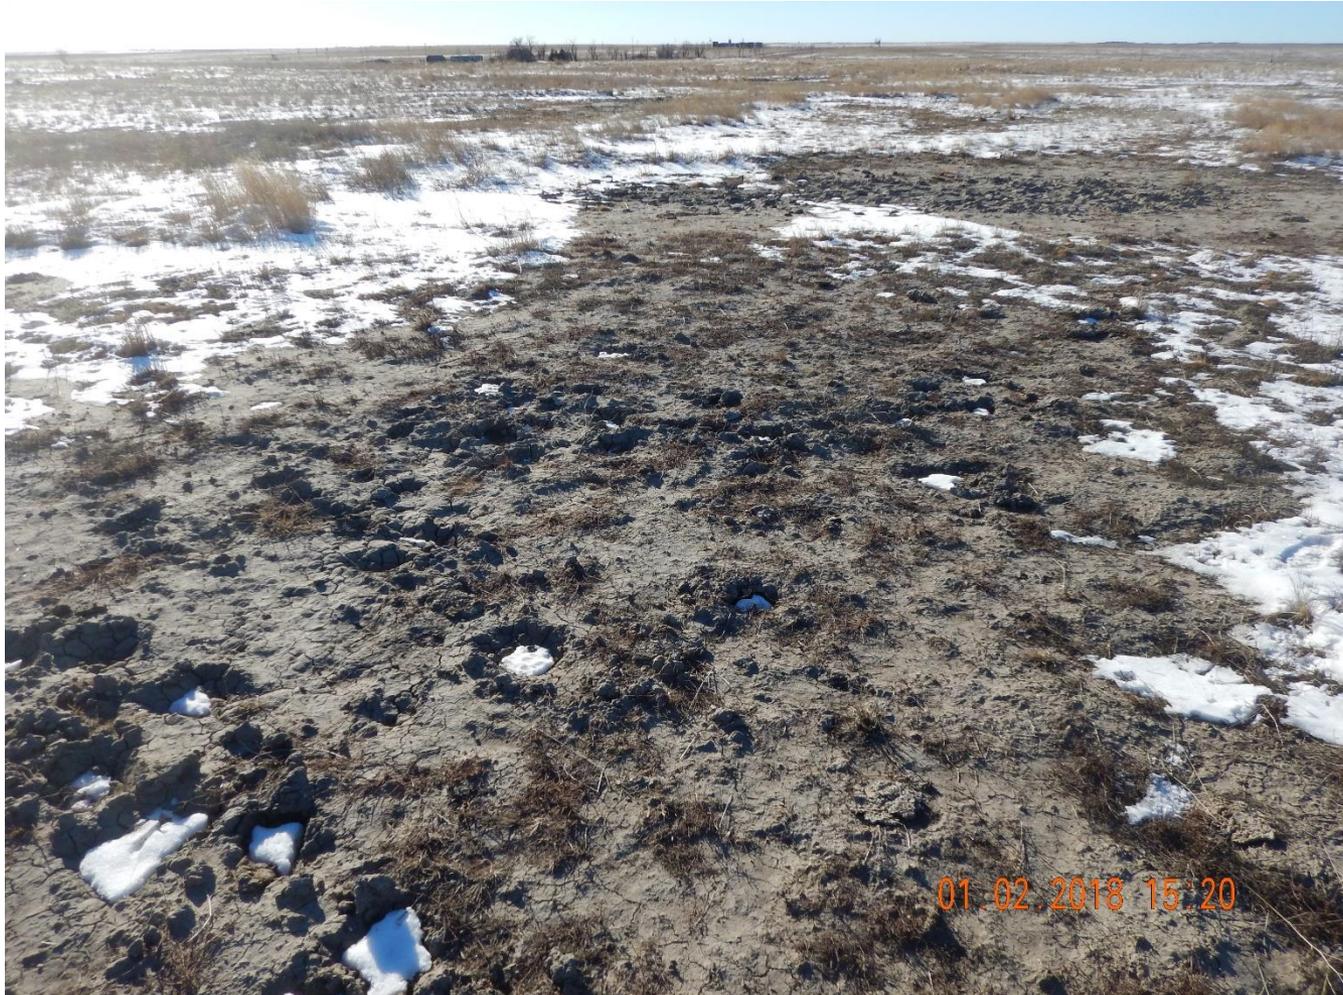
**Photo 11:** Photo taken from the eastern end of the location, facing west. See comments under photo 7

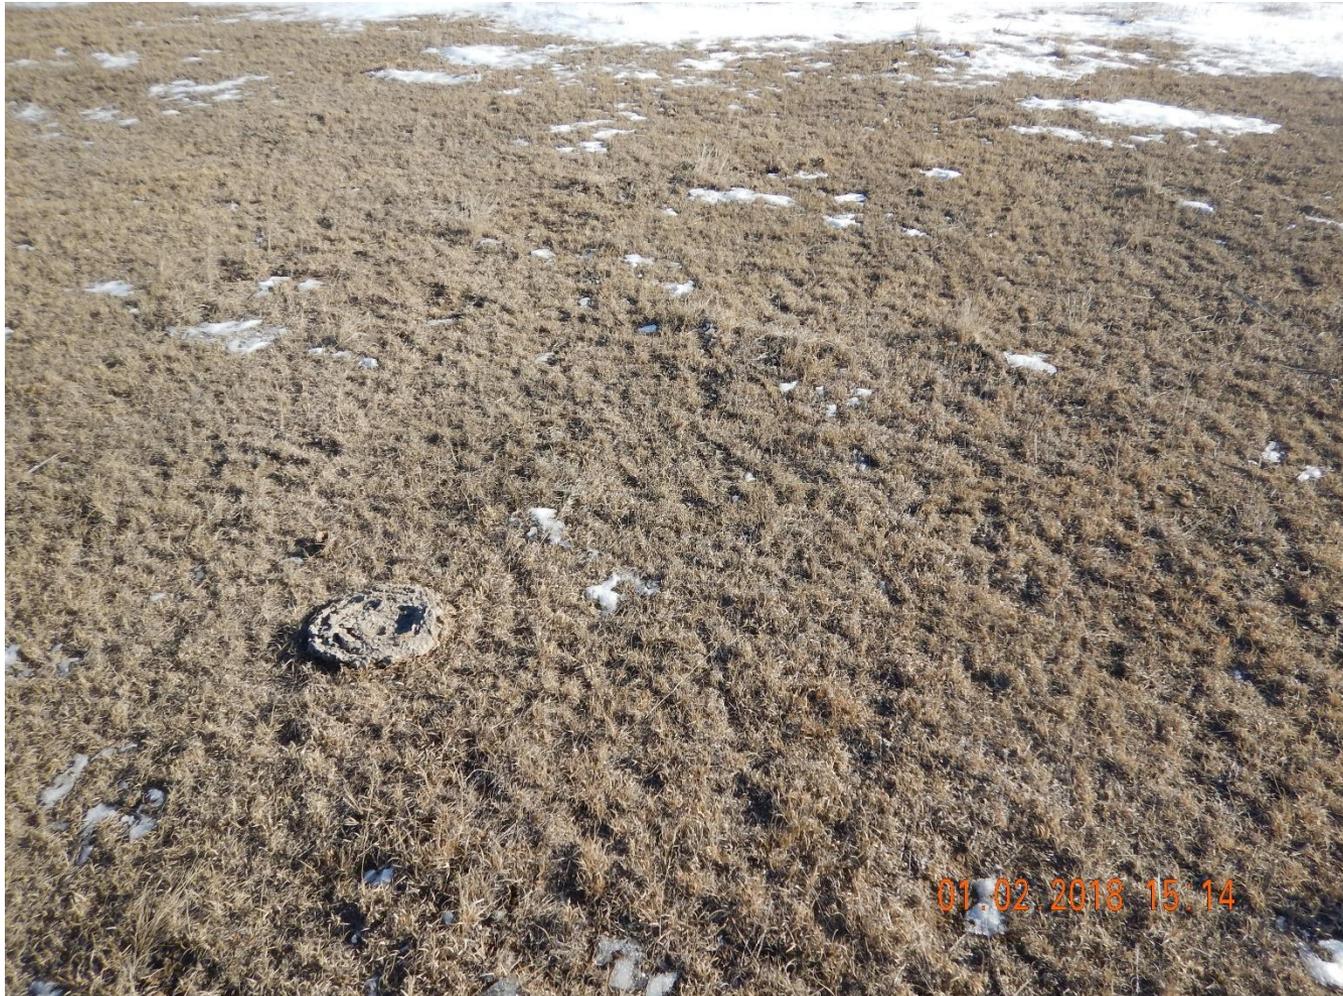
**Photo 12:** Photo taken from the adjacent reference area. Vegetation observed appears to be predominantly a Blue grama / Buffalo grass mix.
