# Interim Reclamation and Stormwater Inspection

January 3, 2018

Operator: LONGS PEAK RESOURCES LLC- #10611

Location ID: 438066

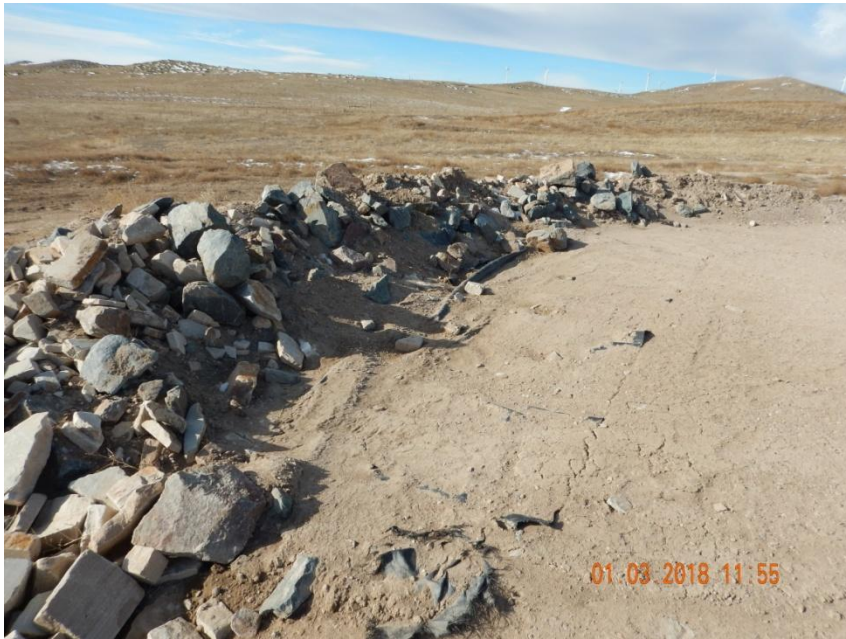
**Photo 1.** Photo taken from the southwestern location, facing West. Operator has not constructed the berm BMP with good engineering practices per Rule 1002.f.(2)., nor has the Operator repaired the berm BMP from the previous corrective action inspection.

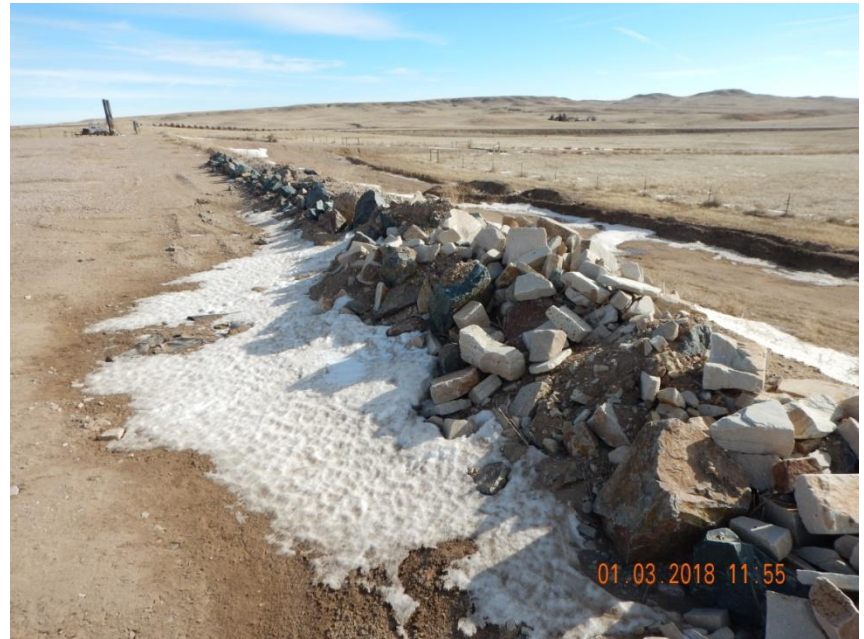
**Photo 2.** Photo taken from the southwestern location, facing East. See comments under Photo 1.

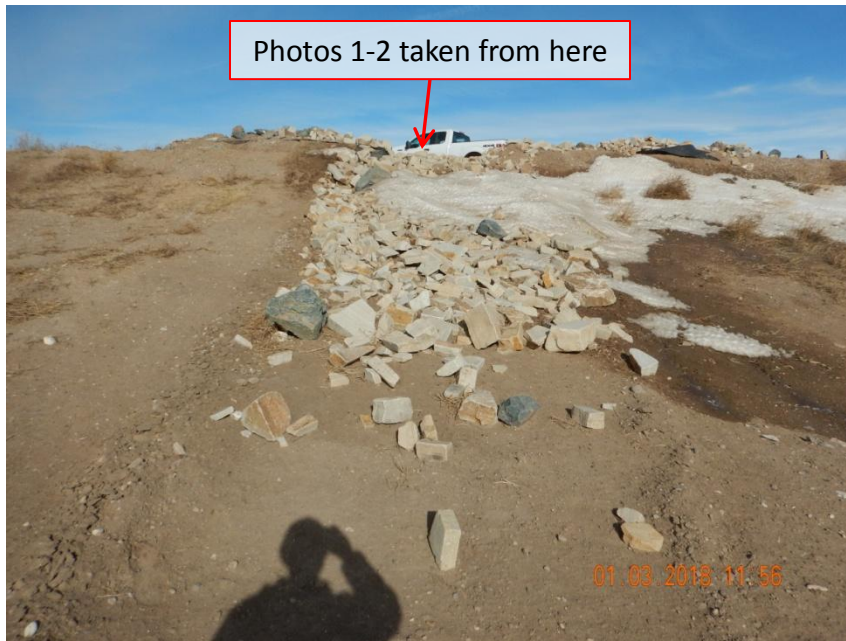
**Photo 3.** Photo taken from the southwestern location, facing North. Operator has haphazardly installed rock material that appears to be used as a berm BMP and a stabilized outfall to the lower perimeter ditch and berm BMP.

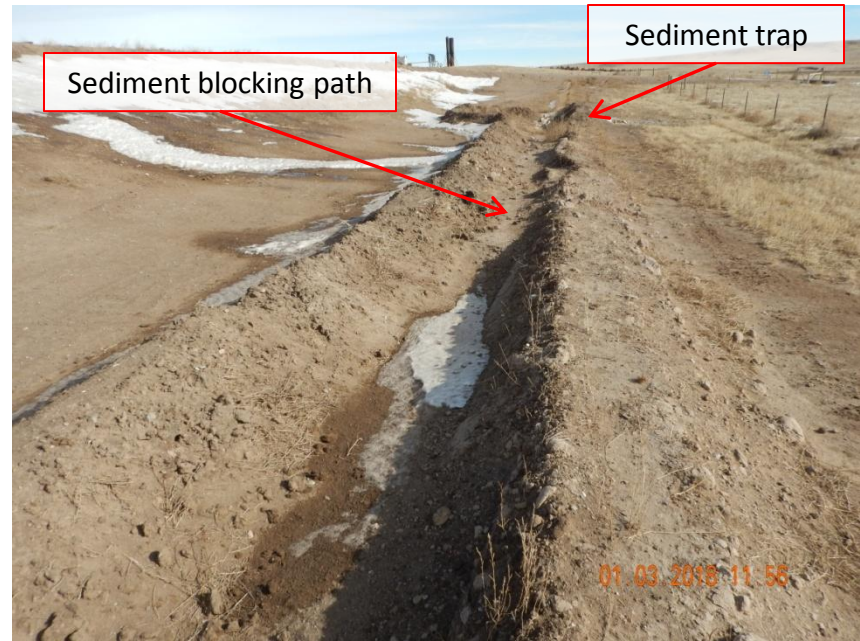
**Photo 4.** Photo taken from the southwestern location, facing East. Operator has constructed a ditch and berm BMP; however, there is sediment blocking the path that will not allow stormwater flows to travel to the sediment trap. Ditch BMP in need of maintenance.

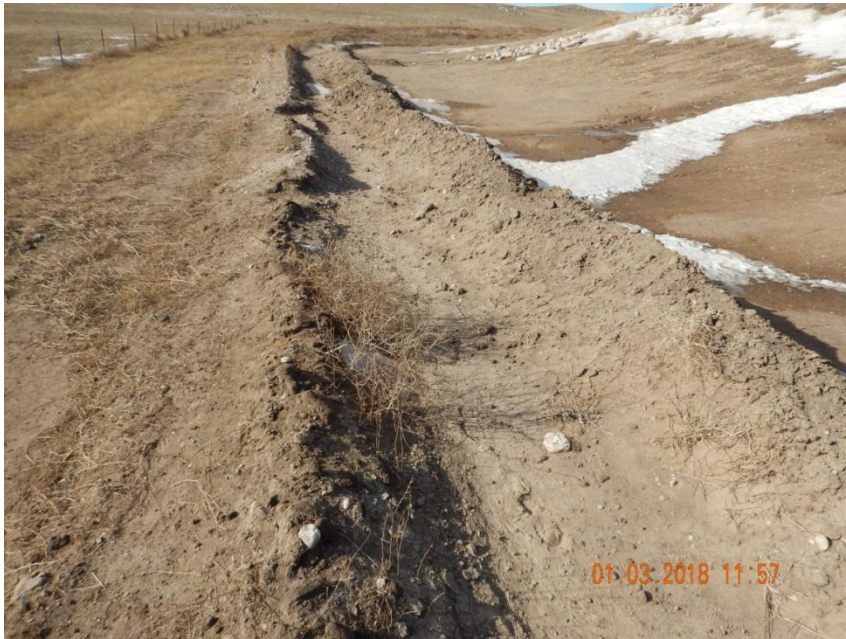
**Photo 5.** Photo taken from the southwestern location, facing West. Operator has not constructed the ditch and berm BMP with good engineering practices. Ditch BMP in need of maintenance.

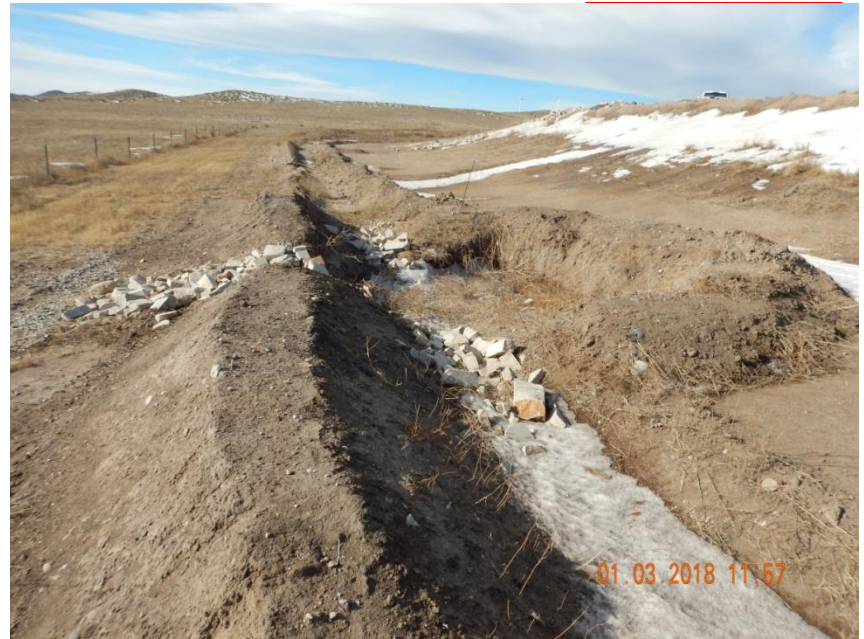
**Photo 6.** Photo taken from the western sediment trap, facing West. Appears the Operator has made improvements to the sediment trap (enlarged the depth and improved the embankment berms). Inlet protection to the sediment trap has not been installed to good engineering practices. Appears the outfall of the sediment trap is higher than the ditches; therefore, the sediment trap would not properly function.

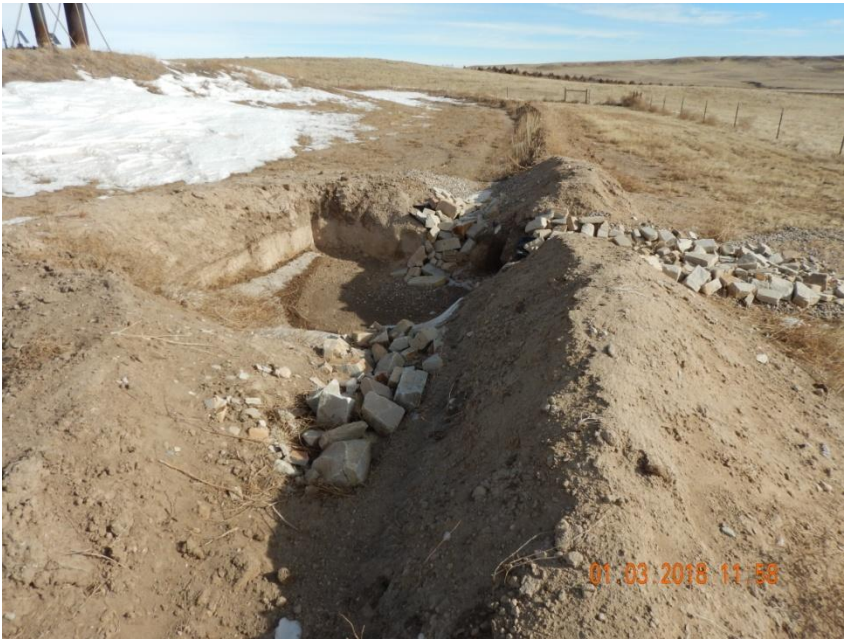
**Photo 7.** Photo taken from the eastern location, facing East. See comments under Photo 6.

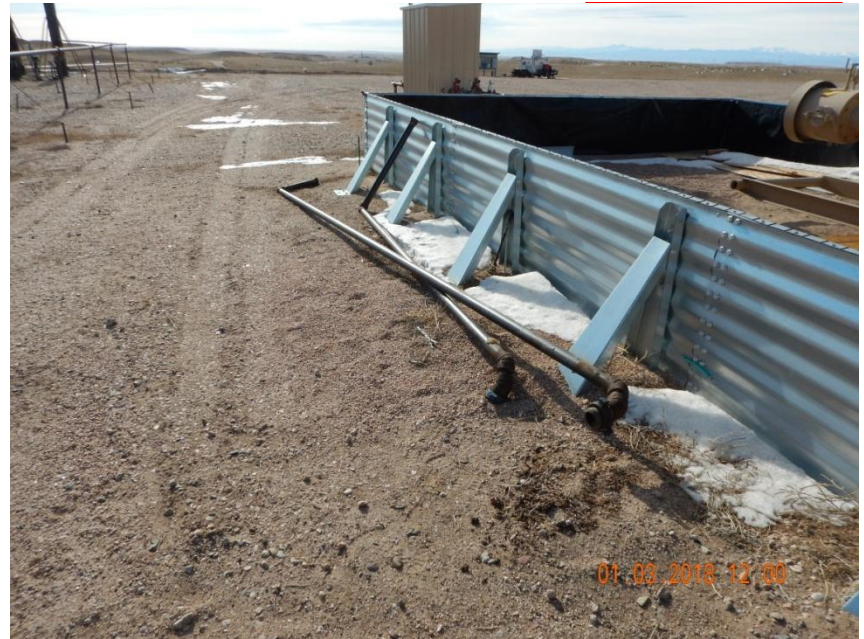
**Photo 8.** Photo taken from the eastern location, facing South. Remove unused equipment per Rule 603.f.

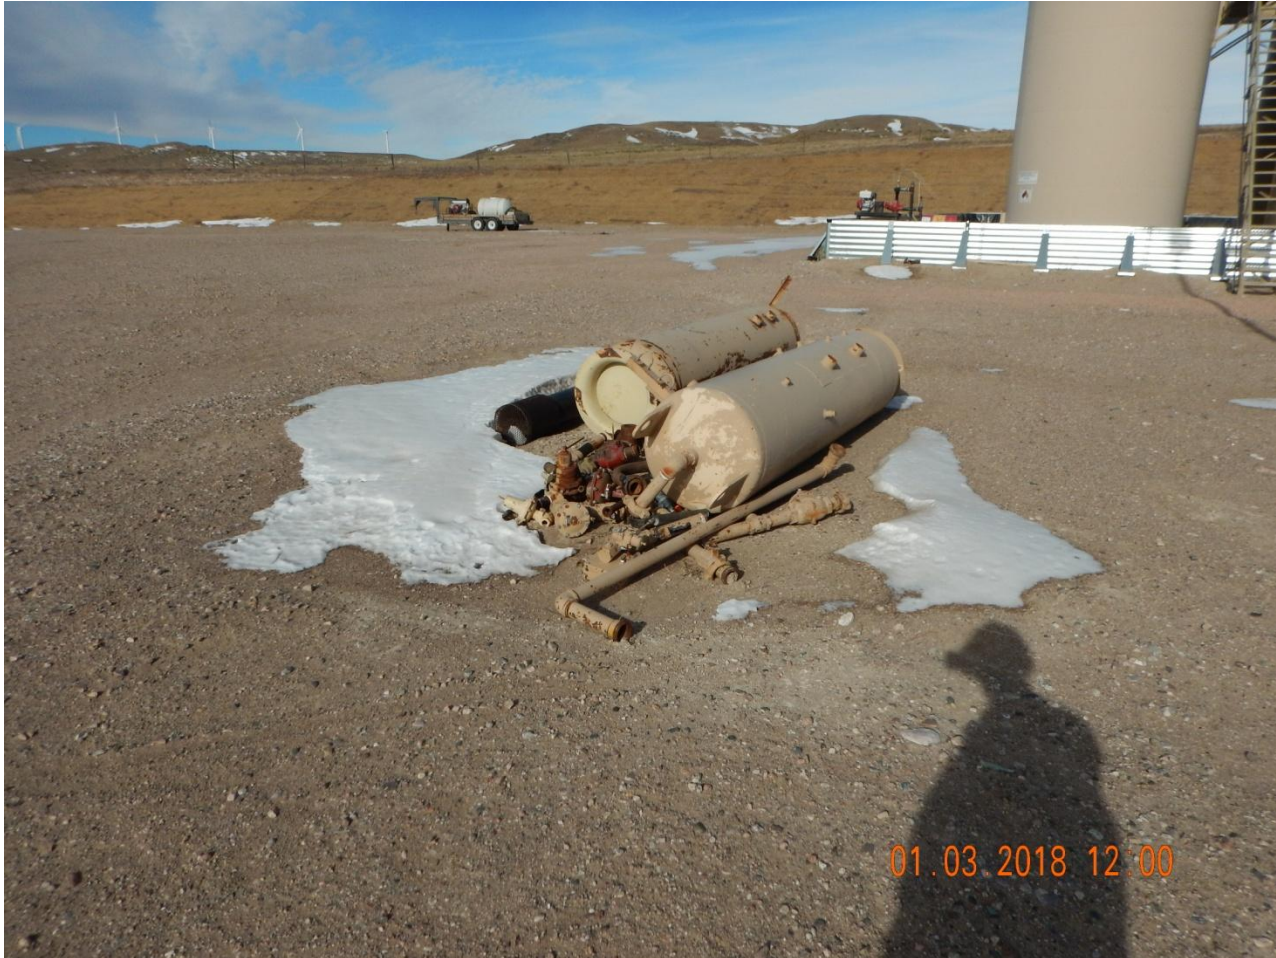
**Photo 9.** Photo taken from the eastern location, facing North. See comments under Photo 8.

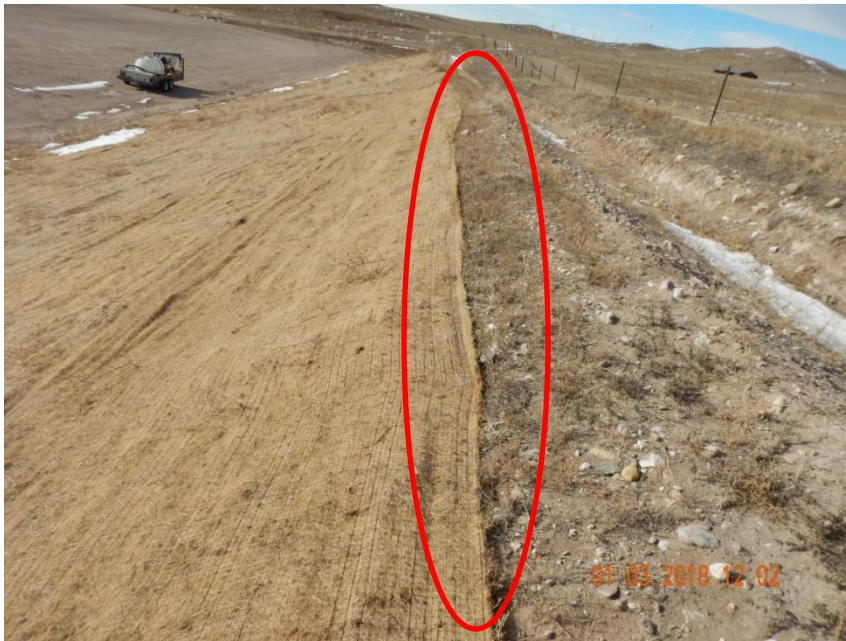
**Photo 10.** Photo taken from the northern cut slope area, facing West on January 3, 2018. Operator has not properly installed the erosion blanket using good engineering practices and has not addressed the issue since the previous inspection. Operator has not properly trenched and anchored BMP. Operator has not installed the BMP with good contact with the ground to avoid tenting.

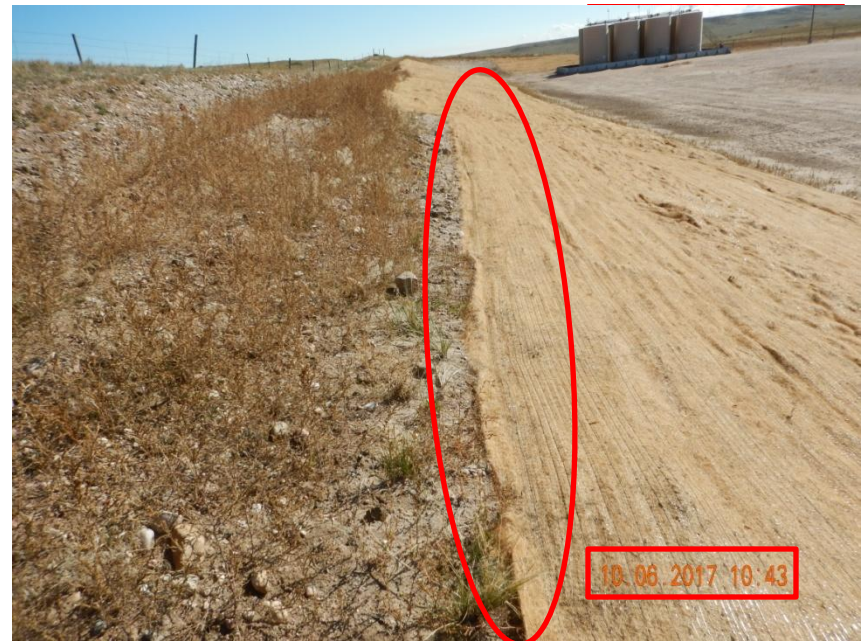
**Photo 11.** Photo taken from the northern cut slope area, facing East on October 6, 2017. Photo illustrates the Operator has not addressed the issue to properly install the erosion blanket.
