Interim Reclamation and Stormwater Inspection

January 3, 2017

Operator: LONGS PEAK RESOURCES LLC- #10611

Location ID: 438066

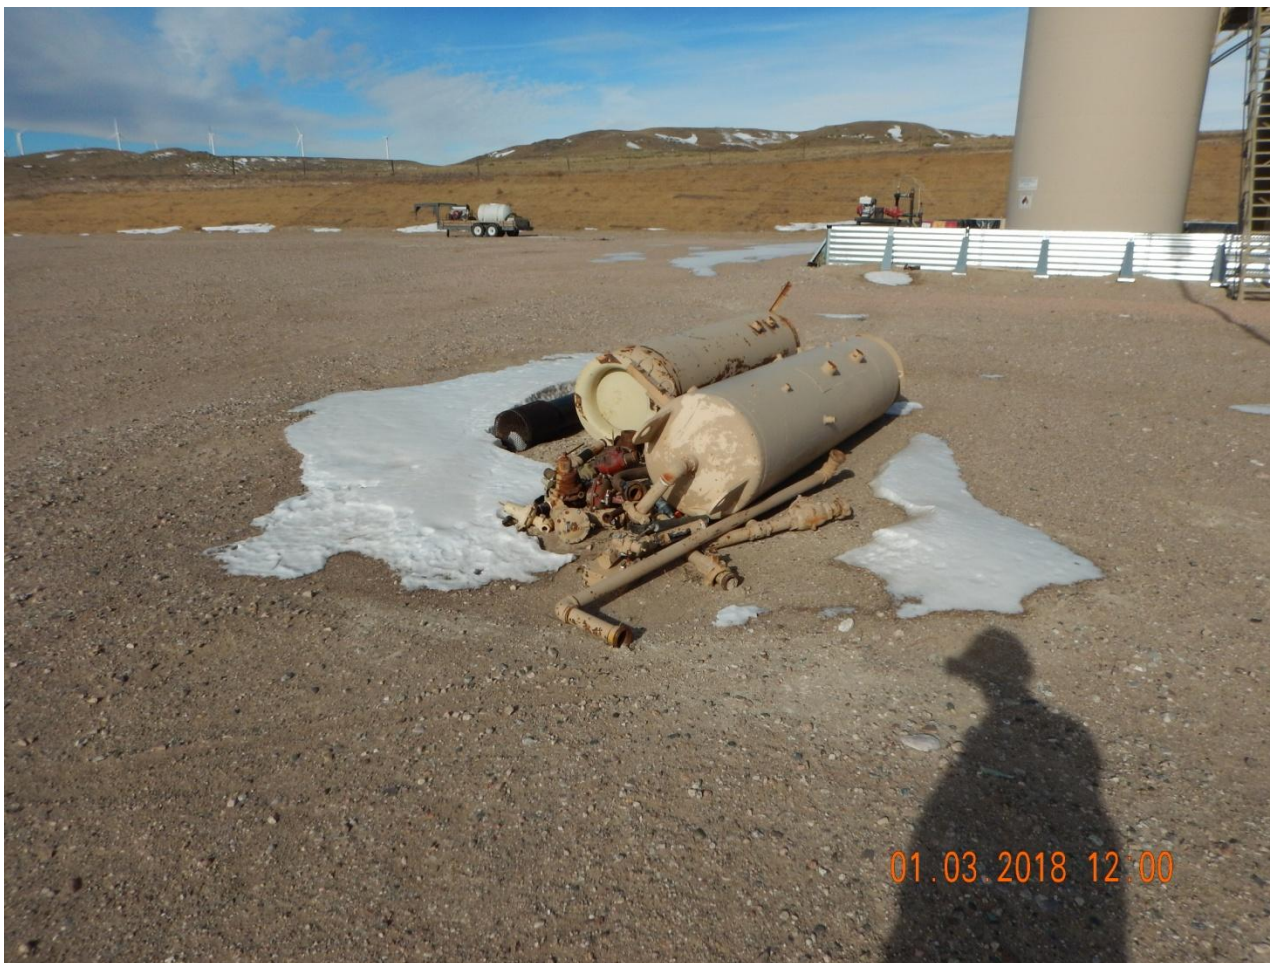
Photo 8. Photo taken from the eastern location, facing South. Remove unused equipment per Rule 603.f.

Photo 9. Photo taken from the eastern location, facing North. See comments under Photo 8.
