## Inspection Photos

Location Name: Tom L. Russell #1, Tom E. Russell #2, and Tom E. Russell Unit E #1 Tank Battery  
SENE Sec. 30 T2N, R67W

Inspection Date: January 8, 2018

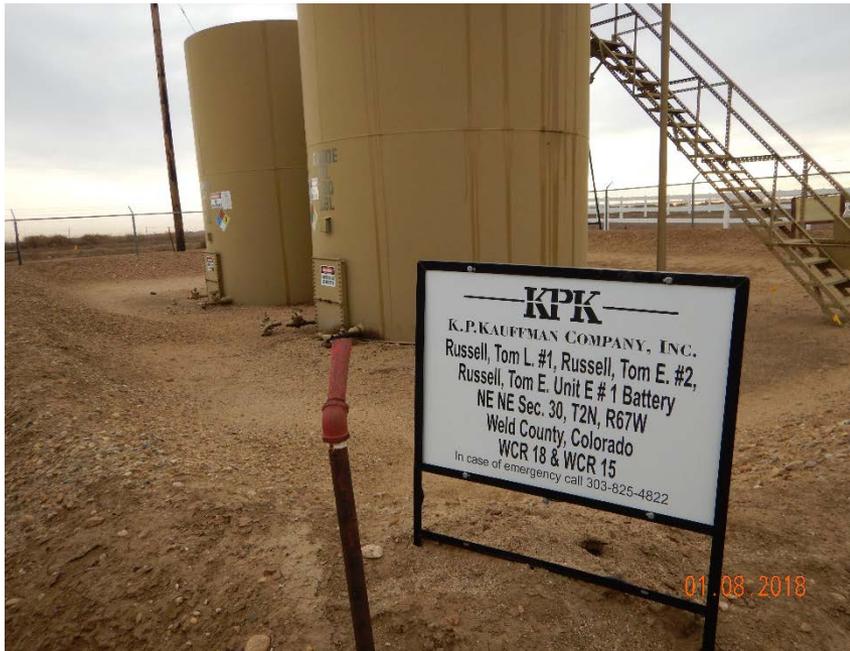
Photo #1 – View of crude oil ASTs and battery sign from NW corner of earthen berm.

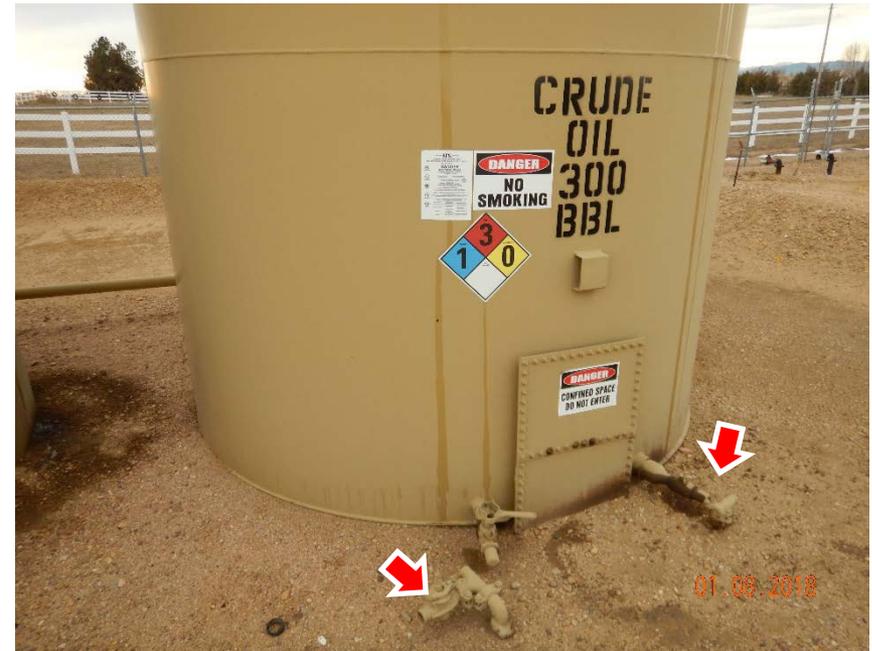
Photo #2 – View of west crude oil AST from NE side. Note oily waste underlying tank valves and presence of unused flowlines north of tank.

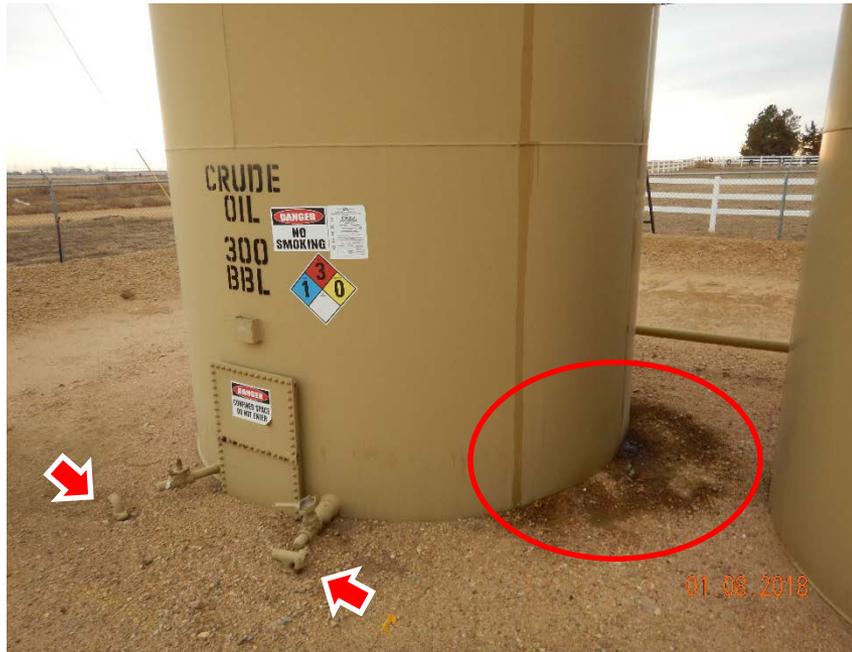
Photo #3 - View of east crude oil AST from NW side. Note oily waste underlying west side of tank and presence of unused flowlines north of tank.

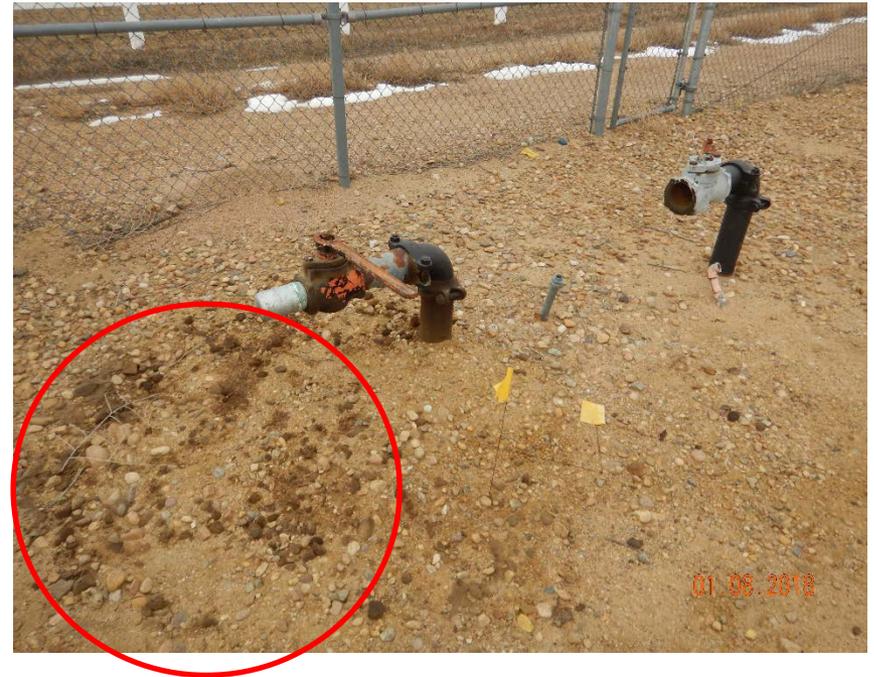
Photo #4 – Steel 4" flowline risers with 90-degree bend located SW of crude oil ASTs. Note localized accumulations of oily waste underlying riser with bullplug installed.

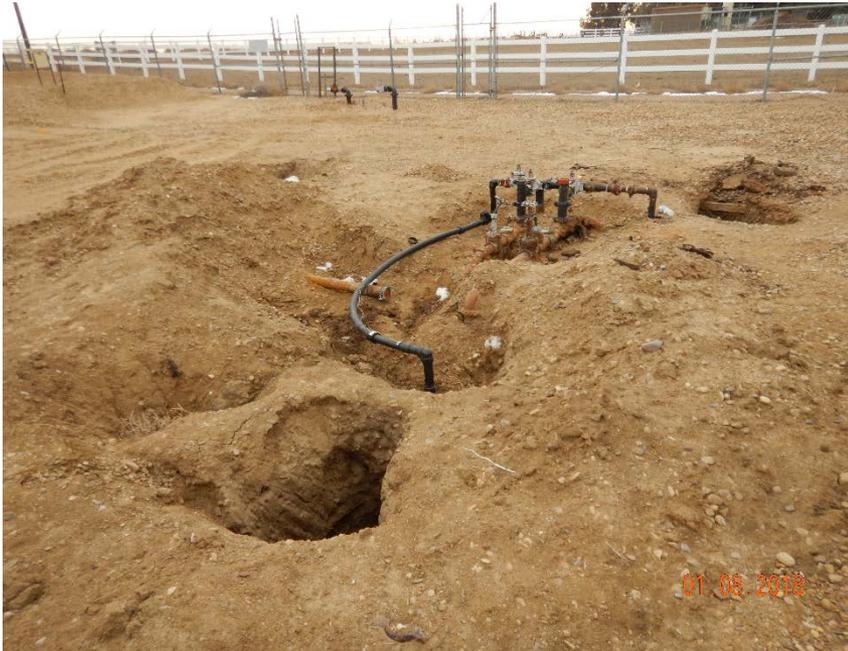
**Photo #5 – View of partially-excavated flowline manifold from NW corner.**

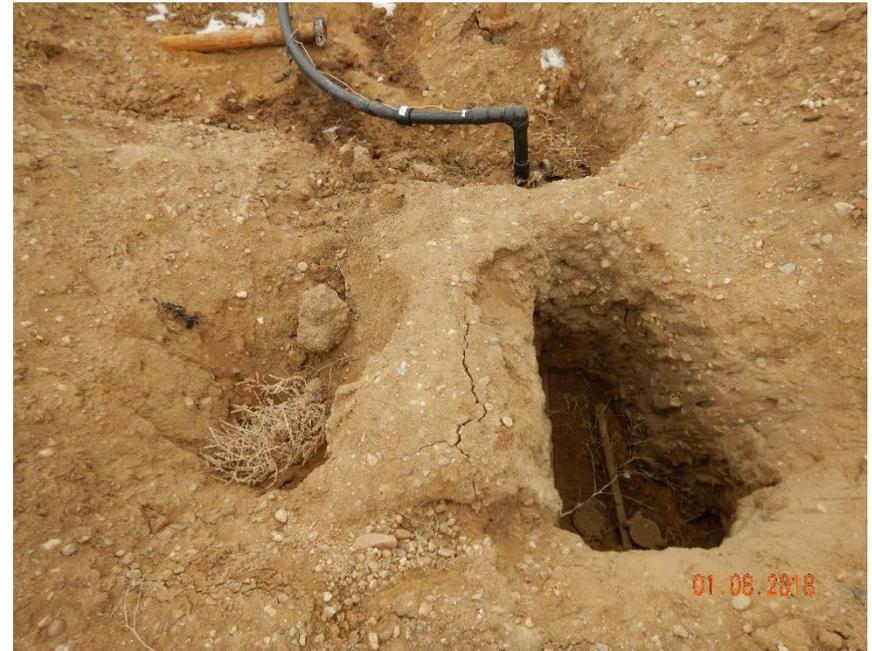
**Photo #6 – Looking into NW flowline excavation.**

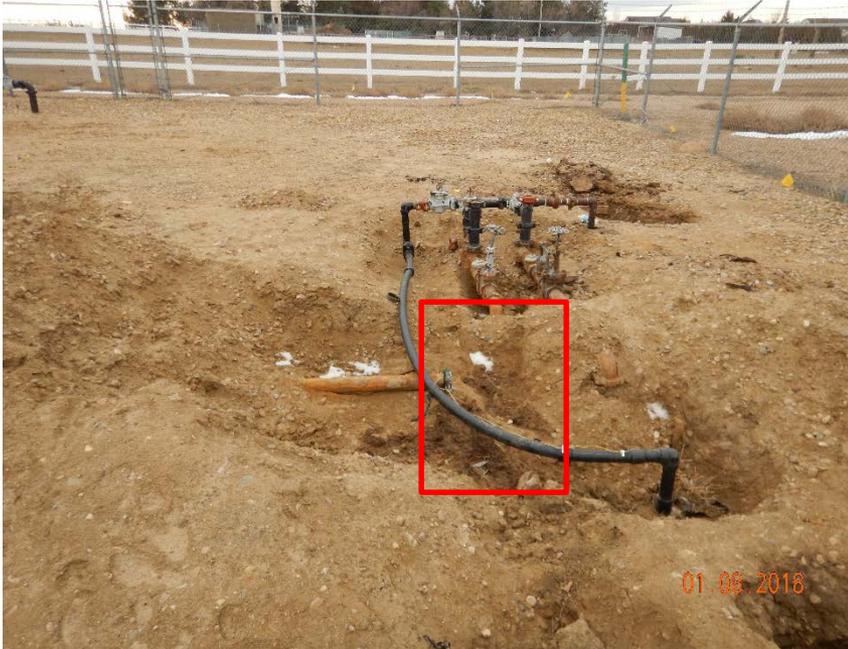
**Photo #7 – Localized accumulations of oily waste beneath exposed flowline.**

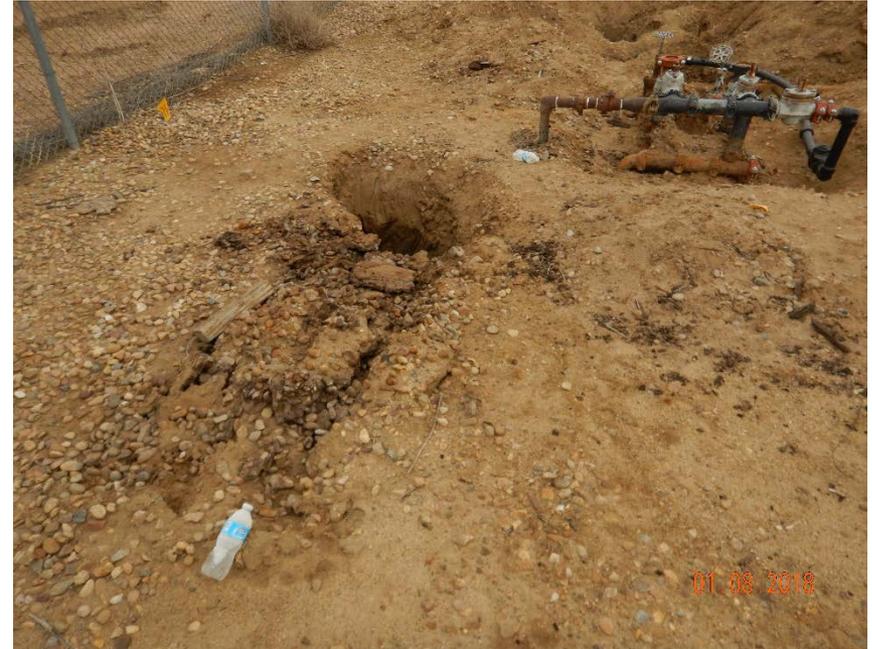
**Photo #8 – Assorted trash, debris, and oily waste at south end of flowline excavation (1).**

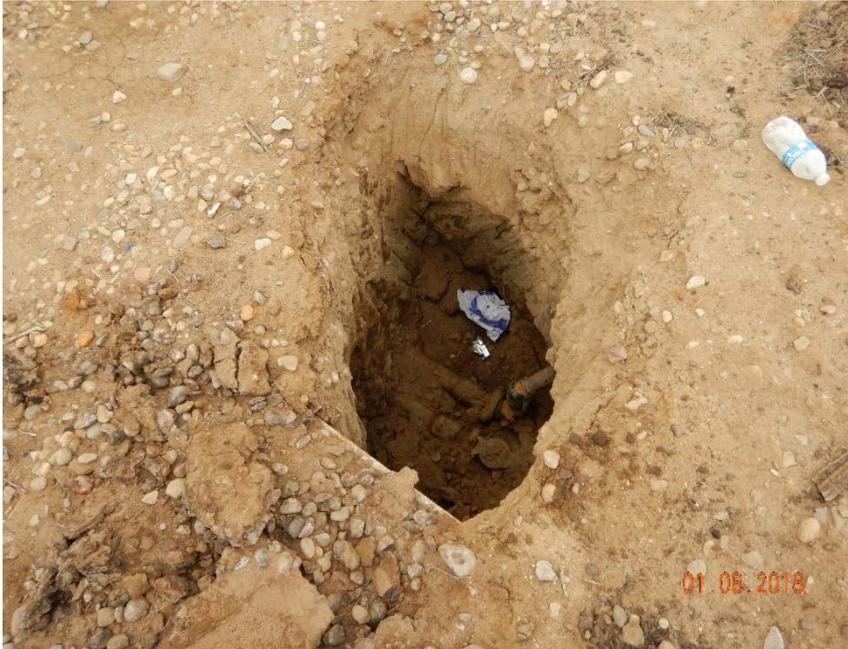
**Photo #9 - Assorted trash, debris, and oily waste at south end of flowline excavation (2).**

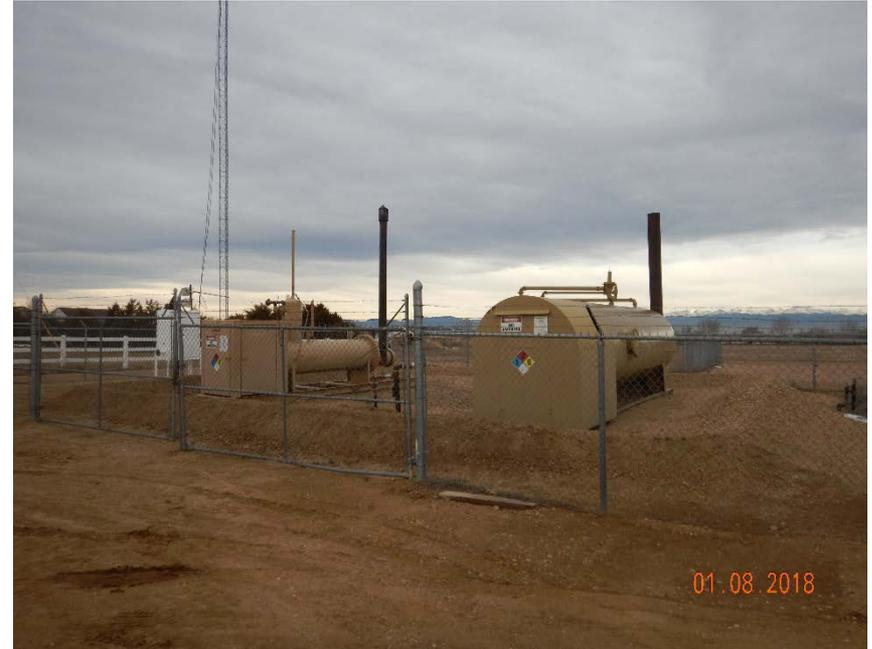
**Photo #10 – View of production equipment located west of crude oil ASTs.**

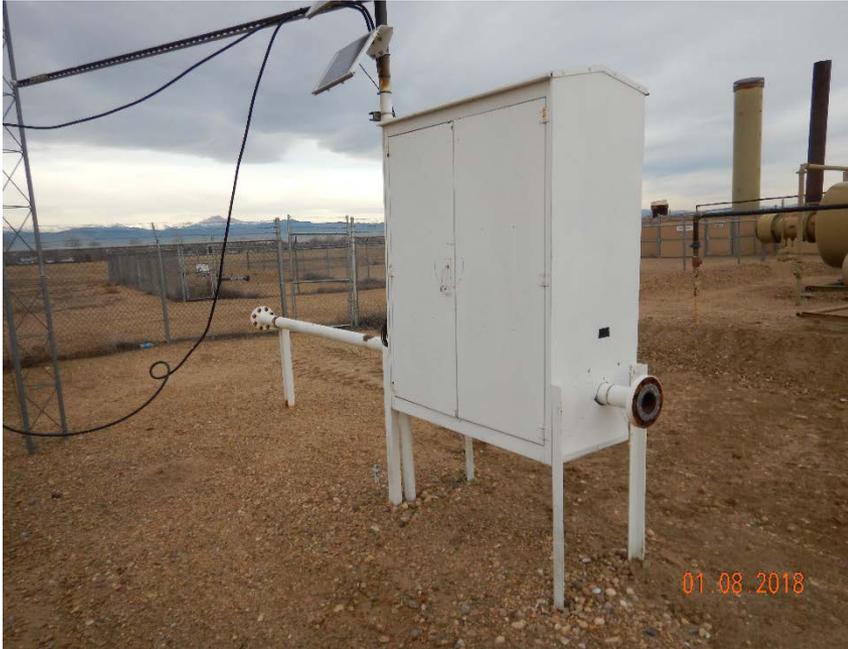
**Photo #11 – Gas meter south of separators was disconnected on date of inspection.**

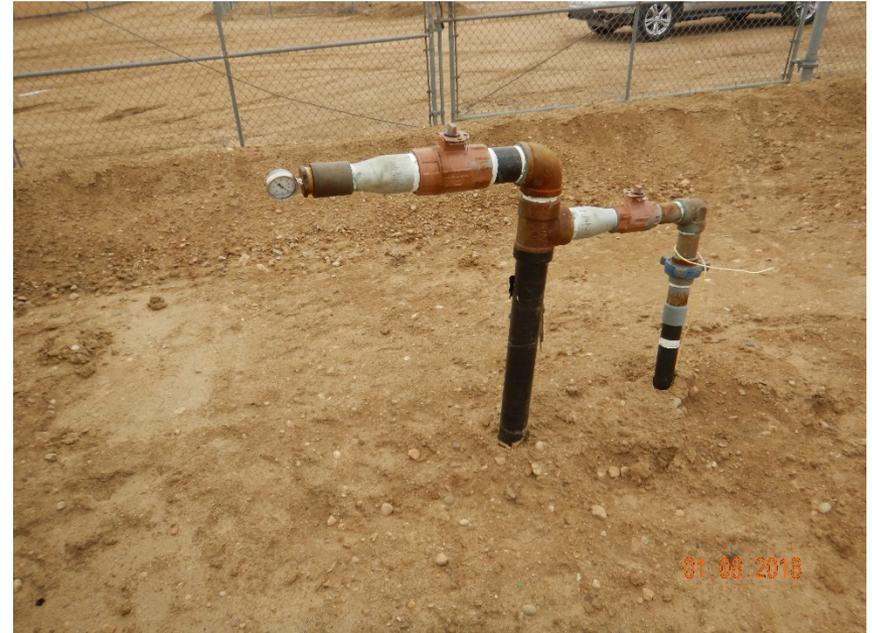
**Photo #12 – Flowline risers located between horizontal separators.**

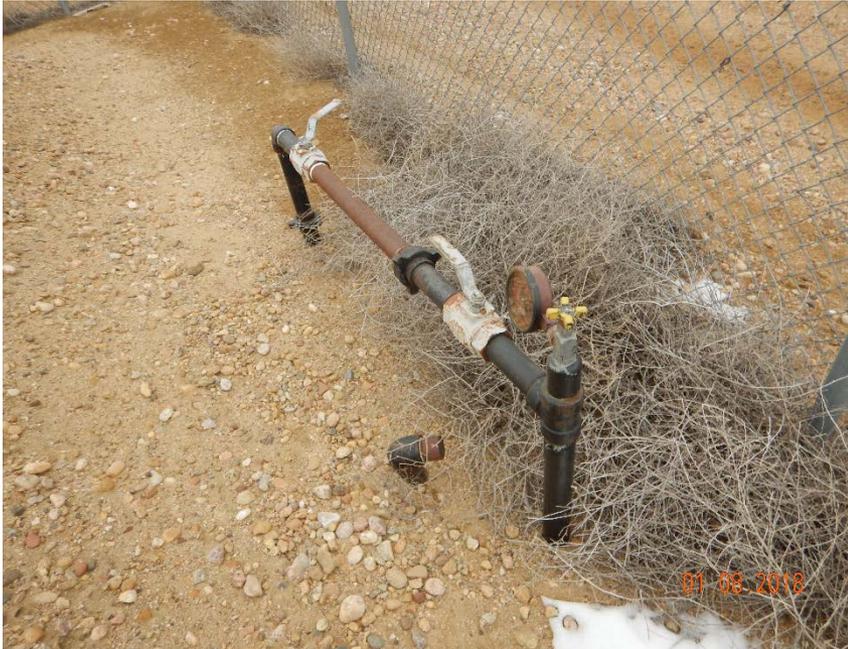
**Photo #13 – Flowline risers and weeds located north of separators.**

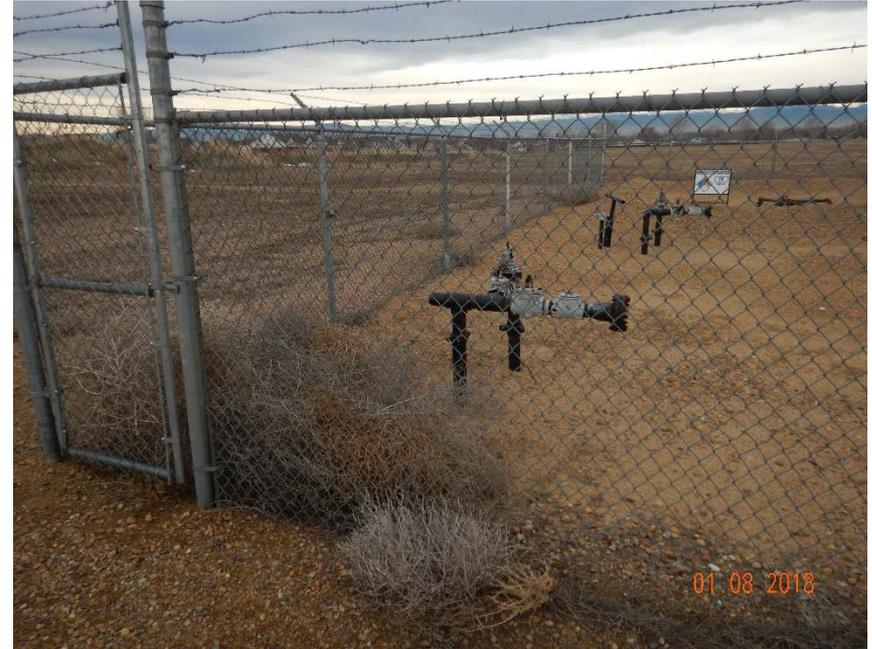
**Photo #14 – Accumulation of weeds inside of fenced area for produced water vault, which is located on west end of facility.**

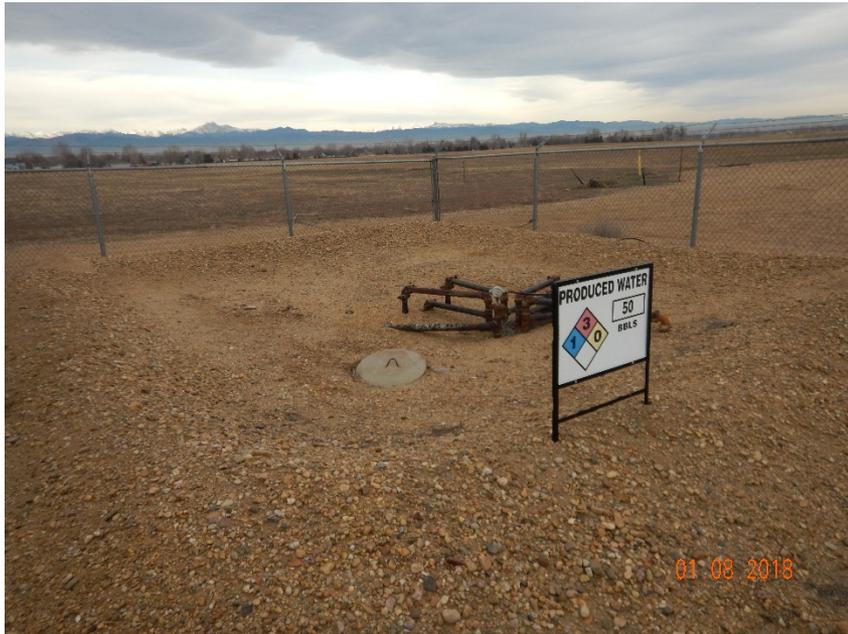
Photo #15 – Produced water vault on west side of facility with flowline risers.

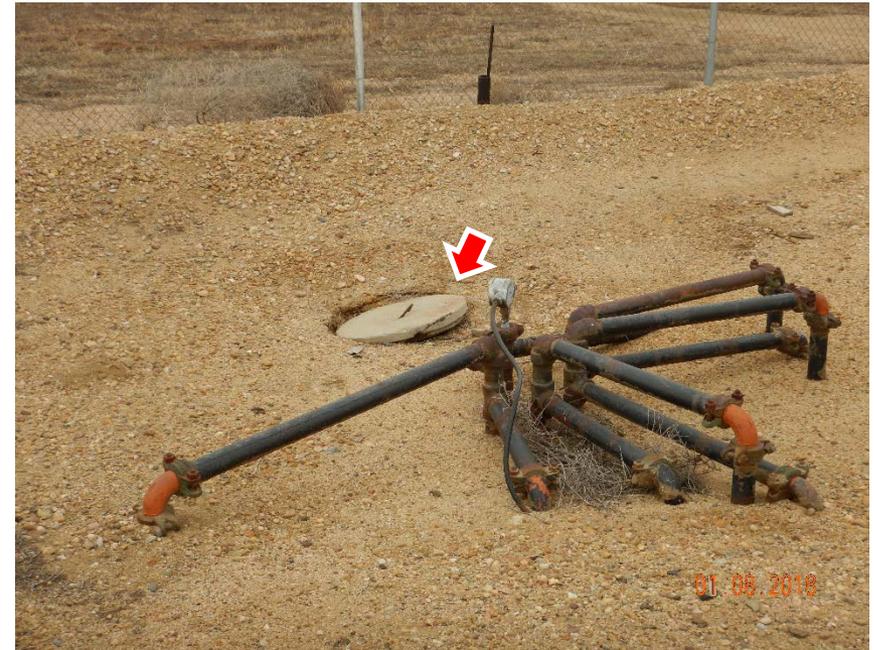
Photo #16 – Produced water vault cap/seal was improperly installed on inspection date.

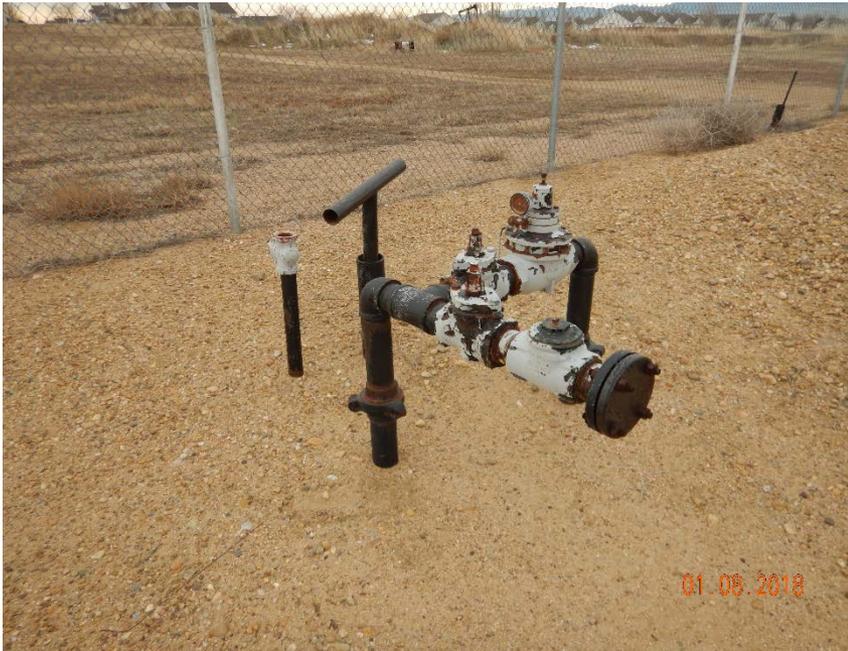
**Photo #17 – Flowline risers located east of produced water vault (1).**

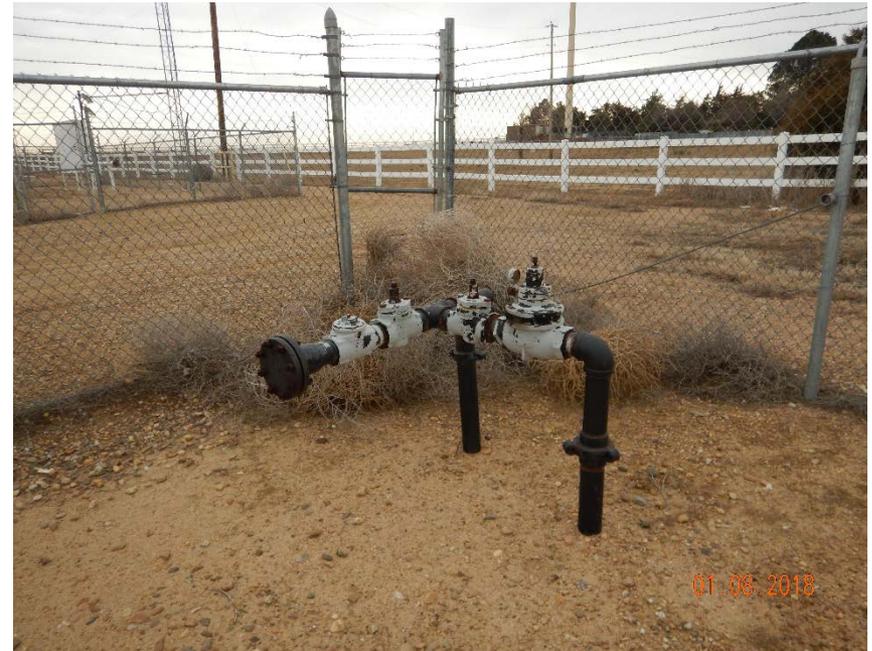
**Photo #18 - Flowline risers located east of produced water vault (2).**
