Interim Reclamation and Stormwater Inspection

January 9, 2018

Operator: NEWPEK LLC - #10484

Location ID: 445039

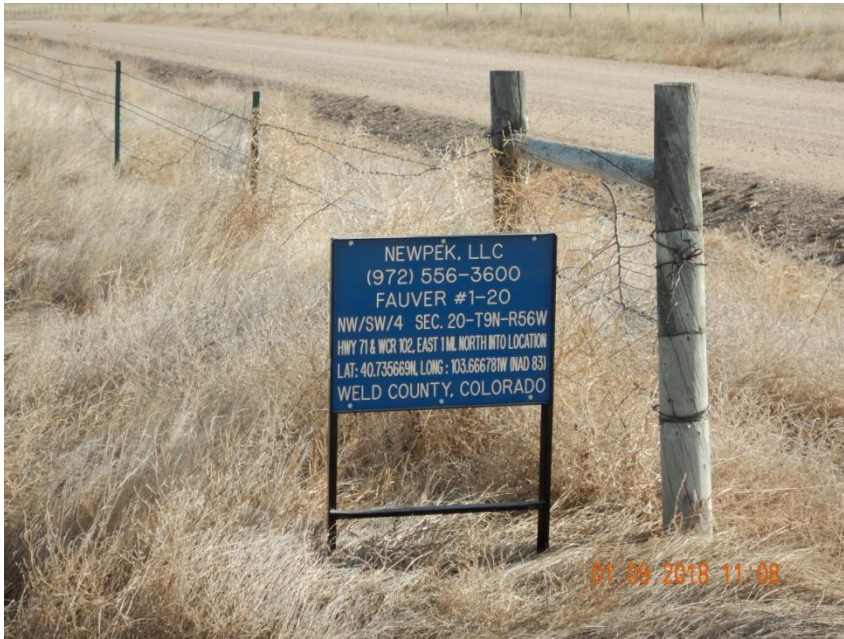
Photo 1. Photo taken from the entrance of the location off CR 102, facing South.

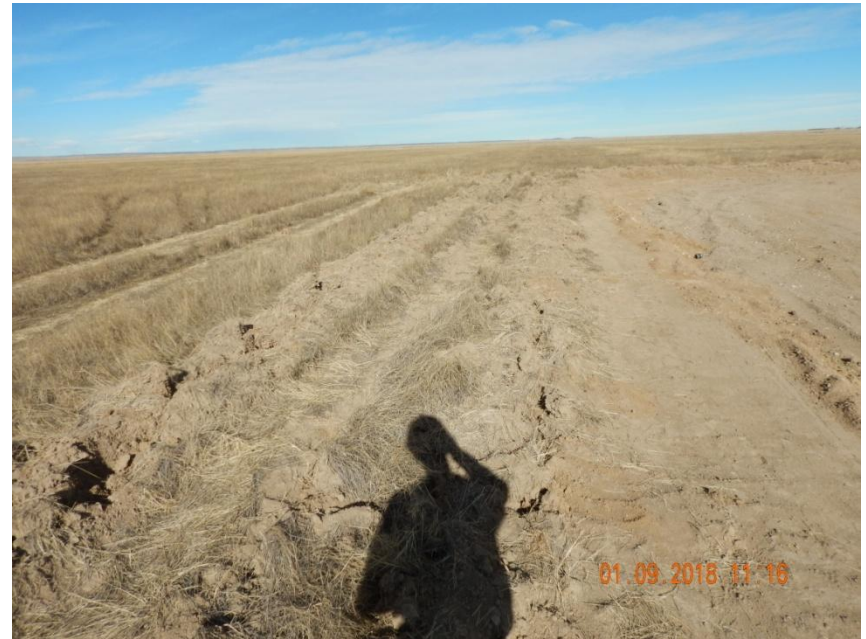
Photo 2. Photo taken from the western location, facing North. Operator has installed surface roughening BMP around the perimeter of the location which should be used in conjunction with other stormwater BMPs. Portions of the surface roughening BMP are in need of maintenance.

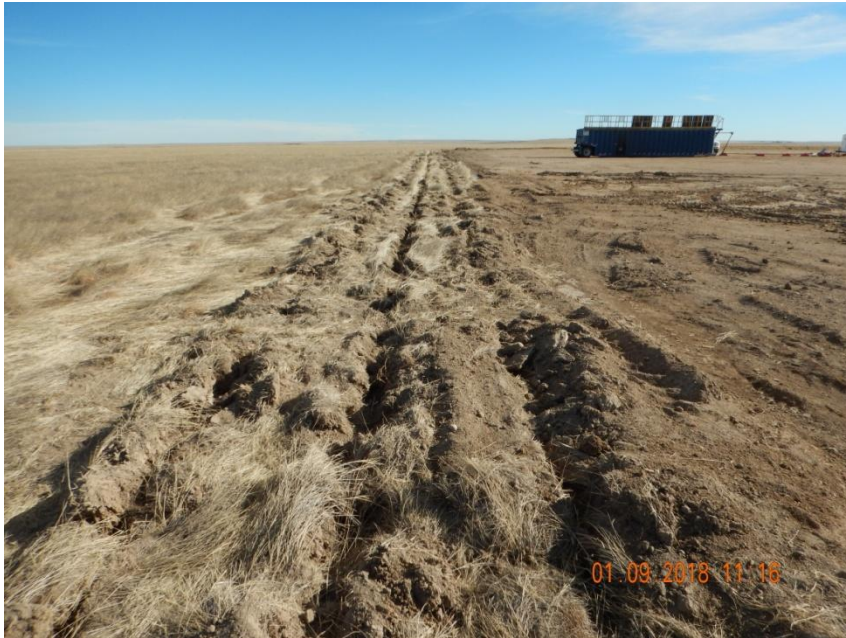
Photo 3. Photo taken from the northwest location, facing East. See comments under Photo 2.

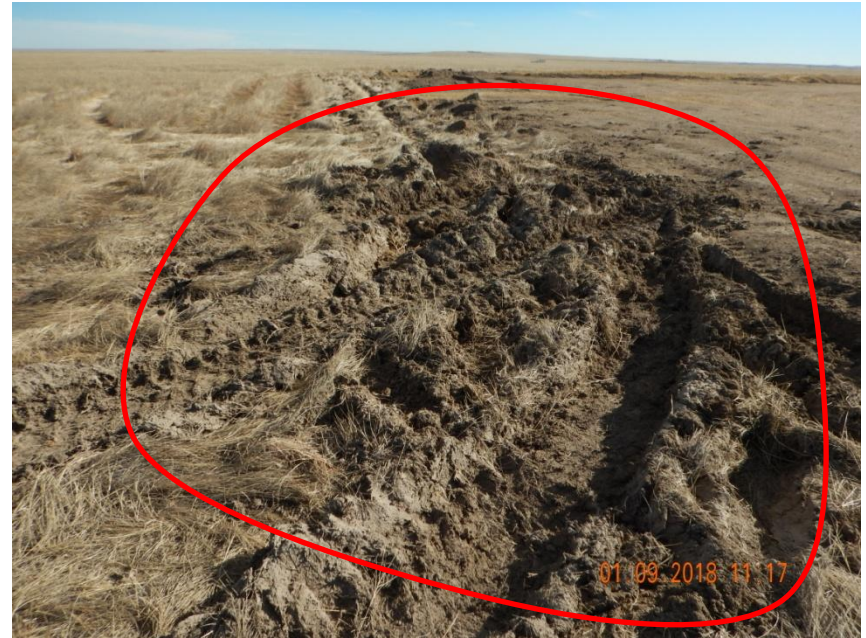
Photo 4. Photo taken from the northern location, facing East. See comments under Photo 3. Equipment traffic has damaged the BMP.

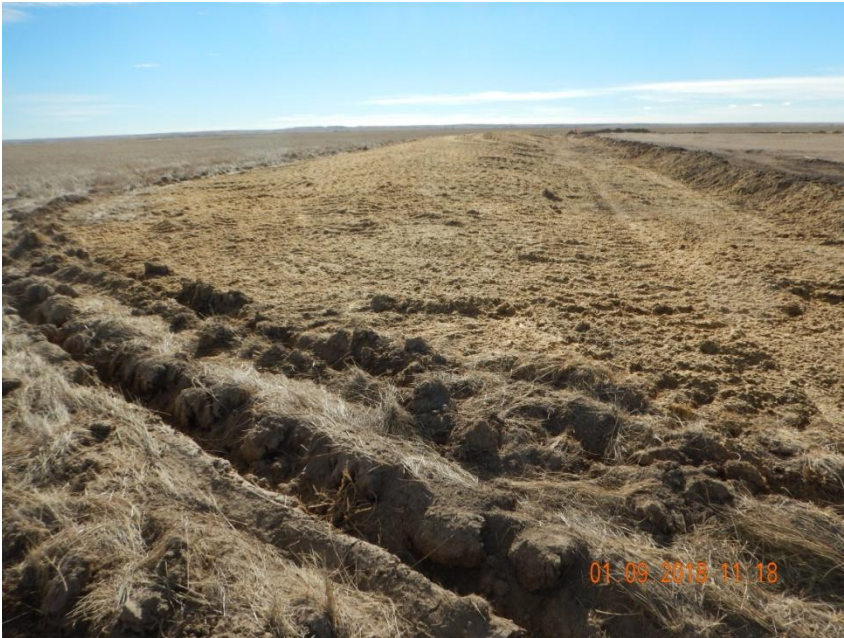
Photo 5. Photo taken from the northeast location, facing South. Appears the Operator has salvaged and stored topsoil along the eastern location. Topsoil has been temporarily stabilized with hydromulch.

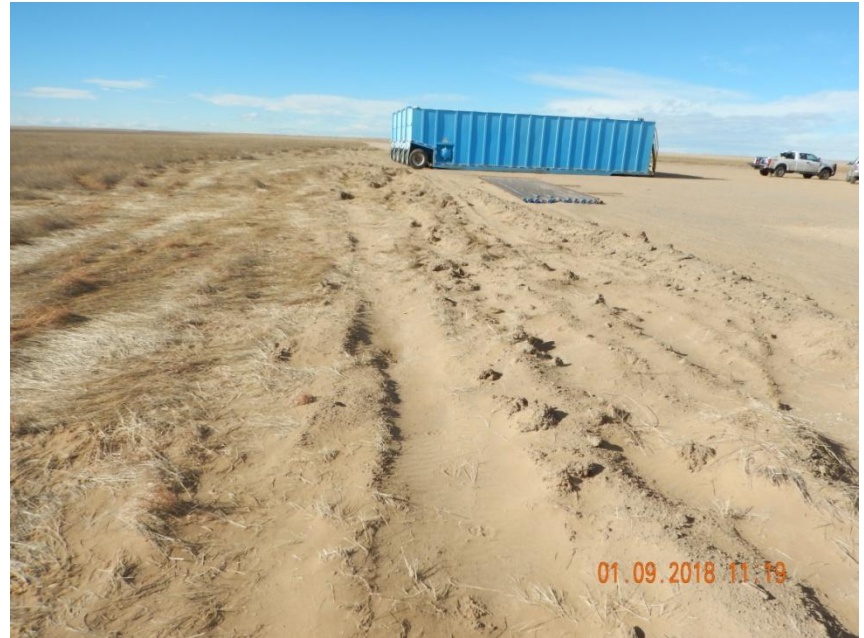
Photo 6. Photo taken from the southeast location, facing West. See comments under Photo 2.

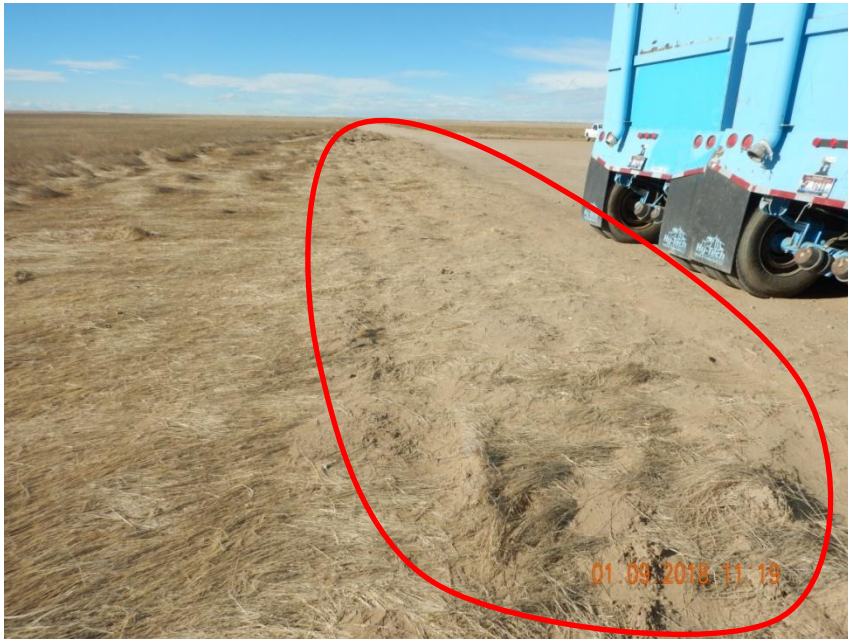
Photo 7. Photo taken from the southern location, facing West. See comments under Photo 4.

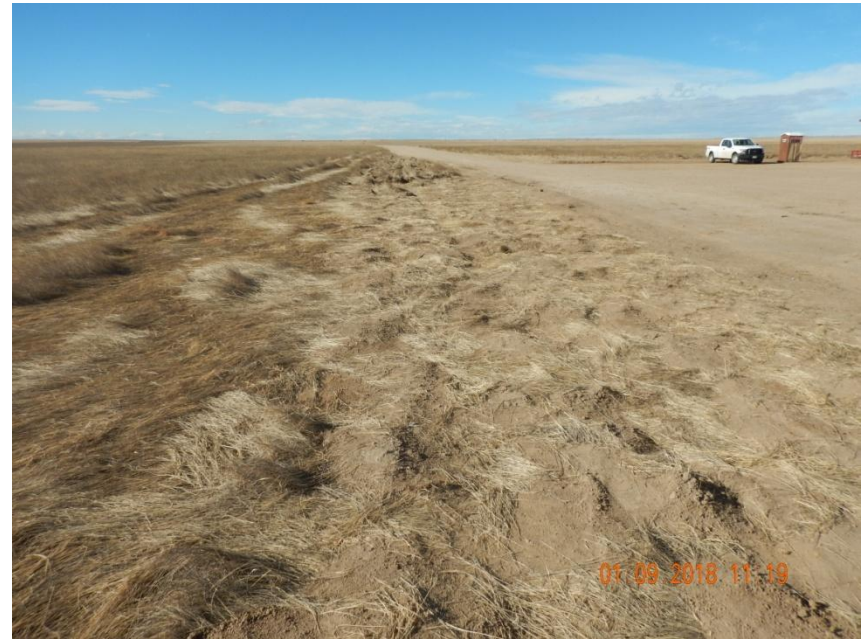
Photo 8. Photo taken from the southwestern location, facing West. See comments under Photo 4.
