Well Name : Herrera 5

API # : 067-06776

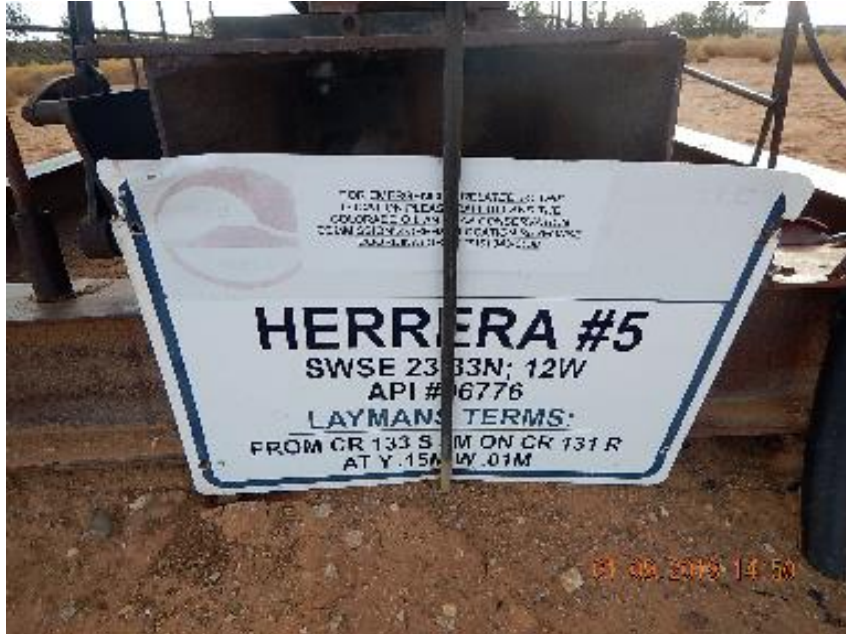
Photo 1: Wellhead sign.

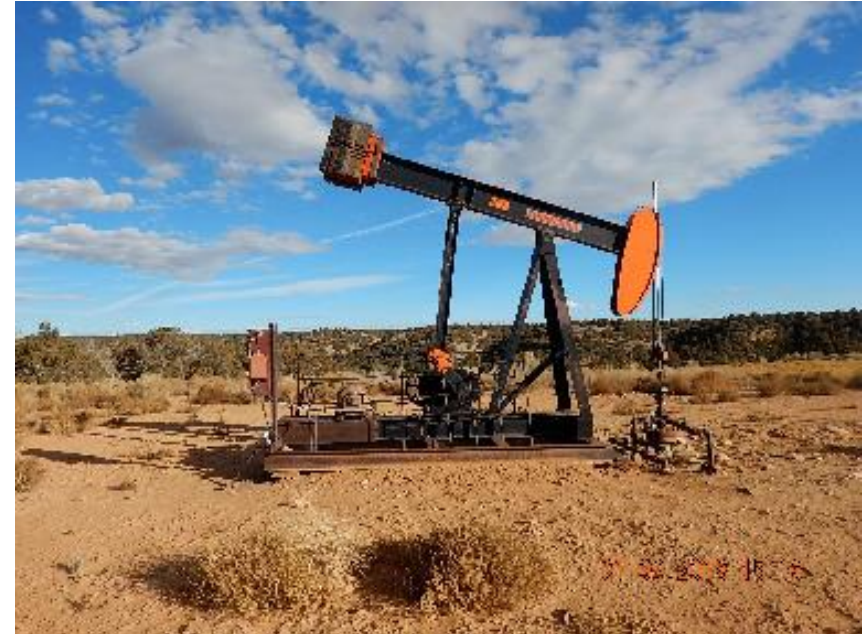
Photo 2: Pump jack, electric panel, and wellhead..

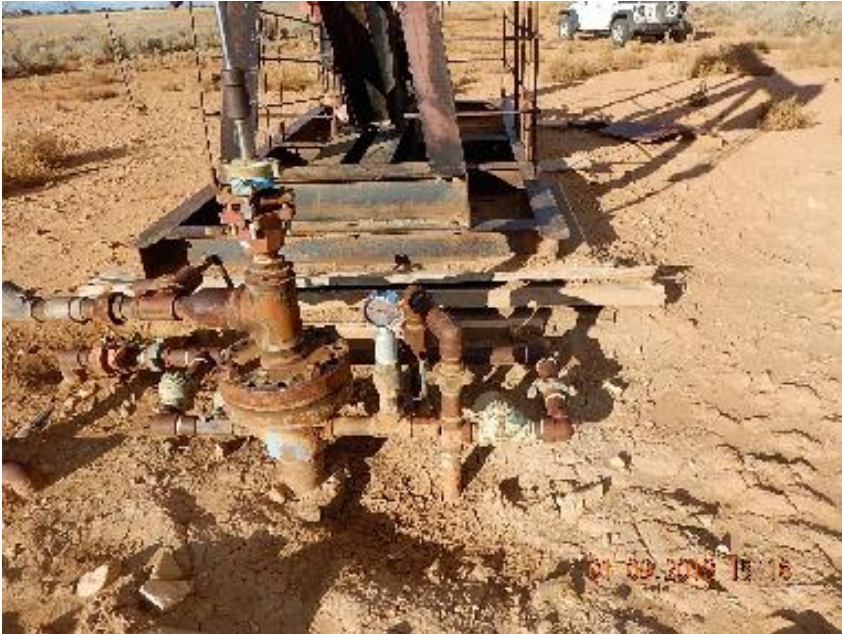
Photo 3: Wellhead flowlines right side.

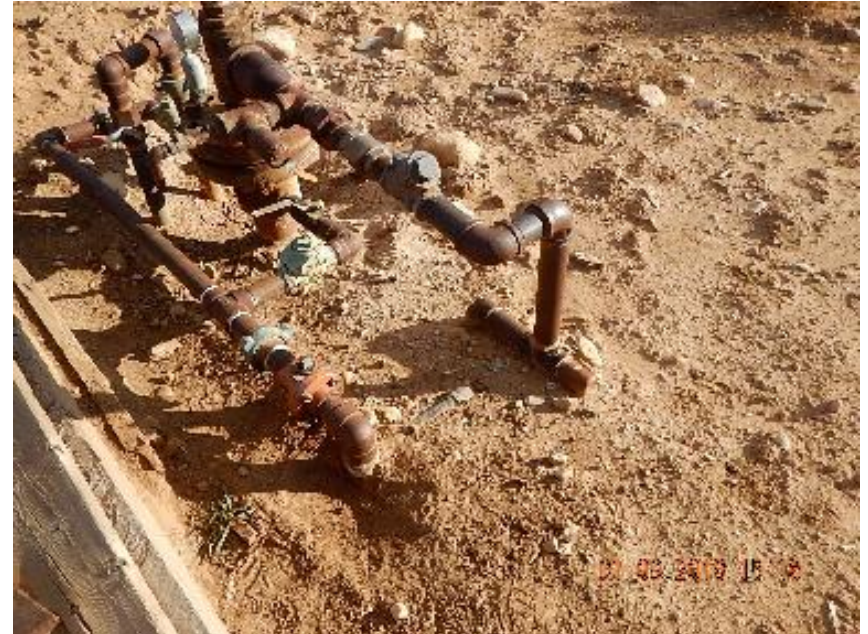
Photo 4: Wellhead flowlines left side.

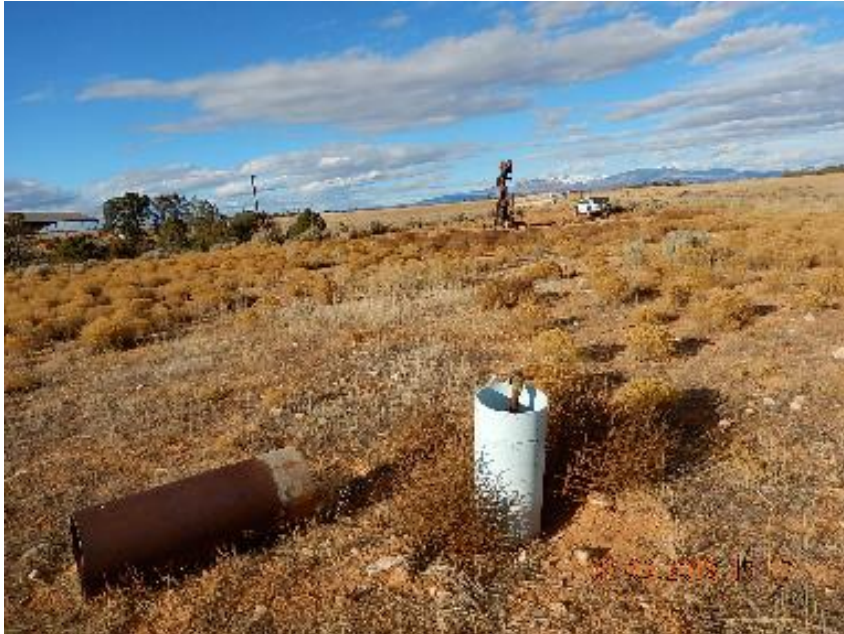
Photo 5: 1" steel riser with pump jack in background.

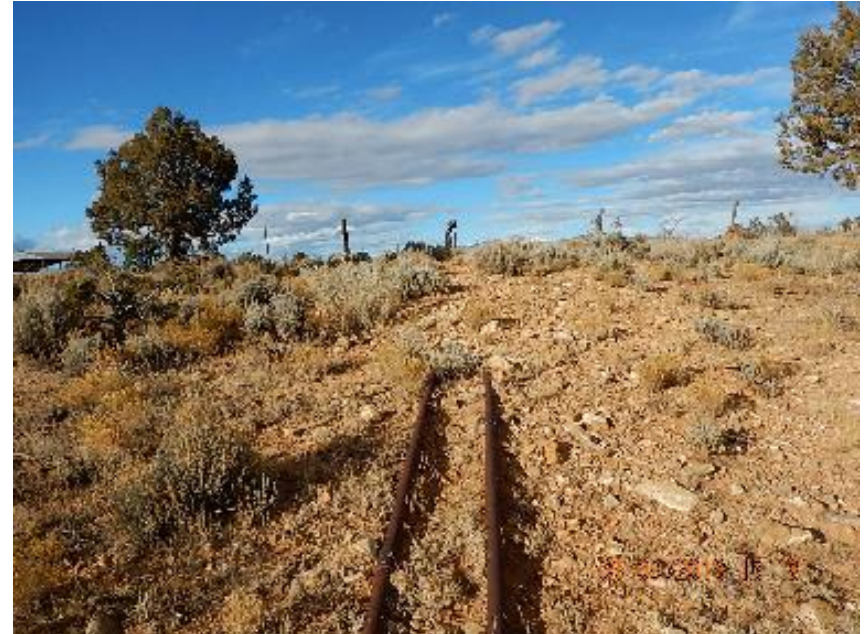
Photo 6: 3" steel lines on edge of slope with pump jack in background.

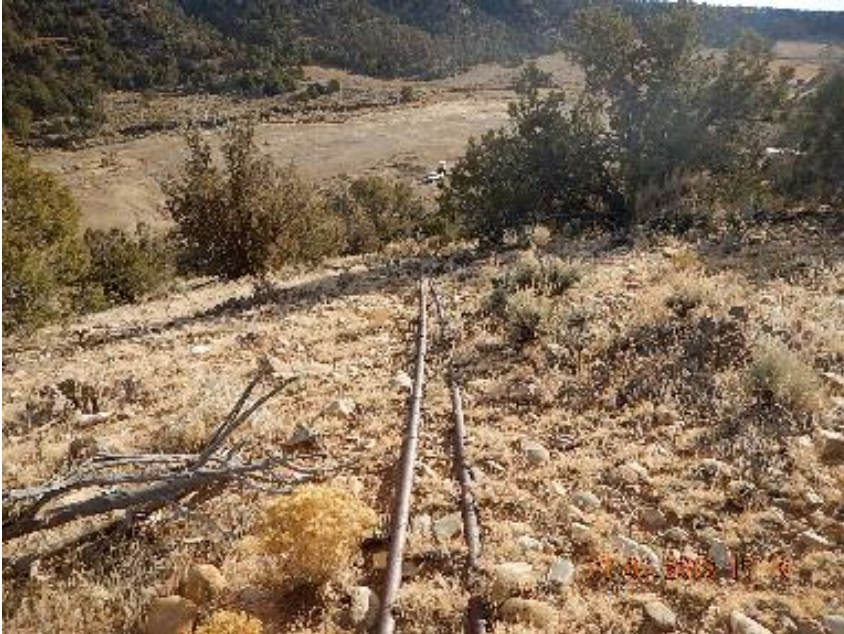
Photo 7: 3" steel lines heading down slope.

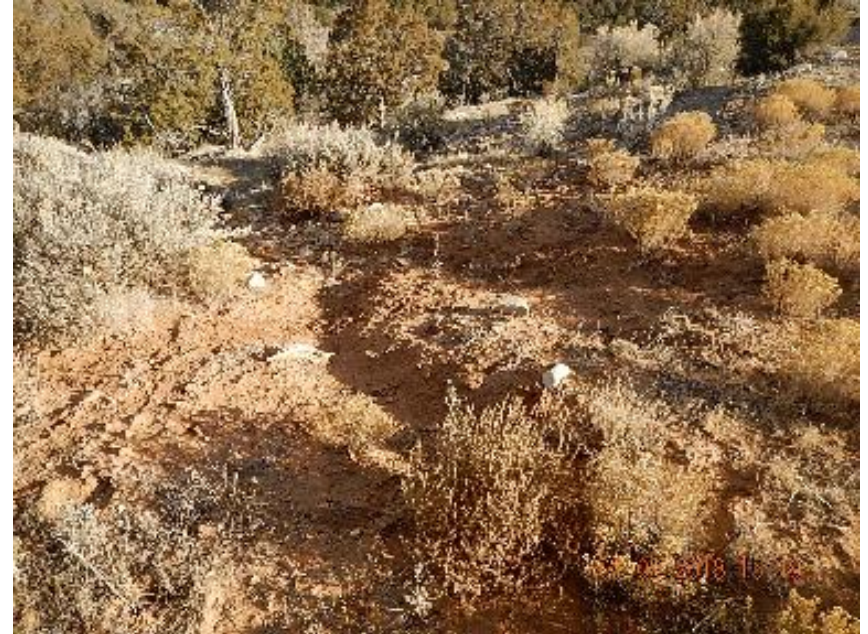
Photo 8: Erosion channels on E side of location.

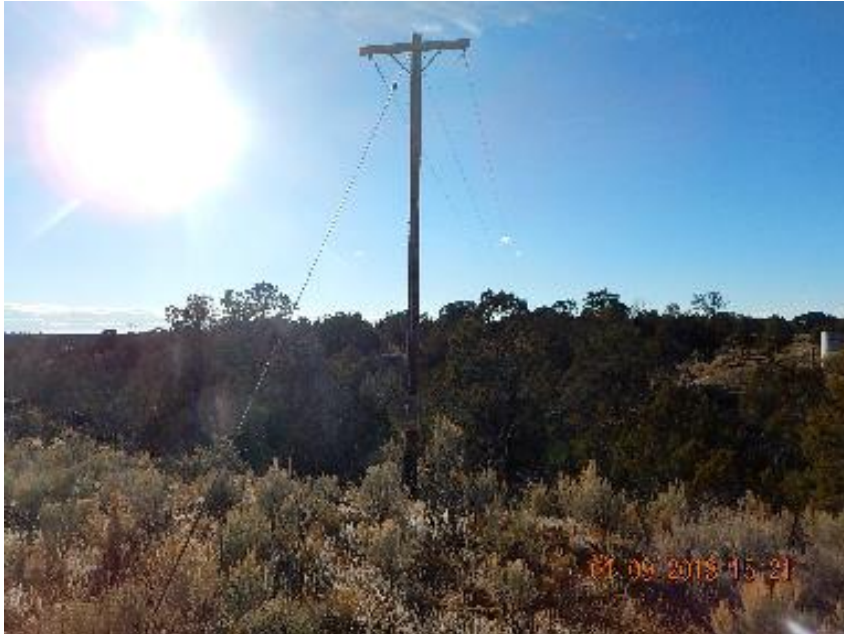
Photo 9: Power pole and power panel for electric motor on pump jack.

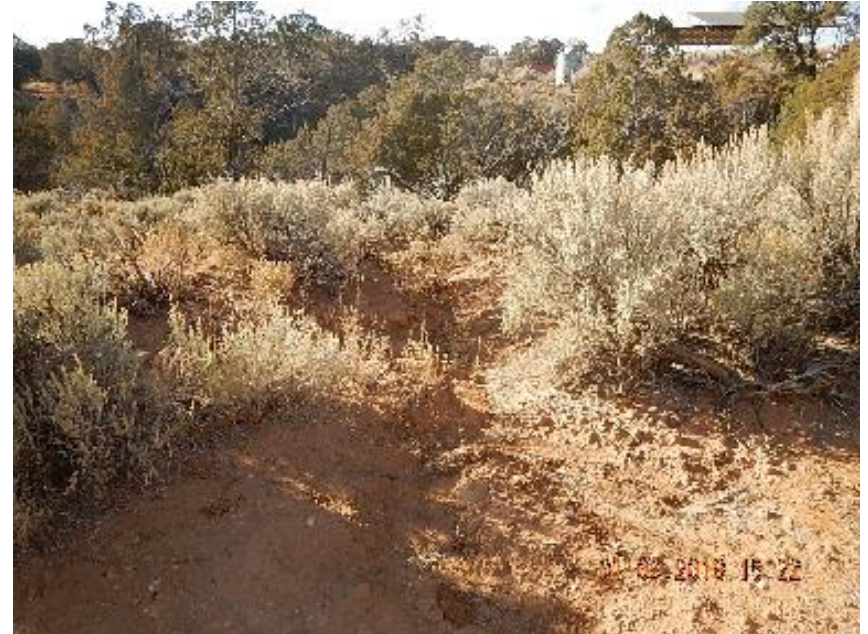
Photo 10: Erosion channel on W side of location.

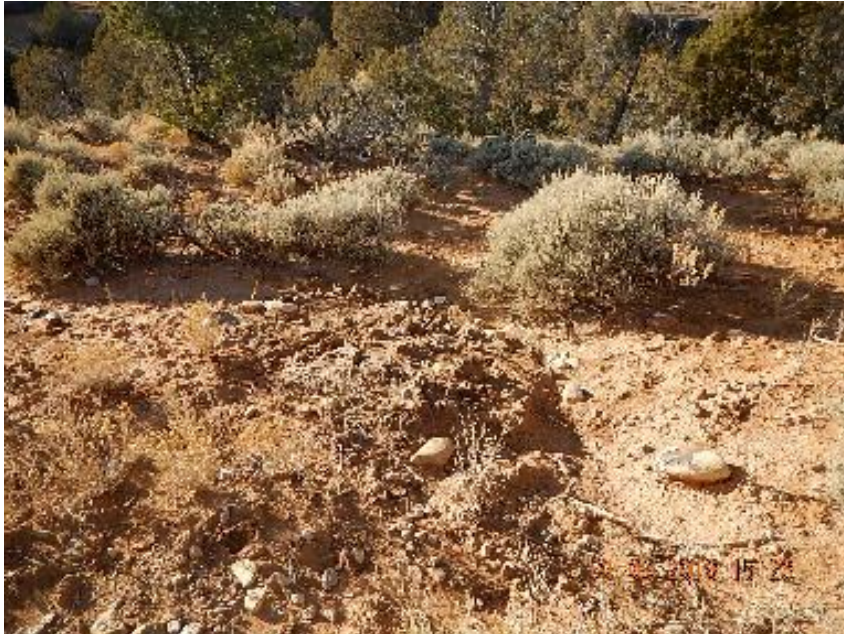
Photo 11: Impacted soil on W perimeter of location.

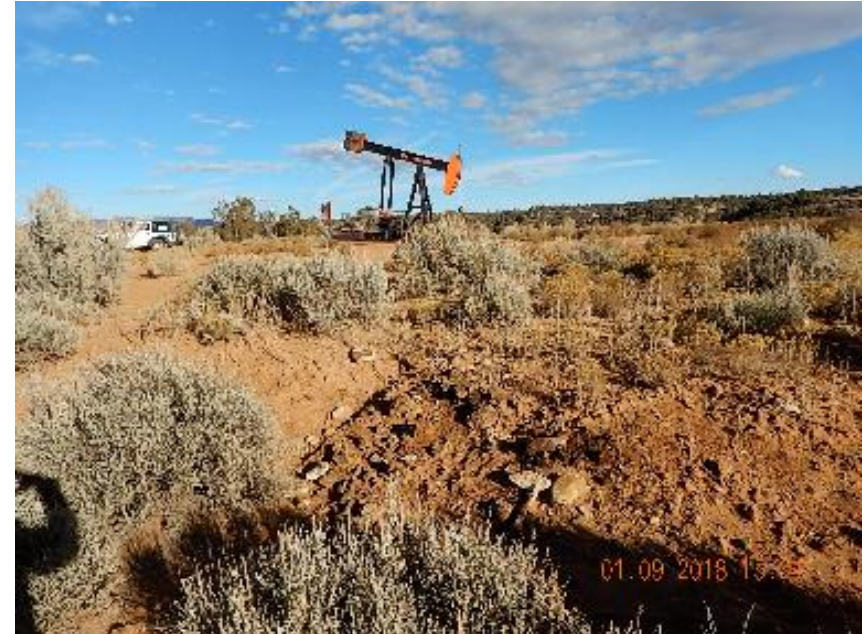
Photo 12: Impacted soil on W perimeter of location with pump jack in background.

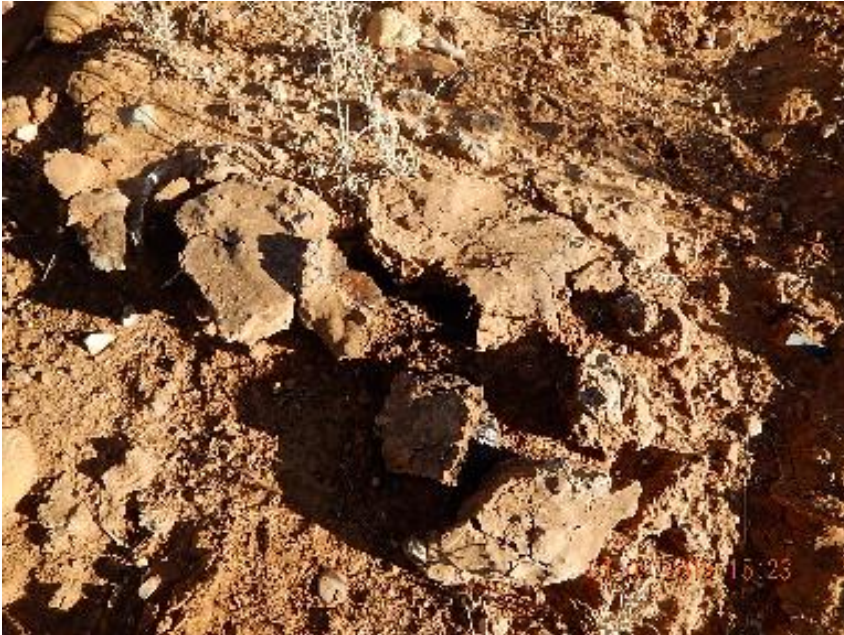
Photo 13: Close up of impacted soil.

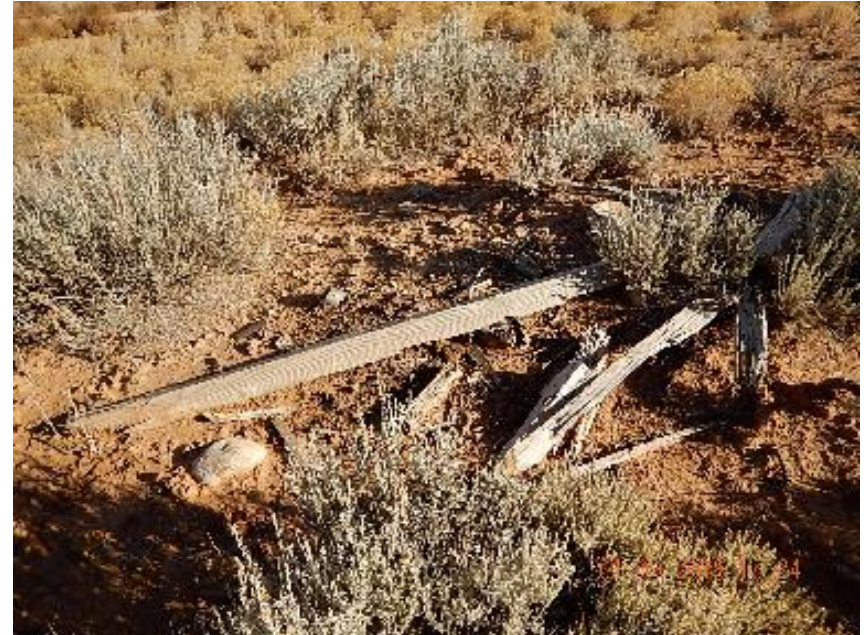
Photo 14: Wood debris on location.

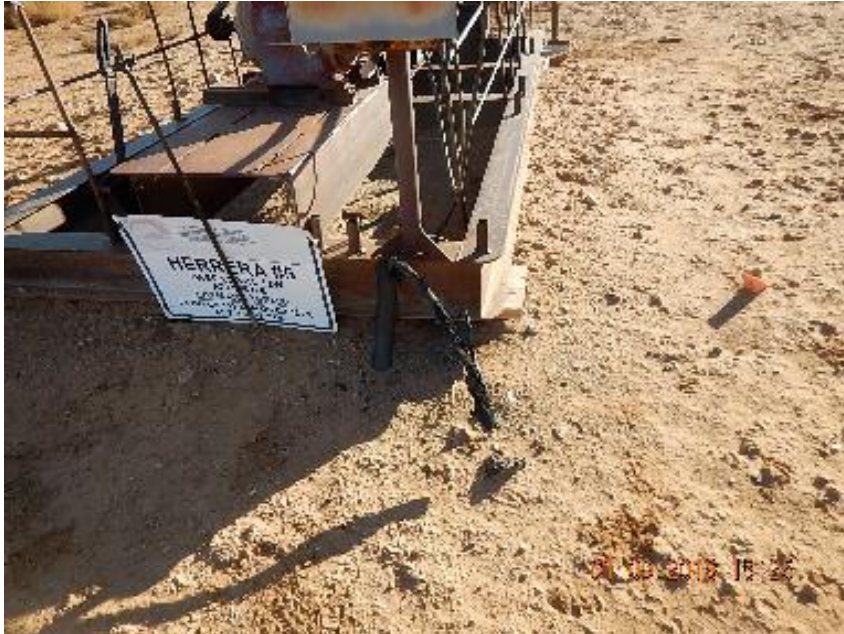
Photo 15: Disconnected power line at wellhead.

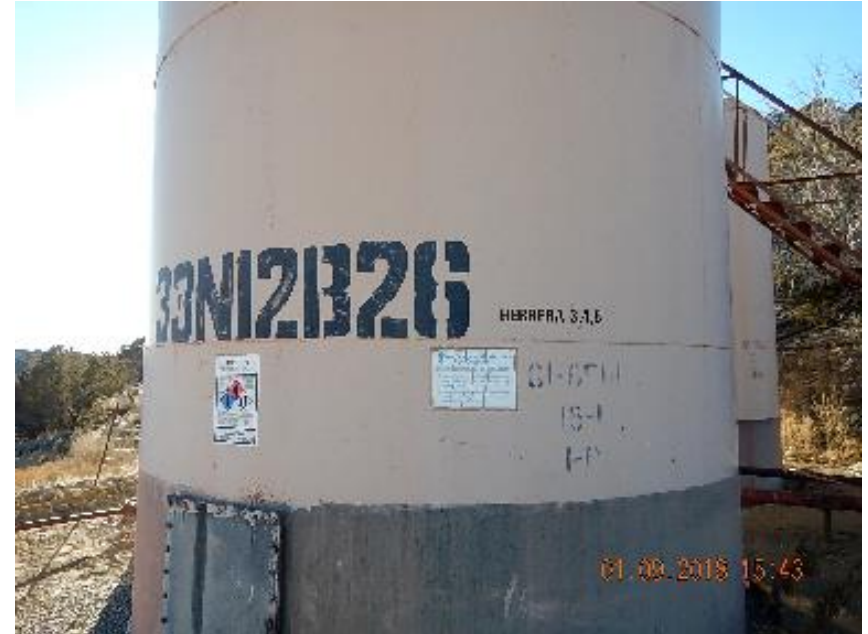
Photo 16: Tank at remote battery location (Herrera 3).
