Inspection Photos  
Location Name: Ridgeview 32-16-1  
API: 05-081-07747

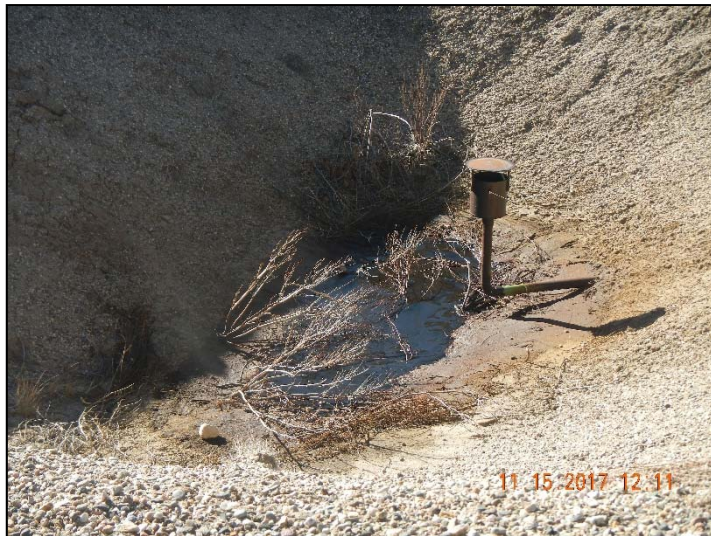
**Photo 1. Fluid in flare pit.**  
**11/15/2017**

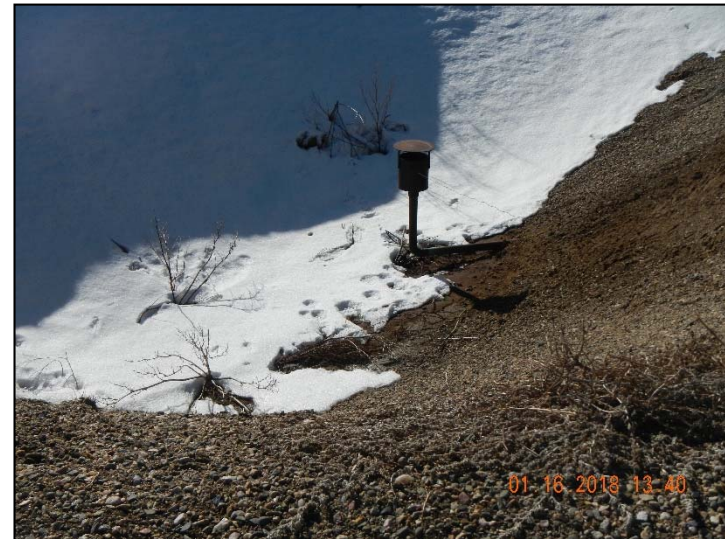
**Photo 2. Current pit conditions unable to see fluid due to snow cover.**  
**1/16/2018**

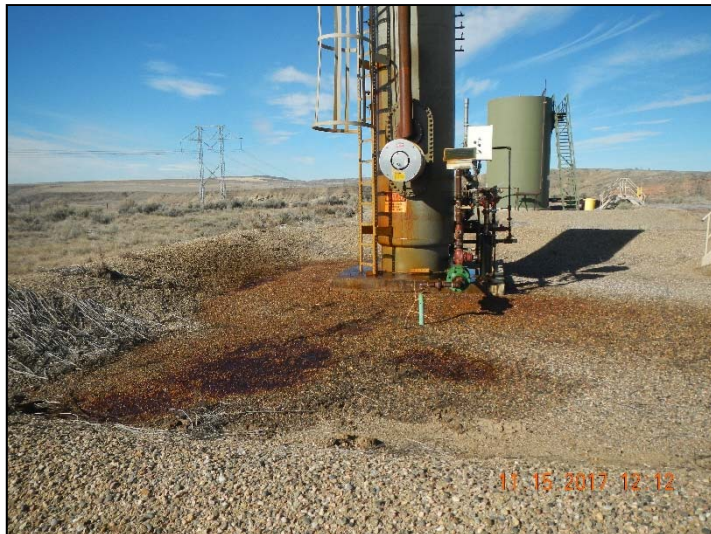
**Photo 3. Fluid in separator berm.**  
**11/15/2017**

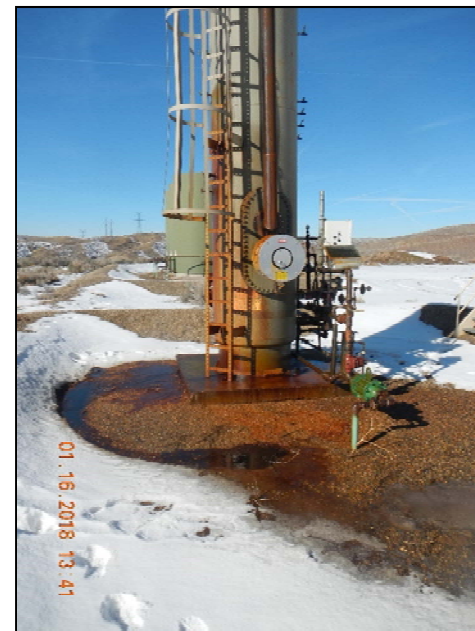
**Photo 4. Fluid in separator berm.**  
**1/16/2018**

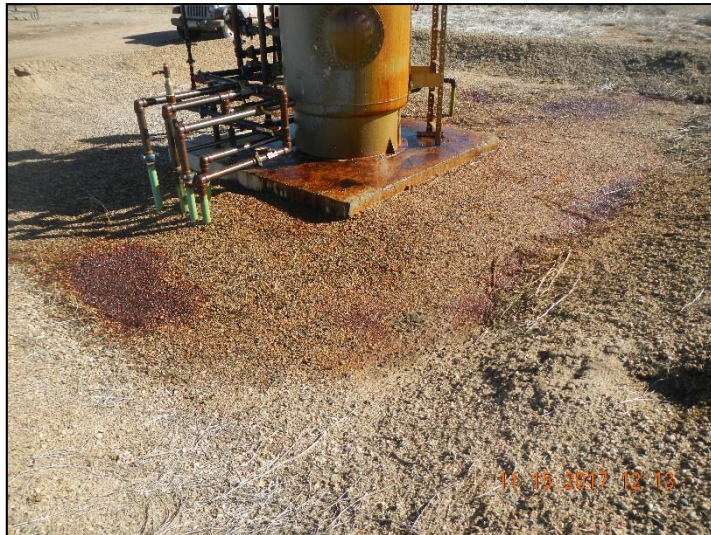
**Photo 5. Fluid in separator berm.**  
**11/15/2017**

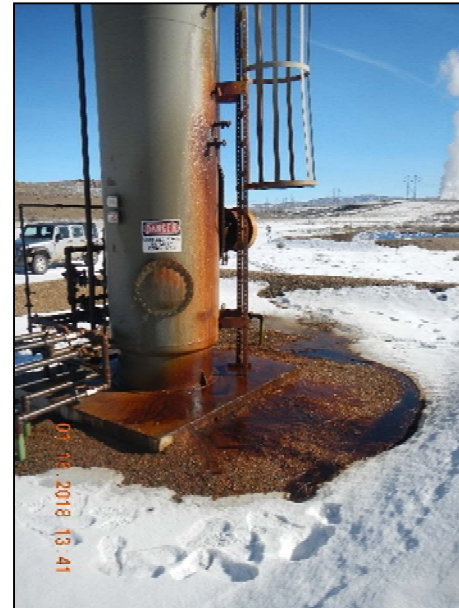
**Photo 6. Fluid in separator berm.**  
**1/16/2018**

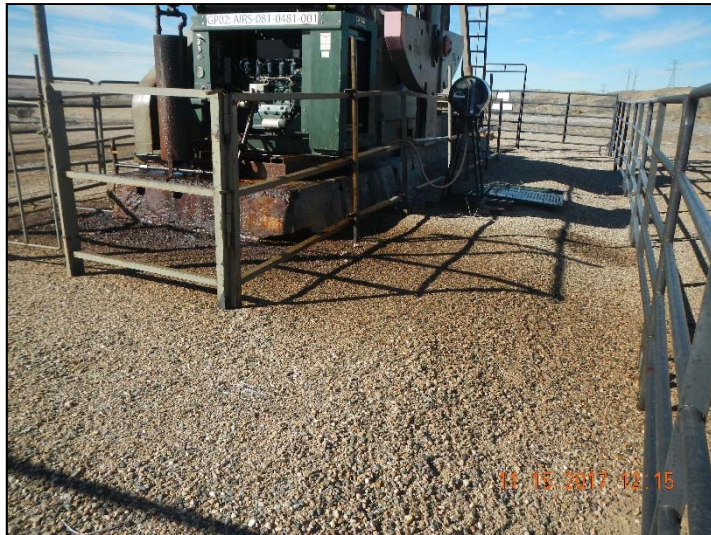
**Photo 7. Fluid at pump jack motor, no containment.**  
**11/15/2017**

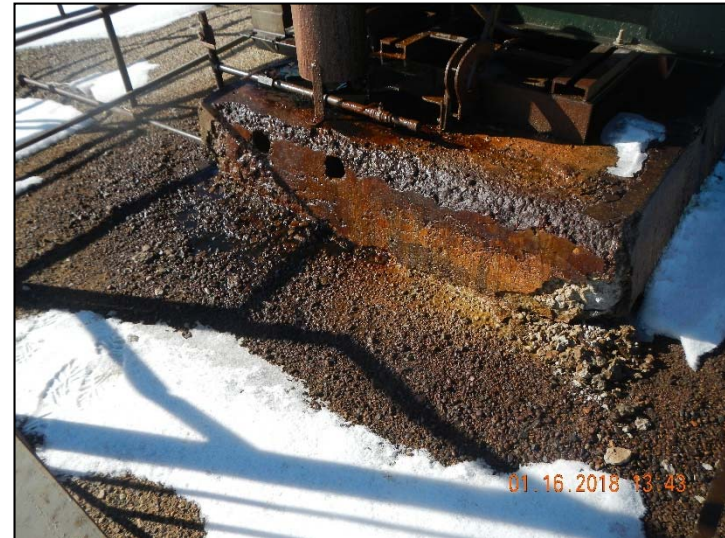
**Photo 8. Fluid at pump jack motor, no containment.**  
**1/16/2018**

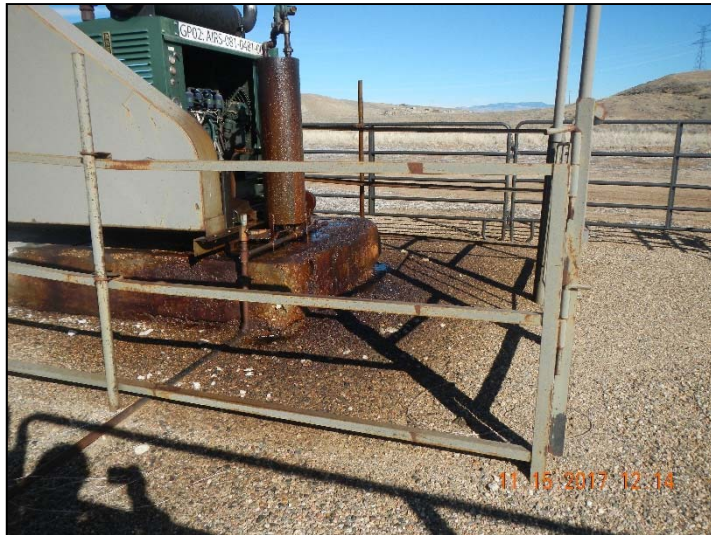
**Photo 9. Fluid at pump jack motor, no containment.**  
**11/15/2017**

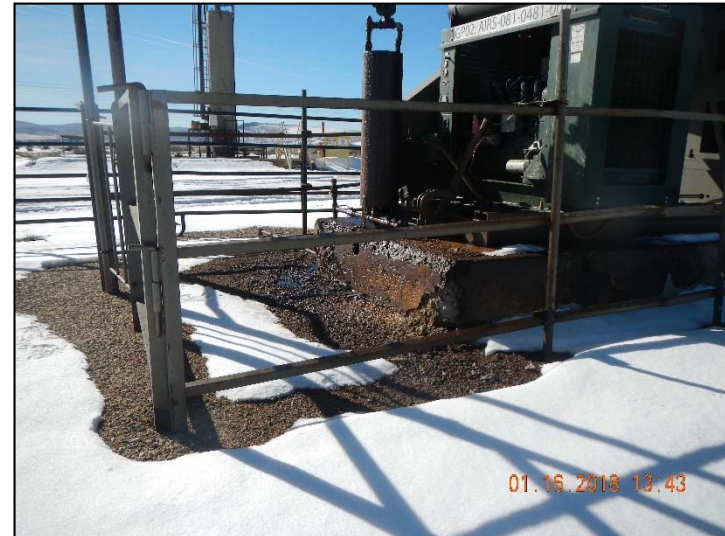
**Photo 10. Fluid at pump jack motor, no containment.**  
**1/16/2018**
