Interim Reclamation and Stormwater Inspection

January 12, 2018

Operator: BARRETT CORPORATION* BILL - #10071

Location Name: Anschutz-Williams /5-61-27 SWSW

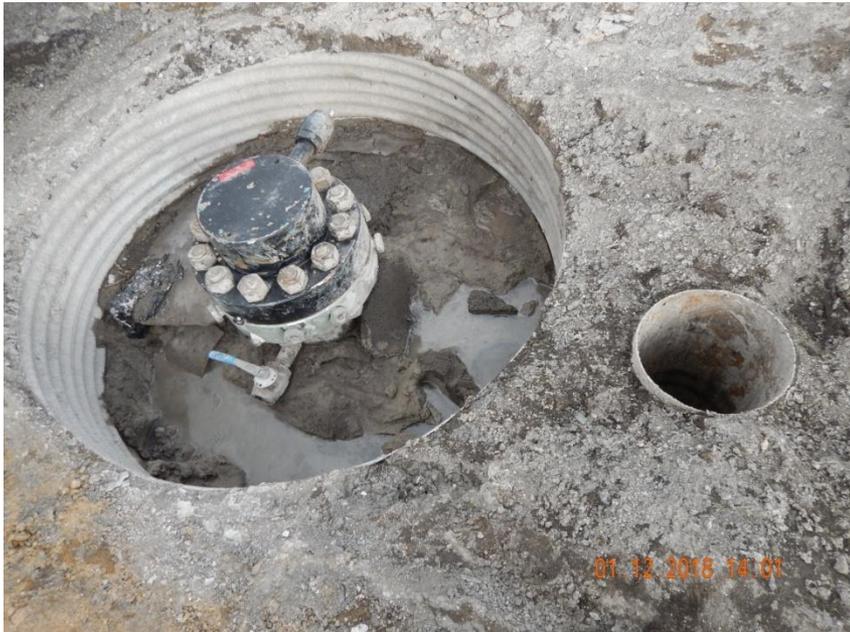
Photo 1. Photo taken from one of the wellheads at location. Photo illustrates a rat hole left open. This is a potential safety and wildlife hazard. Operator should also consider placing safety fence around the wellhead area for safety measures.

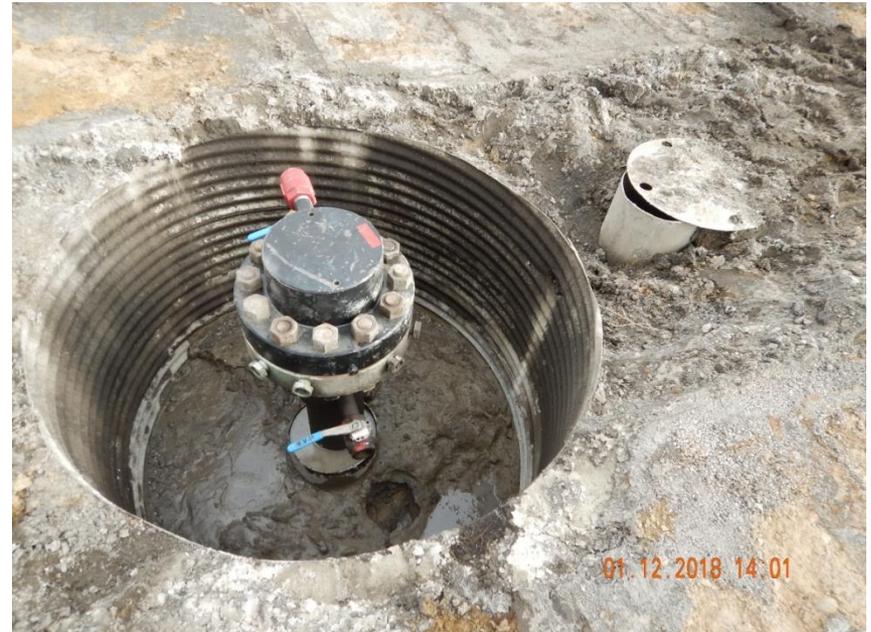
Photo 2. Photo taken from an adjacent wellhead at location. Photo illustrates the rat hole was covered up.

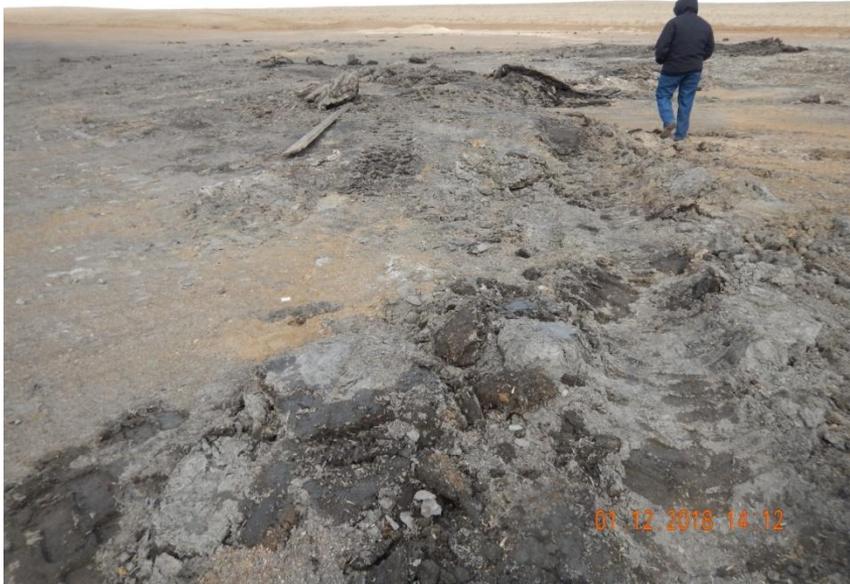
Photo 3. Photo taken from the southern well pad, facing East. Operator has left drill cuttings at location and has not properly transported the drill cuttings off location.

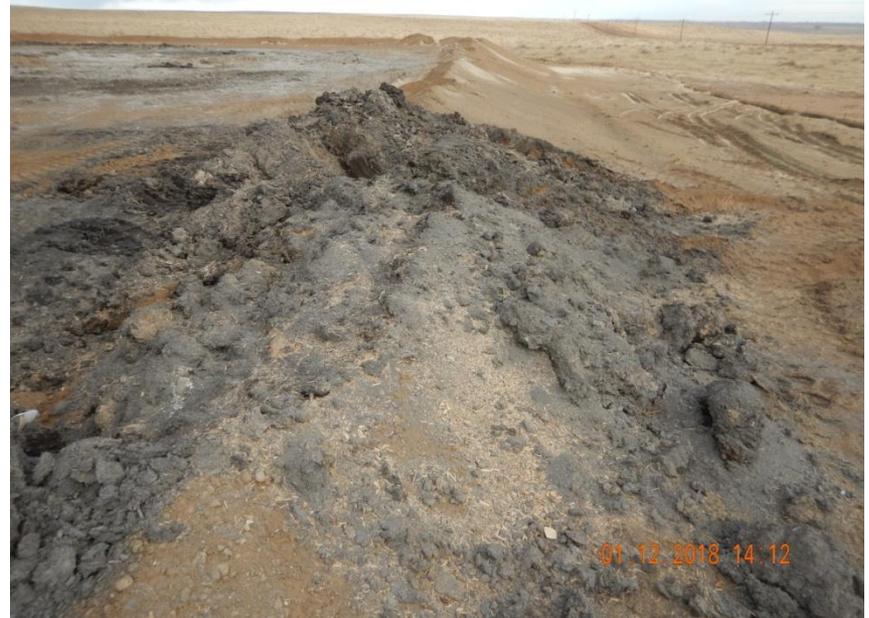
Photo 4. Photo taken from the southern well pad, facing East. Operator has not properly transported and handled drill cuttings at location. Drill cuttings were observed along portions of the fill slope.

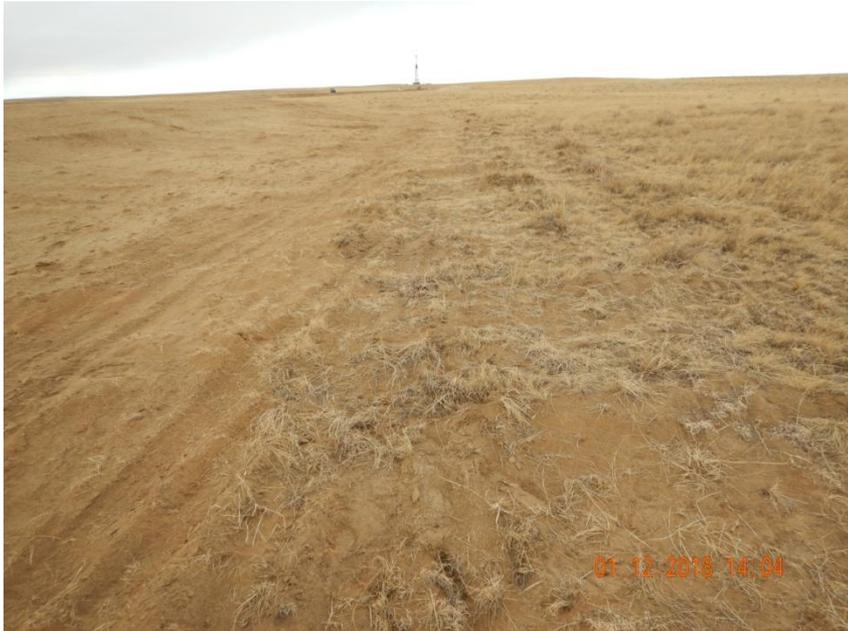
Photo 5. Photo taken from the eastern perimeter of the location, facing North. Appears a surface roughening BMP has been installed along portions of the perimeter; however, this does not appear to be a sufficient and appropriate BMP for the sandy soil conditions. BMP has been filled in from wind erosion sediment deposition. Unconsolidated soil material along the perimeter of the location has not been stabilized.

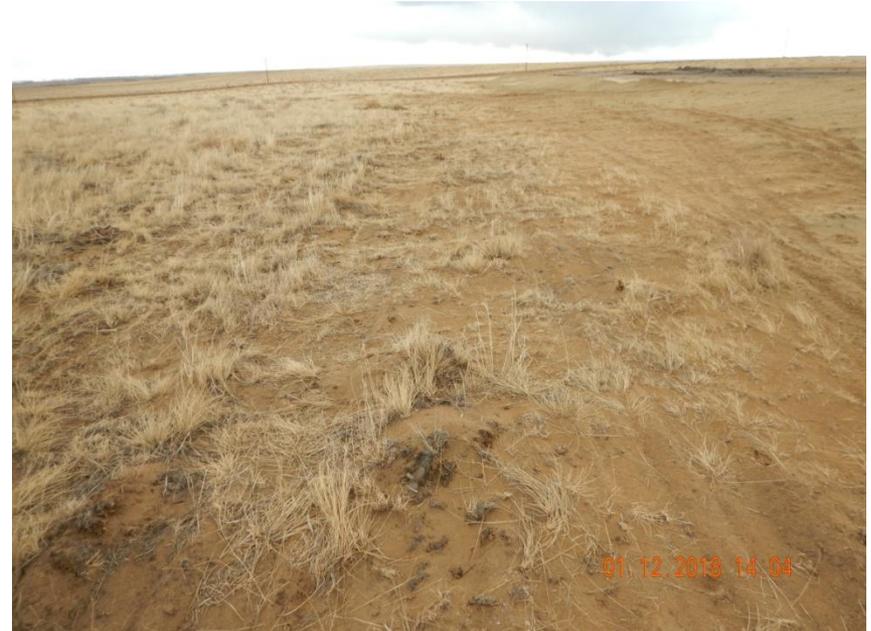
Photo 6. Photo taken from the eastern perimeter of the location, facing South. See comments under Photo 5.

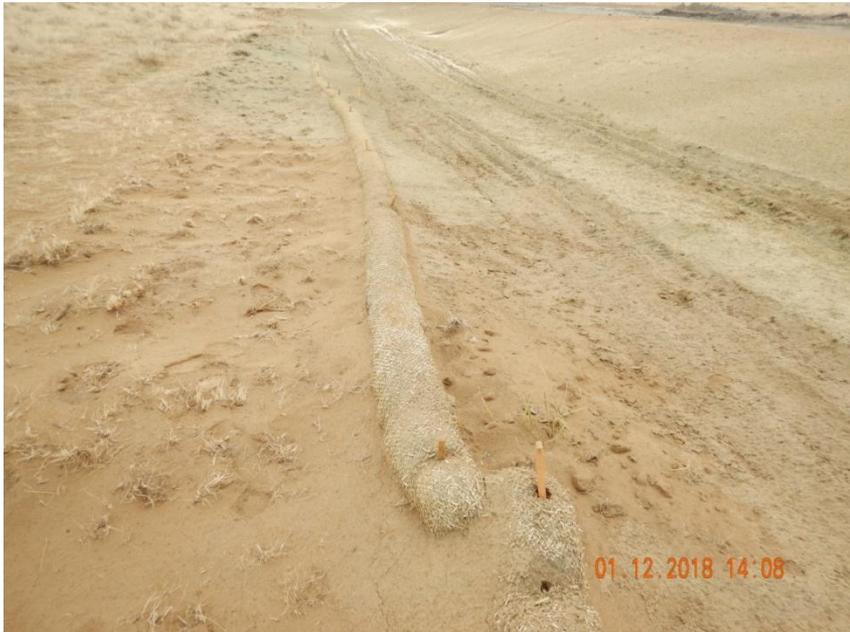
Photo 7. Photo taken from the eastern perimeter of the location, facing South. Appears the Operator has temporarily stabilized the topsoil stockpile with hydromulch. Straw wattle BMP has been installed to the outer perimeter of the stockpile.

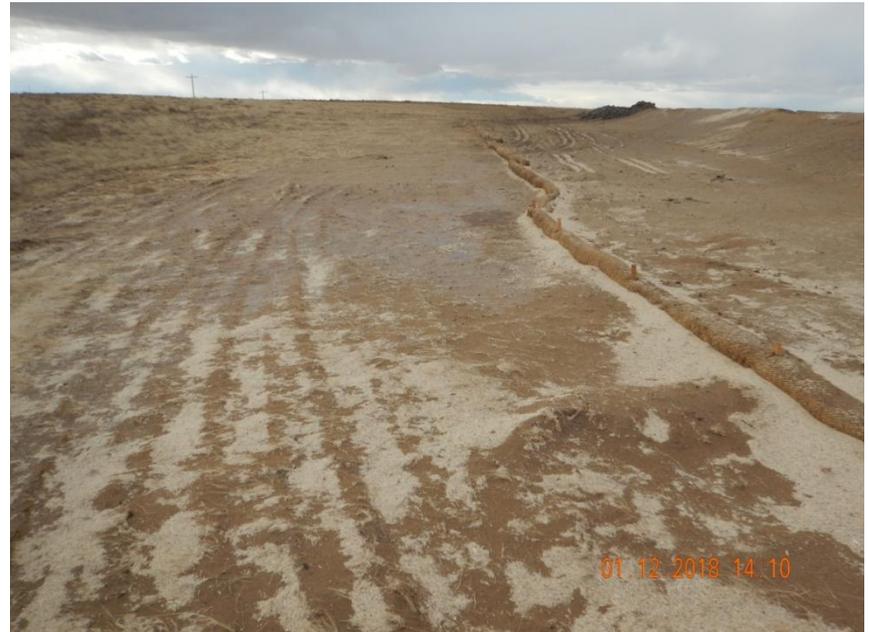
Photo 8. Photo taken from the southeastern perimeter of the location, facing West. Operator needs to store/handle sawdust left at location because it is blowing off location. Comments from Photo 5 apply to this area as well.

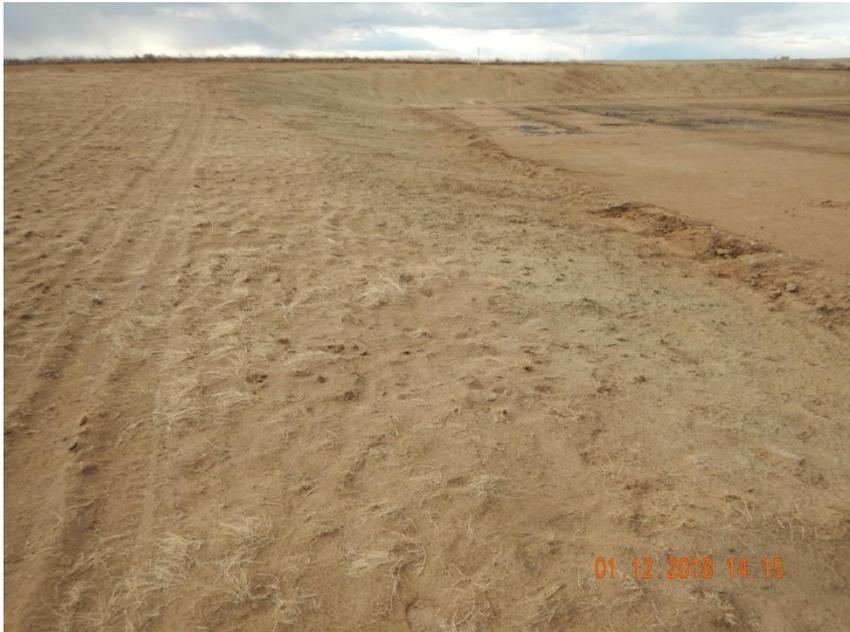
Photo 9. Photo taken from the southern perimeter of the location, facing West. Operator does not have sufficient stormwater BMPs to control stormwater run-on onto location.

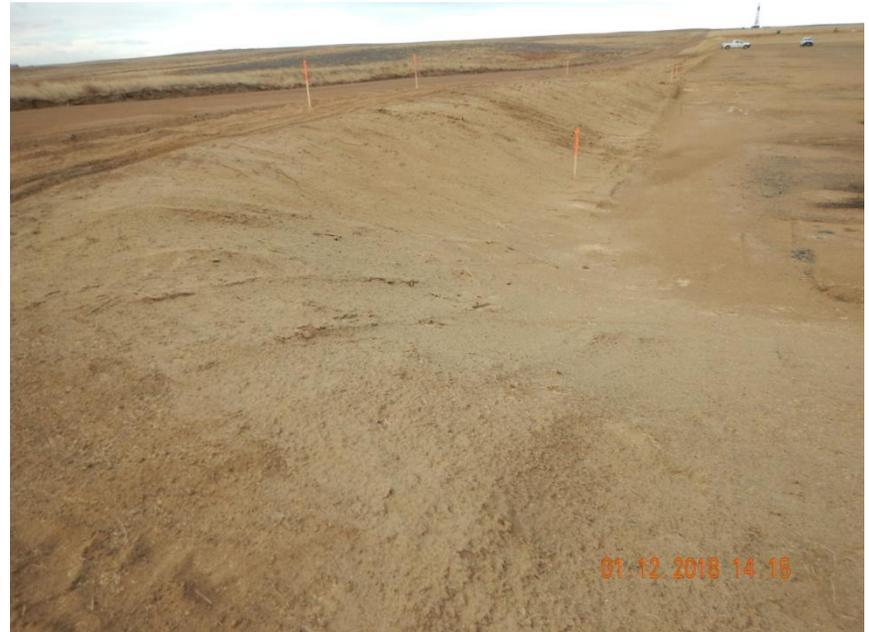
Photo 10. Photo taken from the southwest perimeter of the location, facing North. Operator has applied a hydromulch to the cut slopes as a temporary stabilization BMP.

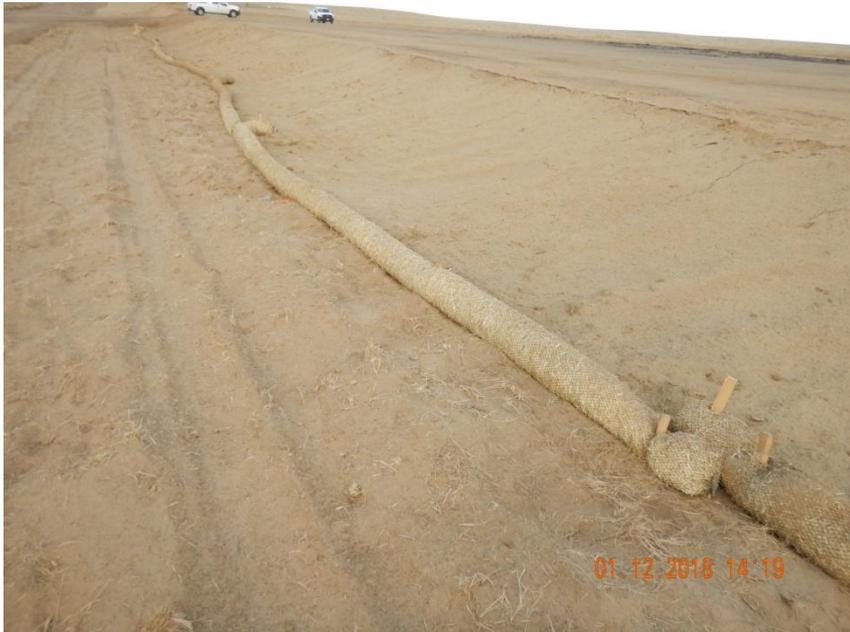
Photo 11. Photo taken from the western perimeter of the location, facing North. Straw wattle BMP has been installed but unconsolidated soil material along the perimeter of the location has not been stabilized.

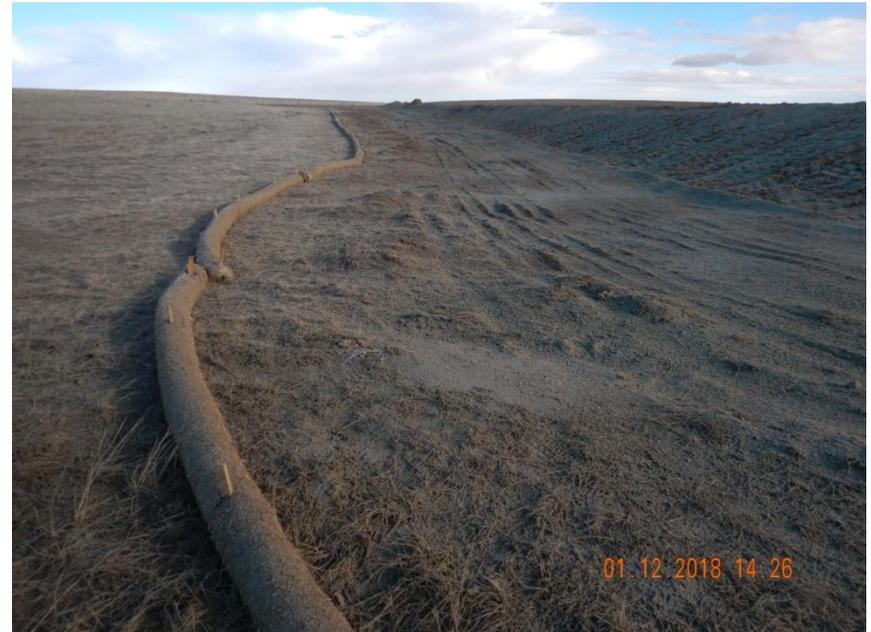
Photo 12. Photo taken from the northwest perimeter of the location, facing East. Straw wattle BMP has been installed and appears hydromulch has been applied to unconsolidated soil material along the perimeter of the location.

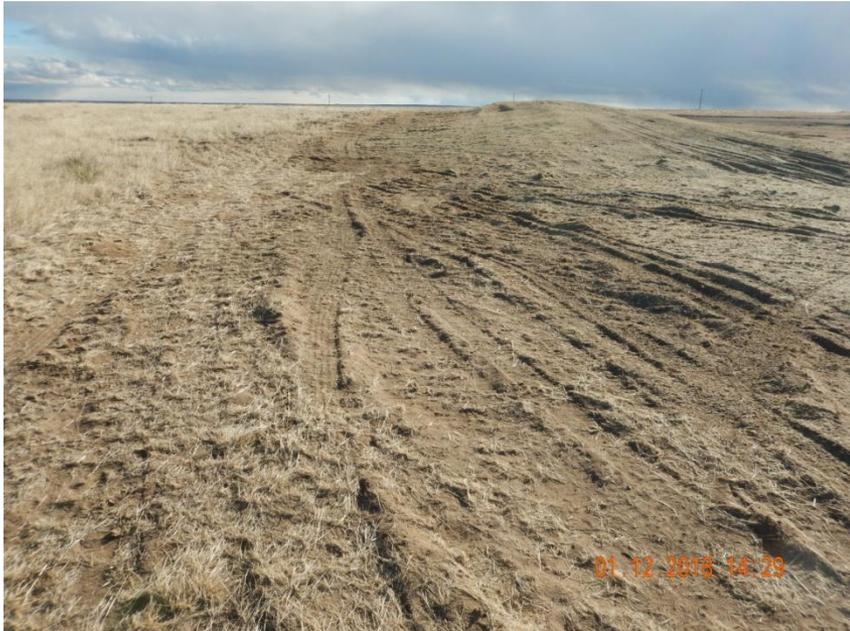
Photo 13. Photo taken from the northeast perimeter of the location, facing South. Operator does not have sufficient stormwater BMPs along the perimeter of the location.

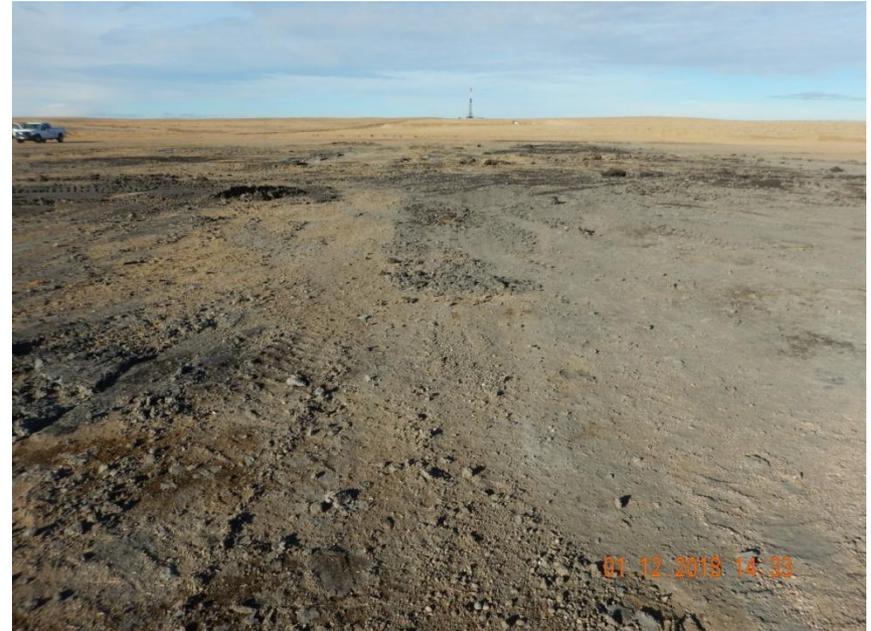
Photo 14. Photo taken from the central location, facing North. Photo further illustrates the Operator has left drill cuttings at location and has not properly transported the drill cuttings off location.
