# Interim Reclamation and Stormwater Inspection

January 12, 2018

Operator: BARRETT CORPORATION\* BILL - #10071

Location ID: 452695

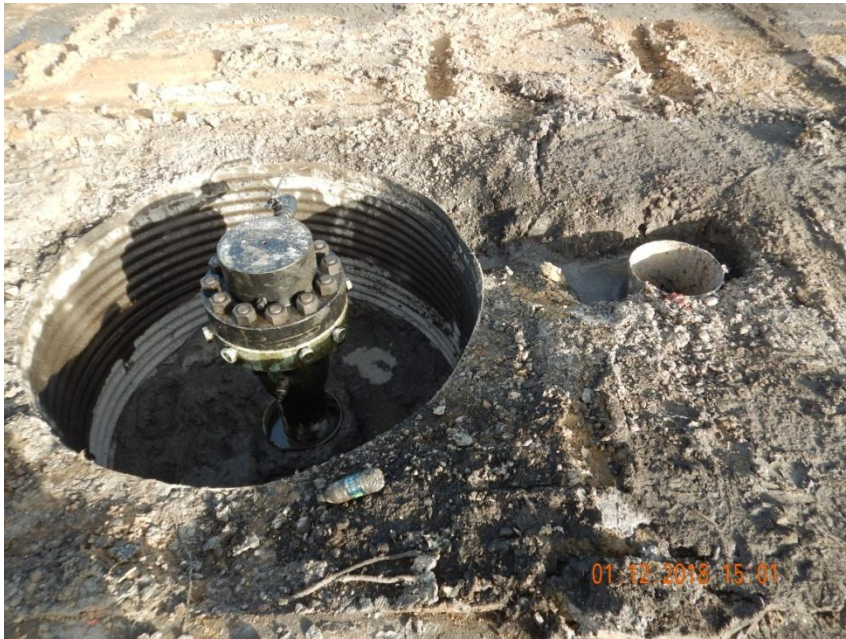
**Photo 1.** Photo taken from one of the wellheads at location. Photo illustrates a rat hole left open. This is a potential safety and wildlife hazard. Operator should also consider placing safety fence around the wellhead area for safety measures.

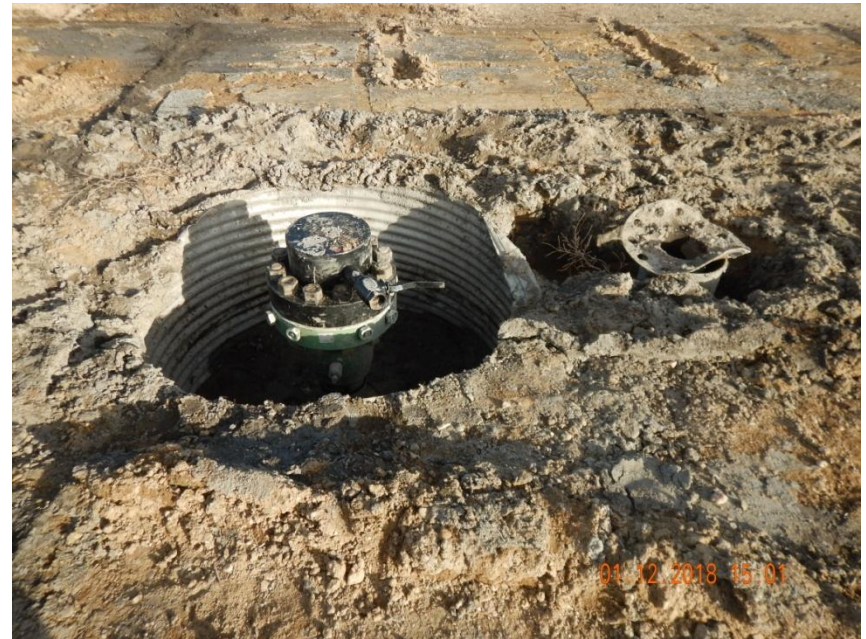
**Photo 2.** Photo taken from an adjacent wellhead at location. Photo illustrates the rat hole was partially covered up.

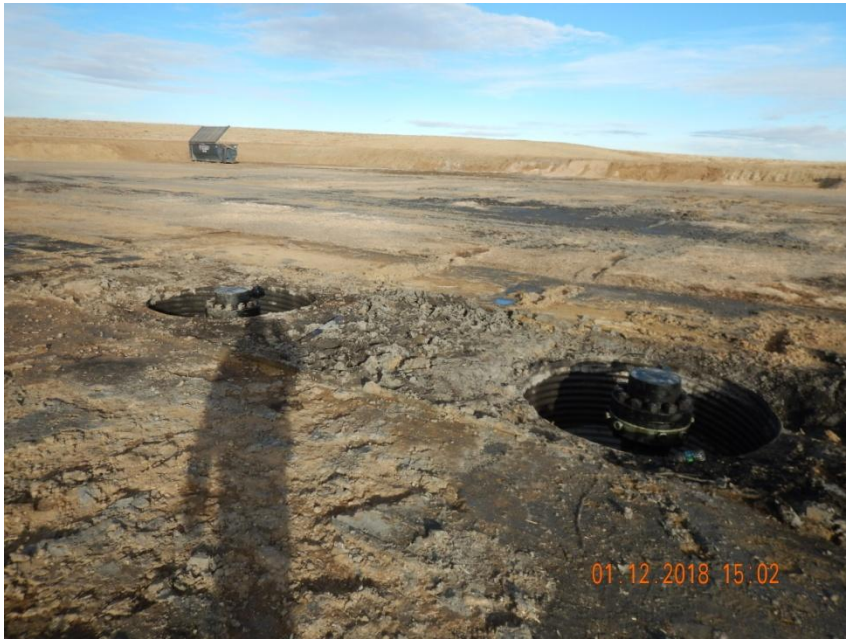
**Photo 3.** Photo taken from the wellhead area, facing East. Operator has left drill cuttings at location and has not properly transported the drill cuttings off location.

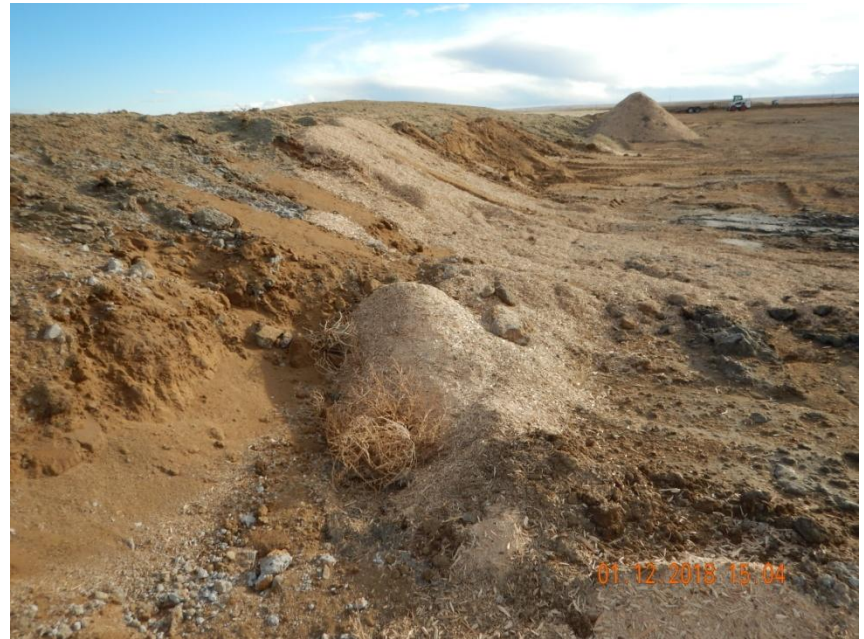
**Photo 4.** Photo taken from the eastern well pad, facing South. Operator needs to properly store or remove sawdust from location.

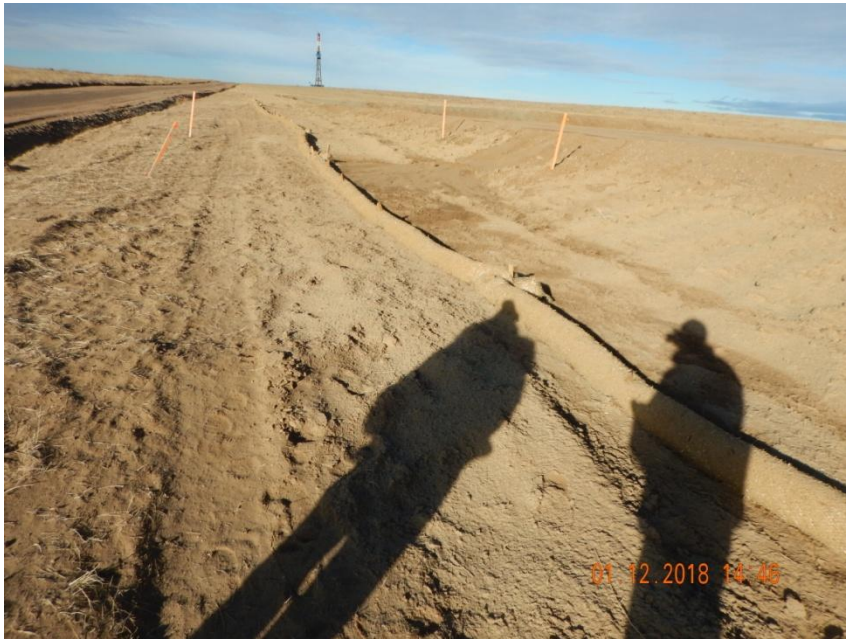
**Photo 5.** Photo taken from the western perimeter of the location, facing North. Straw wattle BMP has been installed and hydromulch has been applied to unconsolidated soil material along the perimeter of the location.

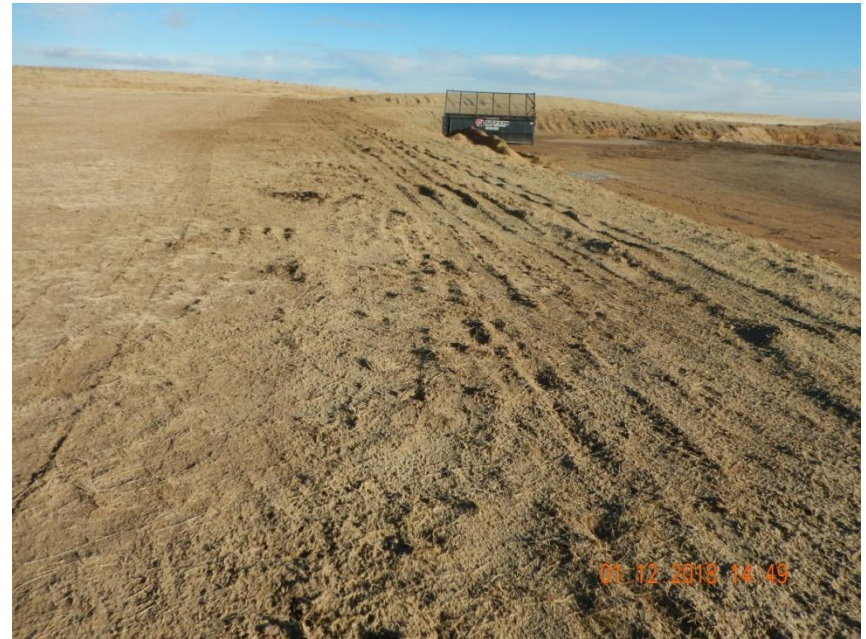
**Photo 6.** Photo taken from the northern perimeter of the location, facing East. Appears a surface roughening BMP has been installed along portions of the perimeter; however, this does not appear to be a sufficient and appropriate BMP for the sandy soil conditions. Hydromulch has been applied to unconsolidated soil material along the perimeter of the location.

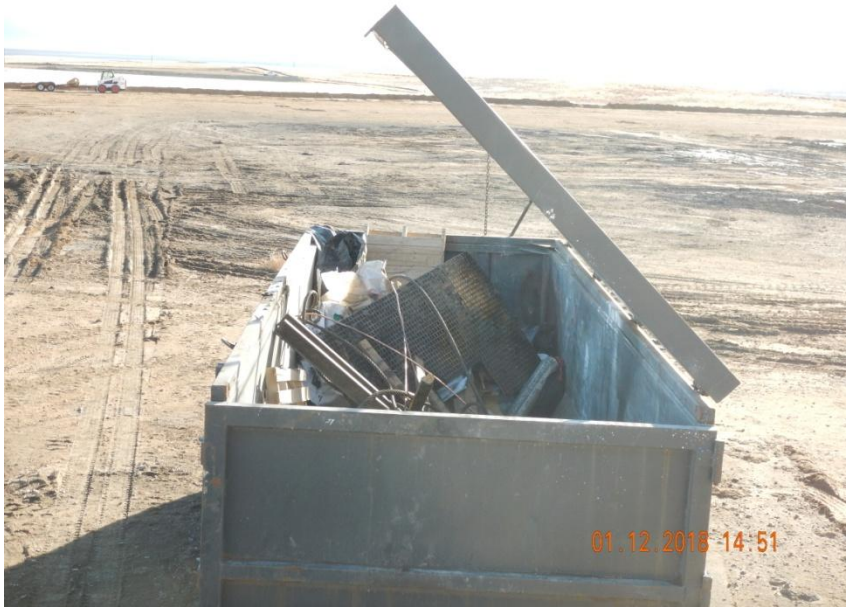
**Photo 7.** Photo taken from the northern location, facing South. Operator shall keep the trash lid closed to prevent trash from blowing out of containment.

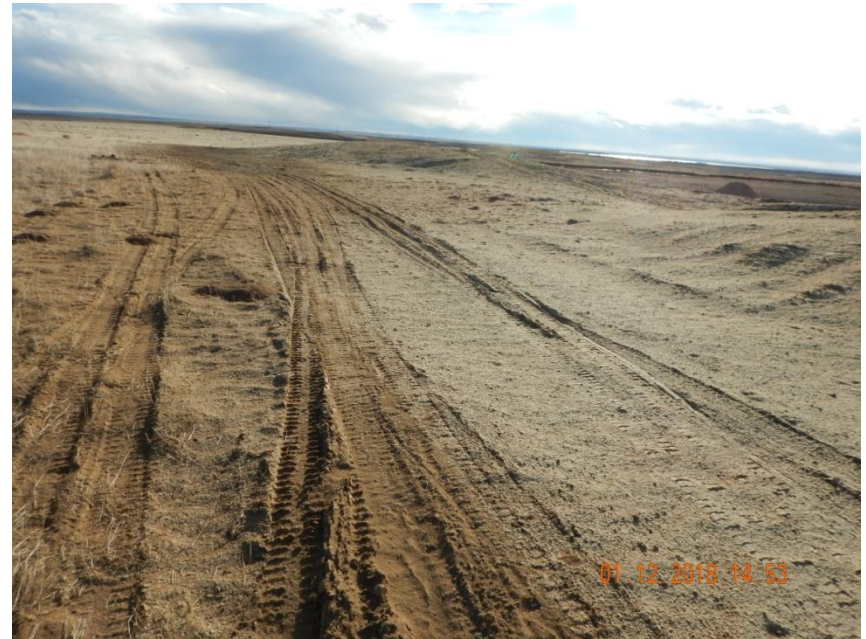
**Photo 8.** Photo taken from the eastern perimeter of the location, facing South. Appears the Operator has temporarily stabilized the topsoil stockpile with hydromulch. Operator does not have sufficient stormwater BMPs along the perimeter of the location.

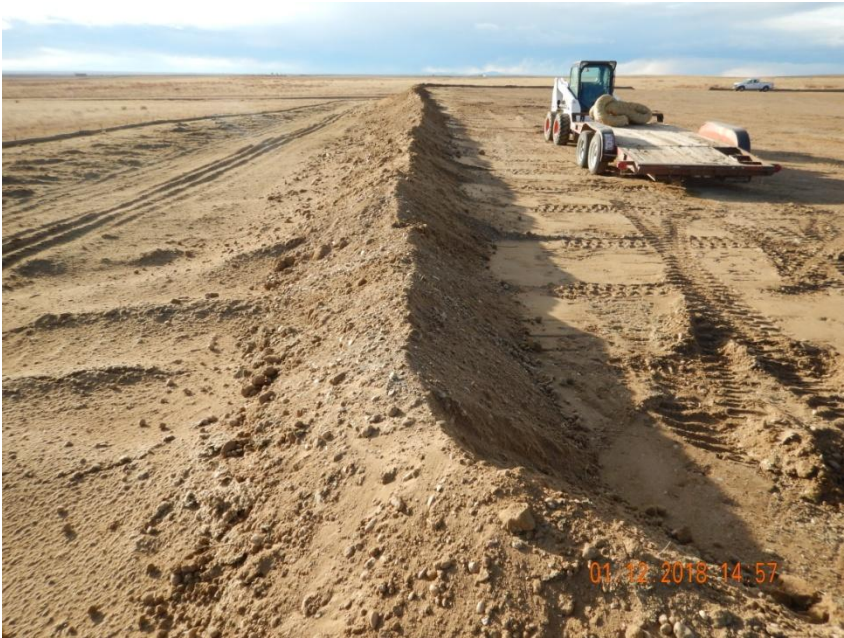
**Photo 9.** Photo taken from the southeastern perimeter of the location, facing West. Operator has not properly stabilized the berm BMP.

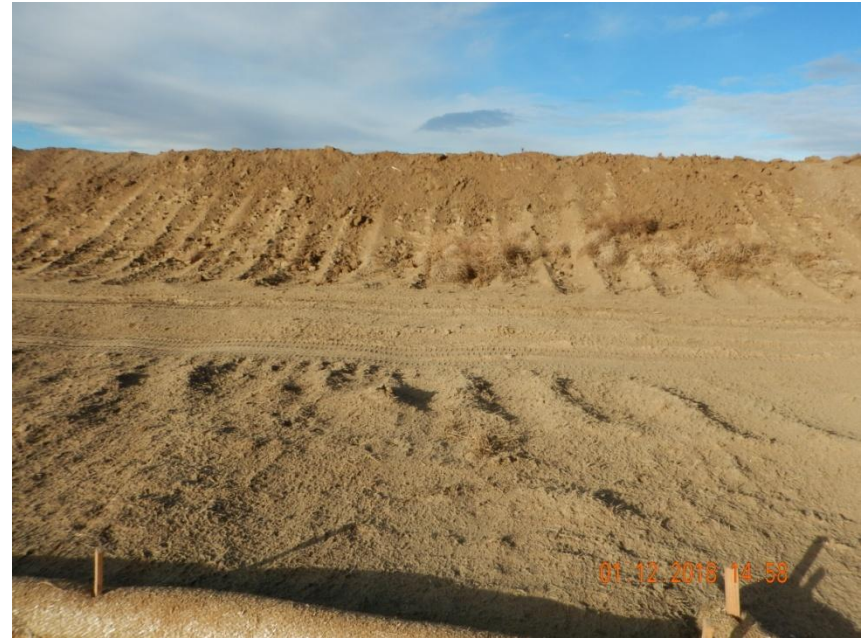
**Photo 10.** Photo taken from the southern perimeter of the location, facing North. Operator has not sufficiently stabilized the southern fill slope.
