Stormwater Inspection Report

Operator:	Laramie Energy
Project:	Cascade Creek Project Area
Location:	C.C. 697-03-07
Date:	Friday, December 15, 2017
Weather:	Mostly Clear, Light Winds, High 30° Lo 10°

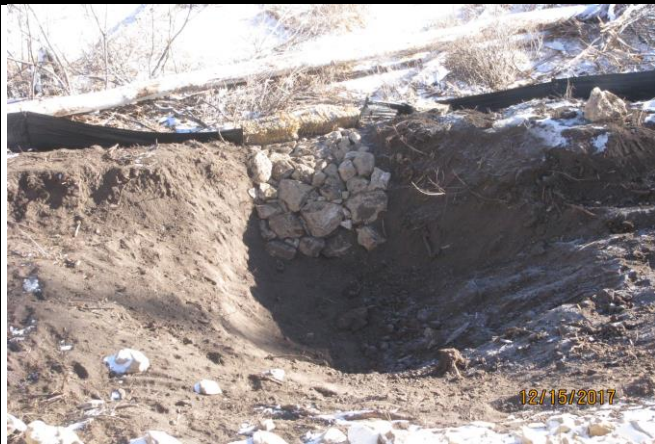
Photo 1

Rock Apron Outlet Installation on the East Side of the C.C. 697-03-07 Pad

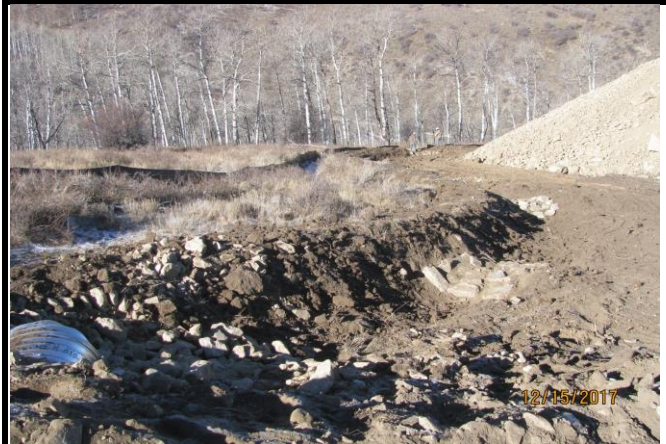
Photo 2

Dewatering Channel and Rock Checks in the SW Corner of the C.C. 697-03-07 Pad

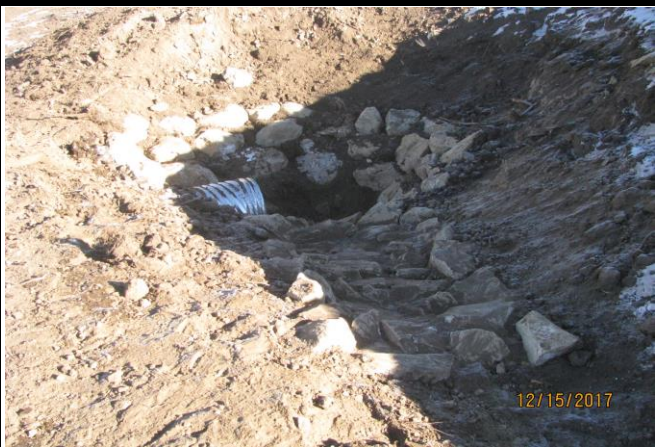
Photo 3

Rock Armor Installation on Culvert Inlet on the C.C. 697-03-07 Access Road

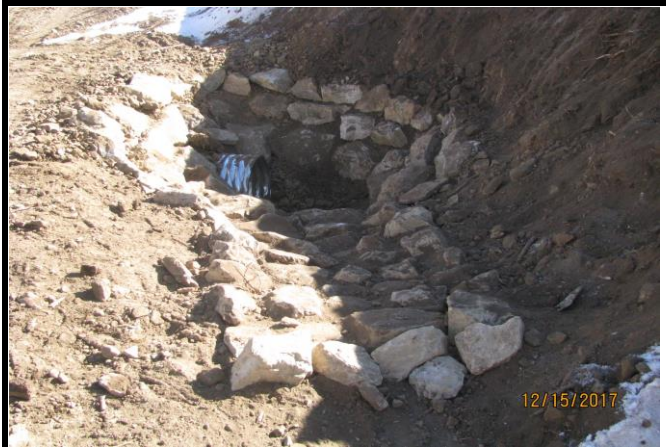
Photo 4

Rock Armor Installation on Culvert Inlet on the C.C. 697-03-07 Access Road
