Stormwater Inspection Report

Operator:	Laramie Energy
Project:	Cascade Creek Project Area
Location:	C.C. 610-24-43 / C.C. 697-03-07
Date:	Thursday, December 14, 2017
Weather:	Partly Cloudy, Gusty Winds, High 28° Lo 4°

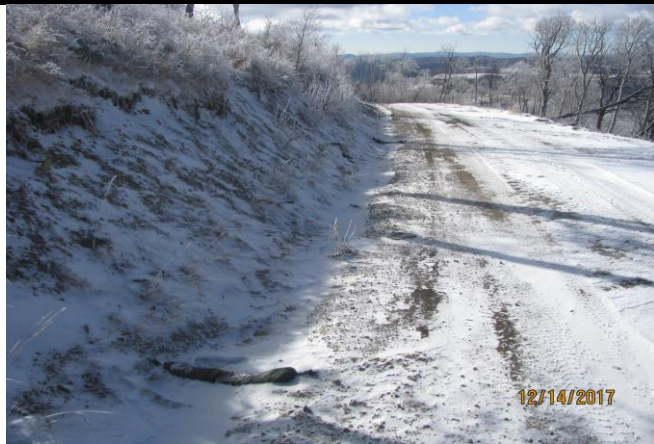
Photo 1

Rock Sock Installation on the C.C. 610-24-43 Access Road

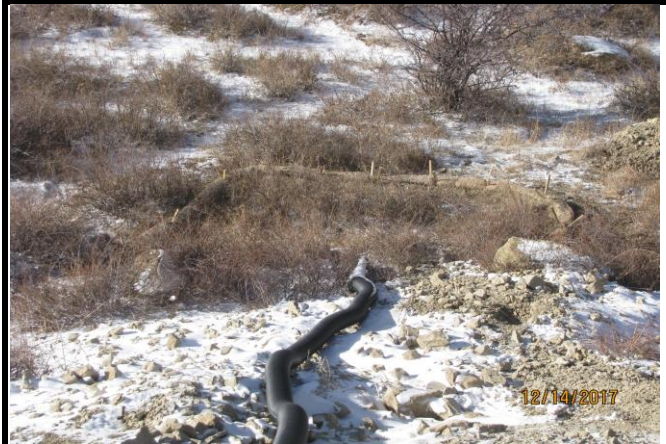
Photo 2

BMP Installation on the C.C. 610-24-43 Pad

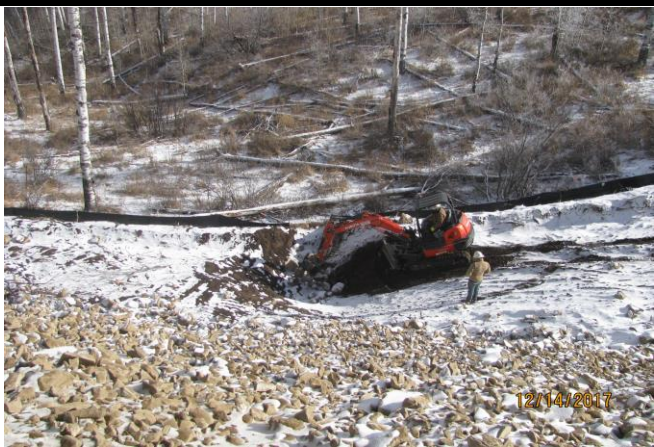
Photo 3

BMP Installation on the East Side of the C.C. 697-03-07 Pad

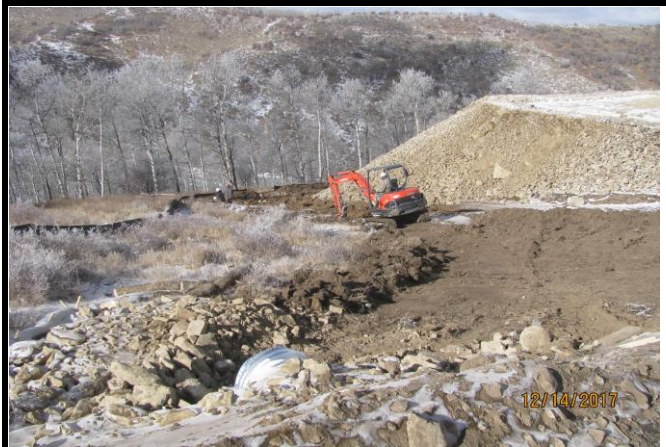
Photo 4

BMP Installation on the West Side of the C.C. 697-03-07 Pad
