Inspection Photos  
Location Name: HL 11-89-19 1  
Location ID: 422990

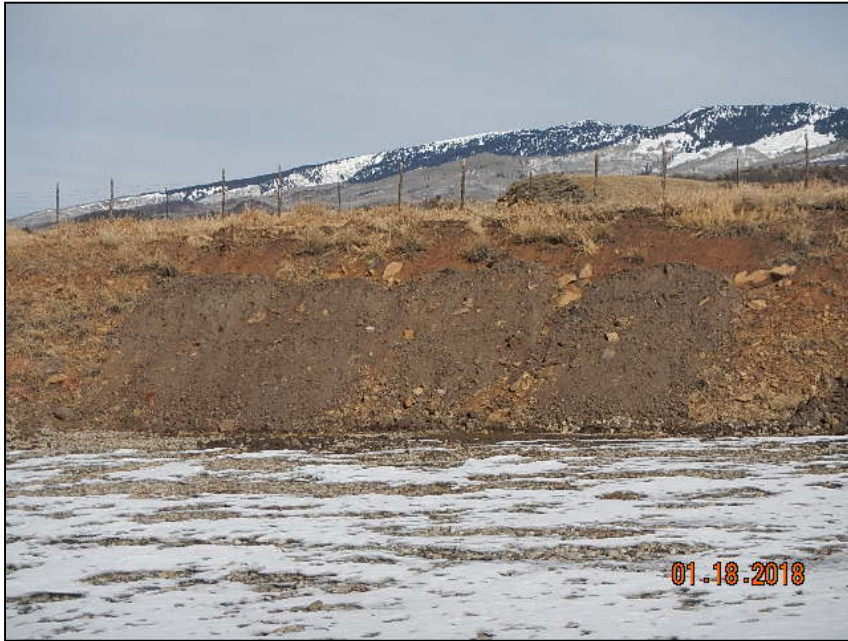
**Photo 1. Top soil has been placed on cut slope to mitigate erosion. Site will need to be reevaluated in the future. Tanks have been removed from location.**

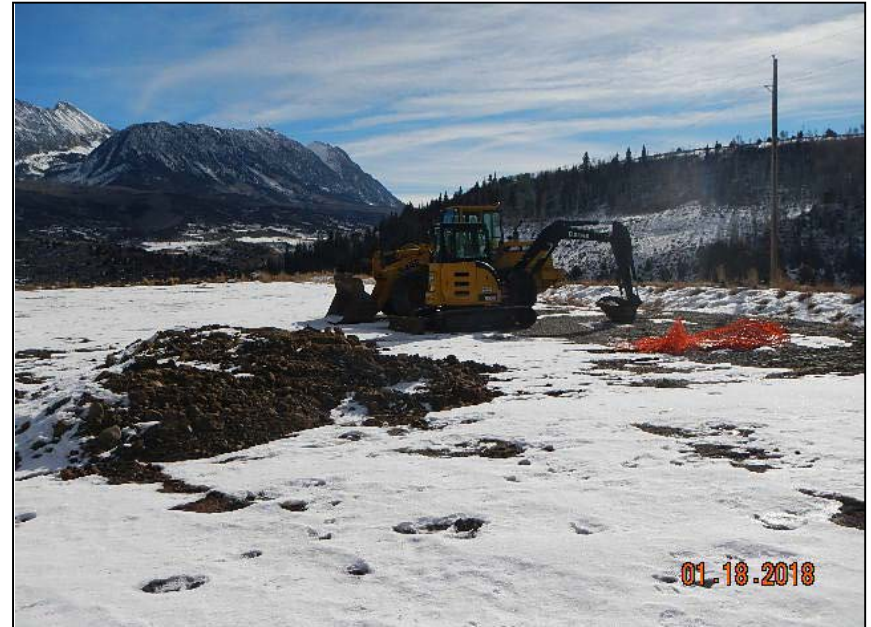
**Photo 2. Equipment and trash on location.**
