Location Name: Sandy Hill Land Application Site: Facility ID 448950 Inspection Date: 01/25/2016

Complaint 200445363
Document 2496258

Inspection Photos
Location Name: Sandy Hill Land Application Site
Facility ID: 448950
Inspection Date: 01/25/2018

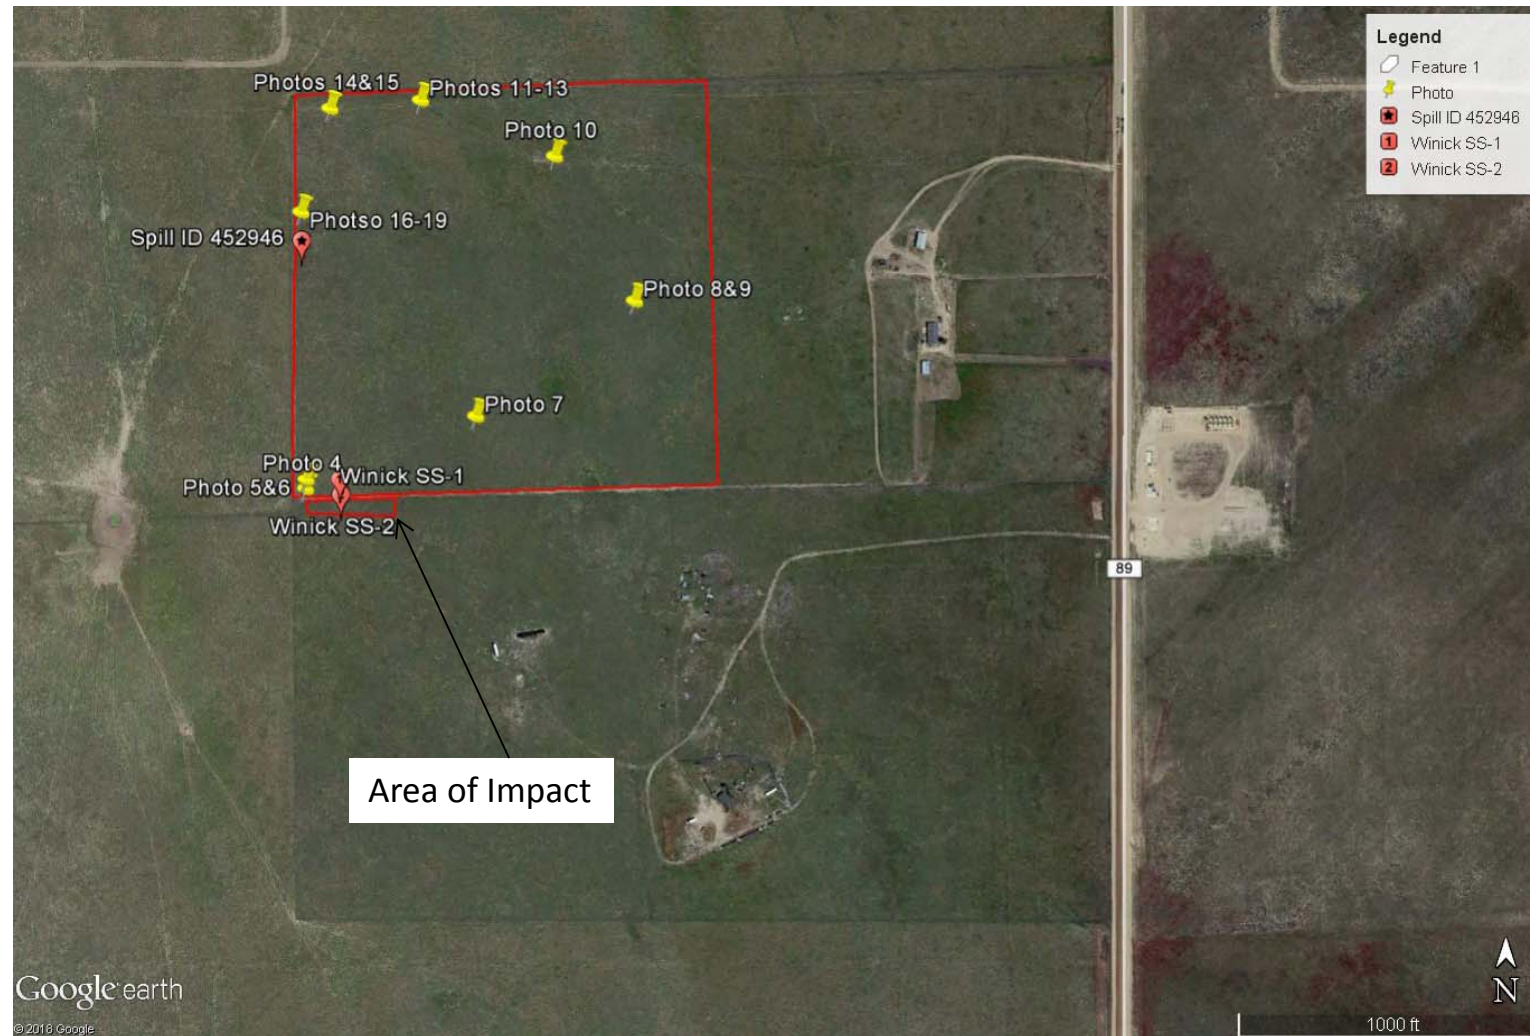
Aerial Image from Google Earth showing Land Application area, soil sample locations, and photograph locations.
Aerial Image Date = 06/14/2016.

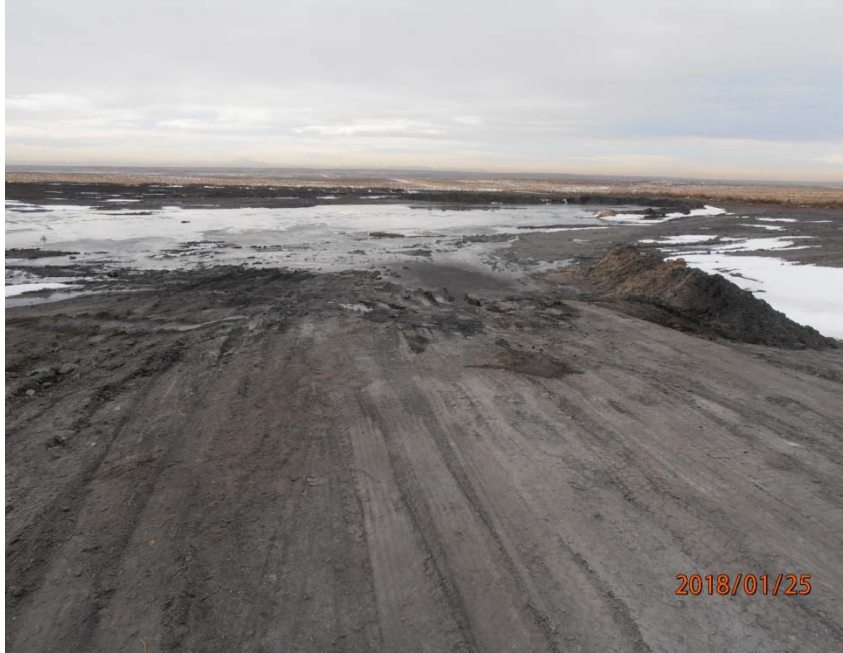
Photo 10 – Photo of ponded drilling fluid on land application site, taken from Lat/Lon 40.37827,-104.23025 looking west-northwest.

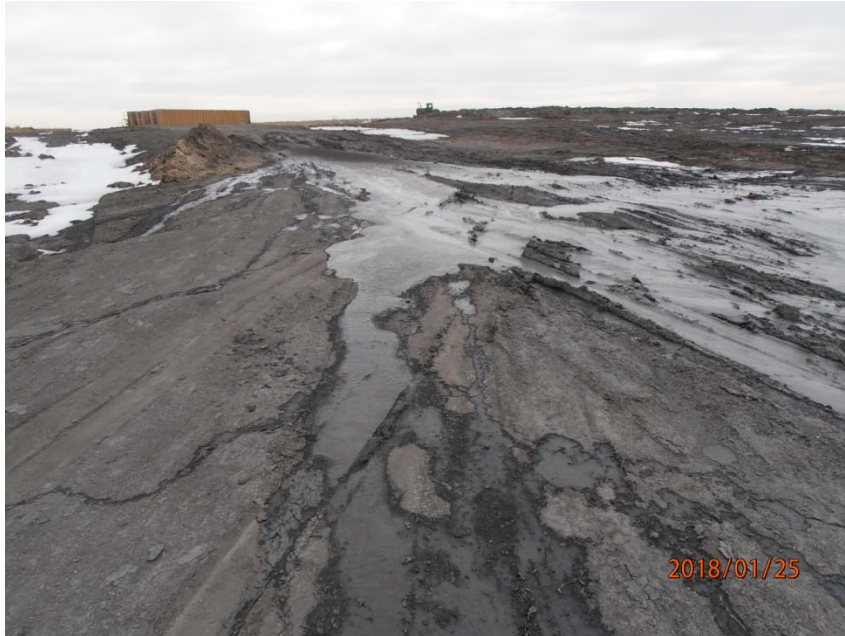
Photo 12 – Photo of area where drilling fluids are drained to flow into pond.

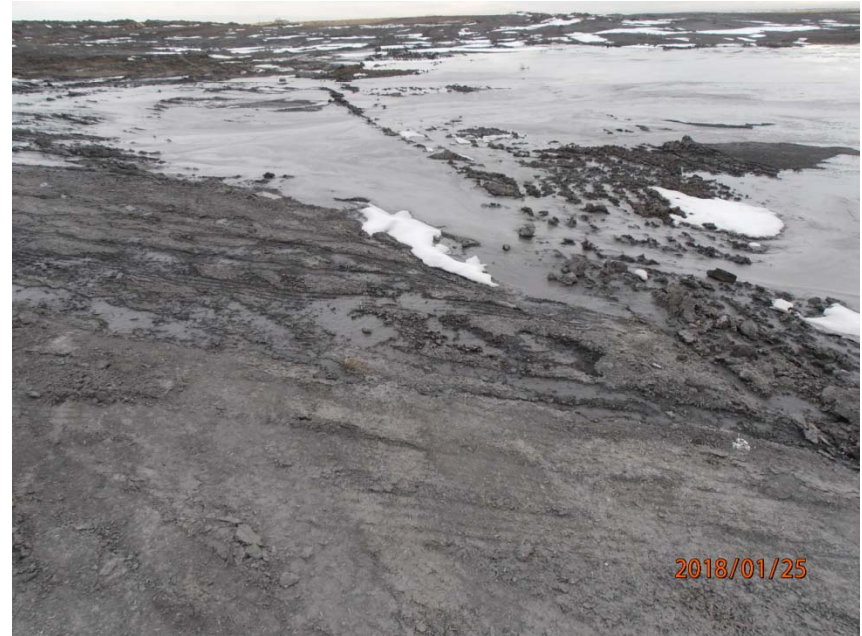
Photo 13 – Photo near edge of pond where drilling fluids are dumped.

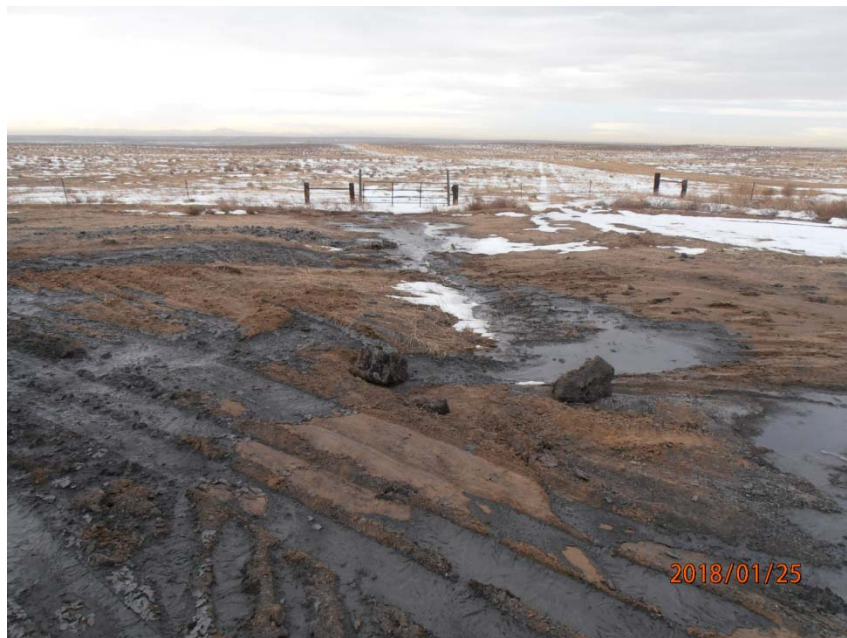
Photo 14 – Drilling fluids and stormwater mixing with waste runoff in northwest corner of Sandy Hill Land Application area. Gate accesses State Land Board land to the west.

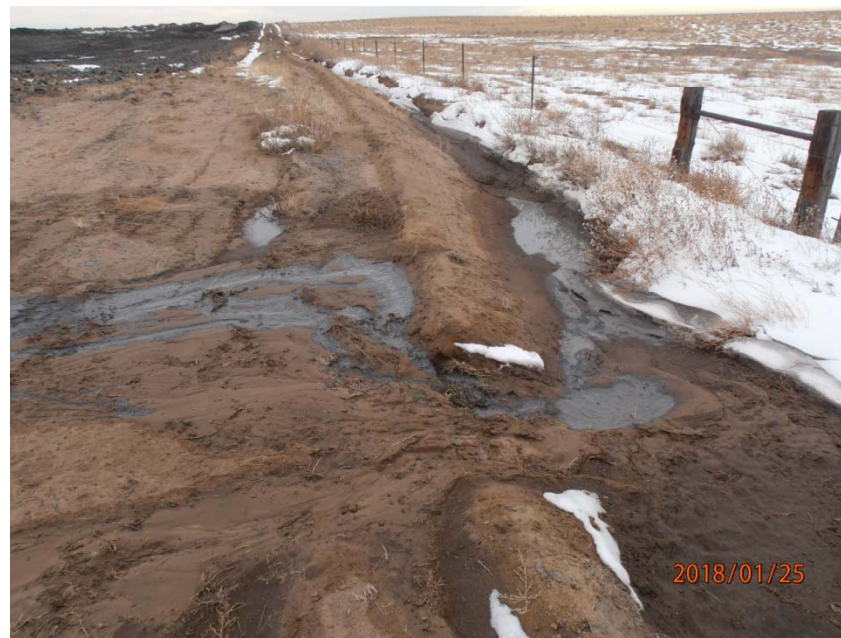
Photo 15 – Drilling fluids and stormwater mixed with waste runoff into ditch at northwest corner of Sandy Hill Land Application area, looking south. State Land Board land is across the fence to the west.

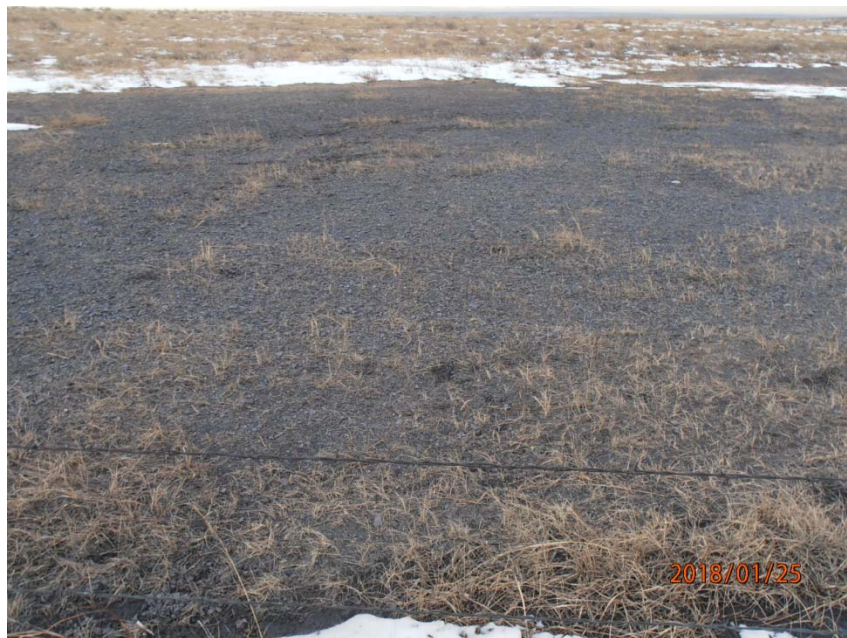
Photo 16 – Photo looking west across fence at dried drilling mud of spill onto State Land Board land. Spill was reported by Operator and assigned Spill ID #452946.

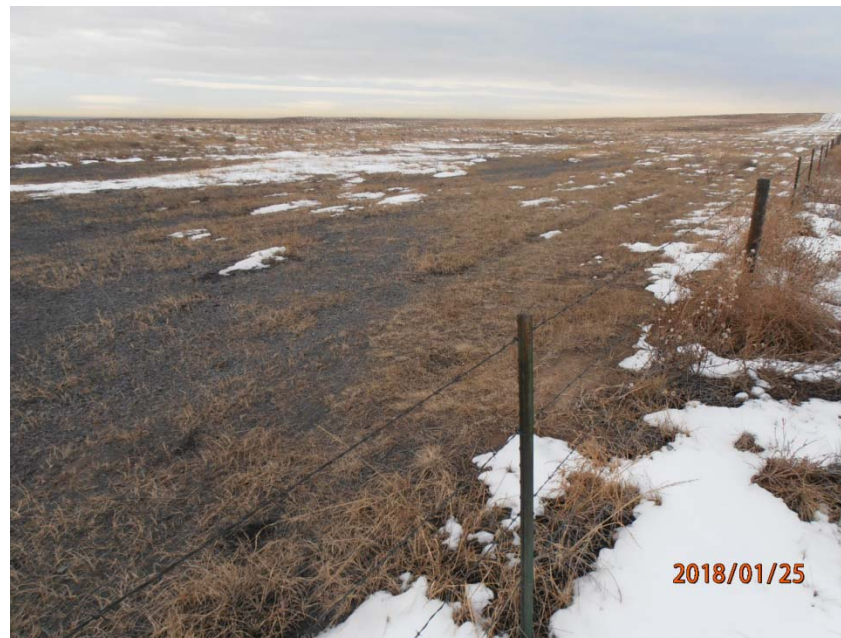
Photo 17 - Photo looking northwest across fence at dried drilling mud of spill onto State Land Board land. Spill was reported by Operator and assigned Spill ID #452946.
