COLORADO
Oil & Gas Conservation
Commission
Department of Natural Resources

Inspection Photos: Caerus Schideler Loc#431050

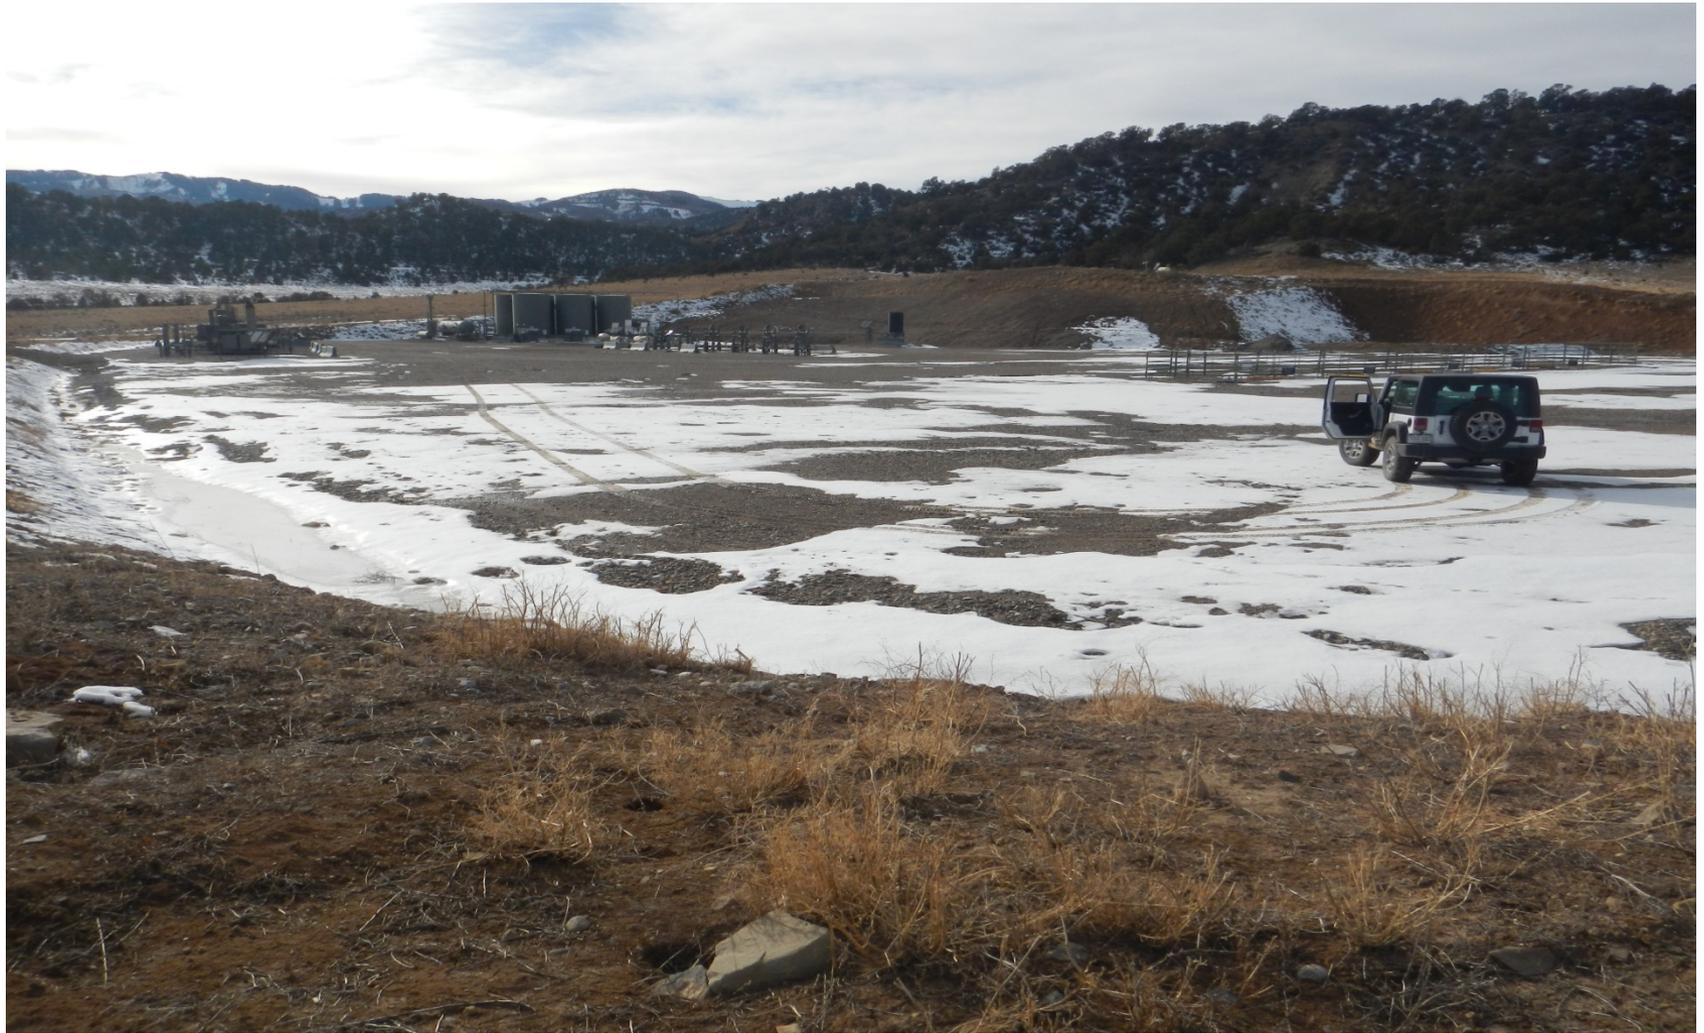
Photo#1:
Overview of Location from NE corner to SW.

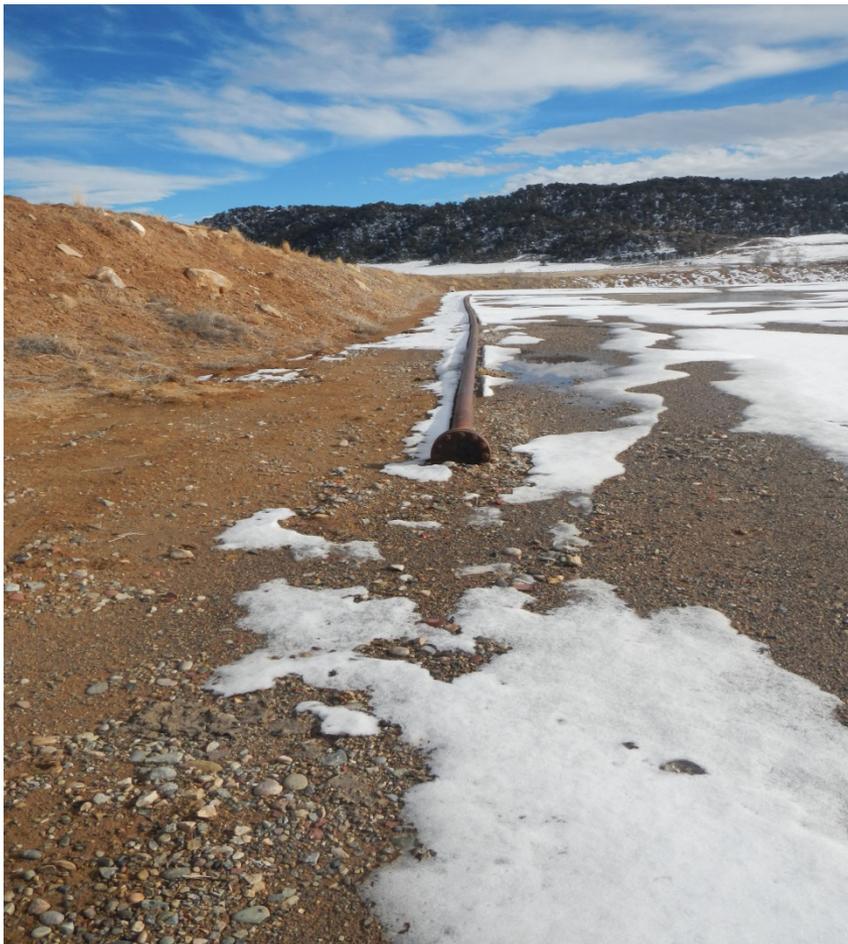
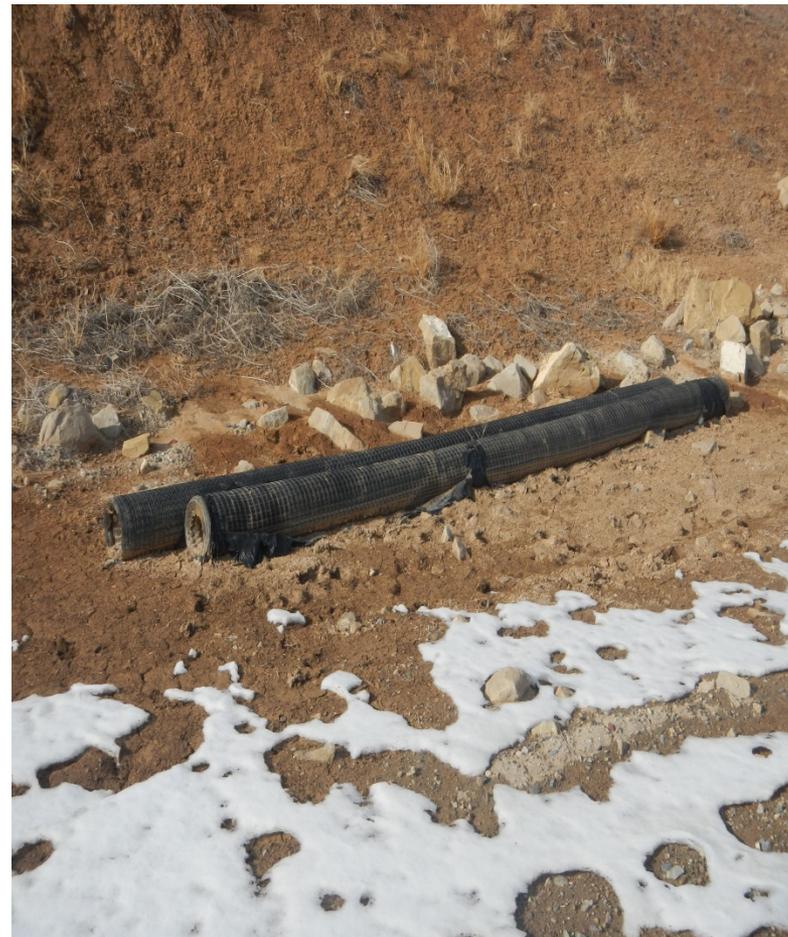
Photo#2:

Unused Equipment on Location

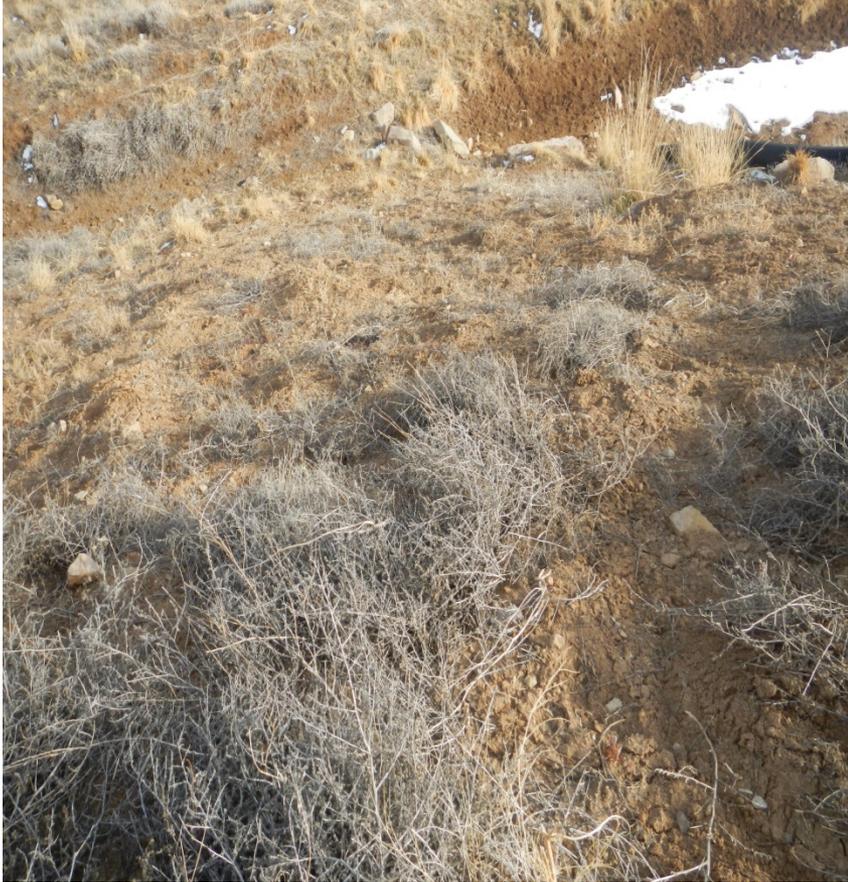
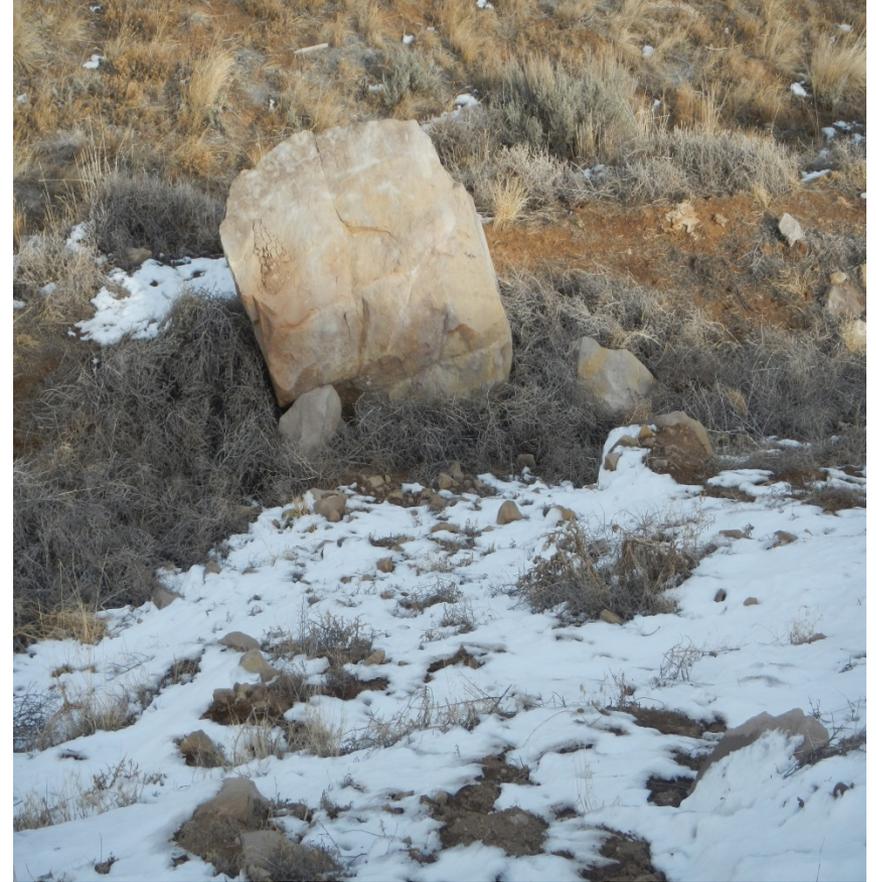
Photo#4:

Ditches & slopes have remnants of large population of senesced non noxious annual weeds that have become Debris.

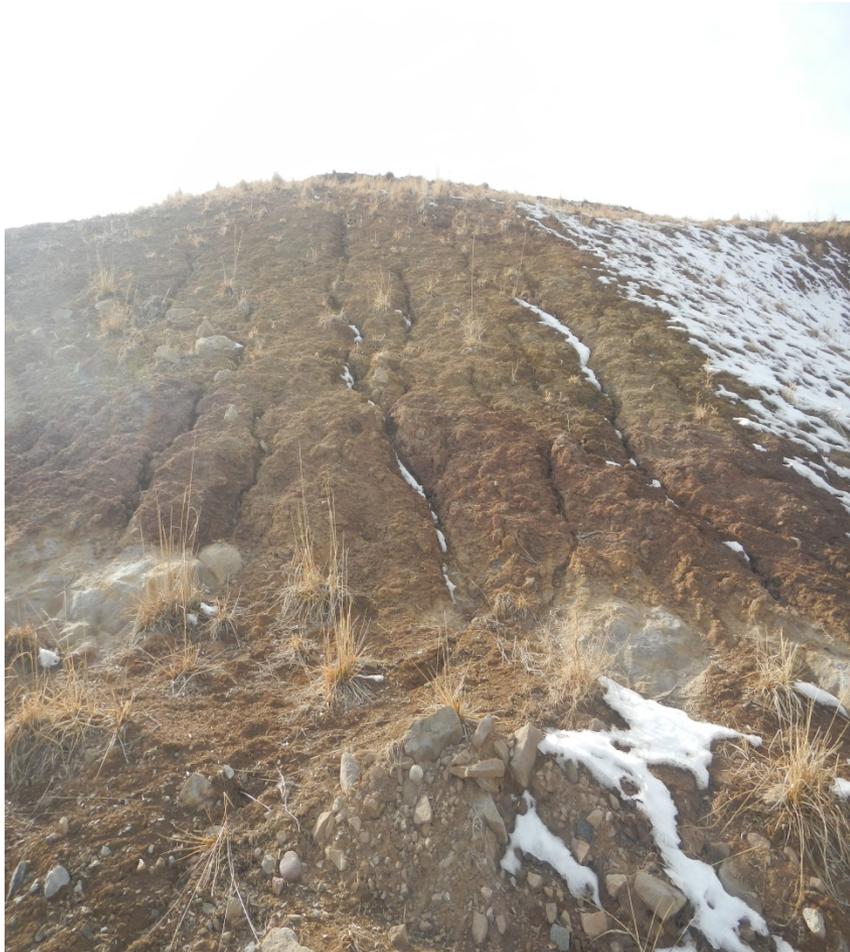
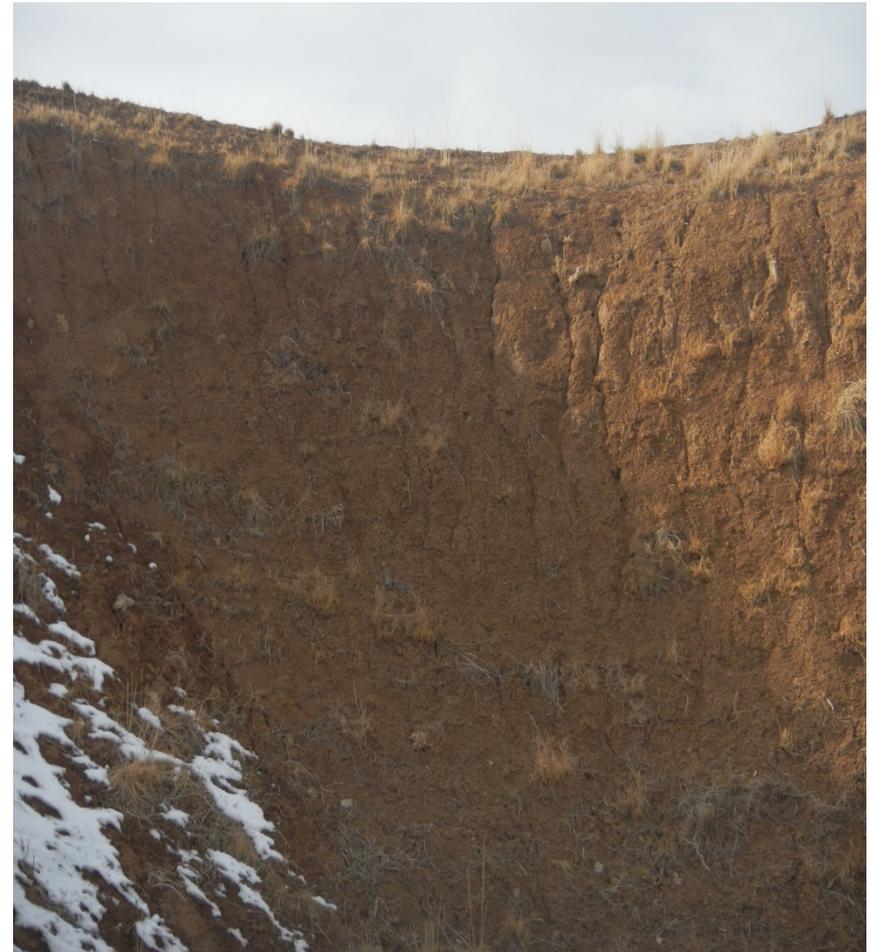
Photo#6:

Rill & Chanel Erosion is occurring on Cut Slopes.

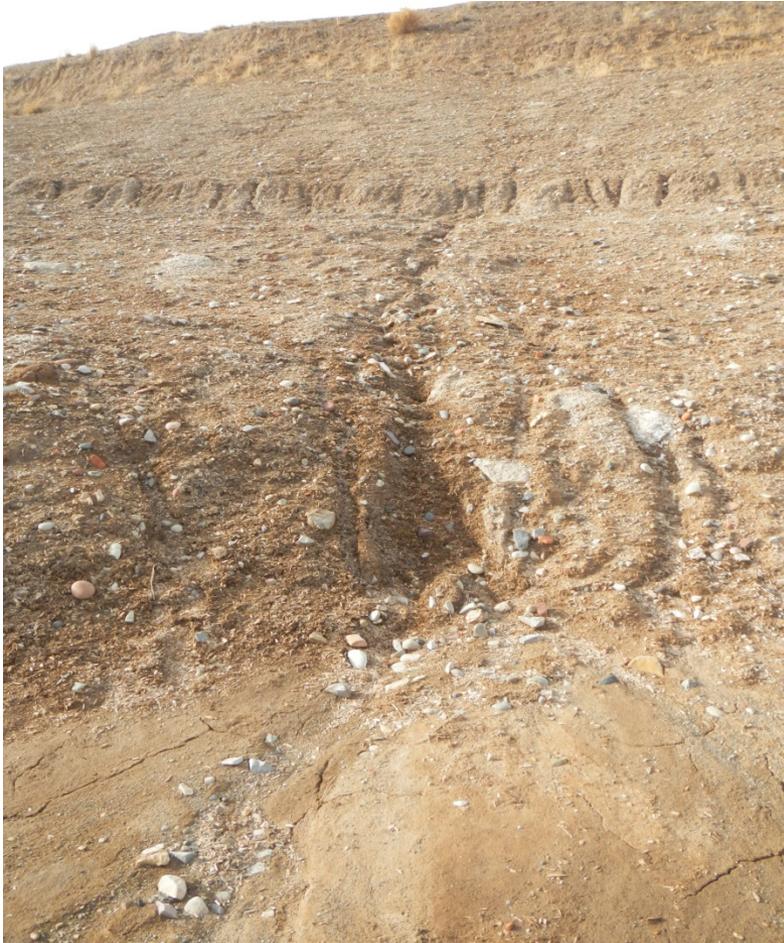
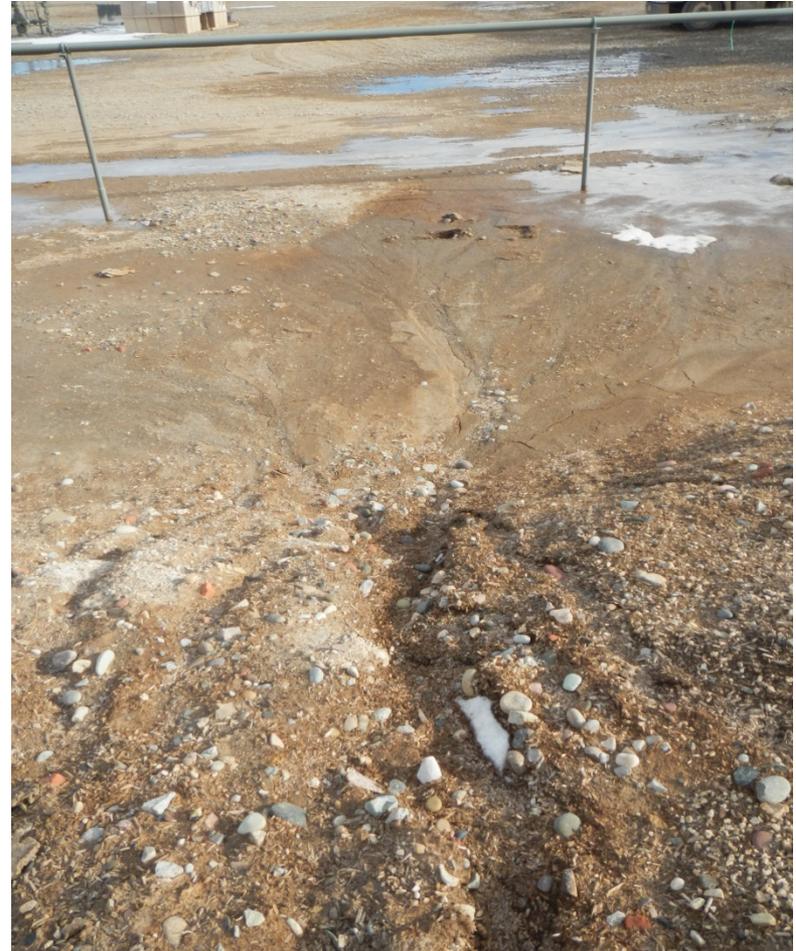
Photo#8:

Rill & Chanel Erosion is occurring on Cut Slopes contributing to Sediment Run-on to Location

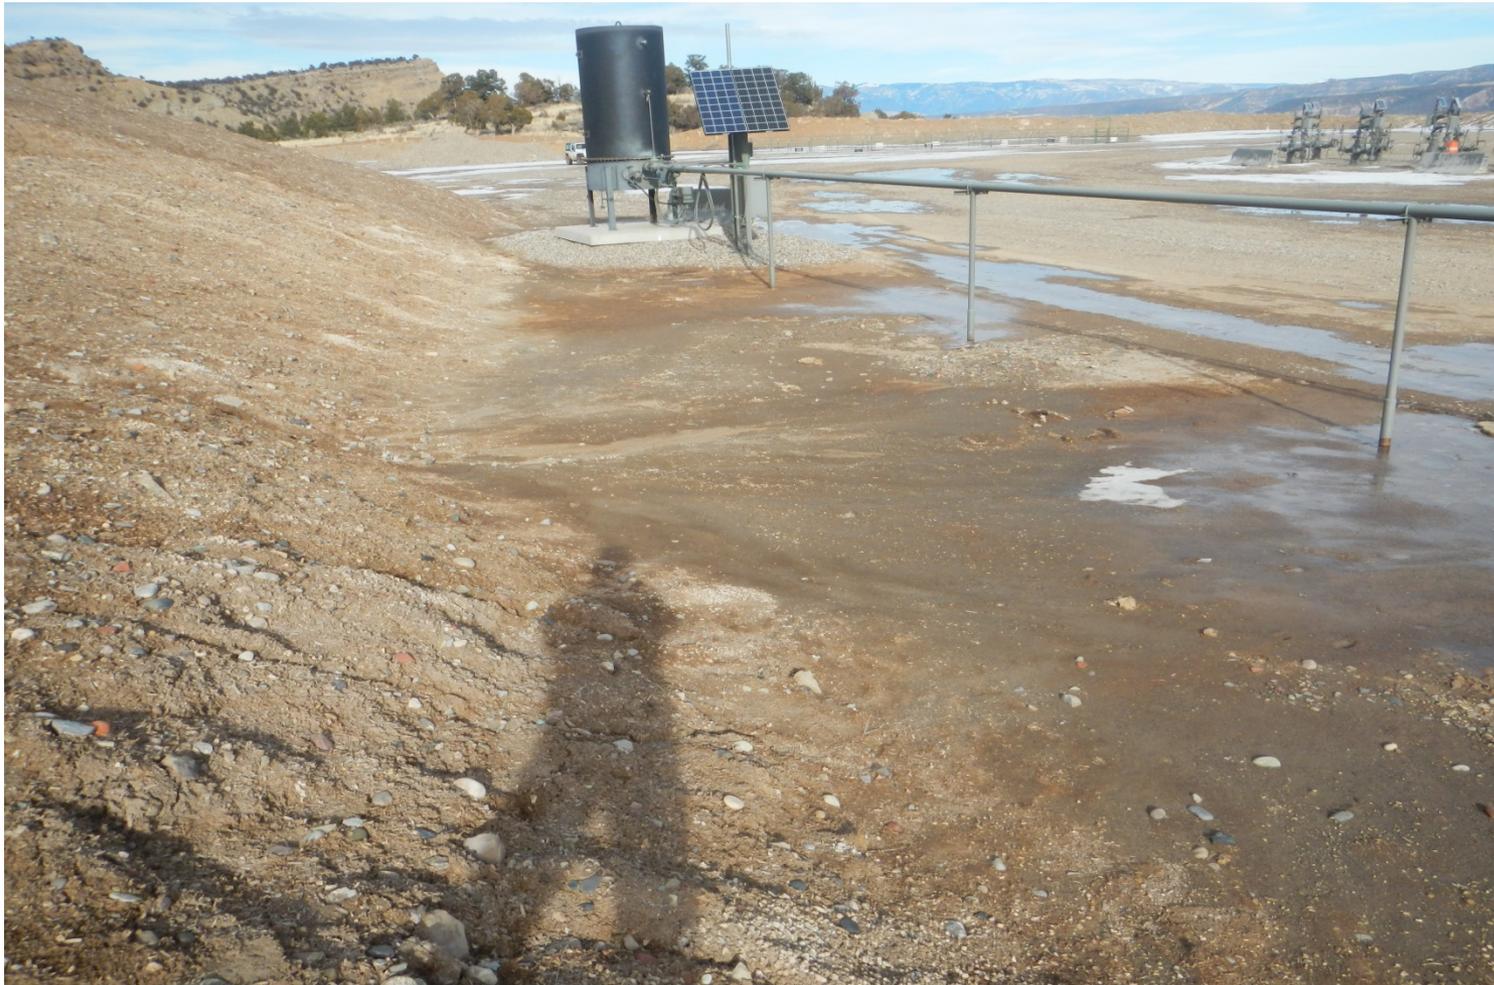
Photo#10:

. Rill & Chanel Erosion is occurring on Cut Slopes contributing to Sediment Run-on to Location

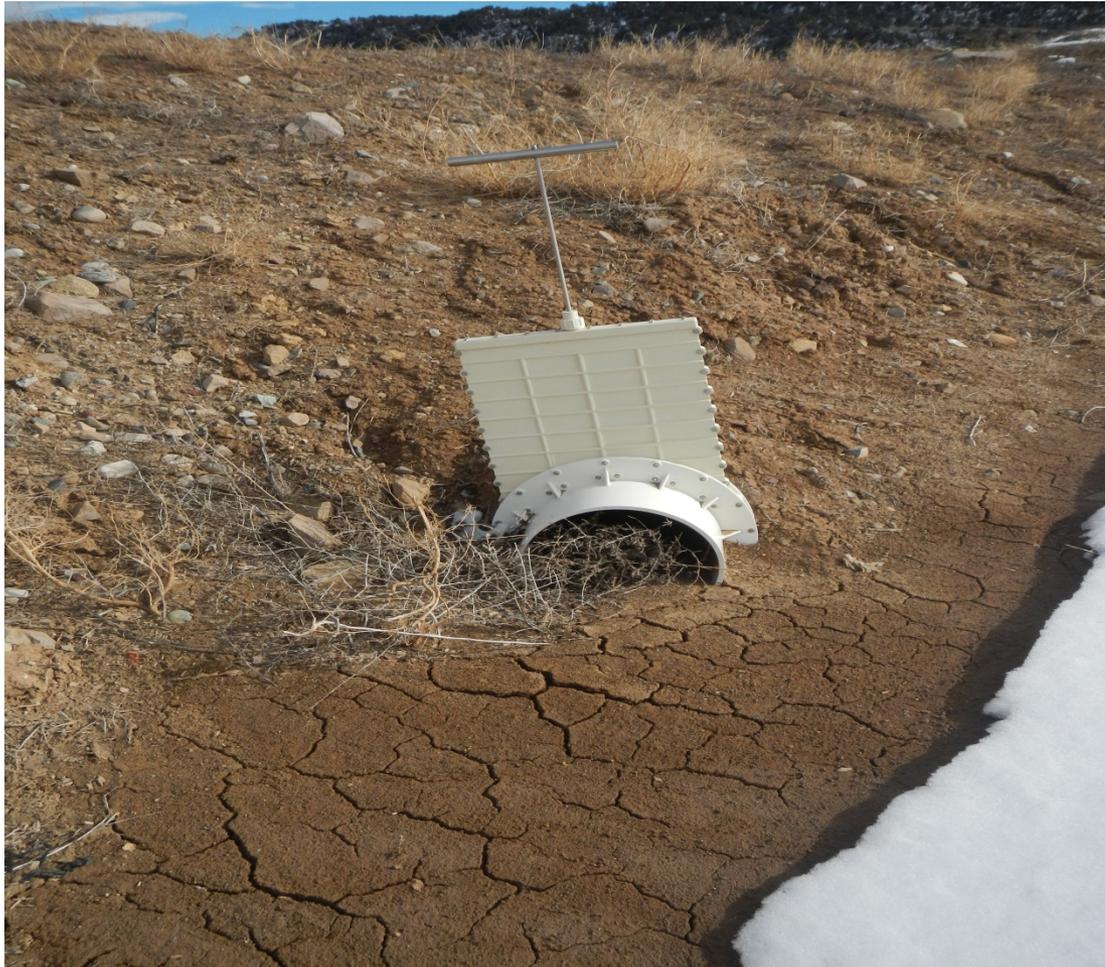
Photo#11:

Drain BMP needs maintenance,
