# Inspection Photos

API: 05-067-06549

Operator: CATAMOUNT ENERGY PARTNERS LLC

Inspection Number: 6806024648

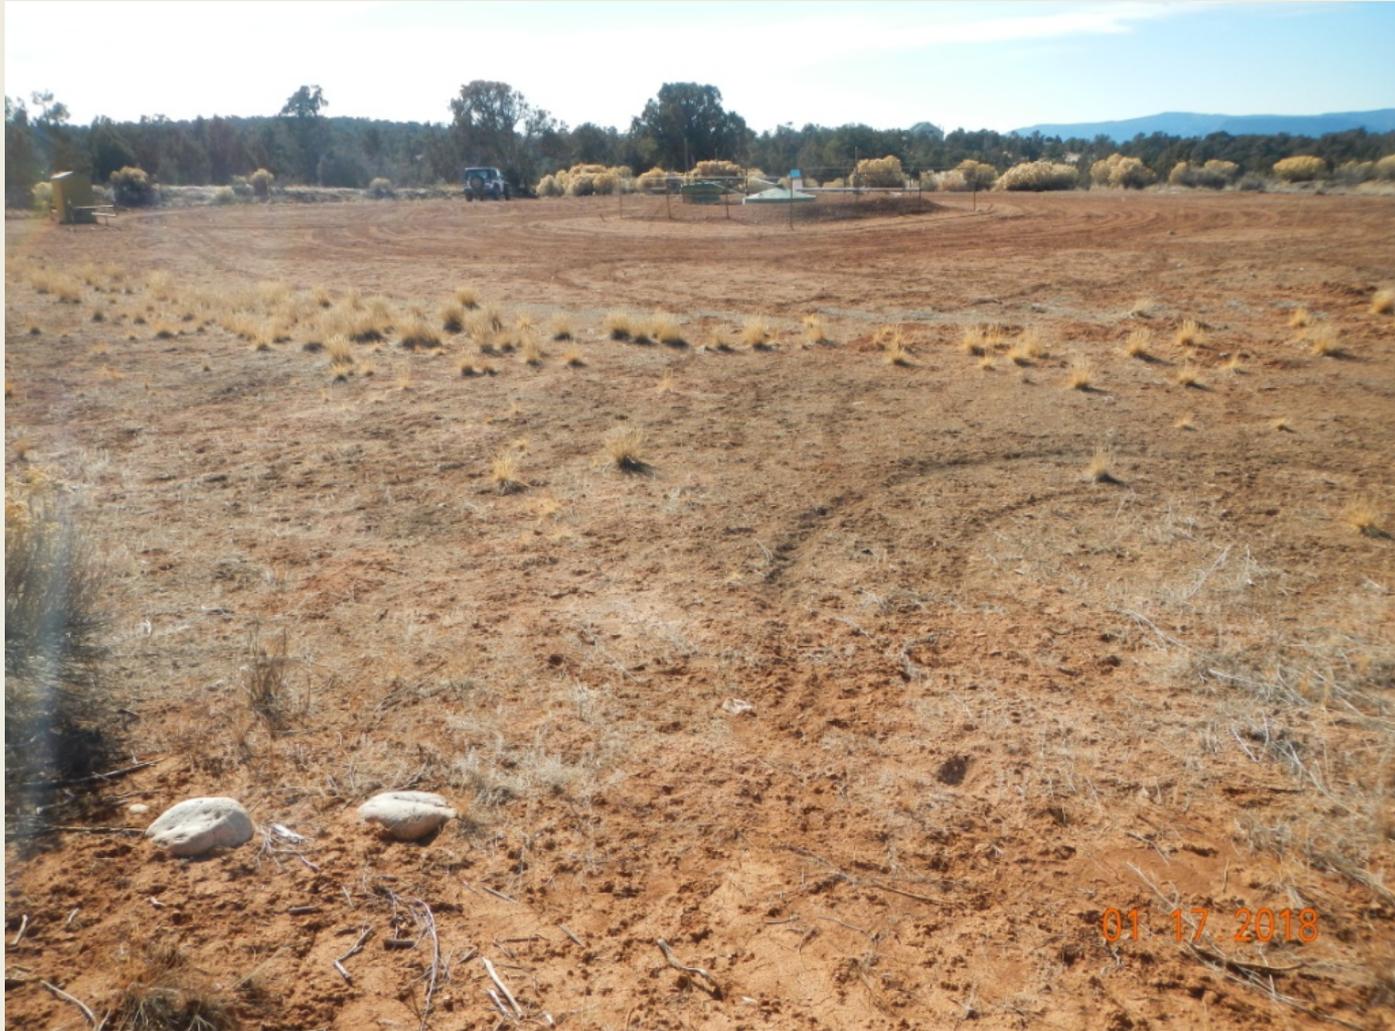
**Photo 1. View of the project area from the northeastern corner facing center.**

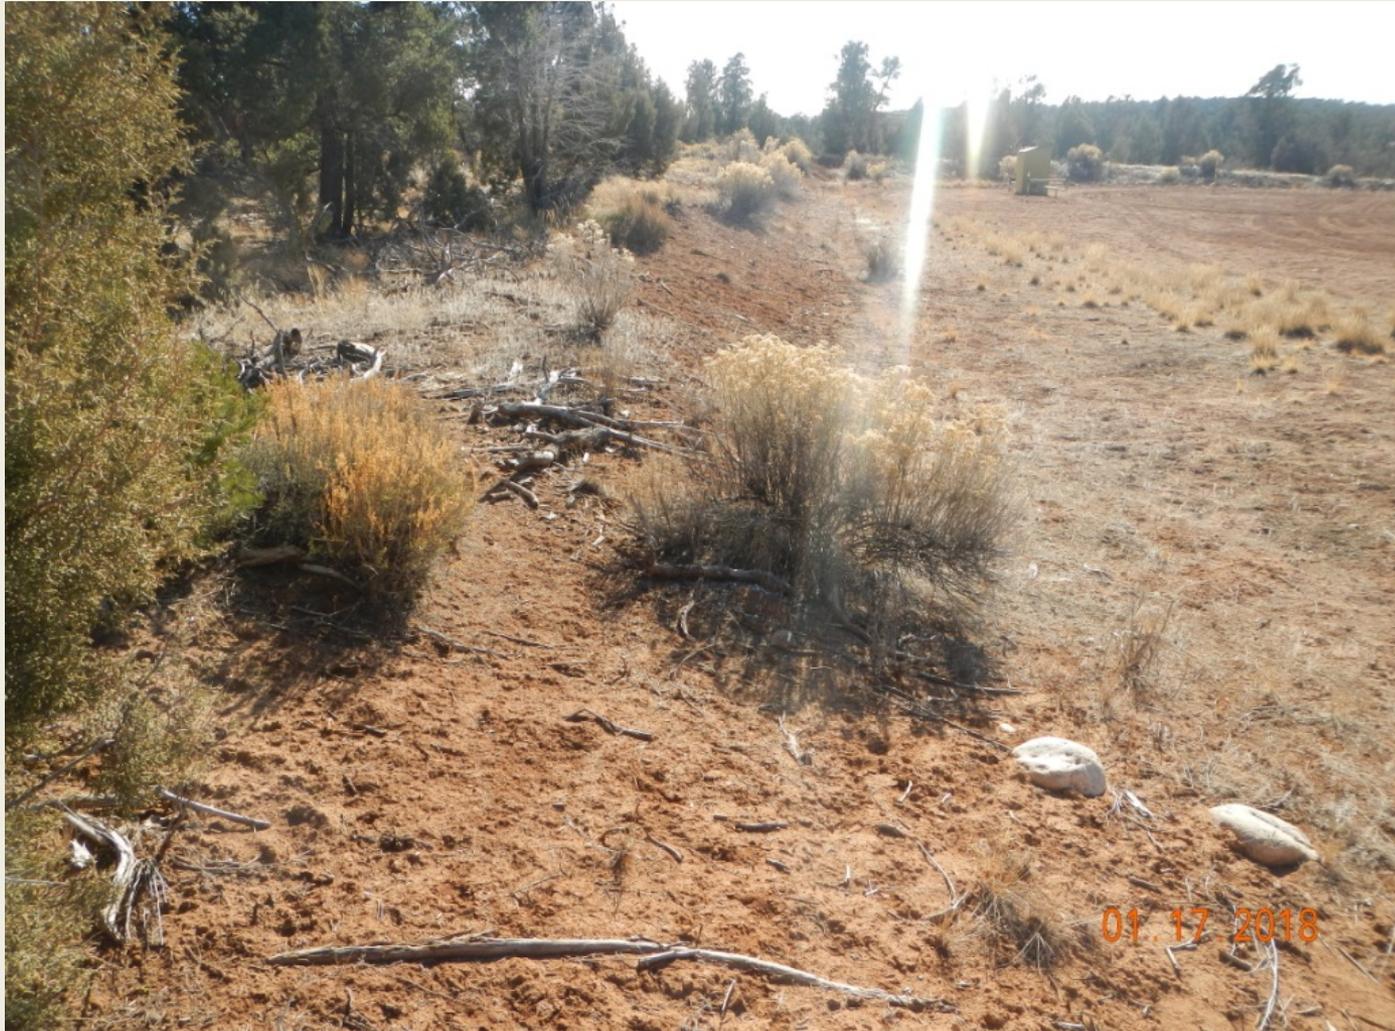
**Photo 2. View of the eastern portion of the project area from the northeastern corner facing southward.**

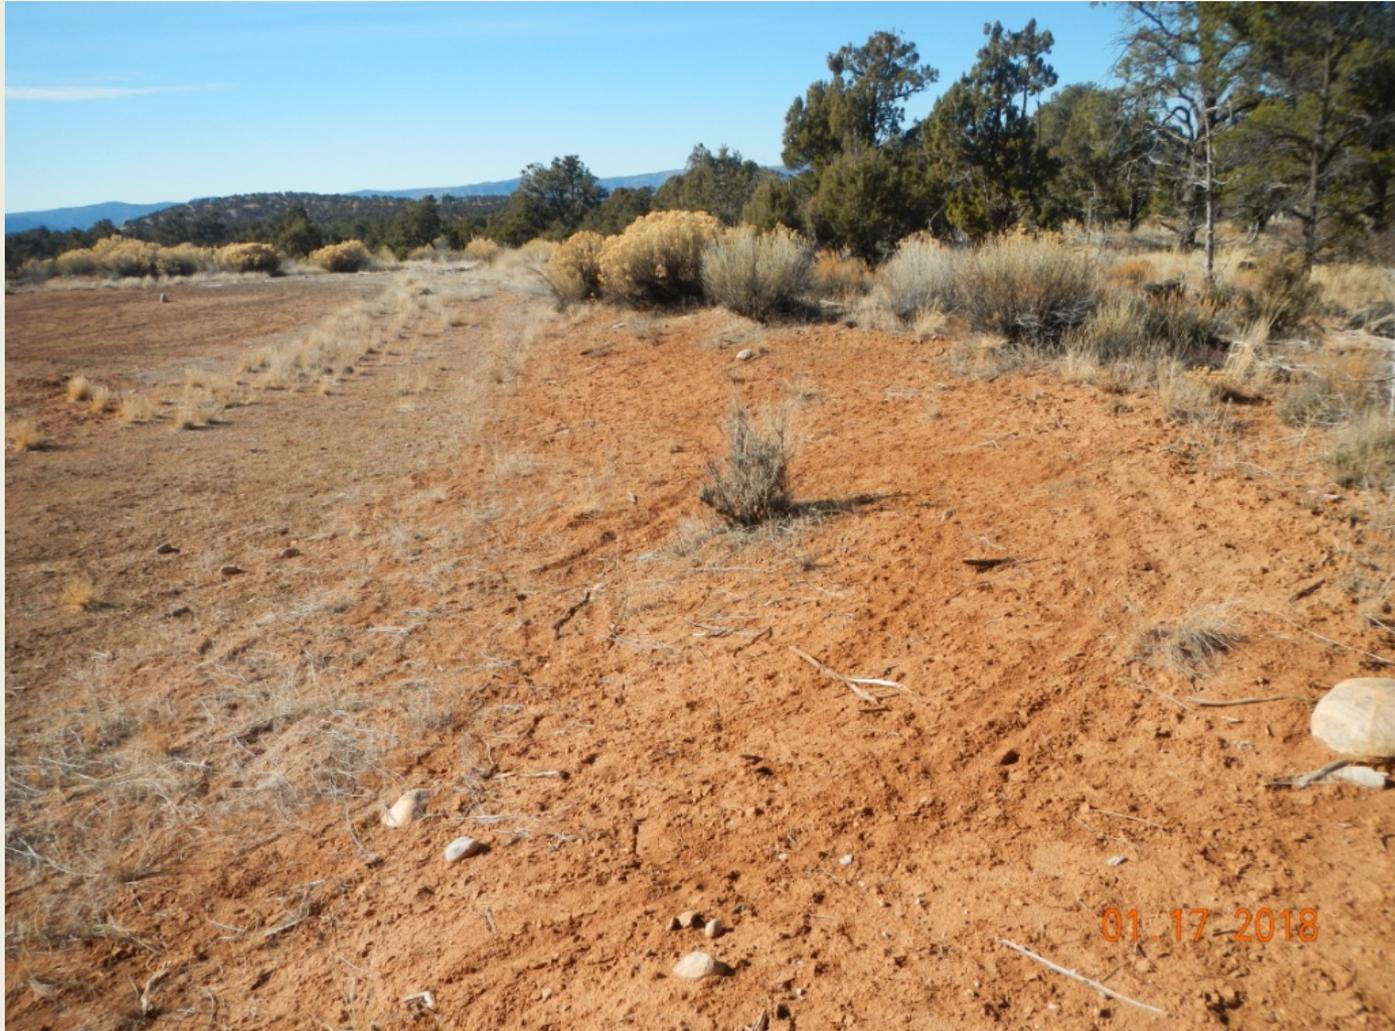
**Photo 3. View of the northern portion of the project area from northeastern corner facing westward.**

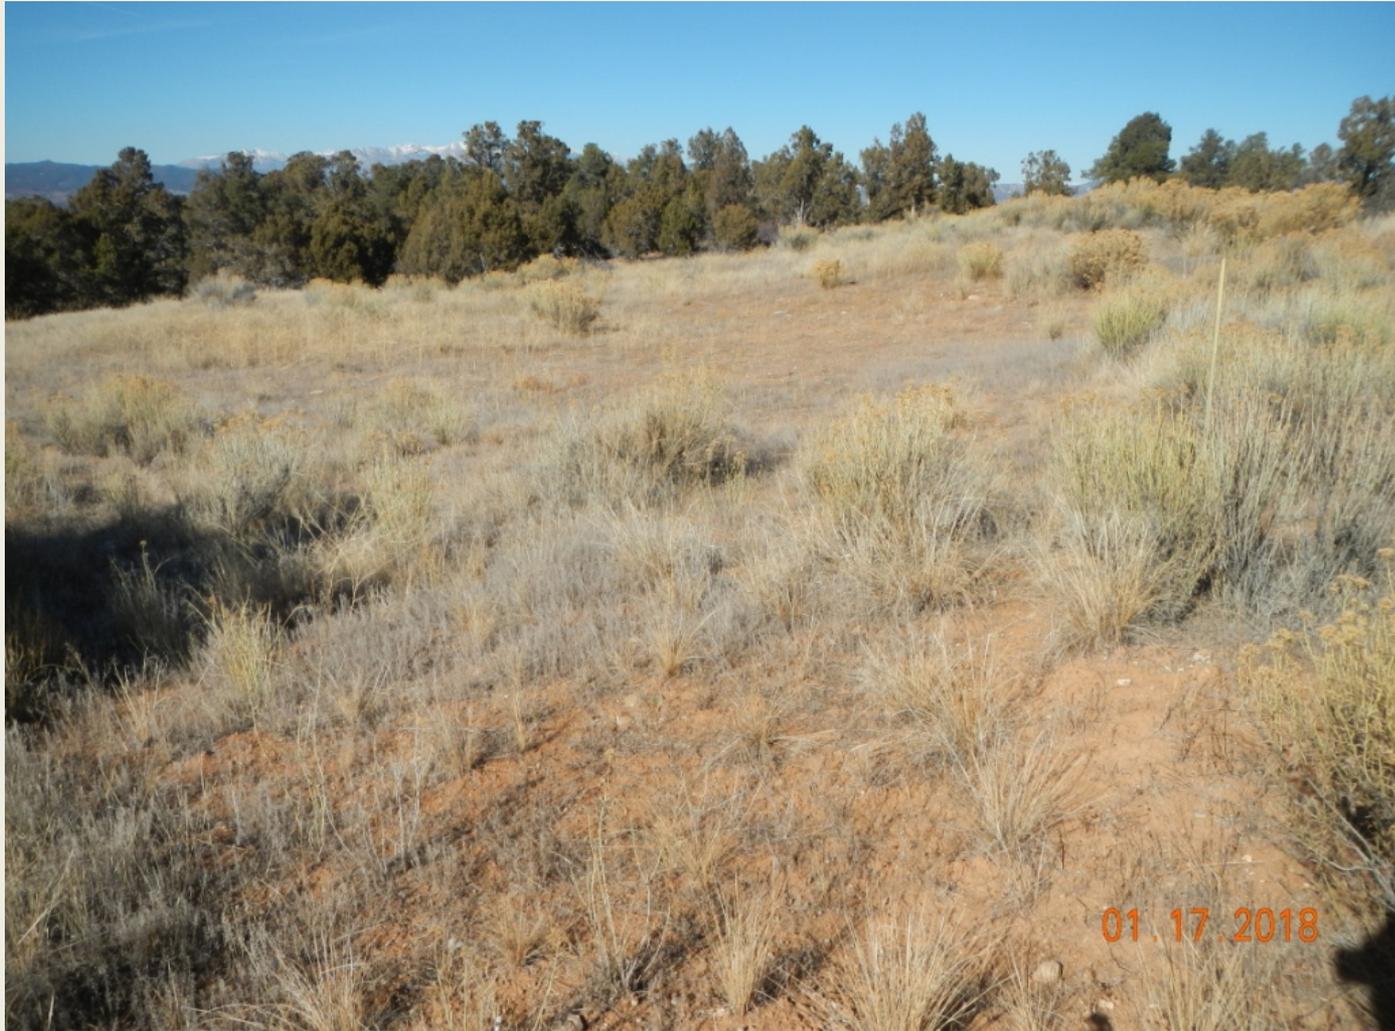
**Photo 4. View of the western portion of the project area from southwestern edge facing northward. Revegetation is progressing but weedy with desirable plans such as Indian ricegrass (*Achnatherum hymenoides*) and rabbitbrush (*Chrysothamnus nauseosus*) as well as weeds such as cheatgrass (*Bromus tectorum*) and alyssum (*Alyssum simplex*).**

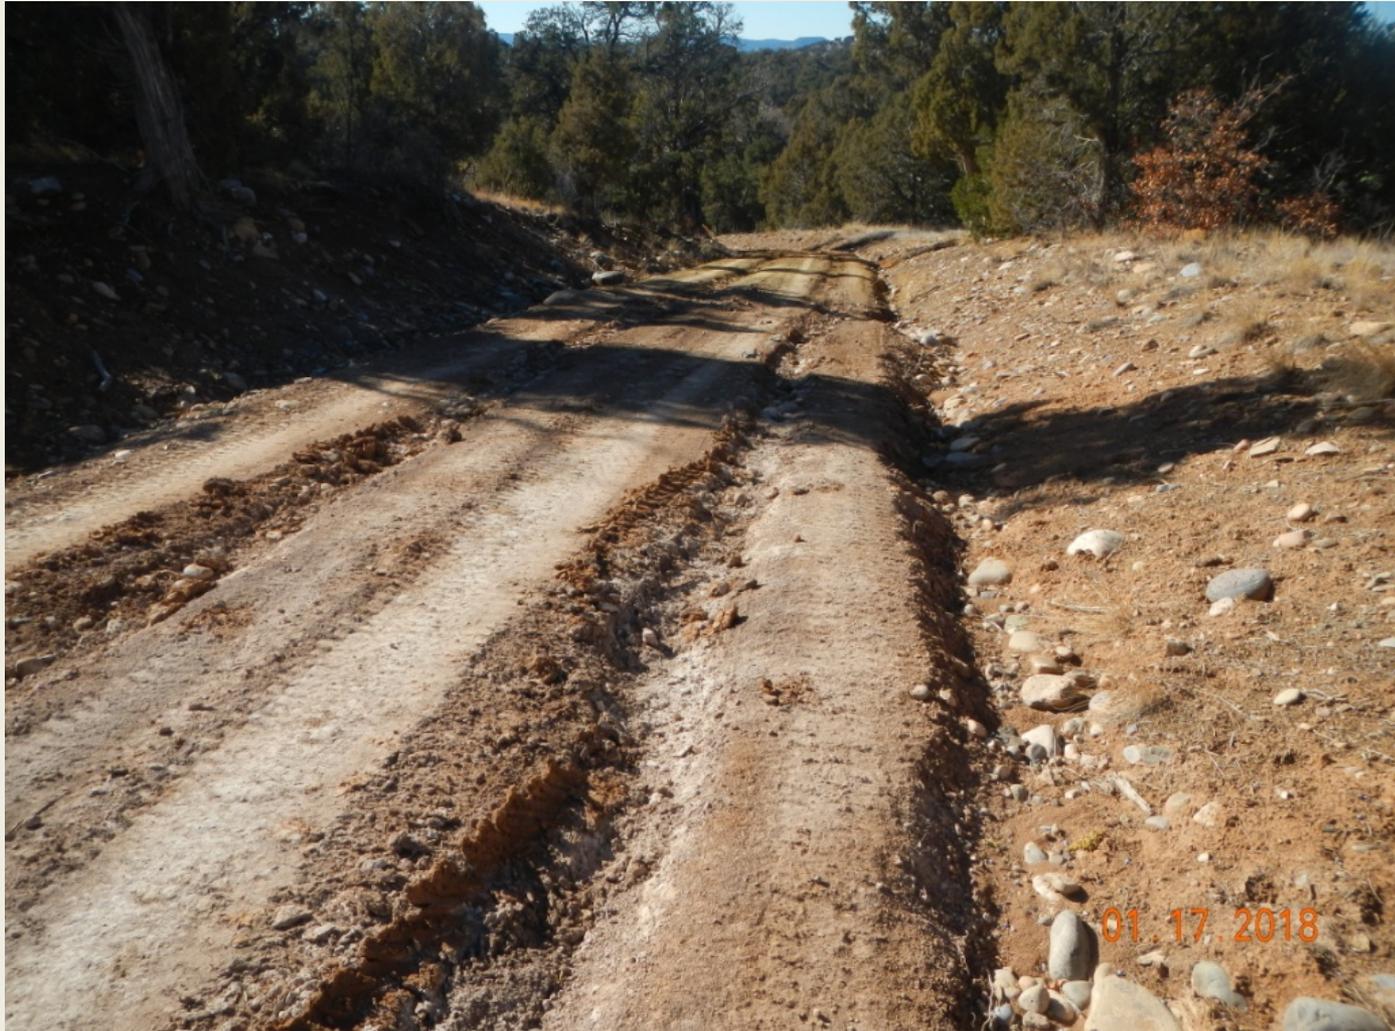
**Photo 5. View of erosion occurring where concentrated stormwater flows down the access road creating erosional channels. Stormwater controls are needed.**
