# Construction and Stormwater Inspection

February 7 & 9, 2018

Operator: EXTRACTION OIL & GAS INC - #10459

Inspection Photos  
Location Name: Wake North /32-K  
Location ID: 451214

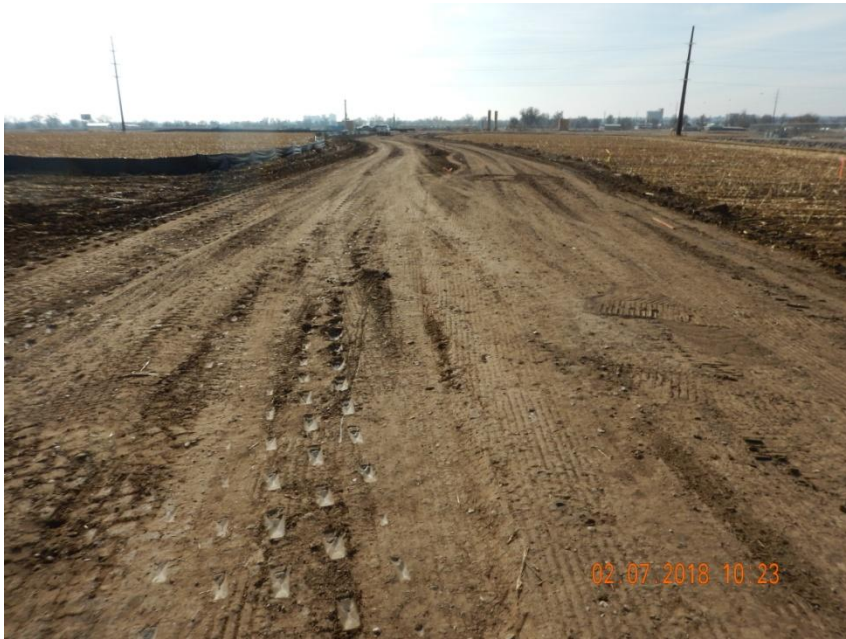
**Photo 1.** Photo taken from the southern location of the main access road, facing South. Operator has installed a silt fence BMP around the eastern portion of the access road.

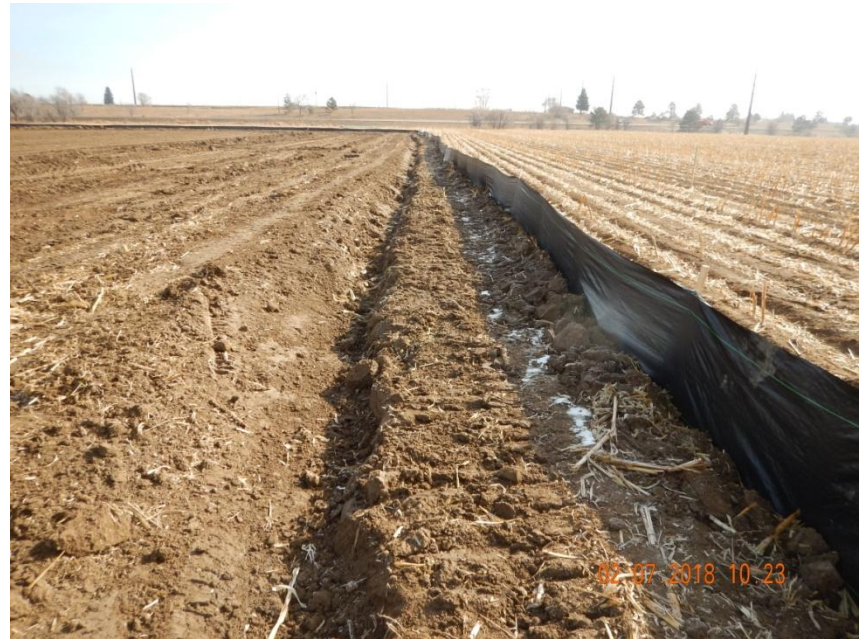
**Photo 2.** Photo taken from the southern location perimeter, facing South. Operator has installed a silt fence BMP around the entire perimeter of the location but the silt fence BMP has not been properly installed. A ditch BMP has been installed around the entire perimeter, inside of the silt fence BMP, but has not been installed in accordance with good engineering practices. Appears frozen soil conditions may have resulted in poor installation for both BMPs.

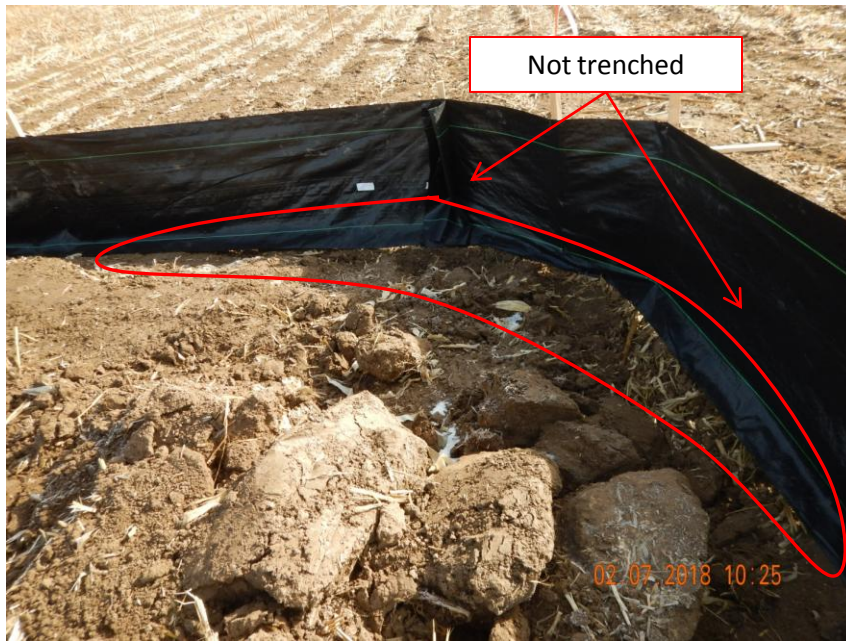
**Photo 3.** Photo taken from the southeast location perimeter on February 7, 2018, facing East. Operator has not properly trenched the silt fence BMP.

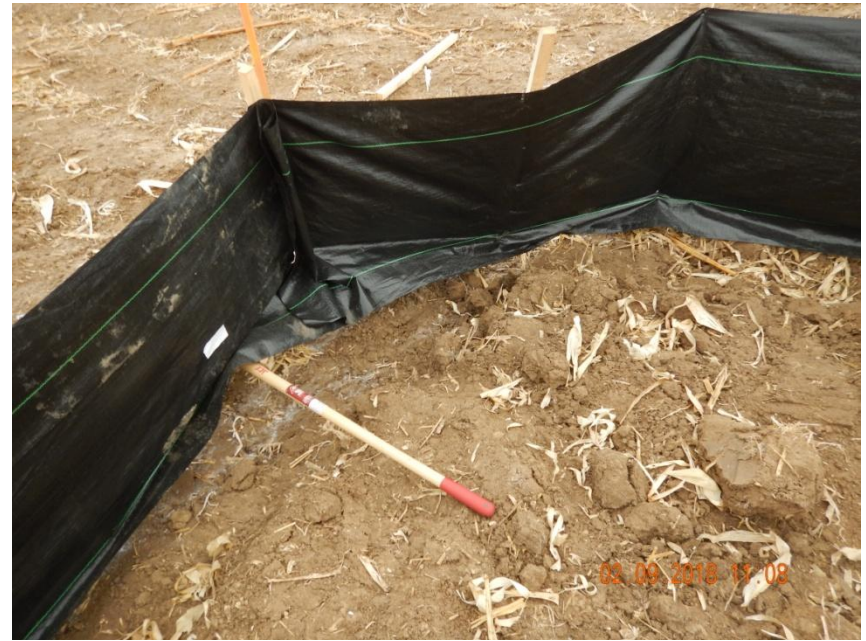
**Photo 4.** Photo taken from the southeast location perimeter on February 9, 2018, facing South. See comments under Photo 3.

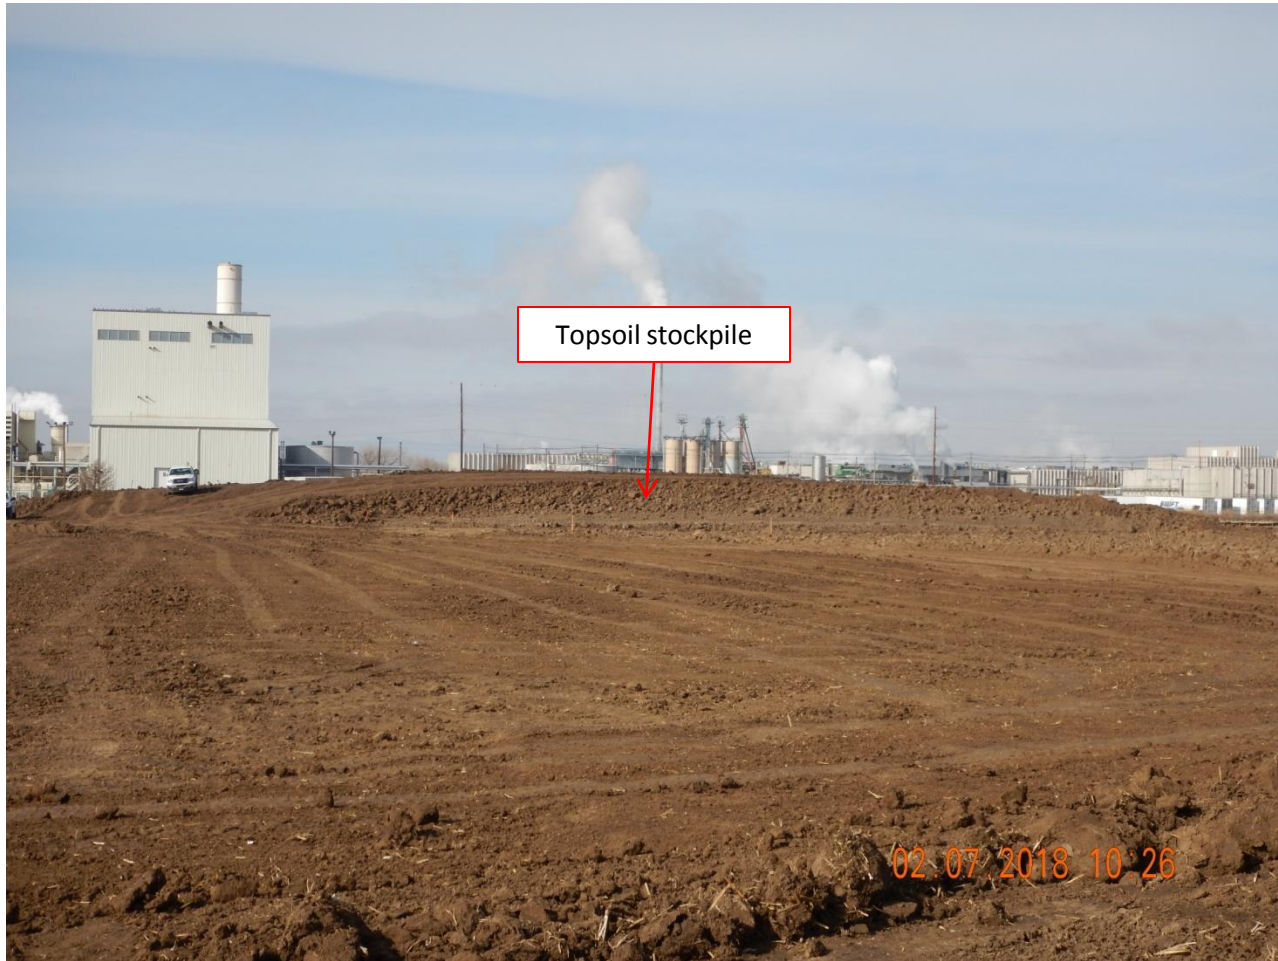
**Photo 5.** Photo taken from the eastern location perimeter, facing West. Operator has stored topsoil along the southwestern location.

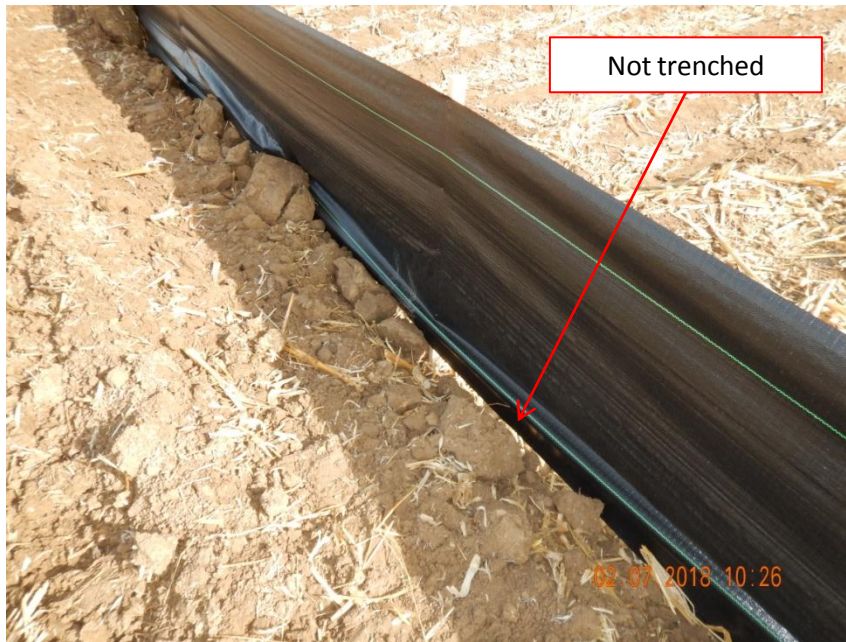
**Photo 6.** Photo taken along a portion of the eastern location on February 7, 2018. See comments under Photo 3.

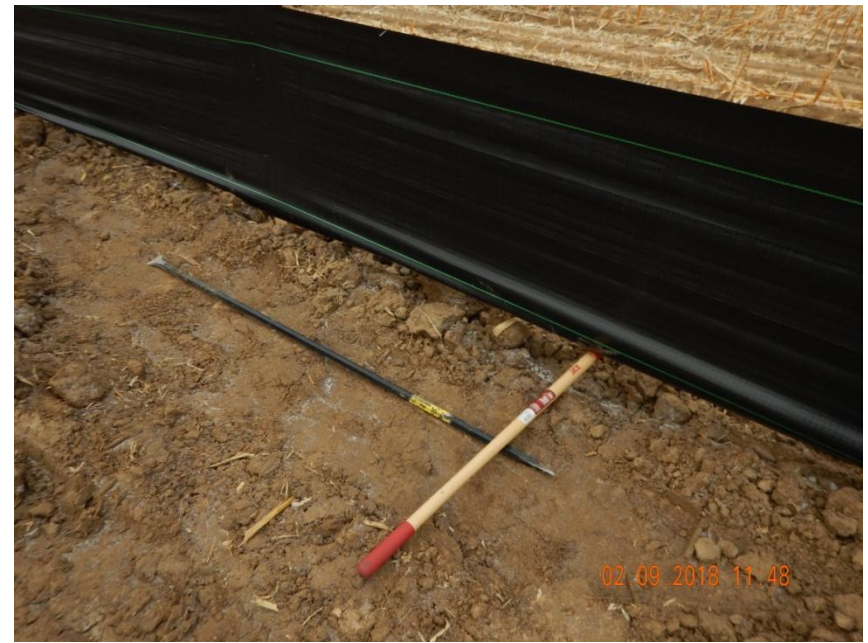
**Photo 7.** Photo taken along a portion of the eastern location on February 9, 2018. See comments under Photo 3.

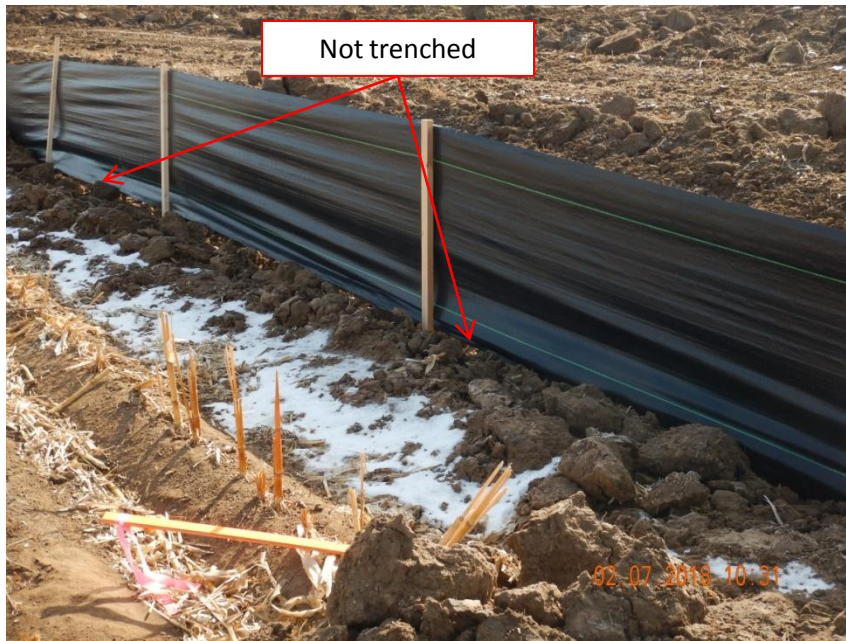
**Photo 8.** Photo taken along a portion of the northeastern location. See comments under Photo 3.

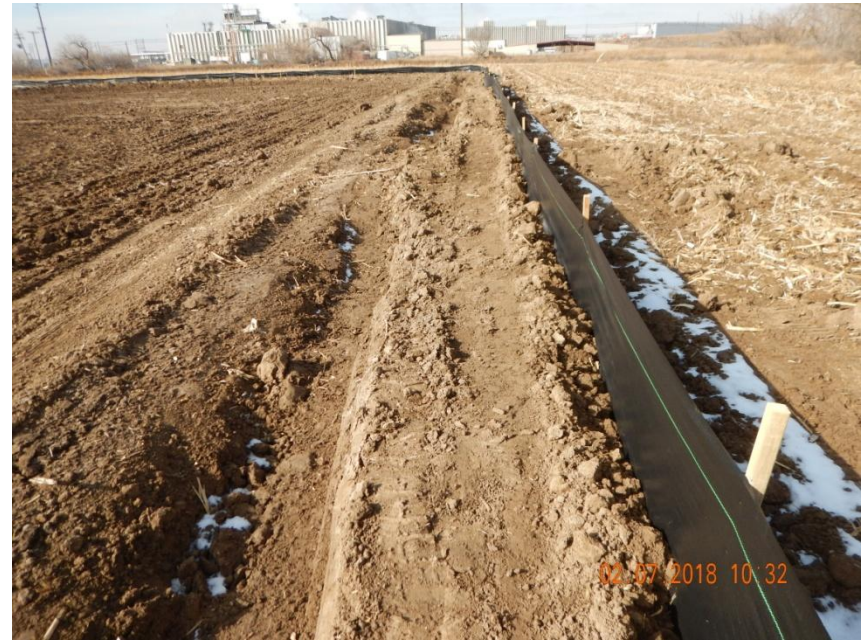
**Photo 9.** Photo taken from the northern location perimeter, facing West. See comments under Photo 2.

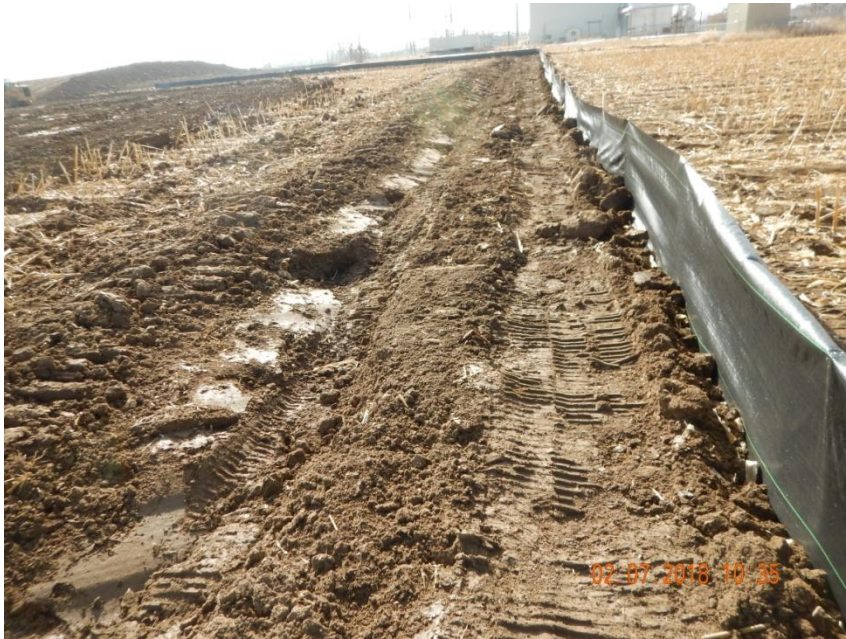
**Photo 10.** Photo taken from the northern location perimeter, facing West. See comments under Photo 2.

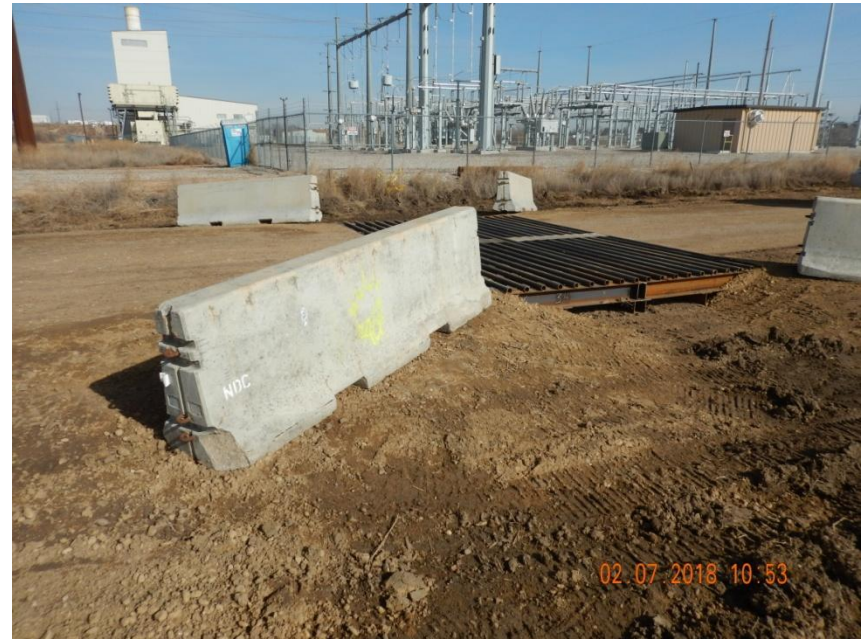
**Photo 11.** Photo taken from the northern location perimeter, facing West. See comments under Photo 2.
