# Inspection Photos

Operator: PRE RESOURCES INC - 10241

Location ID: 390648

Inspection Doc. Number: 682503133

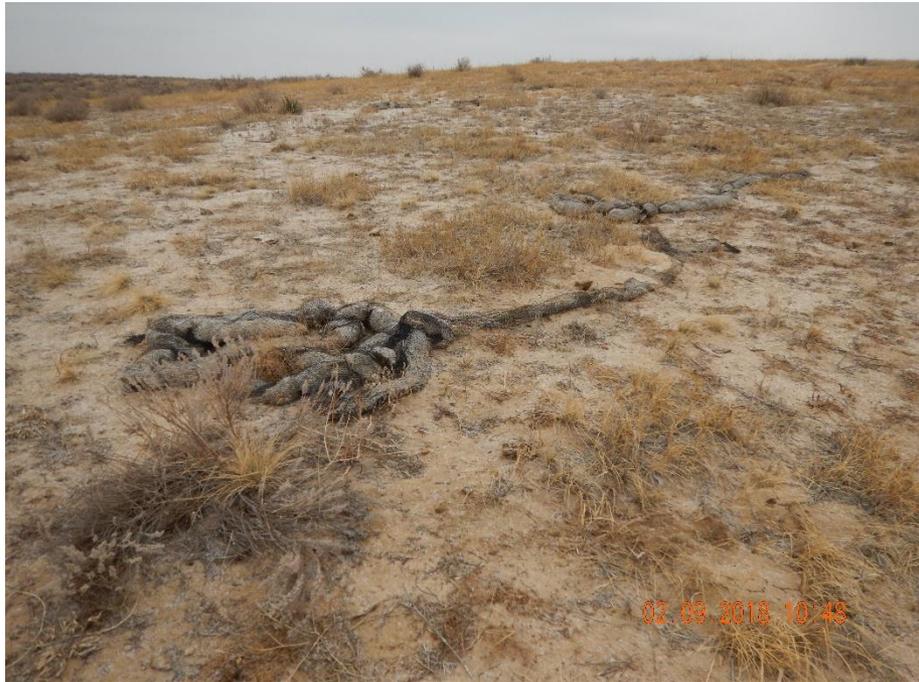
**Photo 1:** Photo taken from the west end of the location, facing north. Photo shows stormwater and sediment control BMPs (wattles) that have not been maintained, are no longer in proper functioning condition, and is considered debris. Wattle debris was observed on the northern, northwestern and southern ends of the location.

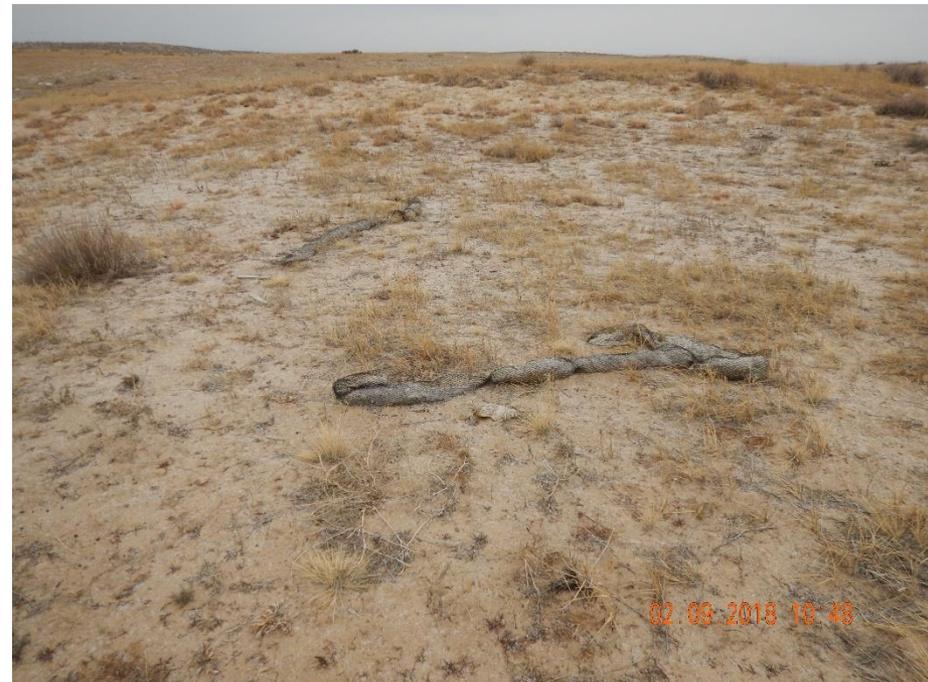
**Photo 2:** Photo taken from the west end of the location, facing northeast. Photo shows additional debris.

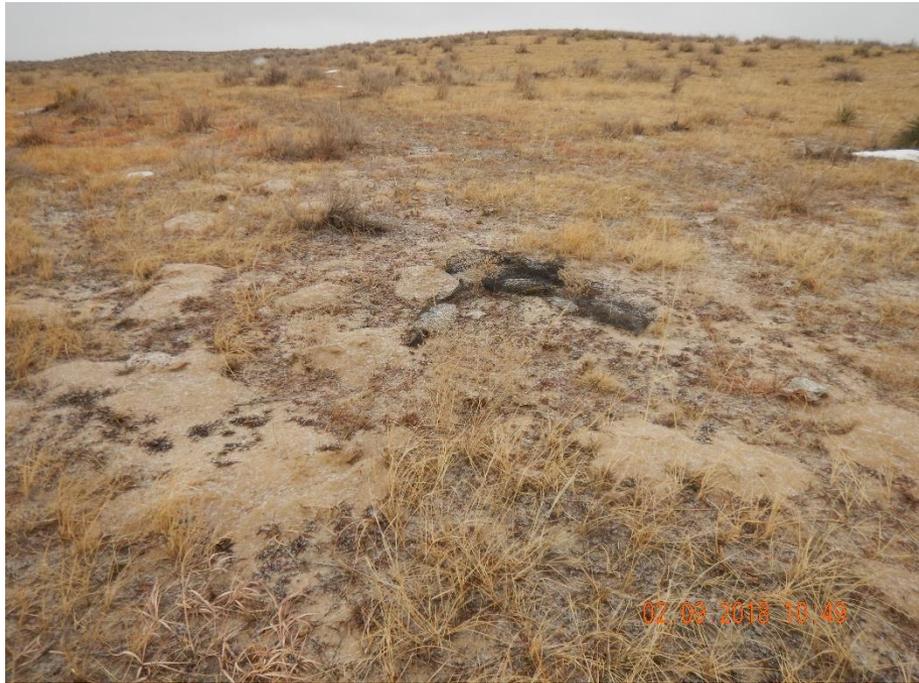
**Photo 3:** Photo taken from the west end of the location, facing north. Photo shows additional debris.

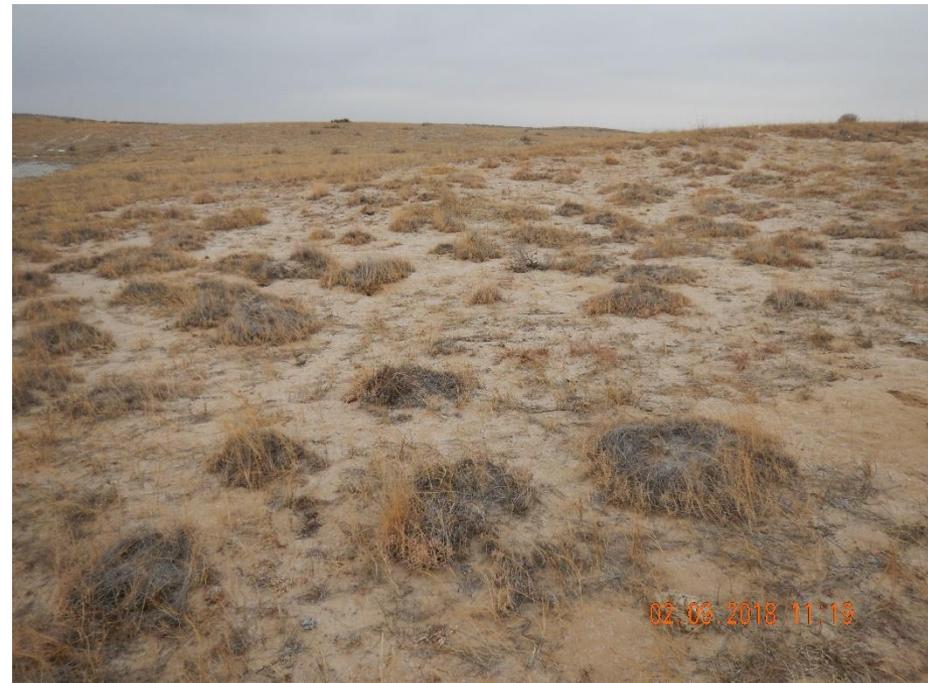
**Photo 4:** Photo taken from the west end of the location, facing west. Photo shows areas of the location where vegetation has not achieved a uniform desirable perennial vegetative cover.

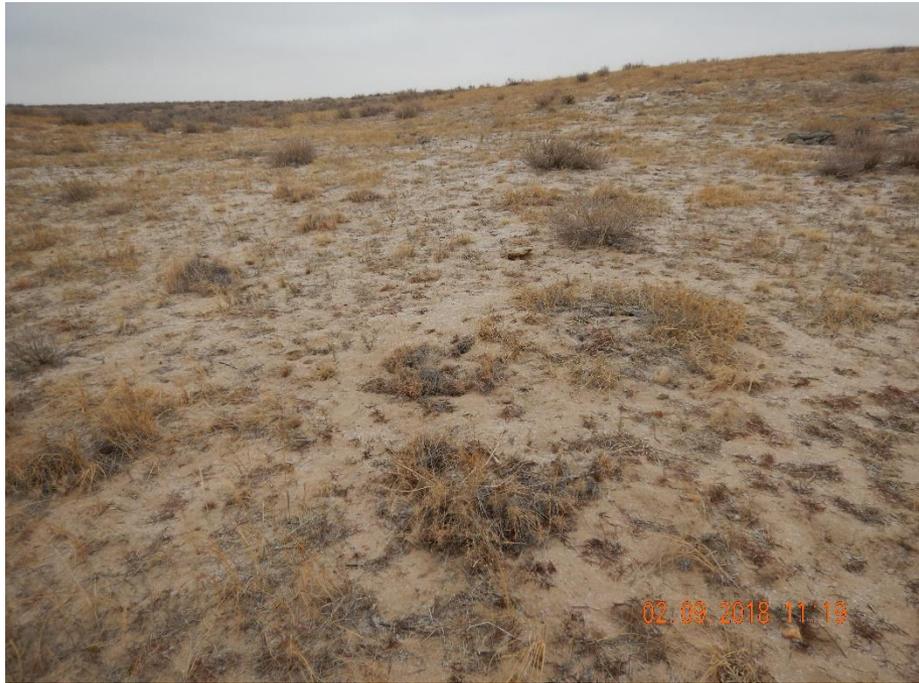
**Photo 5:** Photo taken from the west end of the location, facing north. Photo shows areas of the location where vegetation has not achieved a uniform desirable perennial vegetative cover.

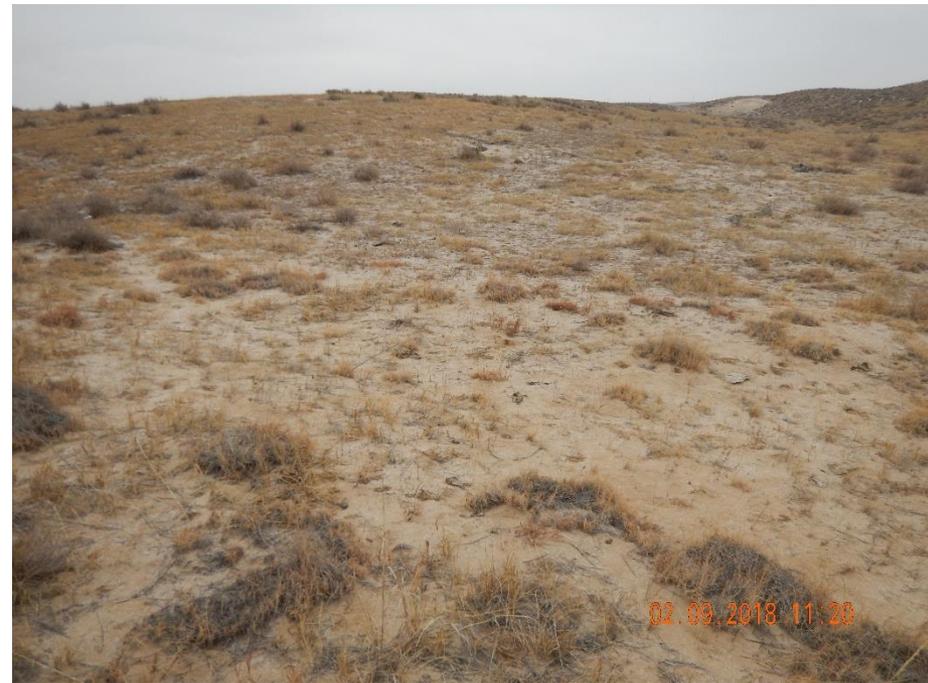
**Photo 6:** Photo taken from the west end of the location, facing east. Photo shows areas of the location where vegetation has not achieved a uniform desirable perennial vegetative cover.

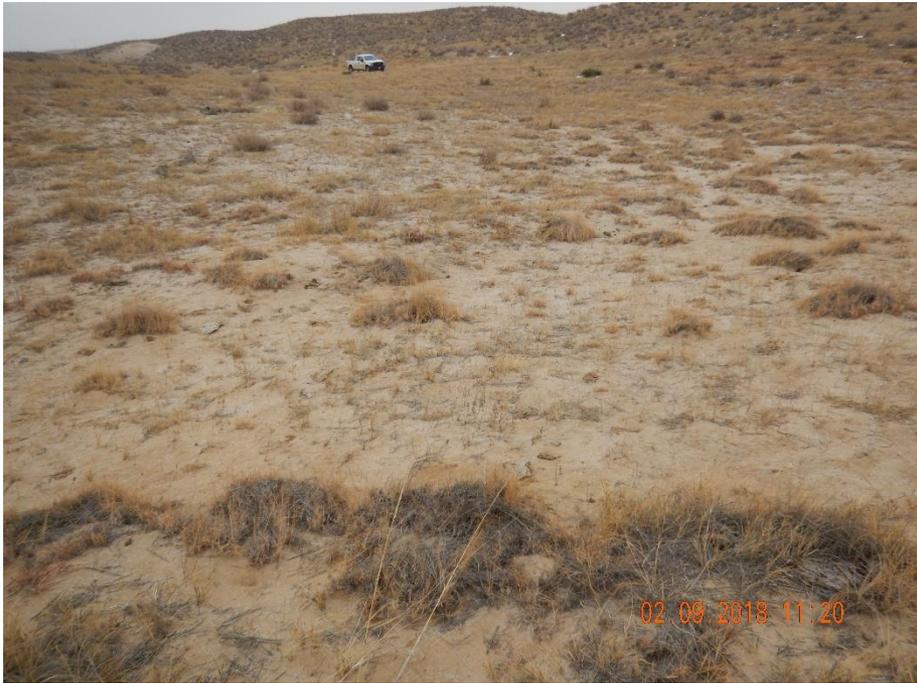
**Photo 7:** Photo taken from the west end of the location, facing southeast. Photo shows areas of the location where vegetation has not achieved a uniform desirable perennial vegetative cover.

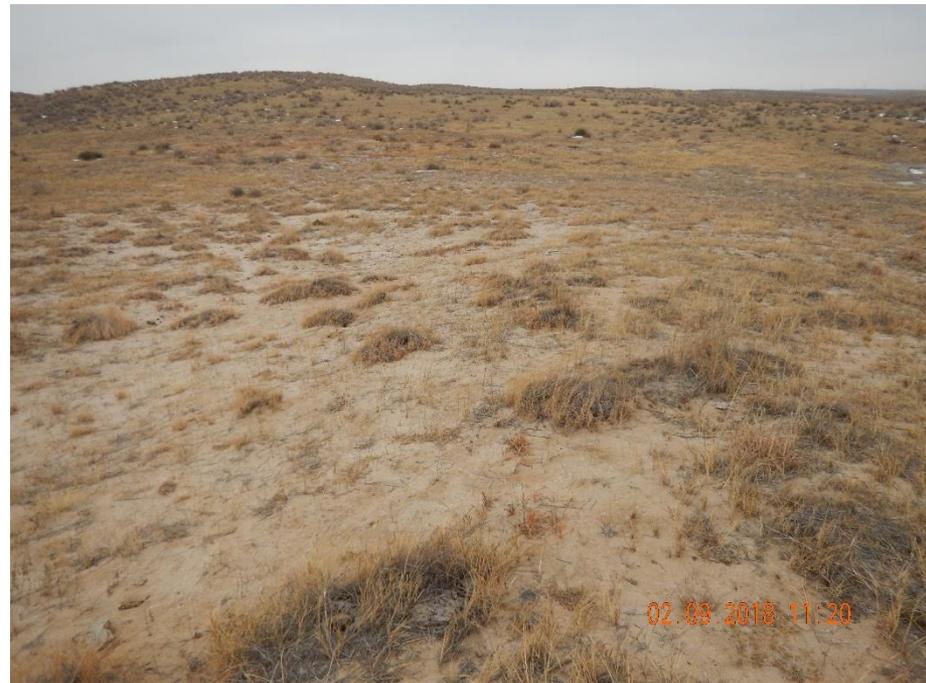
**Photo 8:** Photo taken from the west end of the location, facing south. Photo shows areas of the location where vegetation has not achieved a uniform desirable perennial vegetative cover.

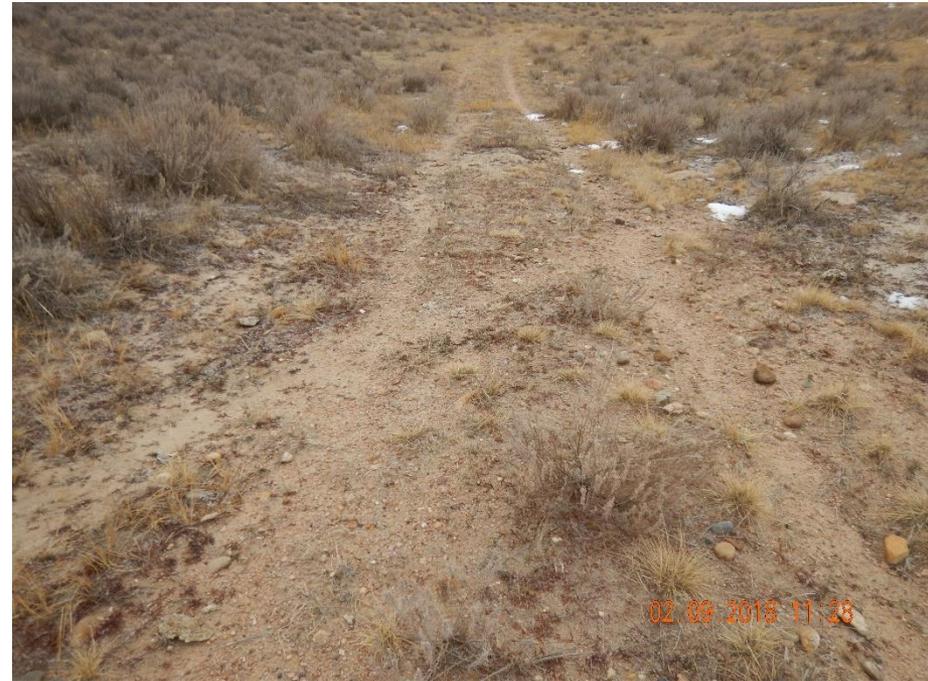
**Photo 10:** Photos 10-15 taken from the access road. Photos shows access road does not meet reclamation standards. Gravel/ruts evident. Road has not achieved a uniform desirable perennial vegetative cover.

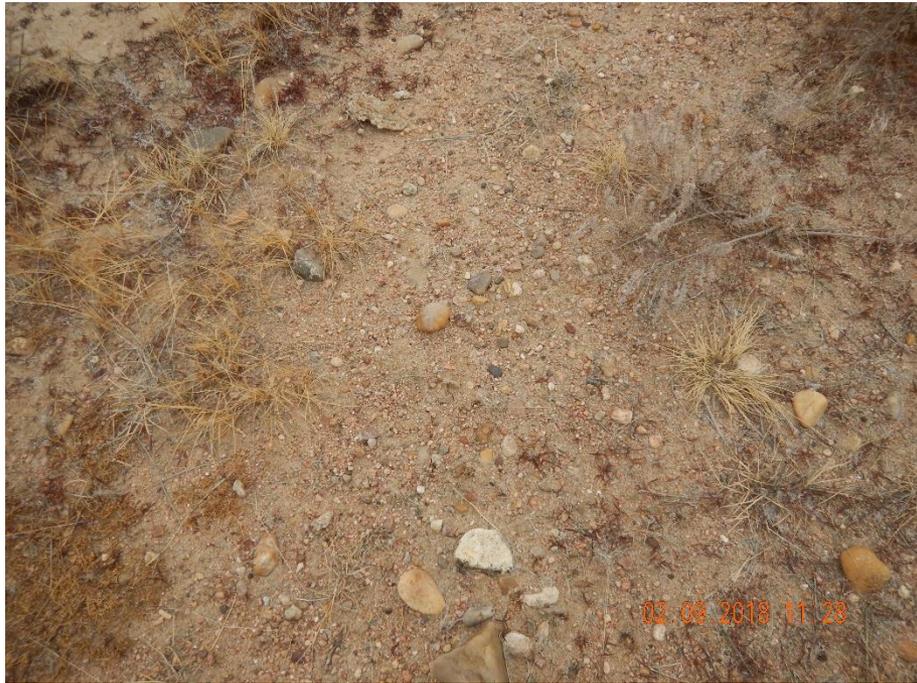
**Photo 15:** Photo taken from the access road. Photo shows gravel remaining.

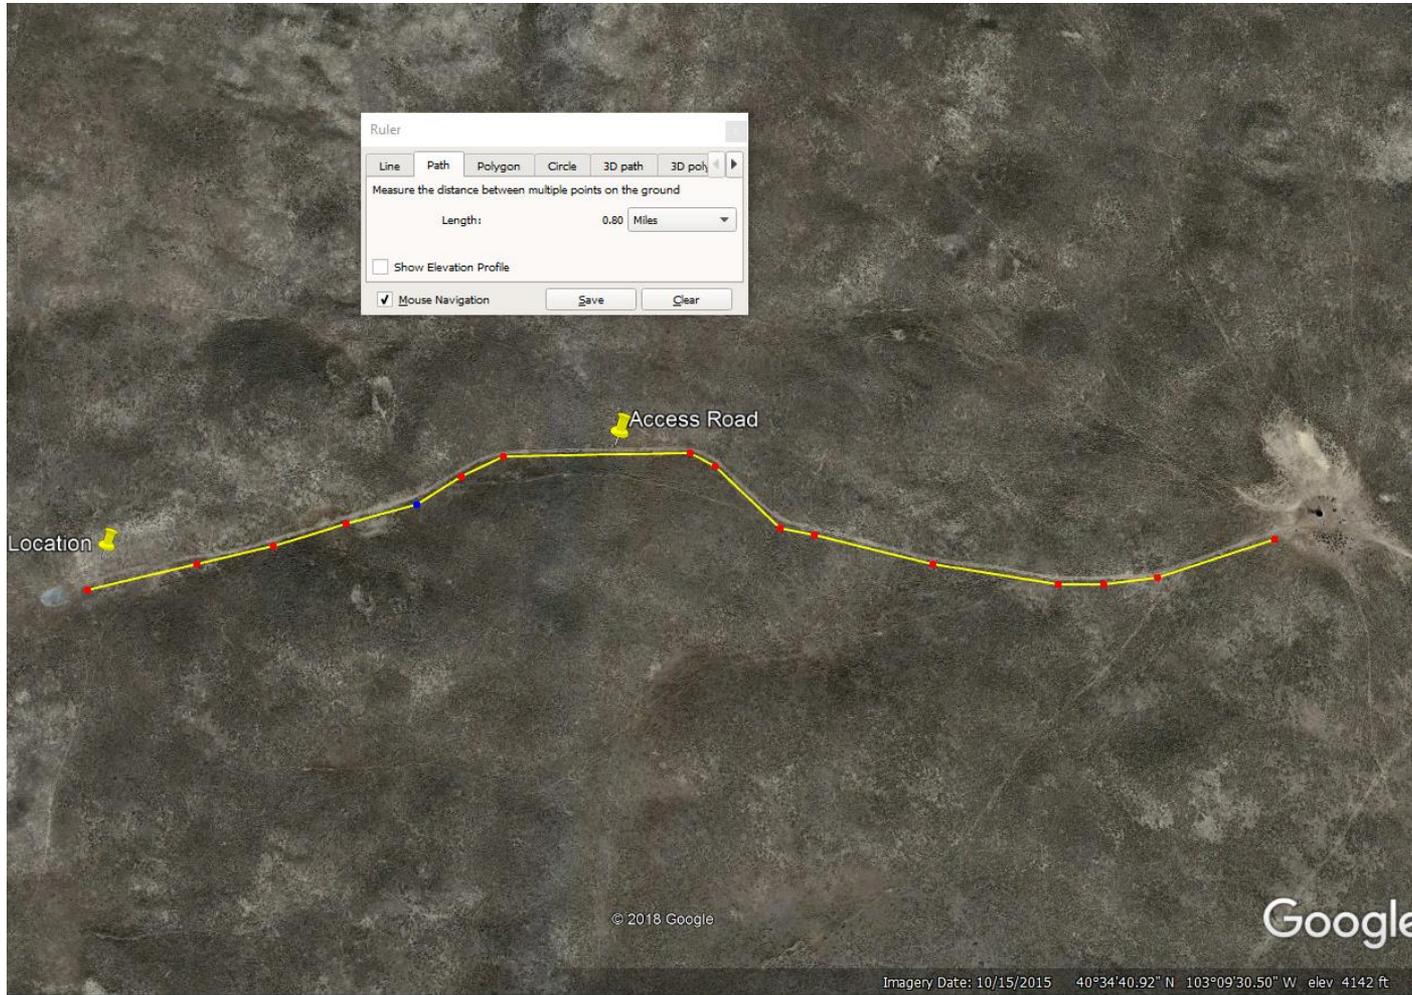
**Photo 17:** Most current available aerial imagery (2015). Photo shows ~0.8 miles of access road requiring reclamation.
