Interim Reclamation Inspection

Operator: BARRETT CORPORATION* BILL (BBC)- 10071

Location ID: 439471

Inspection Photos
Location Name: Coffelt Pad
Location ID: 439471

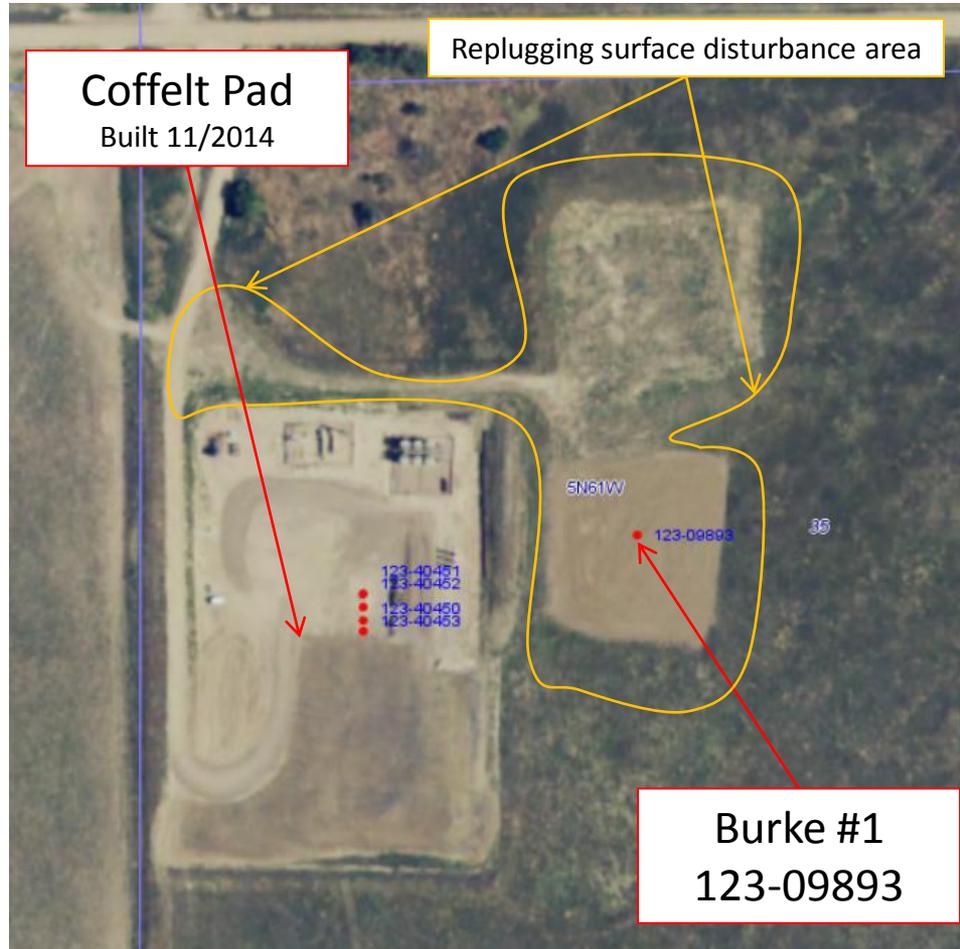
Aerial imagery take in 2015. Imagery illustrates the Coffelt Pad, in addition to the surface disturbance from replugging operations performed by BBC at the Burke location.

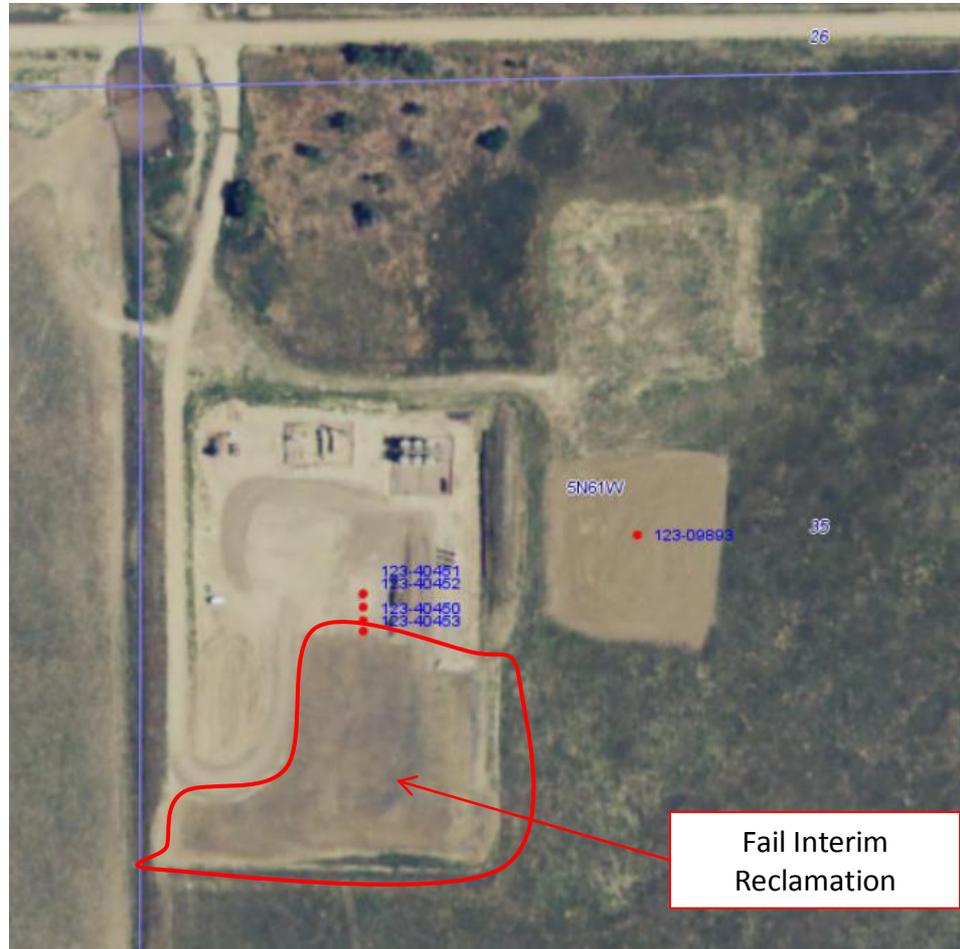
The southern interim area of the Coffelt Pad, highlighted in red above, does not meet Rule 1003 standards.

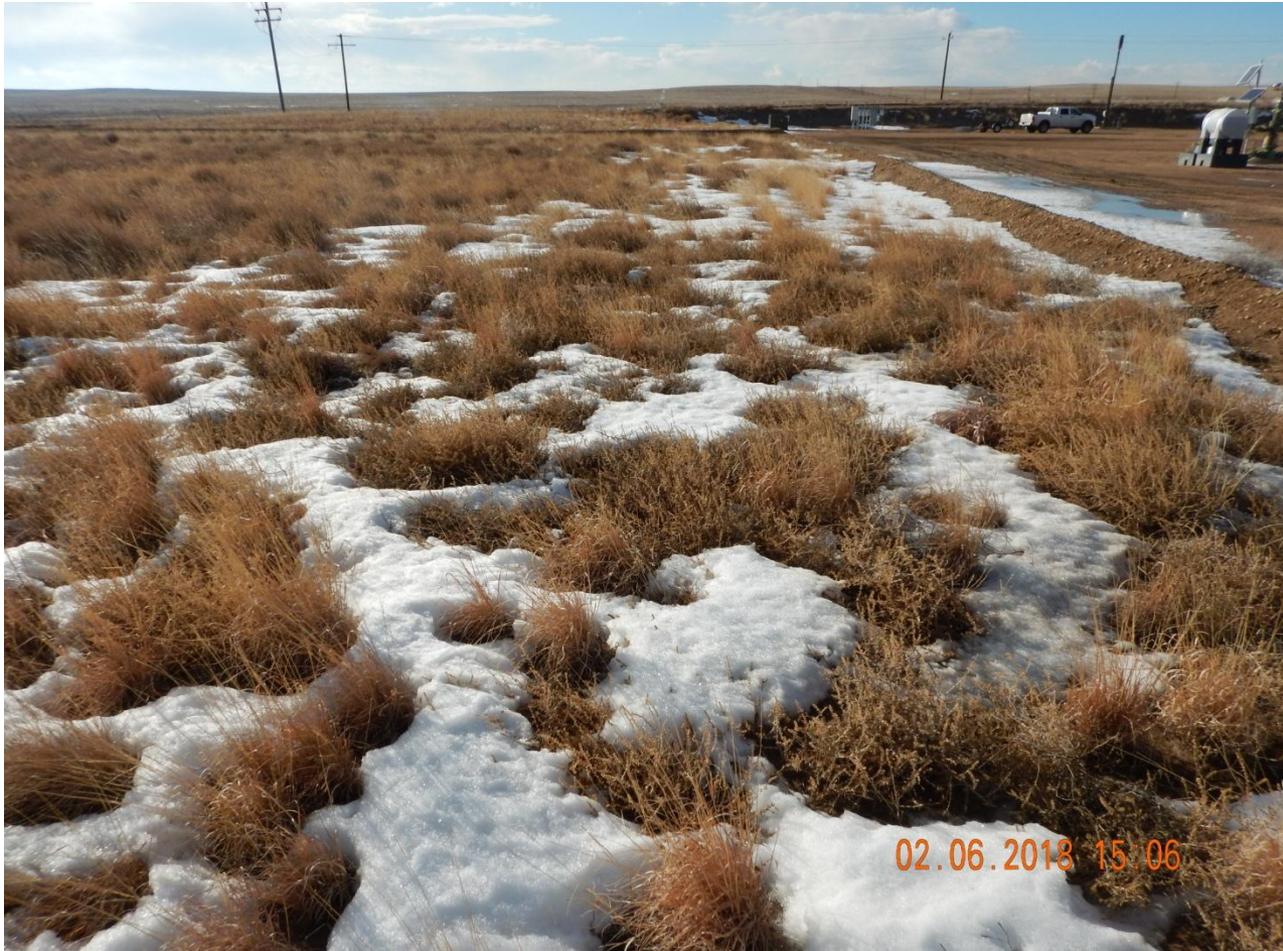
Photo 1. Photo taken from the southern interim area, facing West. Some reference area vegetation was observed but weedy, annual vegetation (Russian thistle) has a higher abundance than desirable species which is not reflective of reference area vegetation.

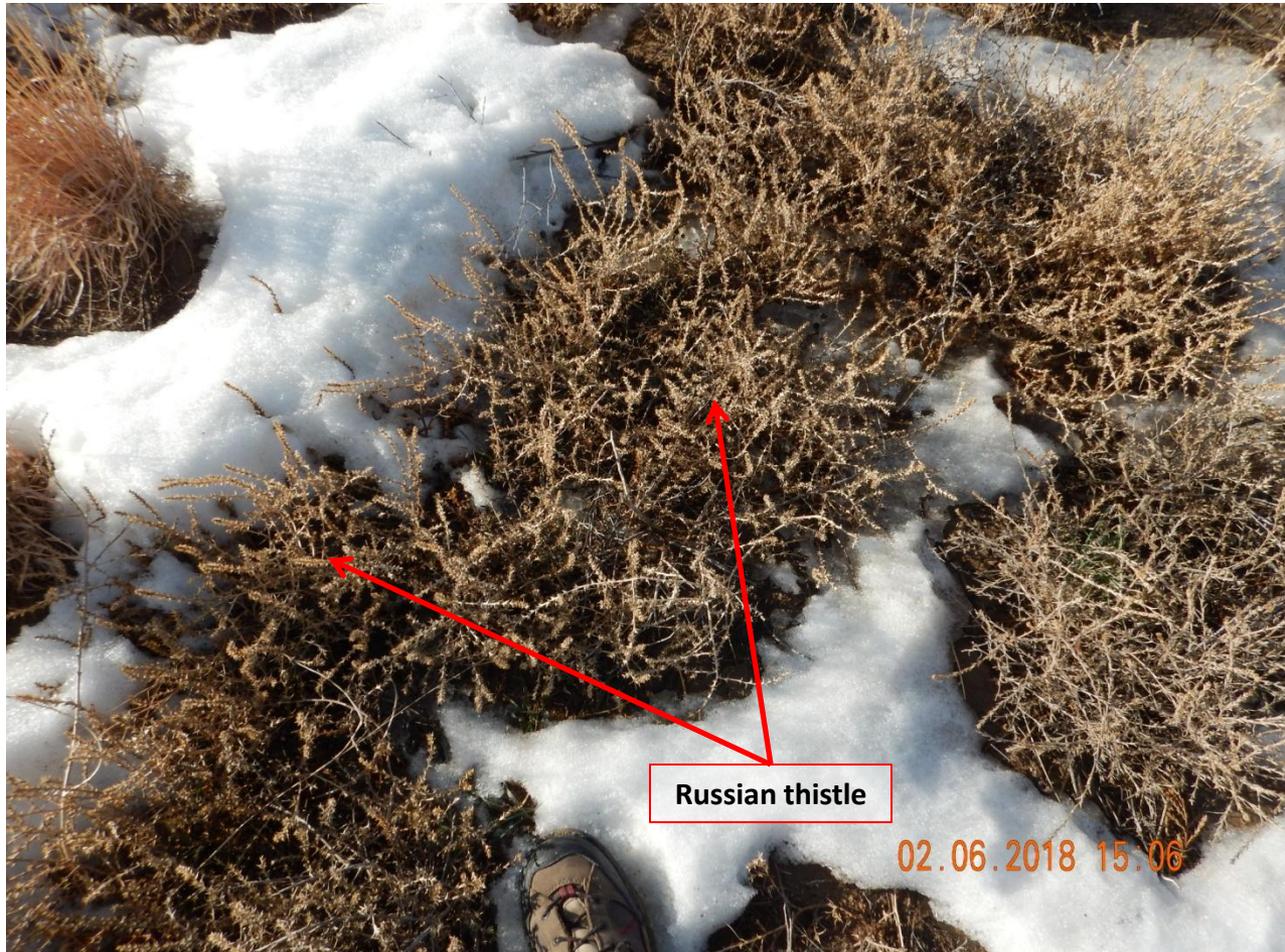
Photo 2. Photo taken from the approximate center of the Burke location, facing West. See comments under Photo 1.

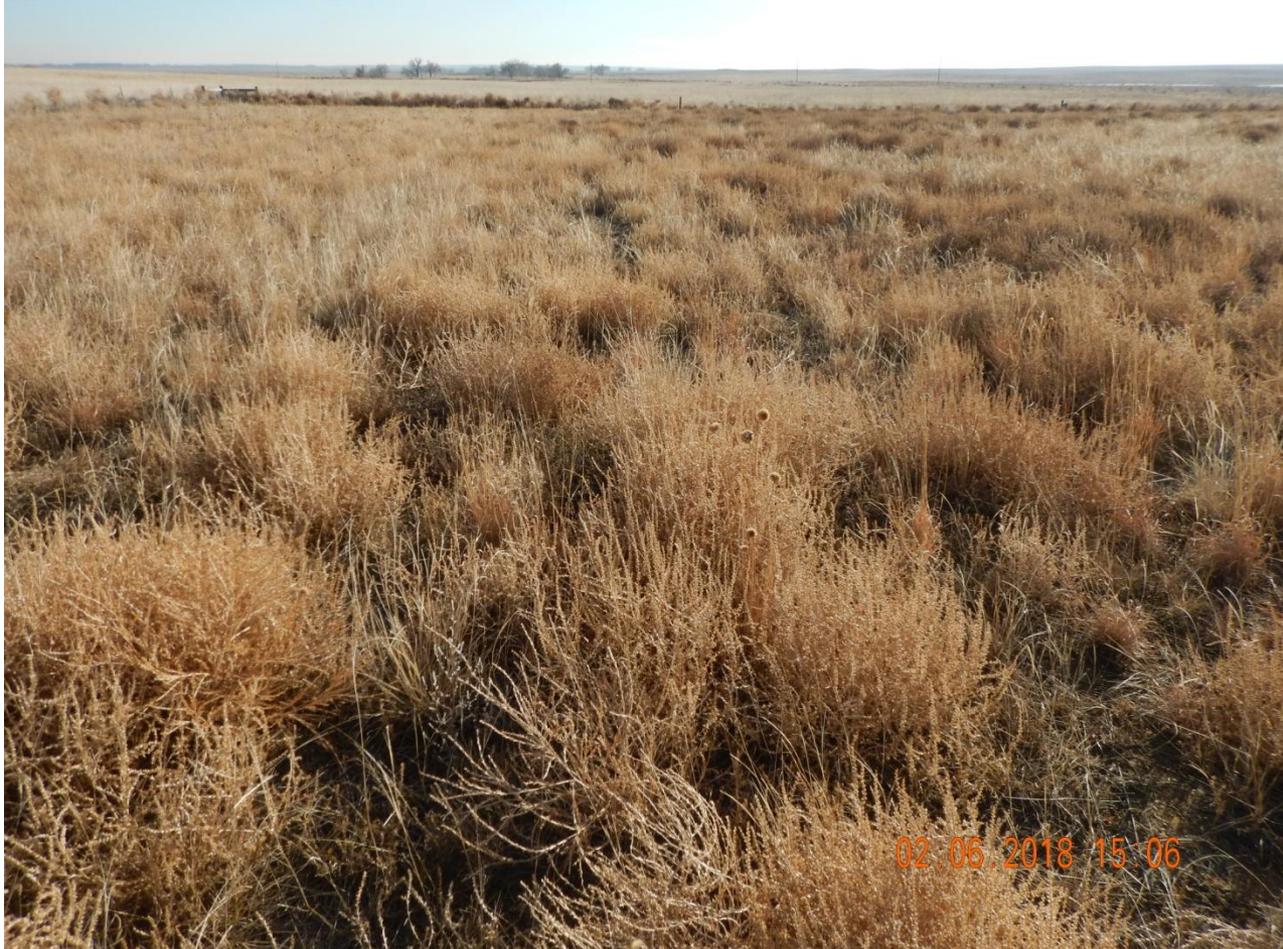
Photo 3. Photo taken from the southern interim area, facing South. Photo illustrates higher abundance of Russian thistle establishment. Most of the southeastern interim area is dominated by Russian thistle and unmanaged weed debris was observed in the perimeter fences.

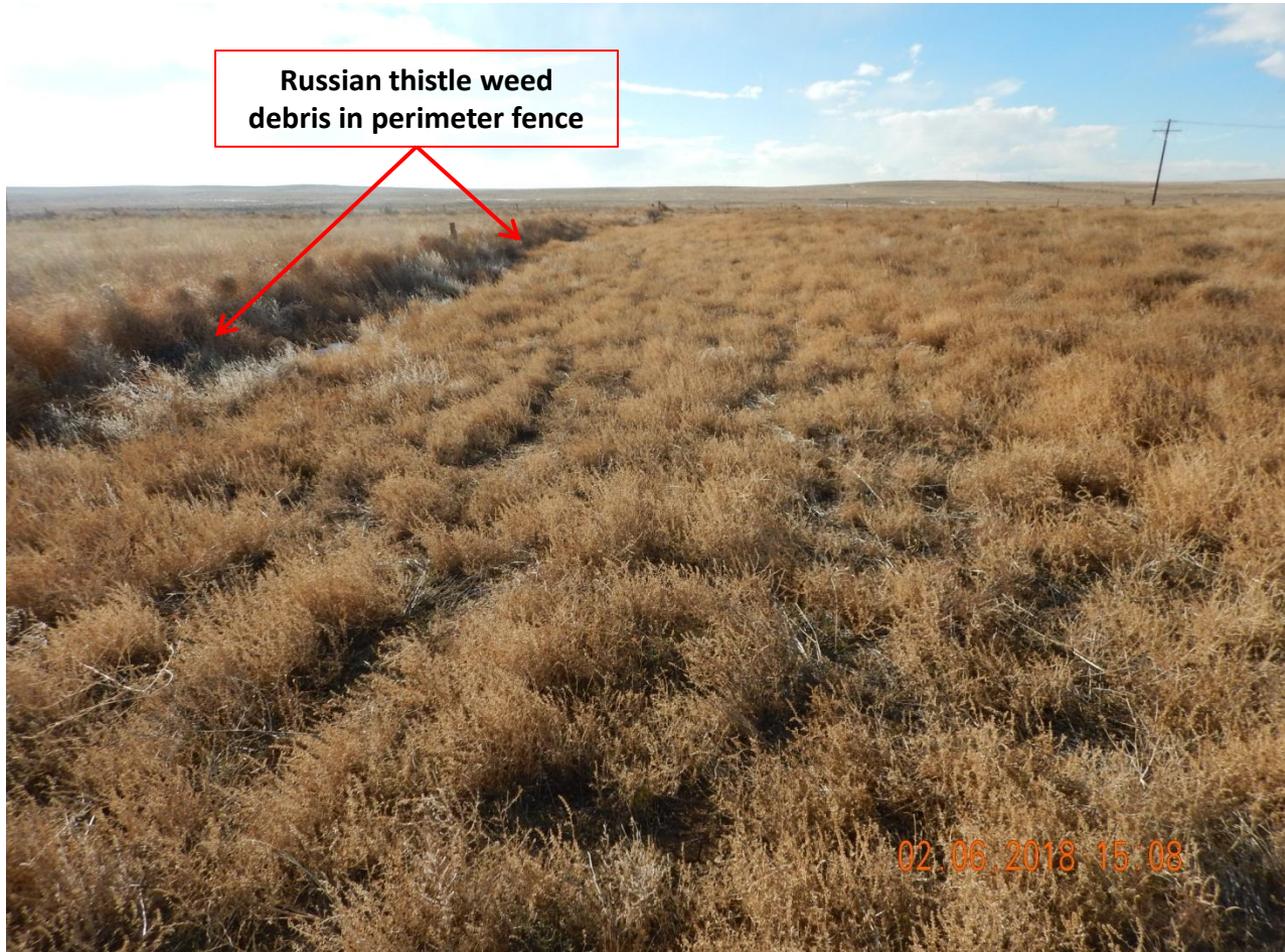
Photo 4. Photo taken from the southeast interim area, facing West. Photo illustrates the southern area is dominated by Russian thistle and unmanaged weed debris was observed in the perimeter fences.

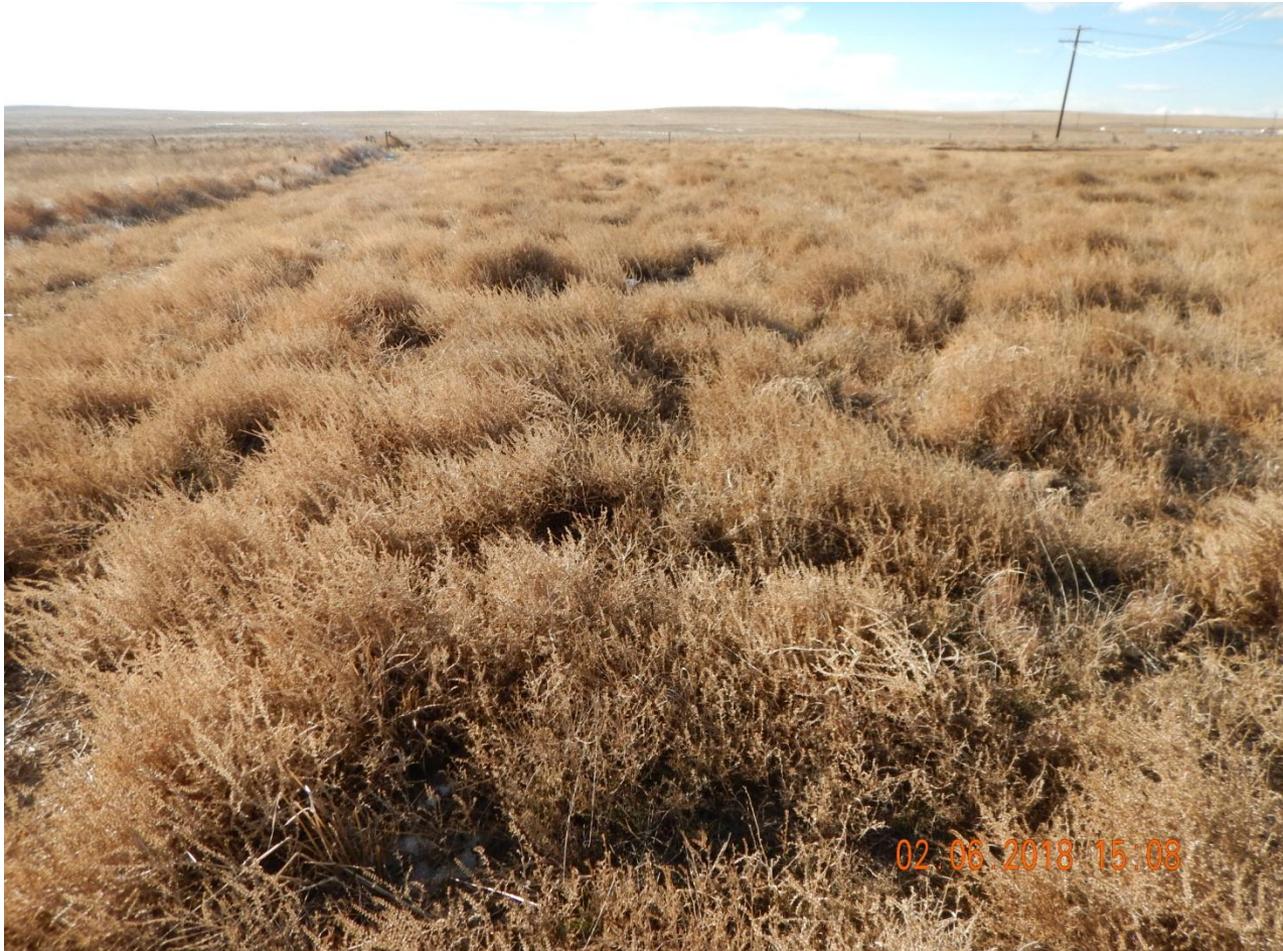
Photo 5. Photo taken from the southern interim area, facing West. See comments under Photo 4.

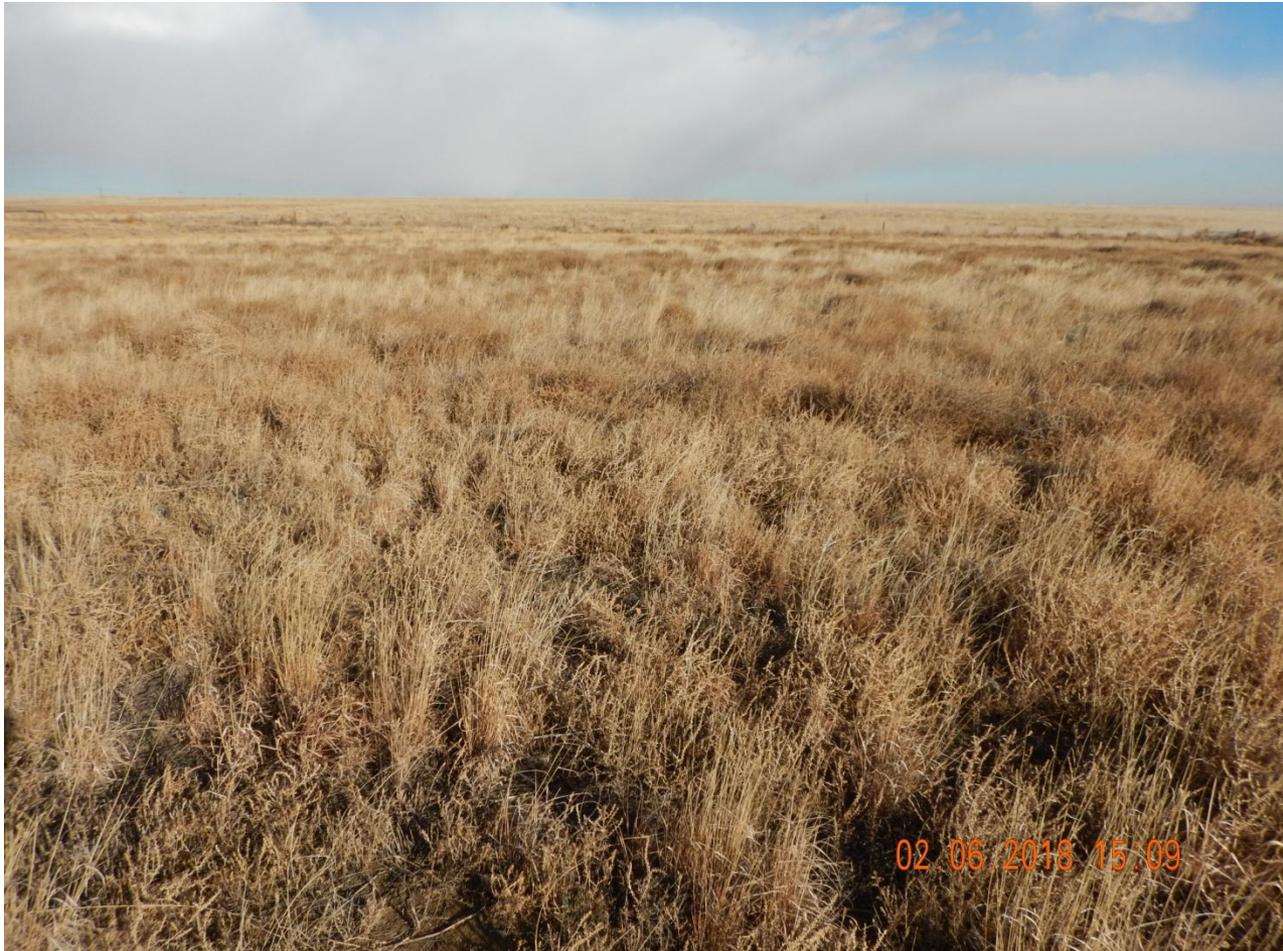
Photo 6. Photo taken from the southwestern interim area, facing East. See comments under Photo 4.

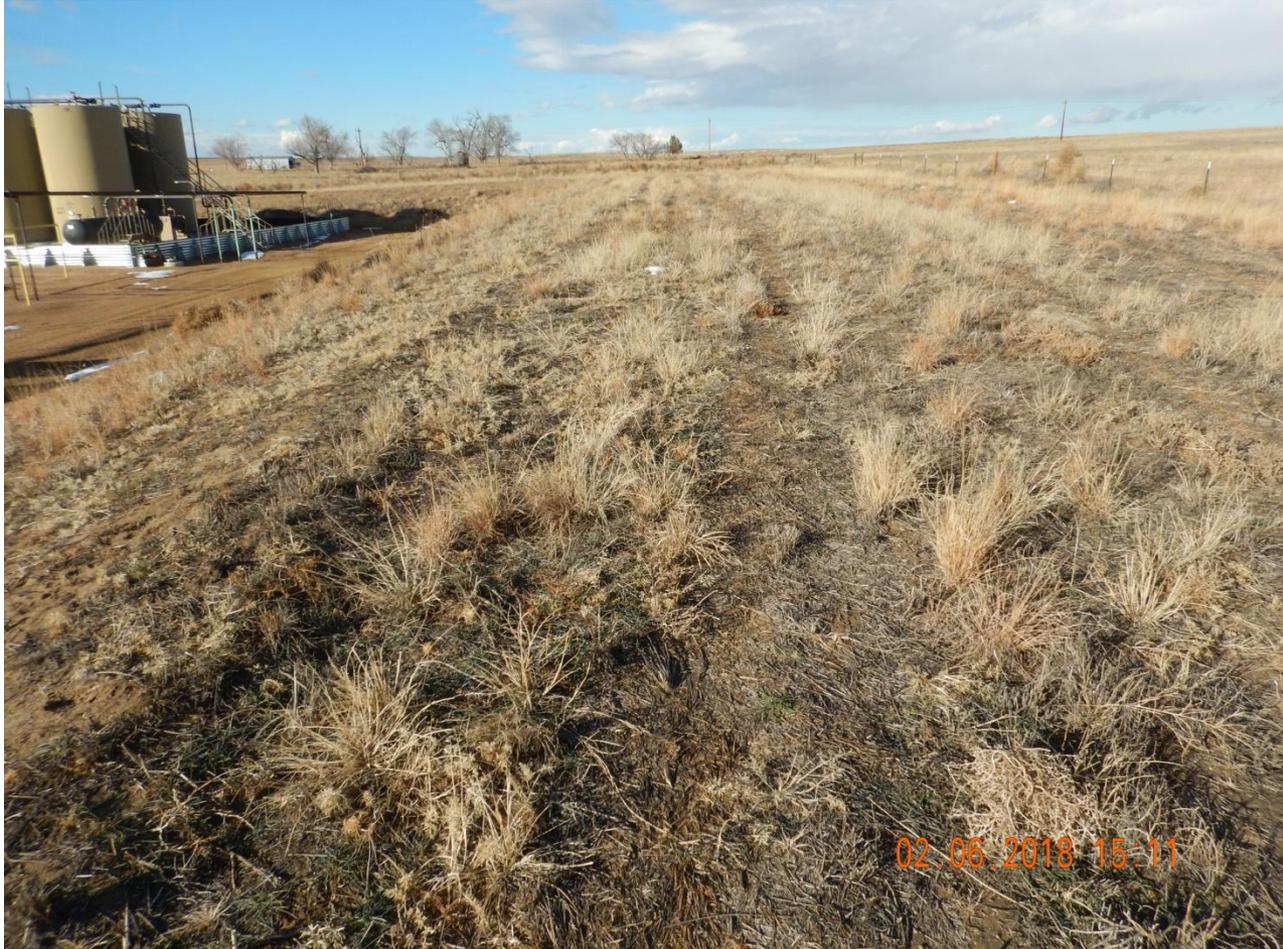
Photo 7. Photo taken from the eastern interim area, facing North. Reference area vegetation was observed and appears to have established throughout; however, there is not uniform established. This would be considered IN-PROCESS.

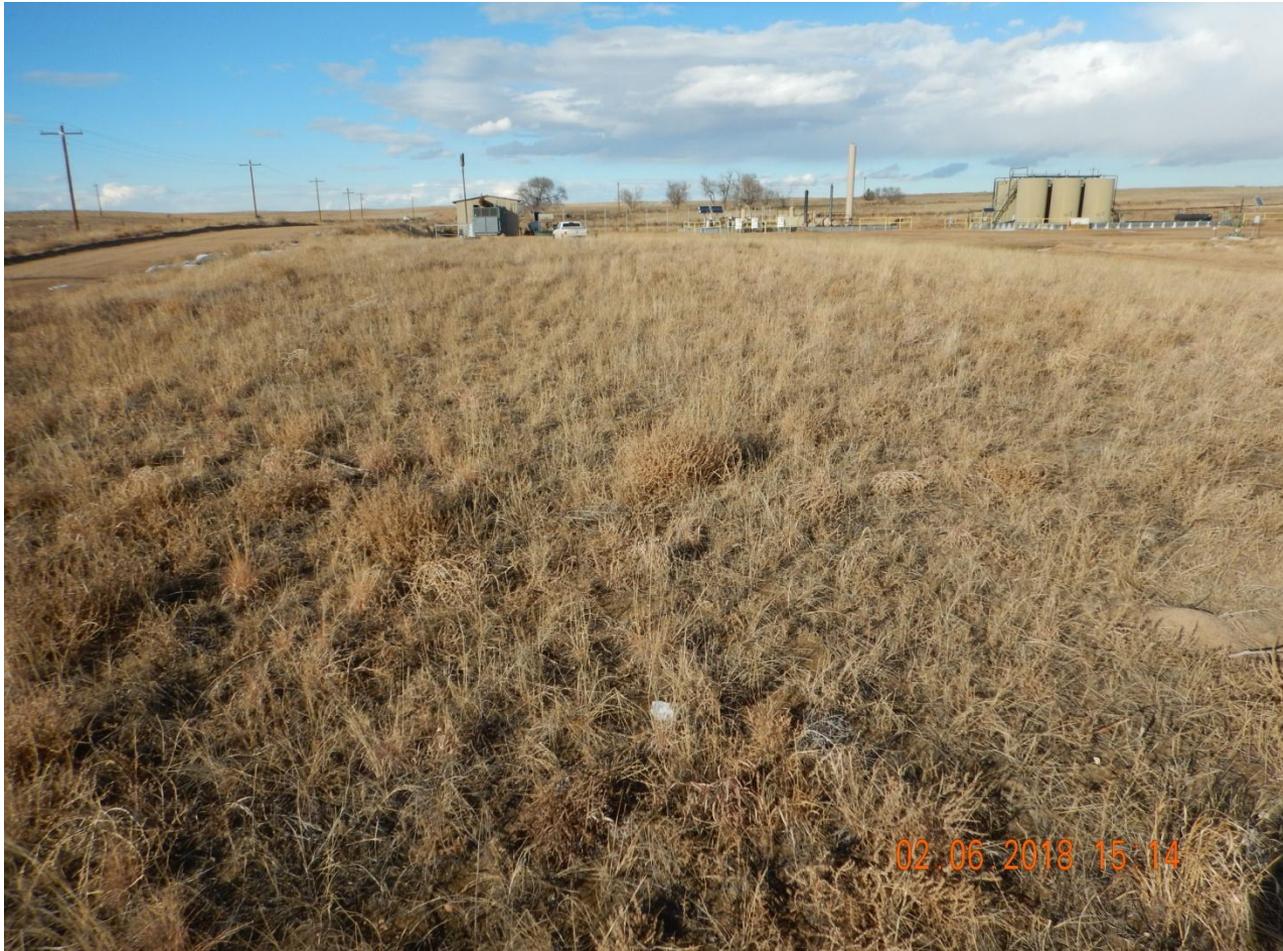
Photo 8. Photo taken from the western interim area, facing North. Reference area vegetation was observed and appears to have established throughout; however, there is not uniform established. Russian thistle was observed throughout portions of the inteim area. This would be considered IN-PROCESS.
