Inspection Photos

API: 05-067-05475

Operator: LOGOS OPERATING LLC

Inspection Number: 680602502

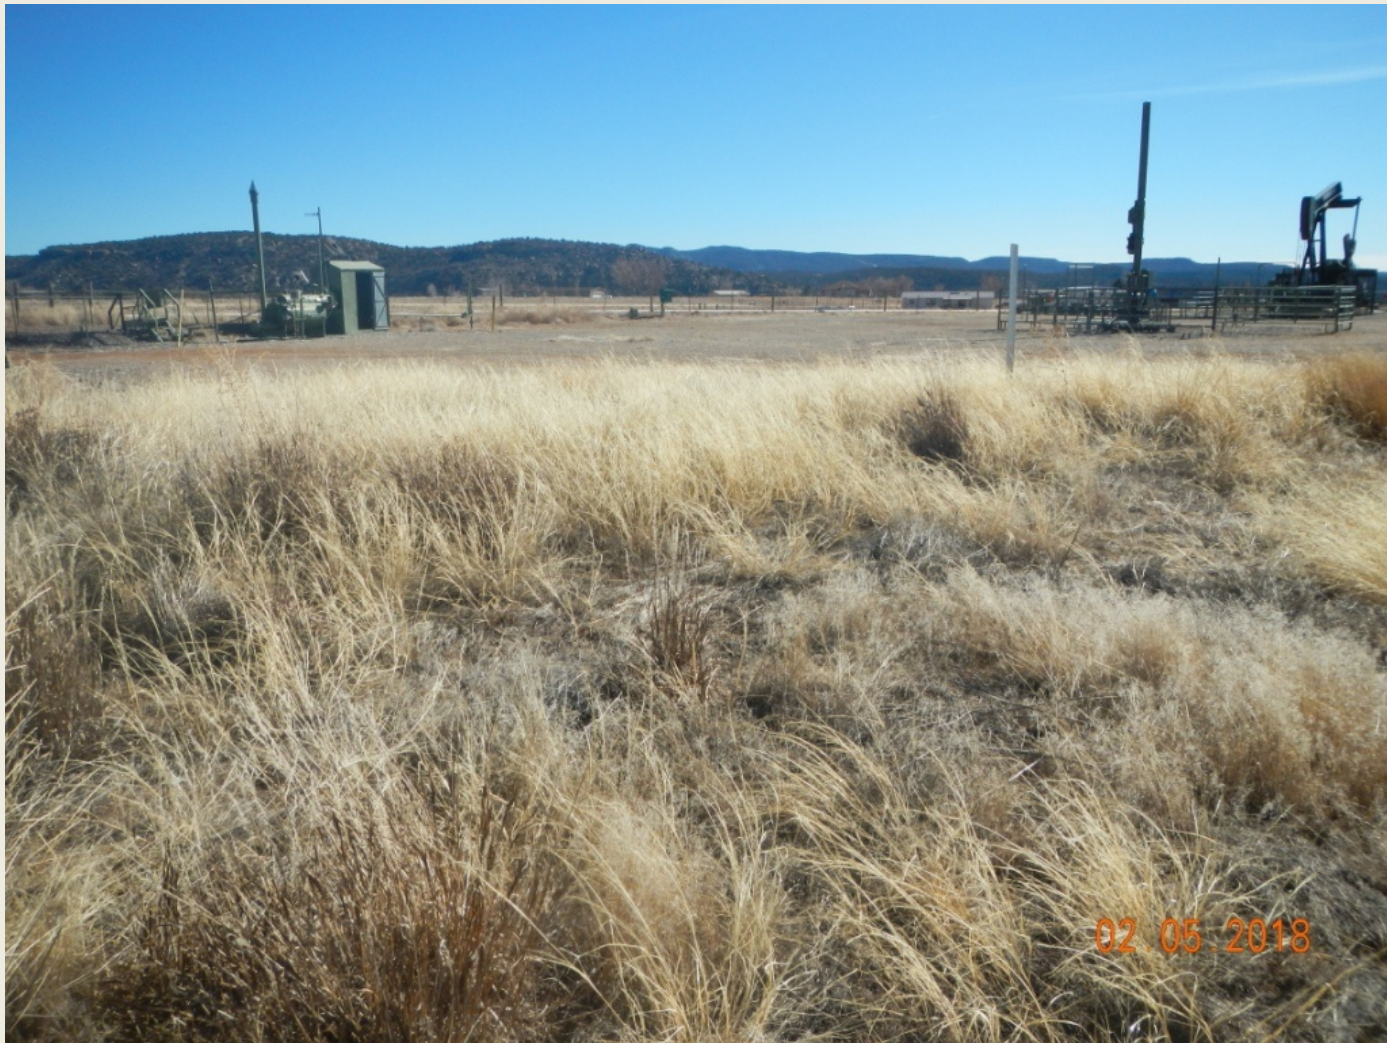
Photo 1. View of the project area from the northwestern corner facing center.

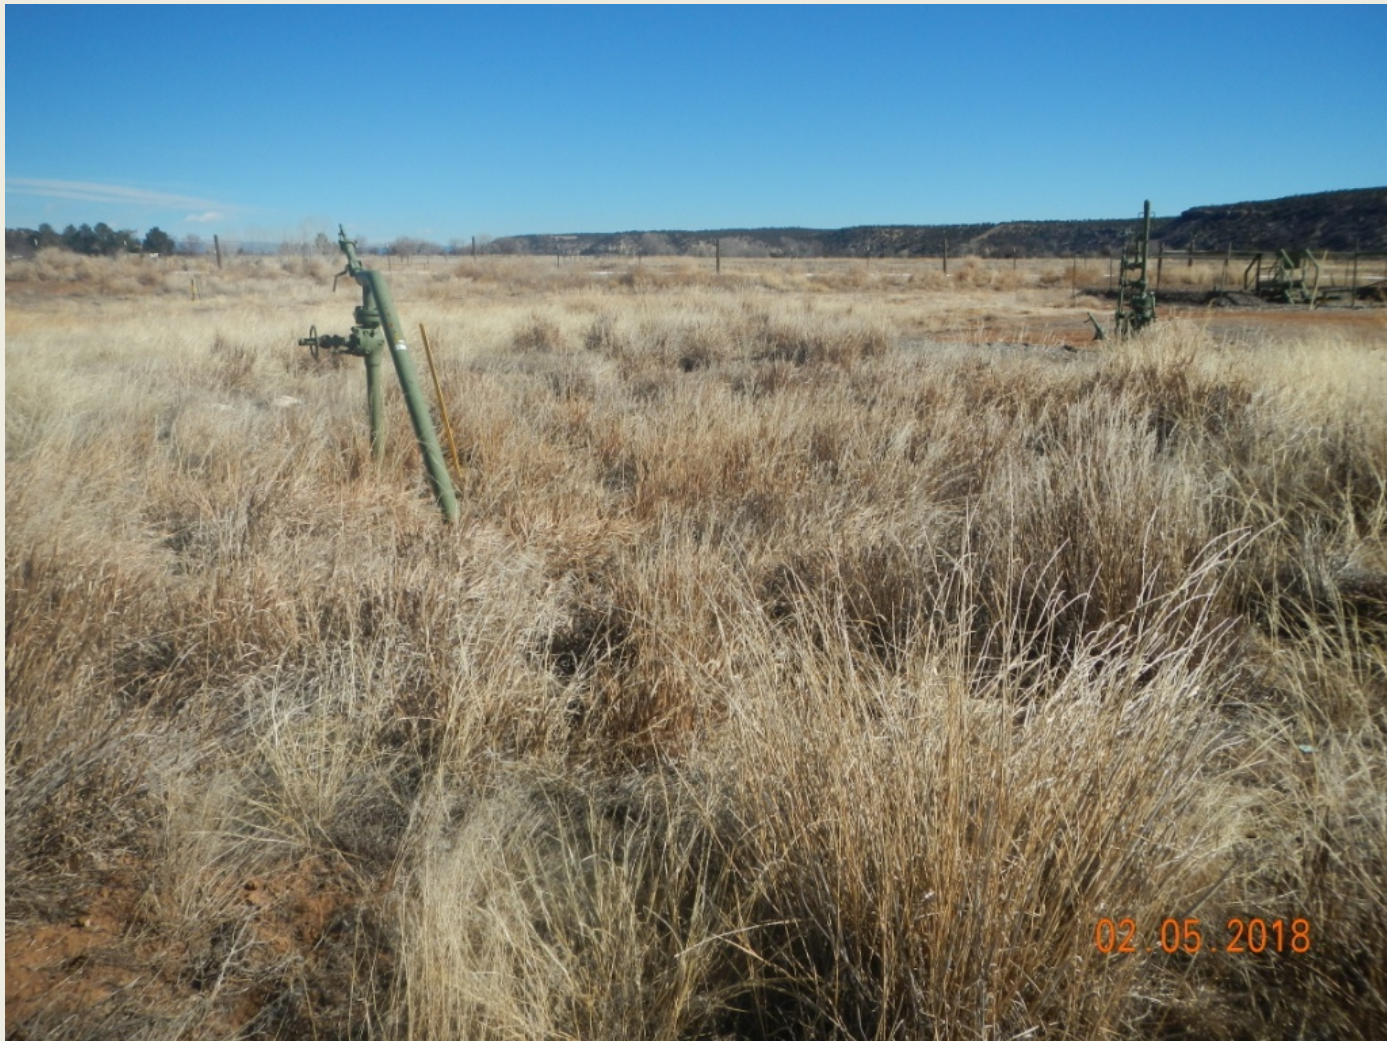
Photo 2. View of the northern portion of the project area from the northwestern corner facing eastward. Revegetation is progressing with grasses such as blue grama (*Bouteloua gracilis*), smooth brome (*Bromus inermis*), and dropseed (*Sporobolus* sp.).

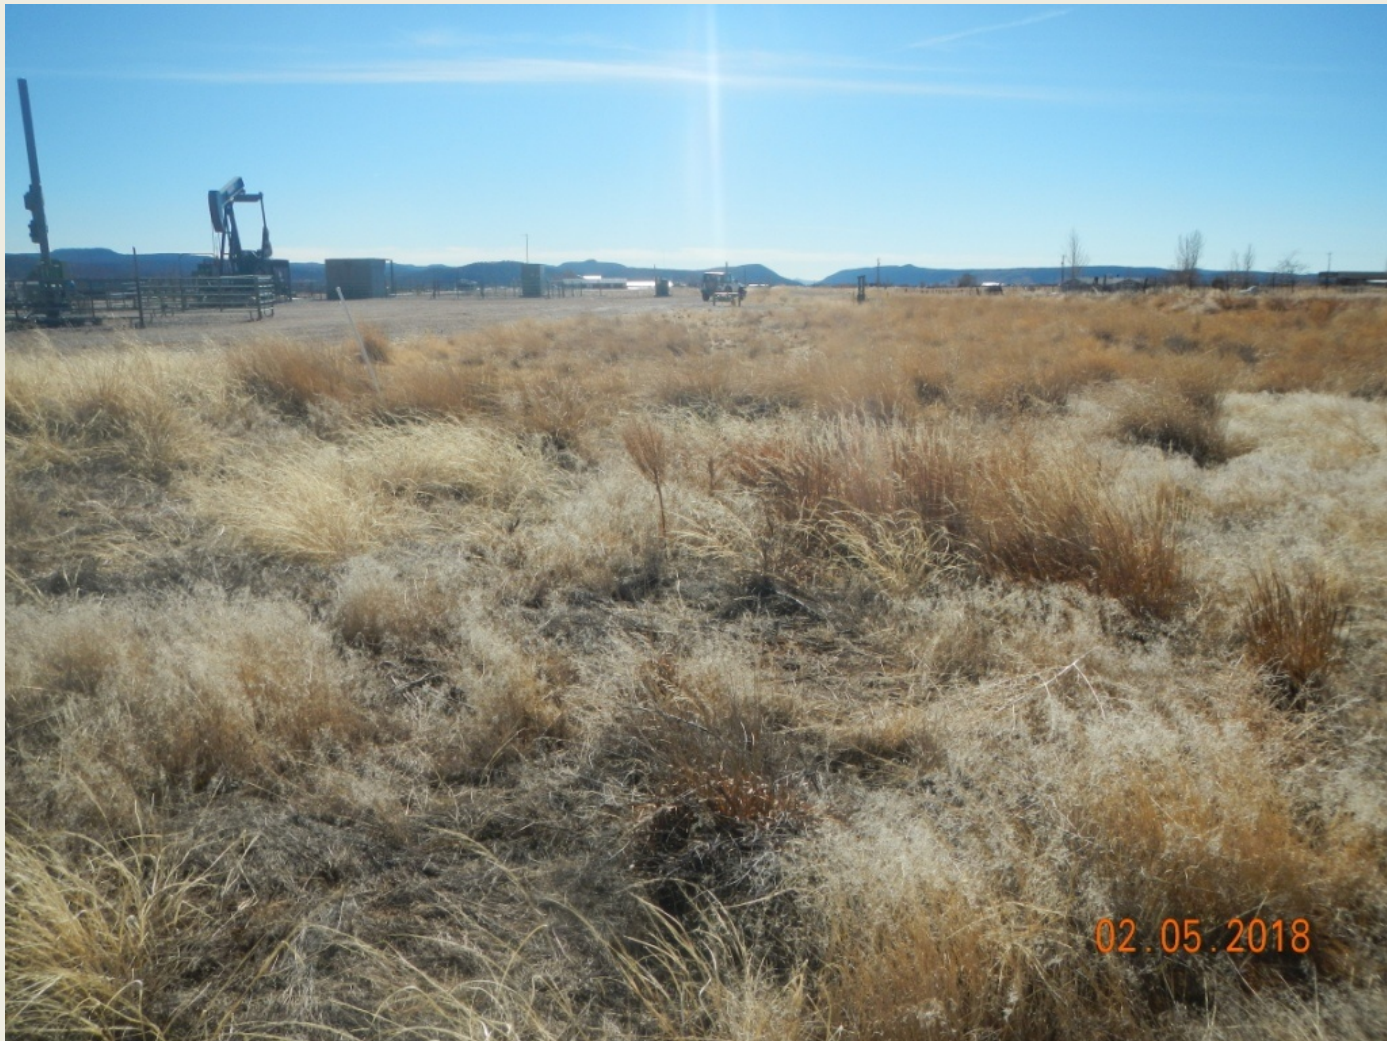
Photo 3. View of the western portion of the working area from the northwestern corner facing southward.

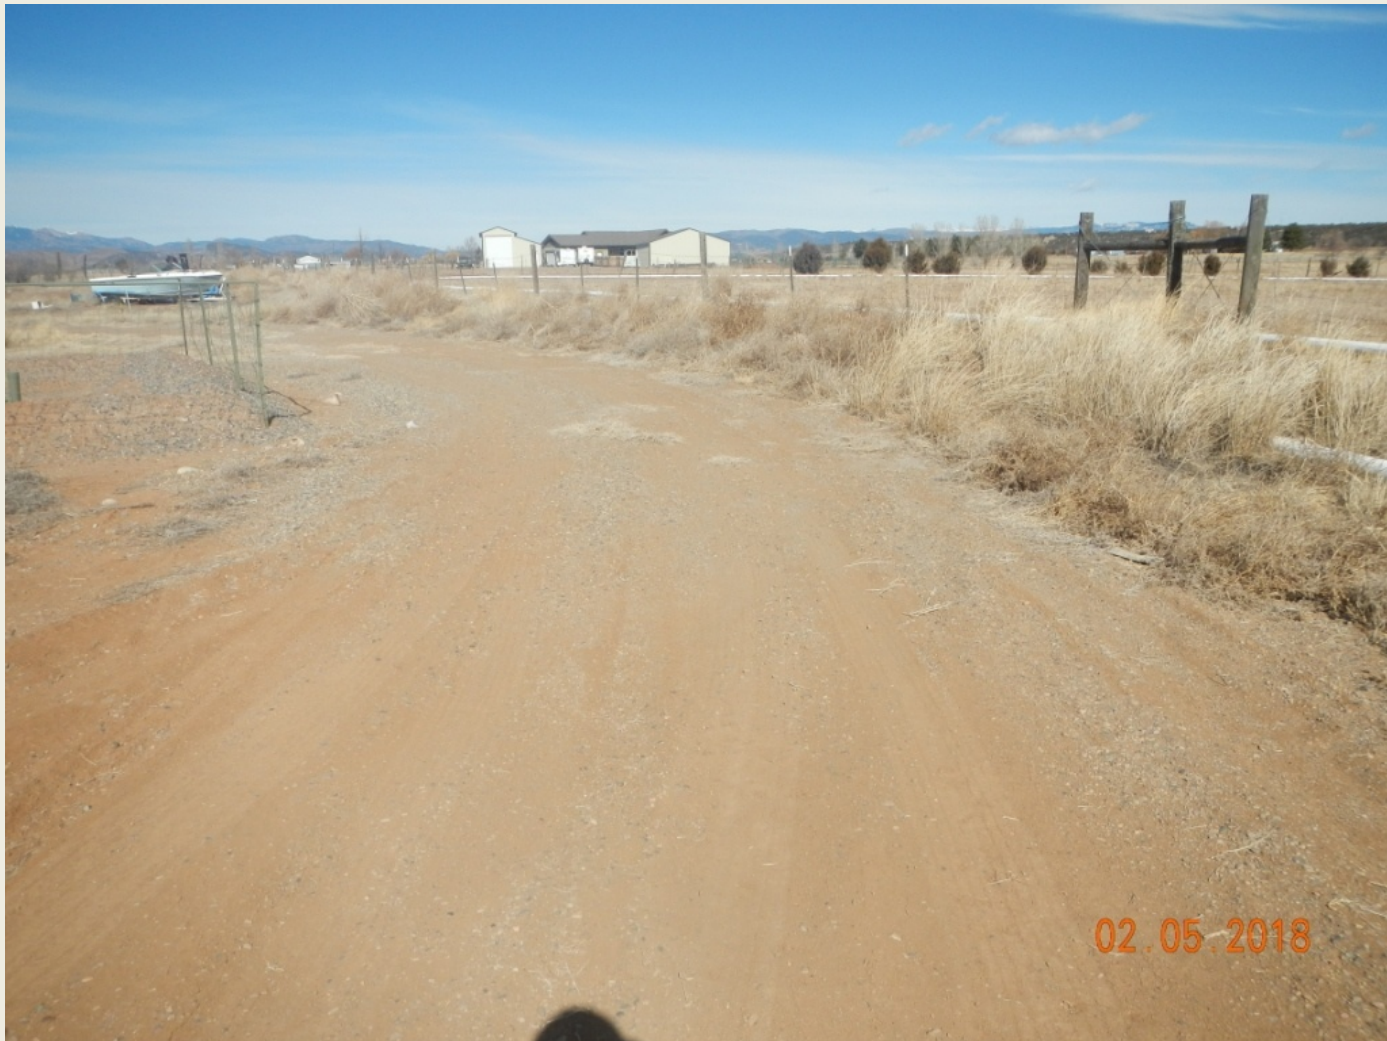
Photo 4. View of the eastern portion of the project area from the southeastern edge facing northward. Russian thistle and kochia debris from the project area is blowing and gathering on the eastern fence (observed during inspection). This debris needs to be cleaned and properly disposed of.
