Inspection Photos
Location Name: UPRR 50 PAN AM D-1
API: 05-123-09386

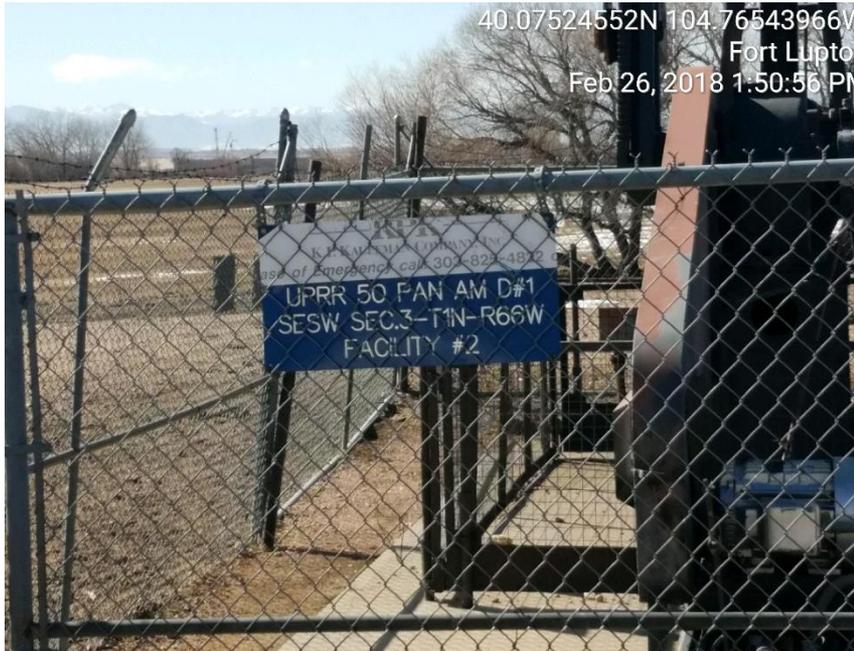
Pumping jack signage looking west

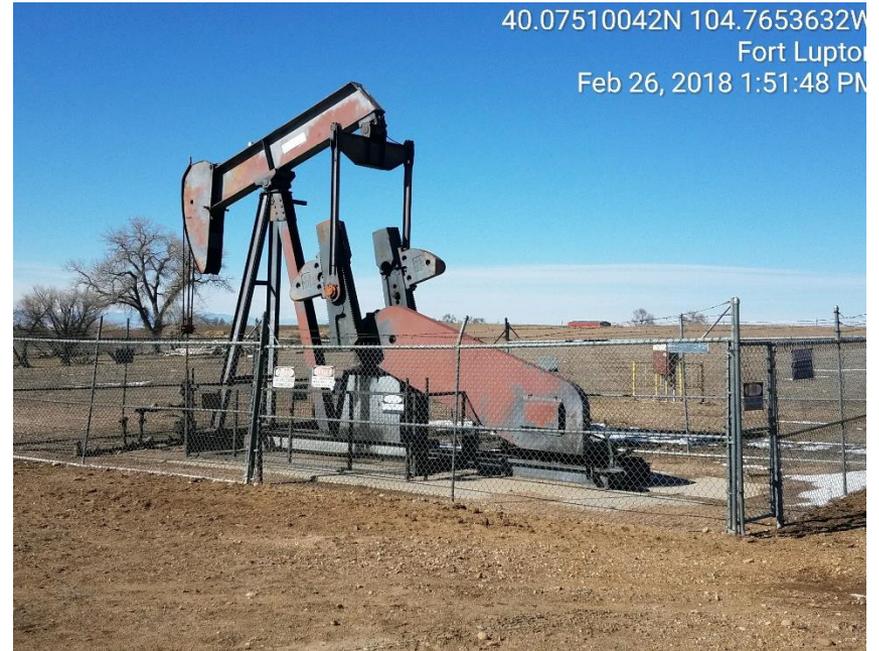
Location site looking NW

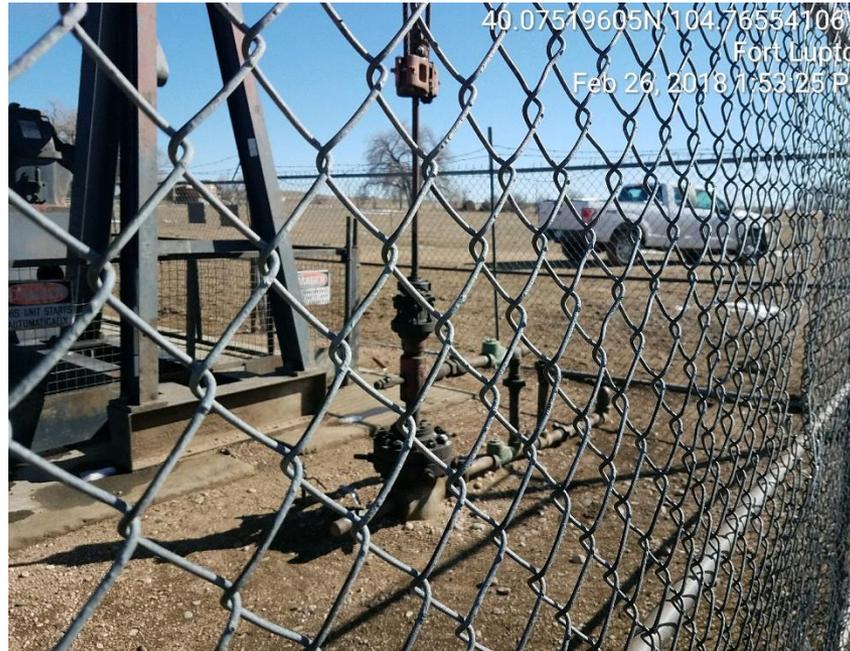
Wellhead looking SE
