Inspection Photos

Operator: WESTERN OPERATING COMPANY -
95620

Location ID: 312292

Inspection Doc. Number: 682503171
Logan County, CO

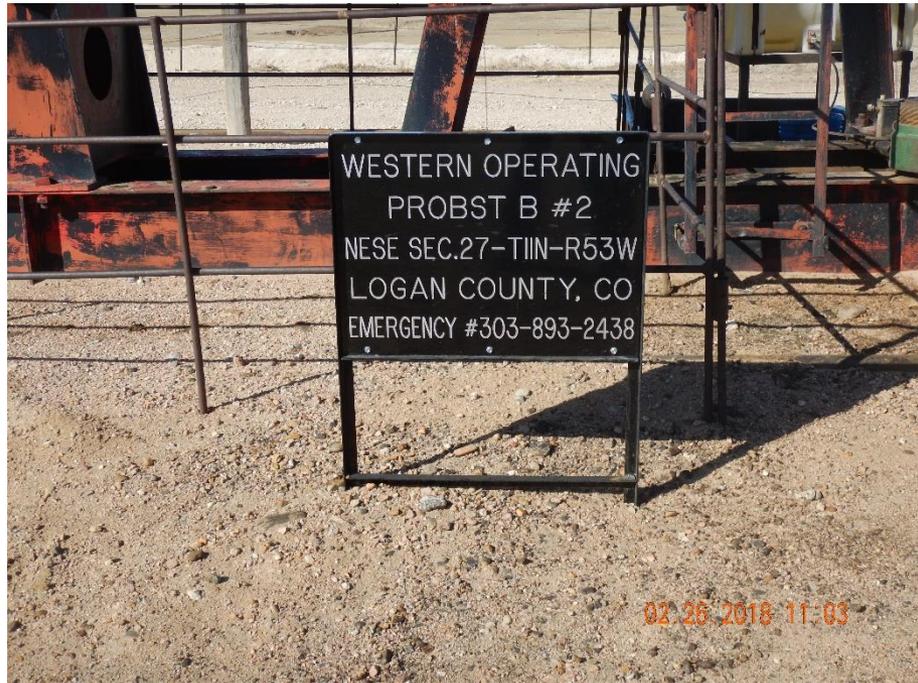
Photo 1: Photo of sign at the well.

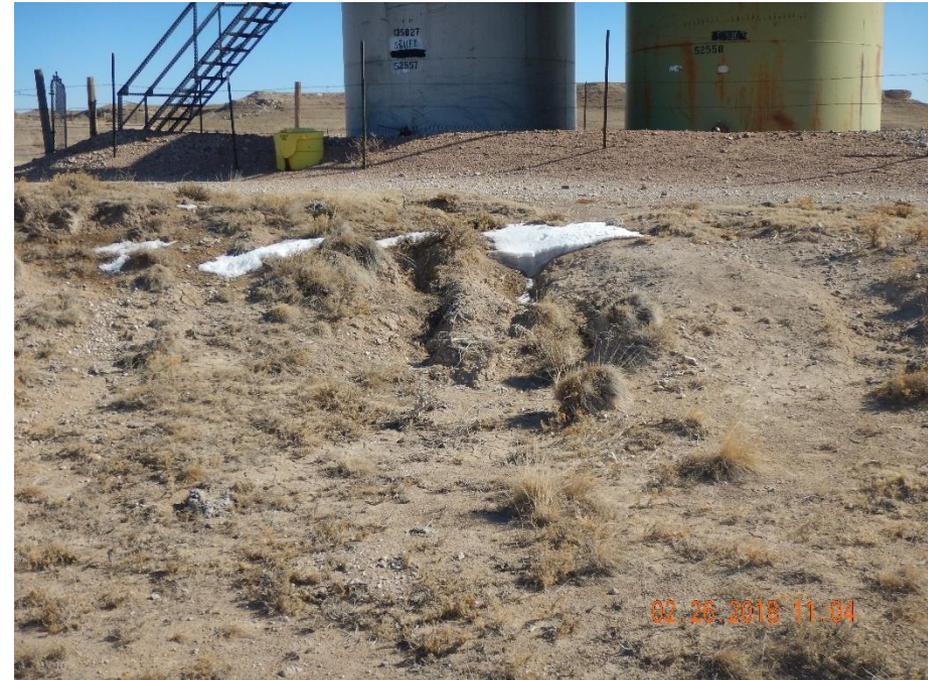
Photo 2: Photo taken from the central area of the location, facing east. Photo shows areas of erosion degradation. Erosion has not been repaired or stabilized and no BMPs have been installed or maintained per corrective actions.

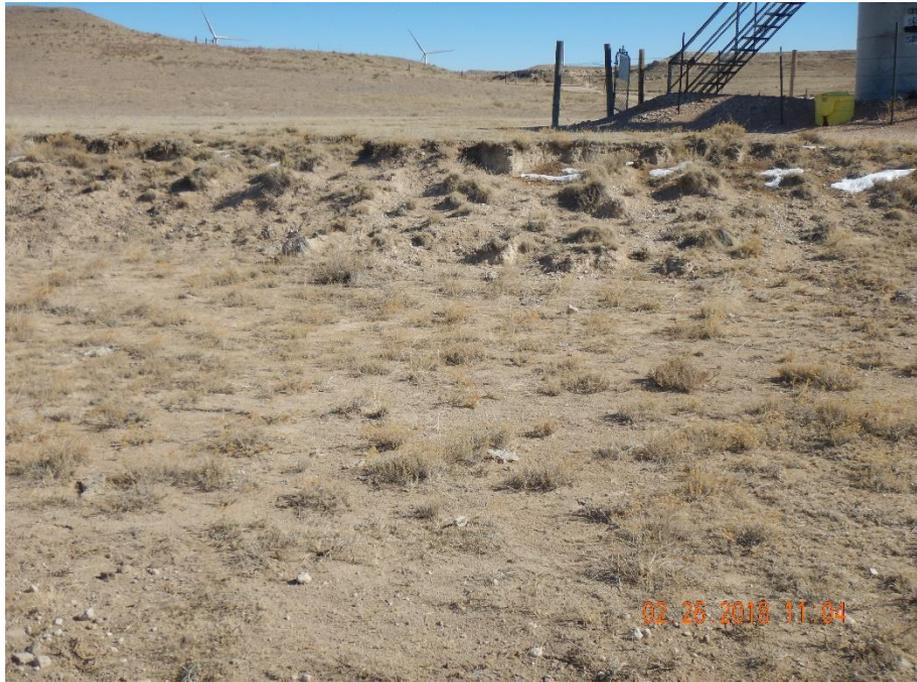
Photo 3: Photo taken from the central area of the location, facing east. Photo shows areas of erosion degradation. Erosion has not been repaired or stabilized and no BMPs have been installed or maintained per corrective actions.

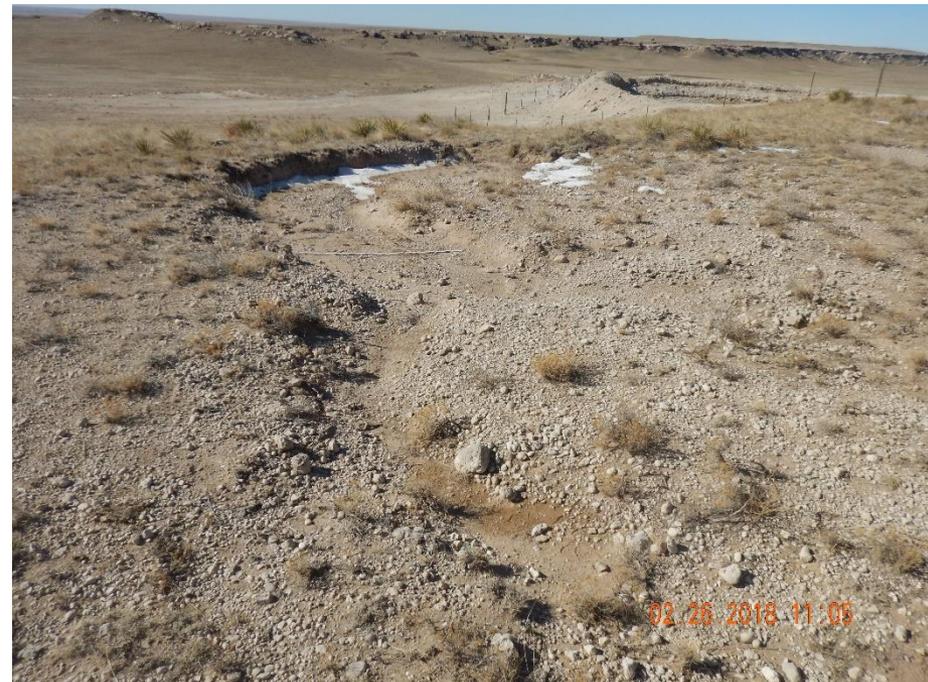
Photo 4: Photo taken from the south end of the location, facing west. Photo shows erosion degradation has not been repaired or stabilized, no BMPs have been installed or maintained, and no remediation and/or reclamation activities have been conducted per corrective actions.

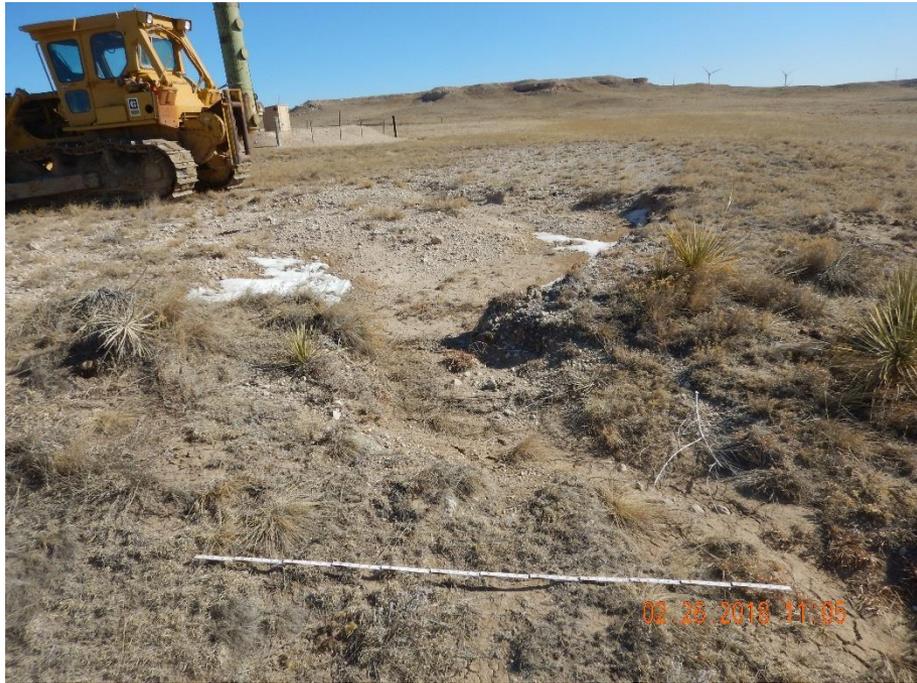
Photo 5: Photo taken from the south end of the location, facing east. See comments under photo 4. Six foot measuring stick for reference.

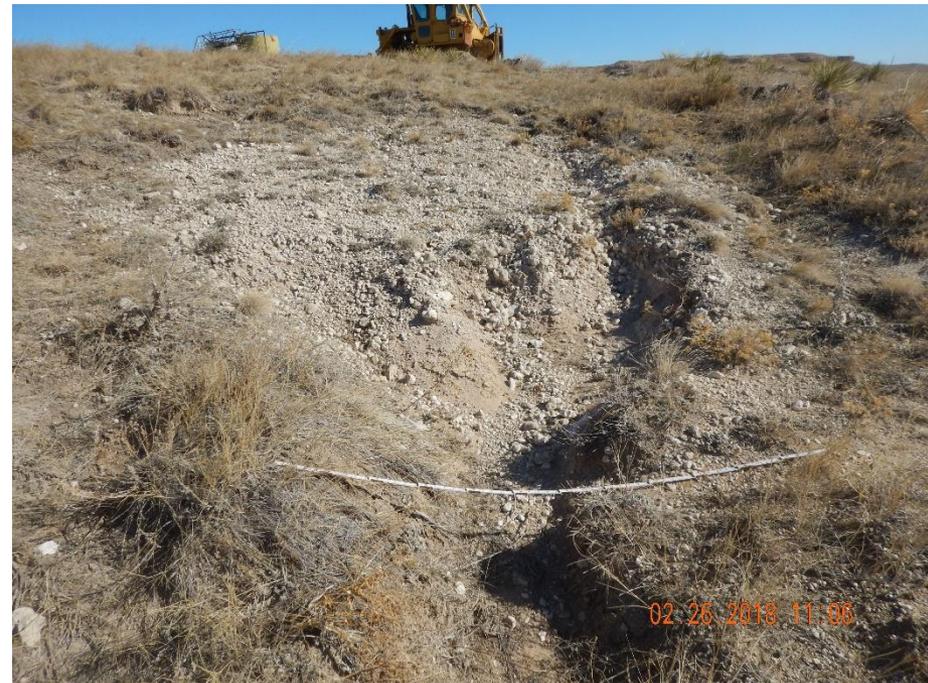
Photo 6: Photo taken from the south end of the location, facing east. See comments under photo 4. Six foot measuring stick for reference.

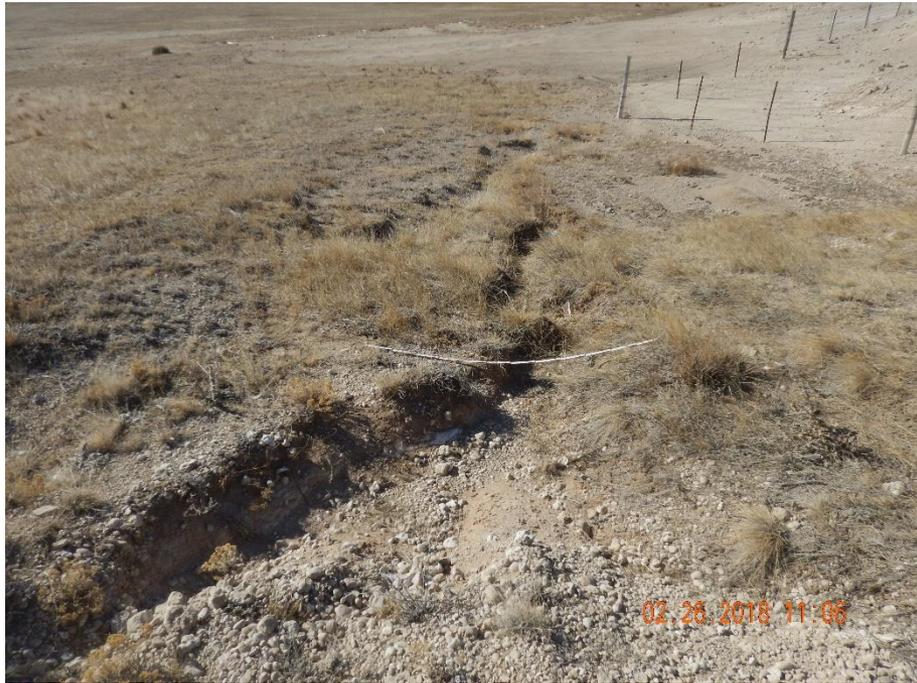
Photo 7: Photo taken from the south end of the location, facing southwest. See comments under photo 4. Six foot measuring stick for reference.

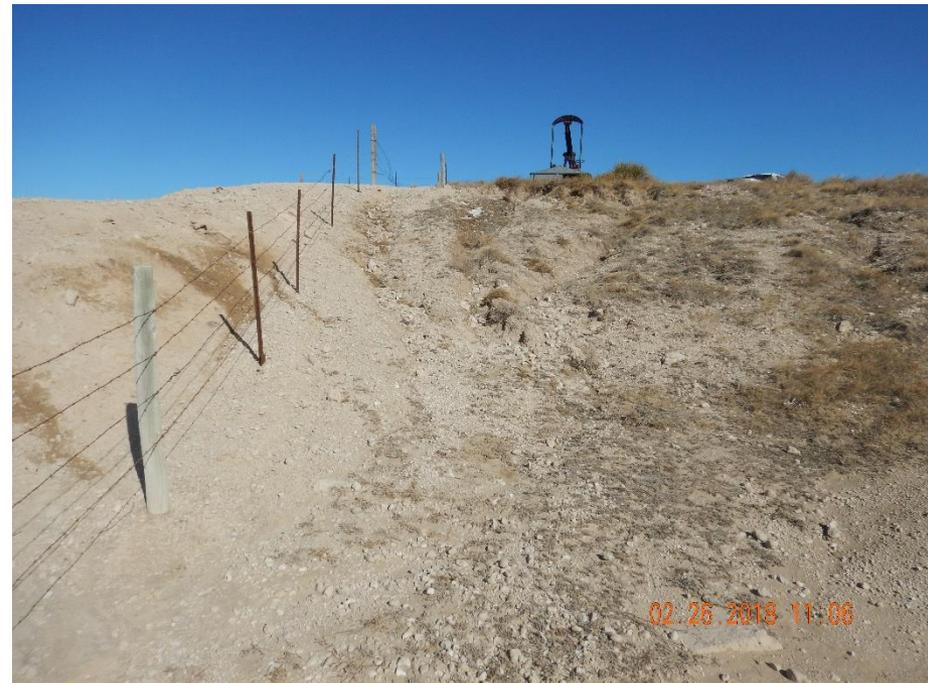
Photo 8: Photo taken from the south end of the location, facing north. See comments under photo 4.

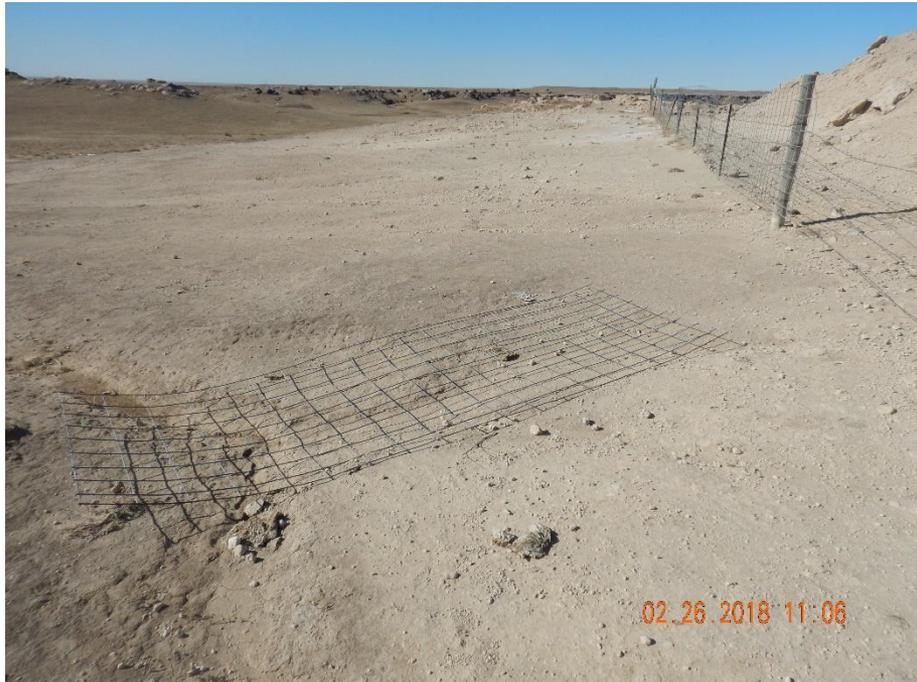
Photo 9: Photo taken from the southeast end of the produced water pit, facing west. Photo shows areas of erosion degradation on the adjacent lands due to runoff and salt kill. Photo shows no remediation activities appear to have been conducted, and no stabilization and stormwater BMPs have been installed or maintained per corrective actions.

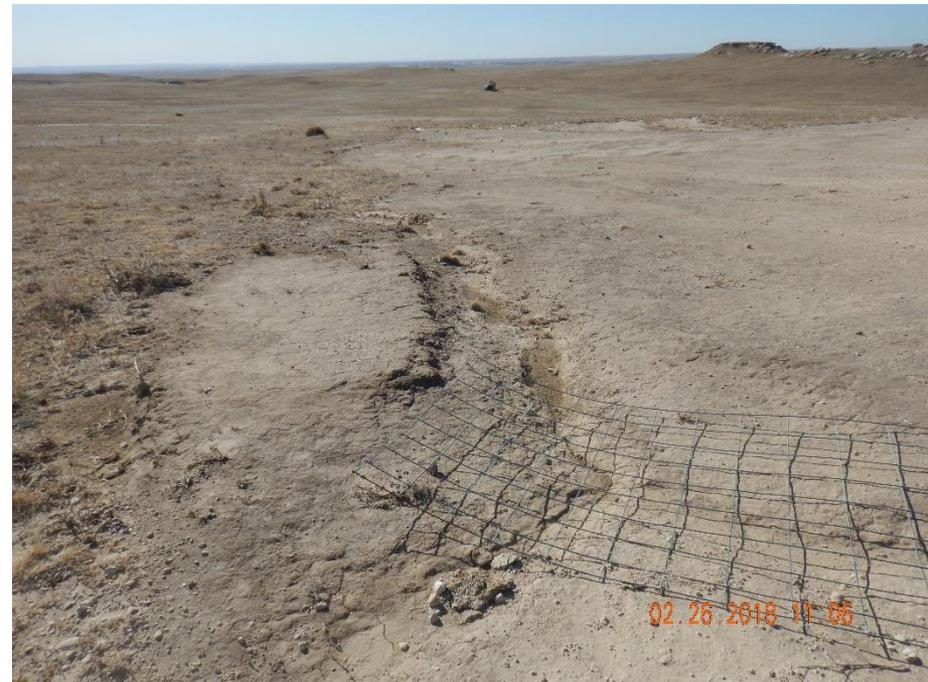
Photo 10: Photo taken from the southeast end of the produced water pit, facing south. See comments under photo 9.

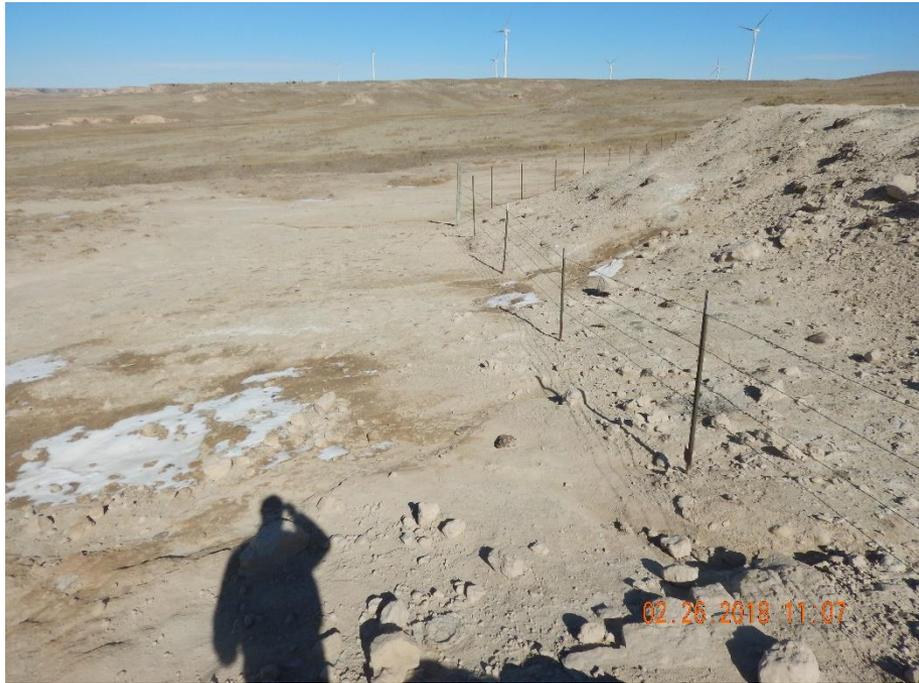
Photo 11: Photo taken from the southwest end of the produced water pit, facing north. See comments under photo 9.

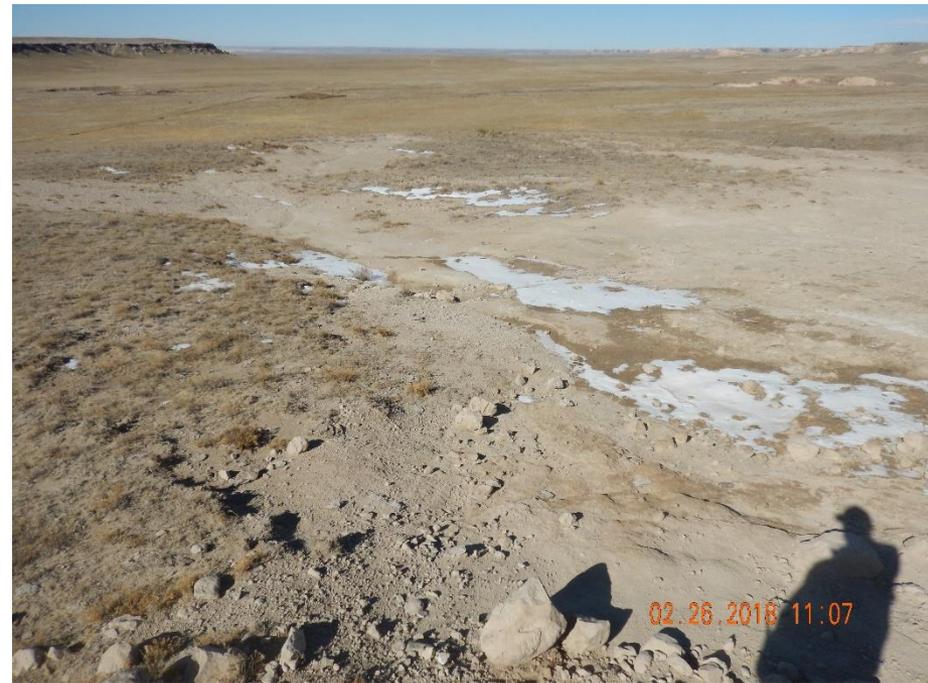
Photo 12: Photo taken from the southwest end of the produced water pit, facing west. See comments under photo 9.

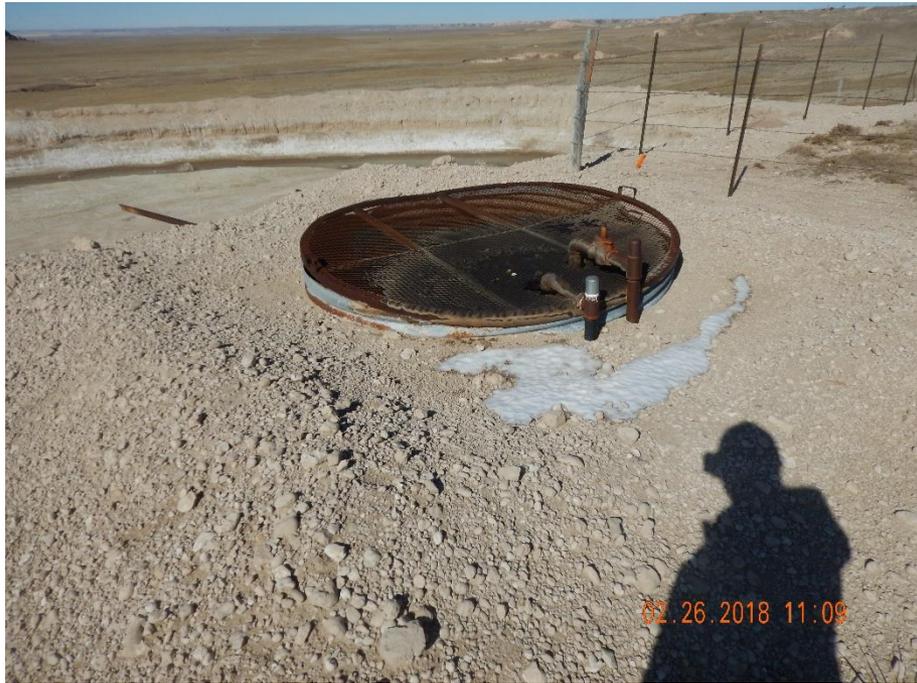
Photo 13: Photo taken from the east end of the pit, facing northwest. Photo shows tinhorn has not been removed.

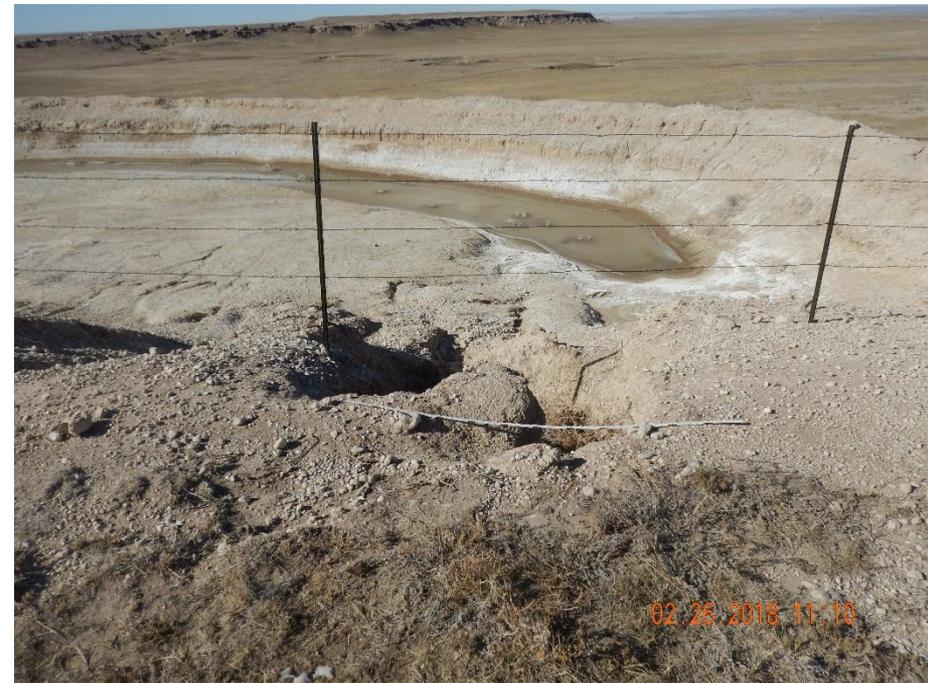
Photo 14: Photo taken from the east end of the produced water pit, facing west. Photo shows erosion degradation has not been repaired or stabilized, no BMPs have been installed or maintained, and no remediation and/or reclamation activities have been conducted per corrective actions.

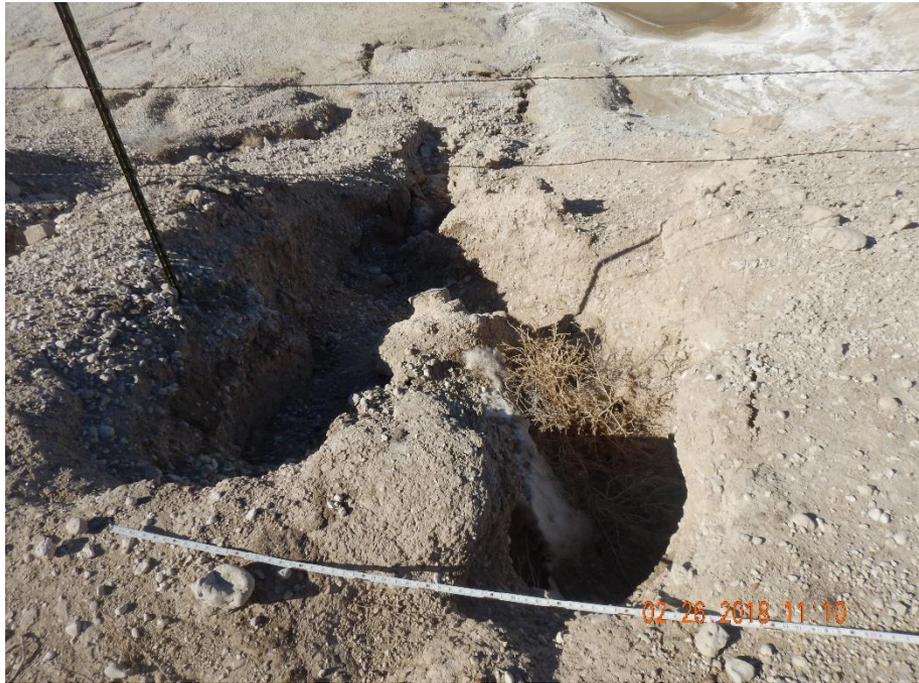
Photo 15: Photo taken from the east end of the produced water pit, facing west. See comments under photo 14. 6 foot measuring stick for reference.

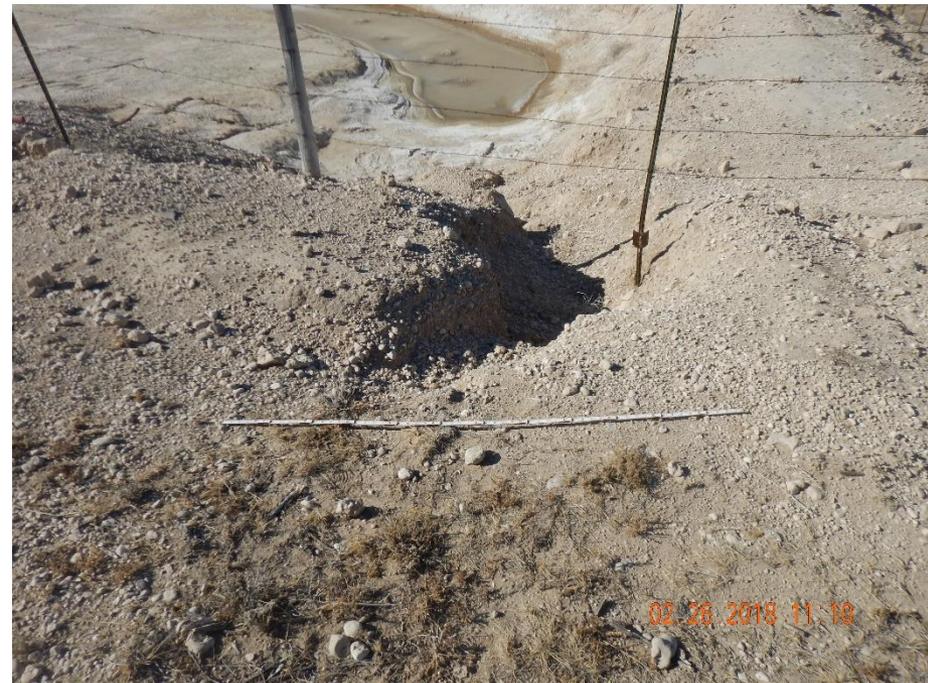
Photo 16: Photo taken from the east end of the produced water pit, facing west. See comments under photo 14. 6 foot measuring stick for reference.
