Interim Reclamation and Stormwater Inspection

February 14, 2018

Operator: EXTRACTION OIL & GAS LLC- #10459

Location ID: 439079

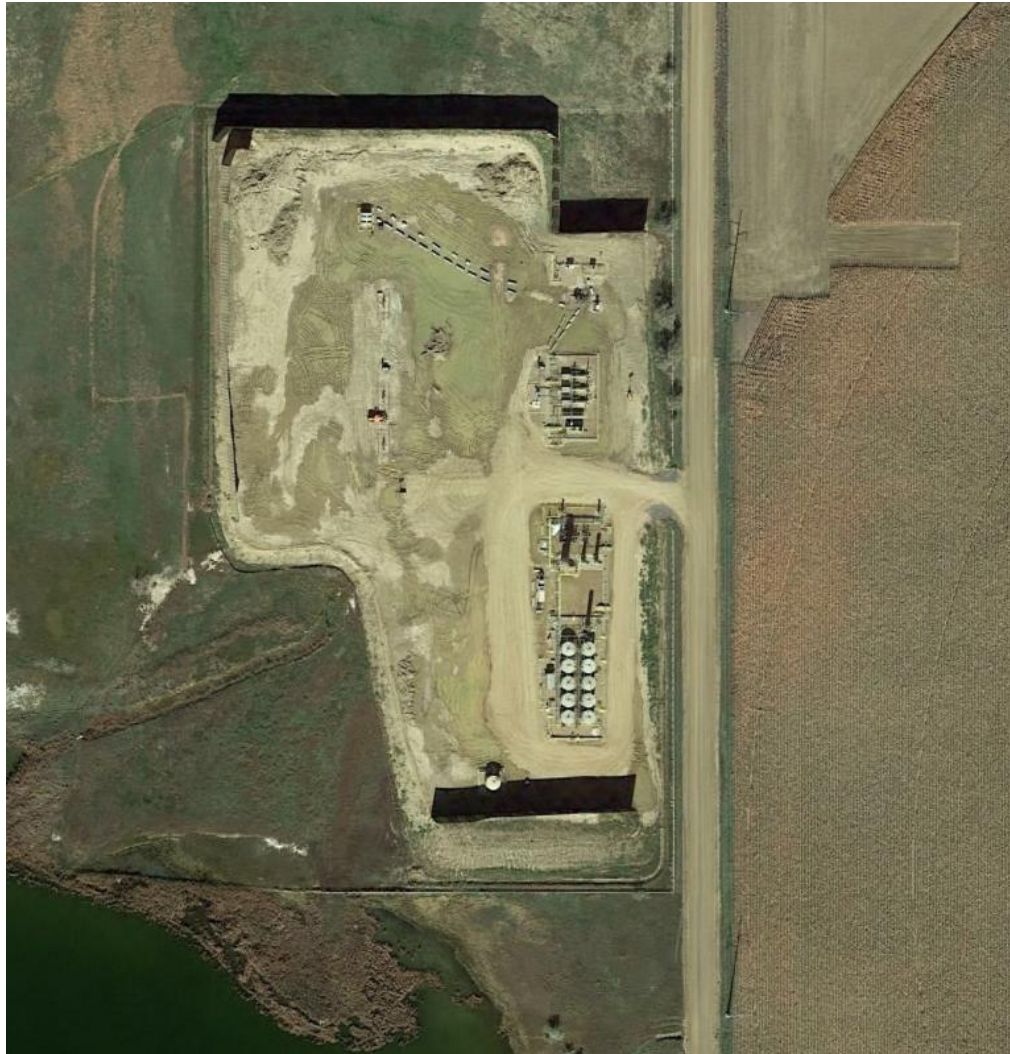
Google Earth aerial photo taken October 14, 2017 of the Kennedy Pad, totaling 8.03 acres of construction disturbance. This is the current state of total disturbance observed on February 14, 2018. Operator has failed to perform interim reclamation by the required date.

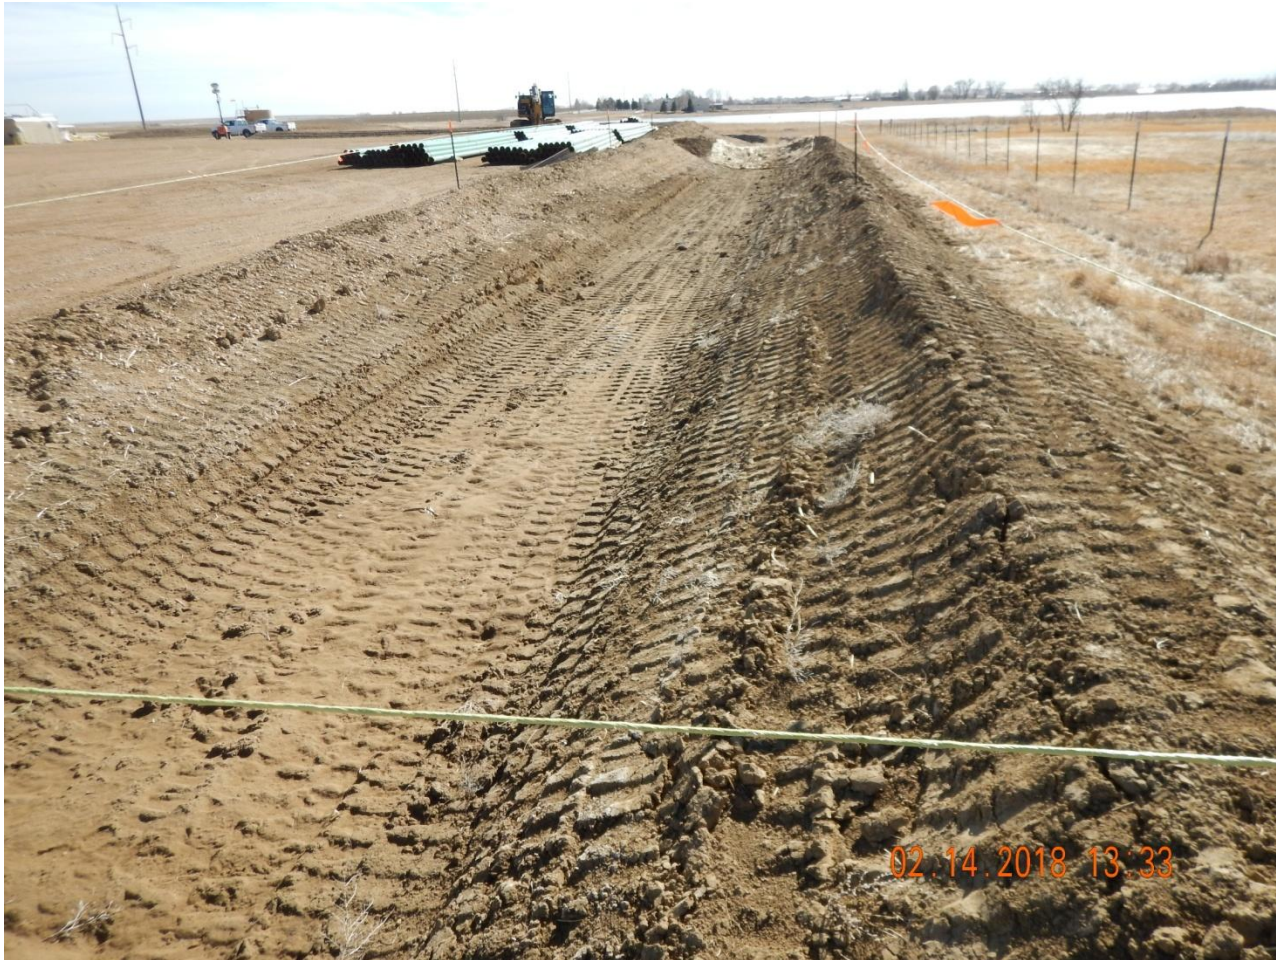
Photo 1. Photo taken from the western sediment basin, facing South. Operator has installed a sediment basin increasing the sediment storage area. However, Operator has not constructed to the sediment basin per the Stormwater Technical Drainage Analysis Memo.

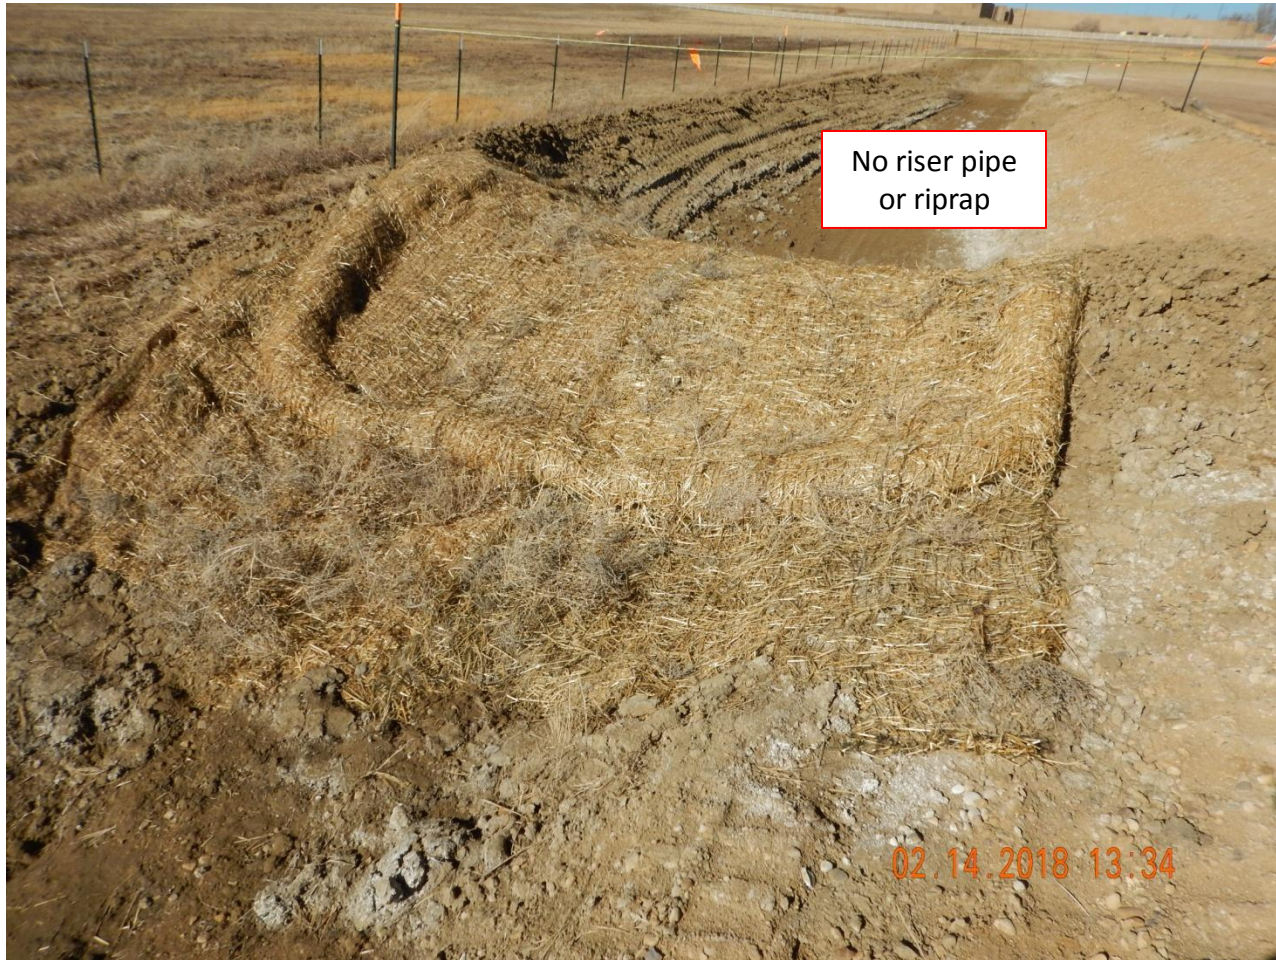
Photo 2. Photo taken from the western sediment basin spillway, facing North. See comments under Photo 1. Operator has not installed a riser pipe and the spillway has not been constructed with riprap.

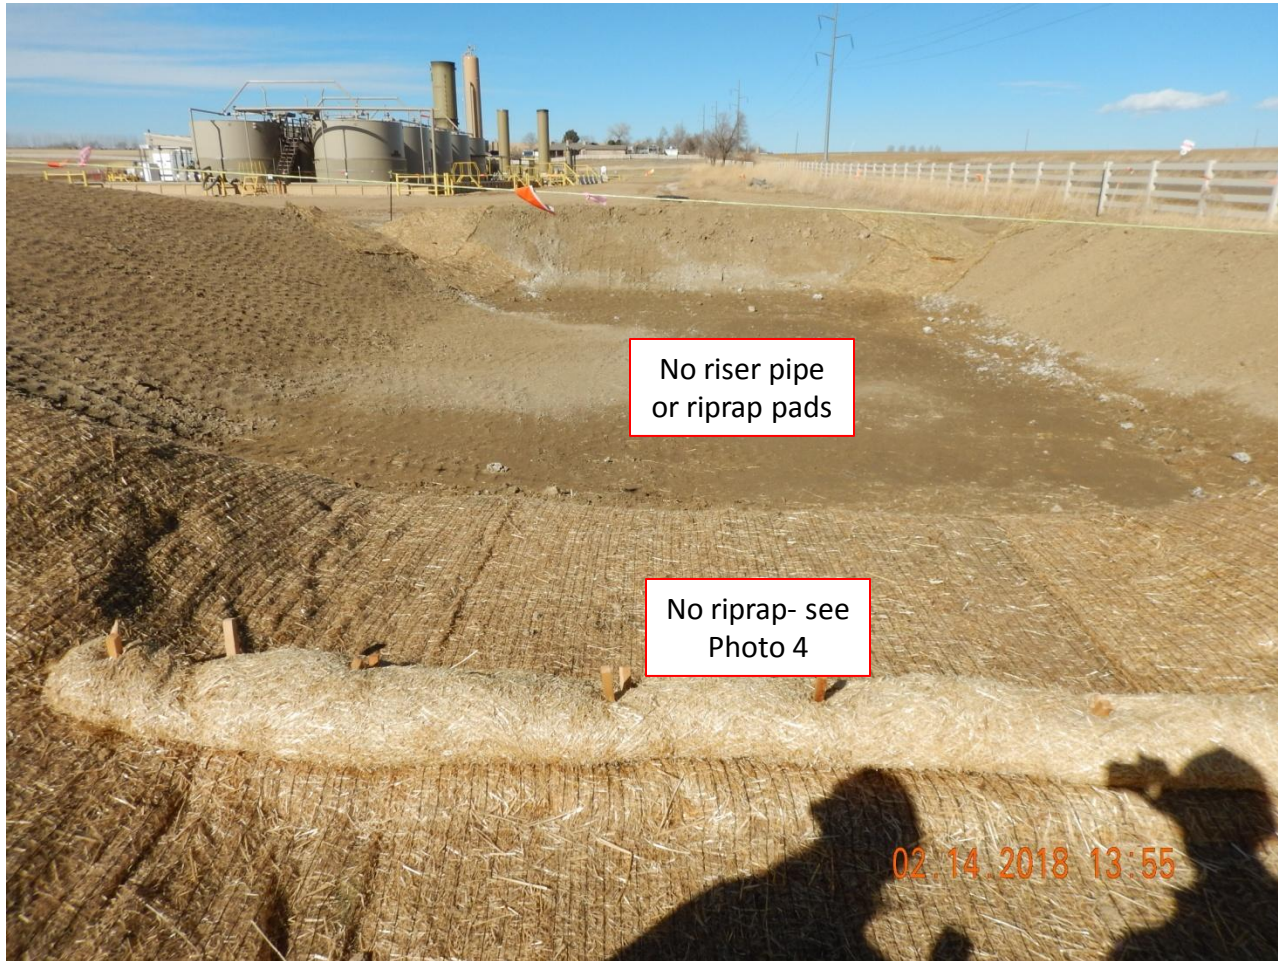
Photo 3. Photo taken from the southeast sediment basin, facing North. See comments under Photo 1.

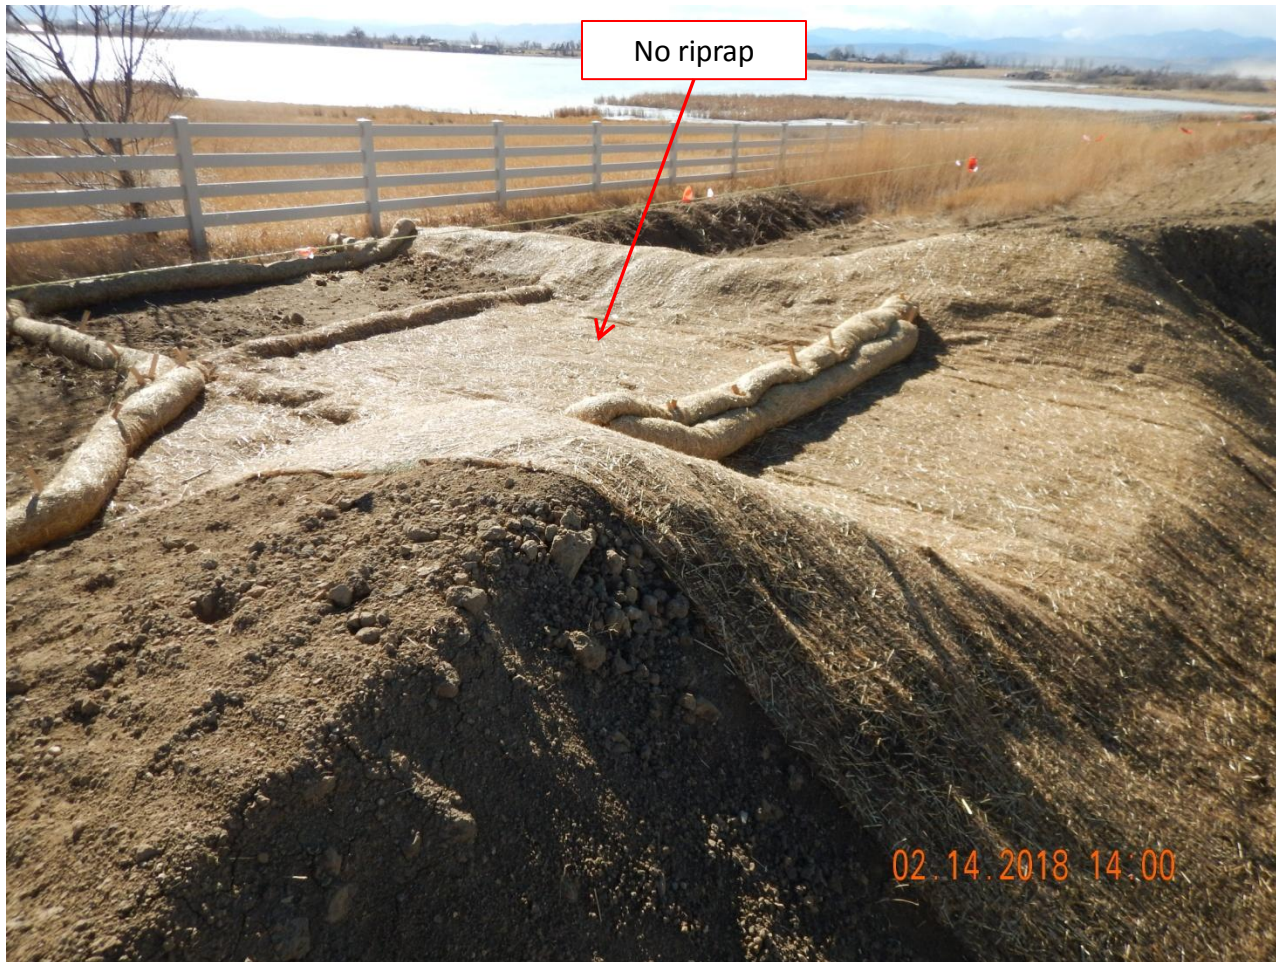
Photo 4. Photo taken from the southeast sediment basin spillway, facing Southwest. See comments under Photo 2.

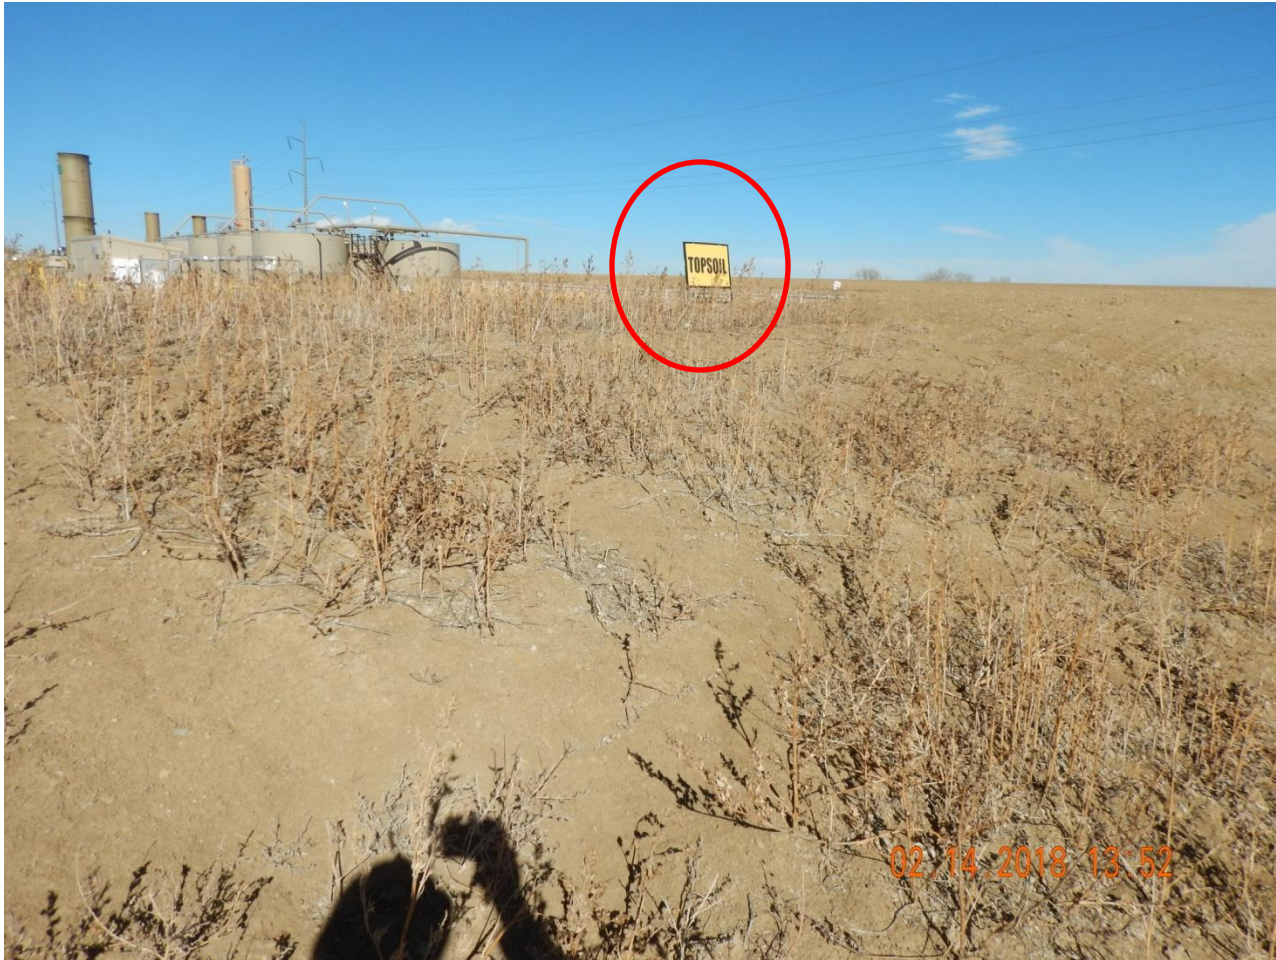
Photo 5. Photo taken from the topsoil stockpile, facing East. Operator has failed to prevent weed establishment on the topsoil stockpile per Rule 1002.

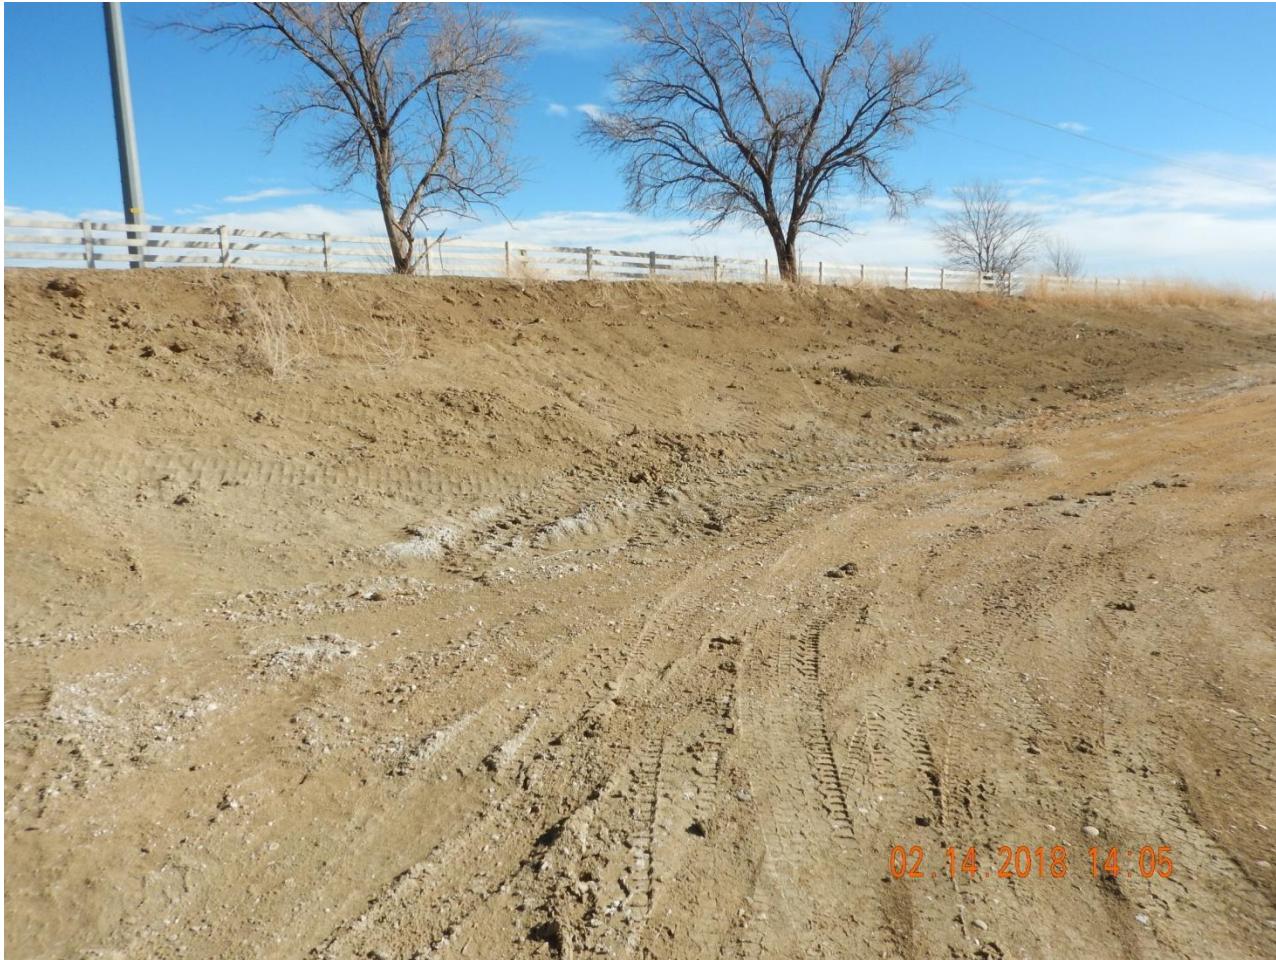
Photo 6. Photo taken from the northeastern location, facing East. Operator has not properly stabilized the cut slope which is susceptible to erosion.

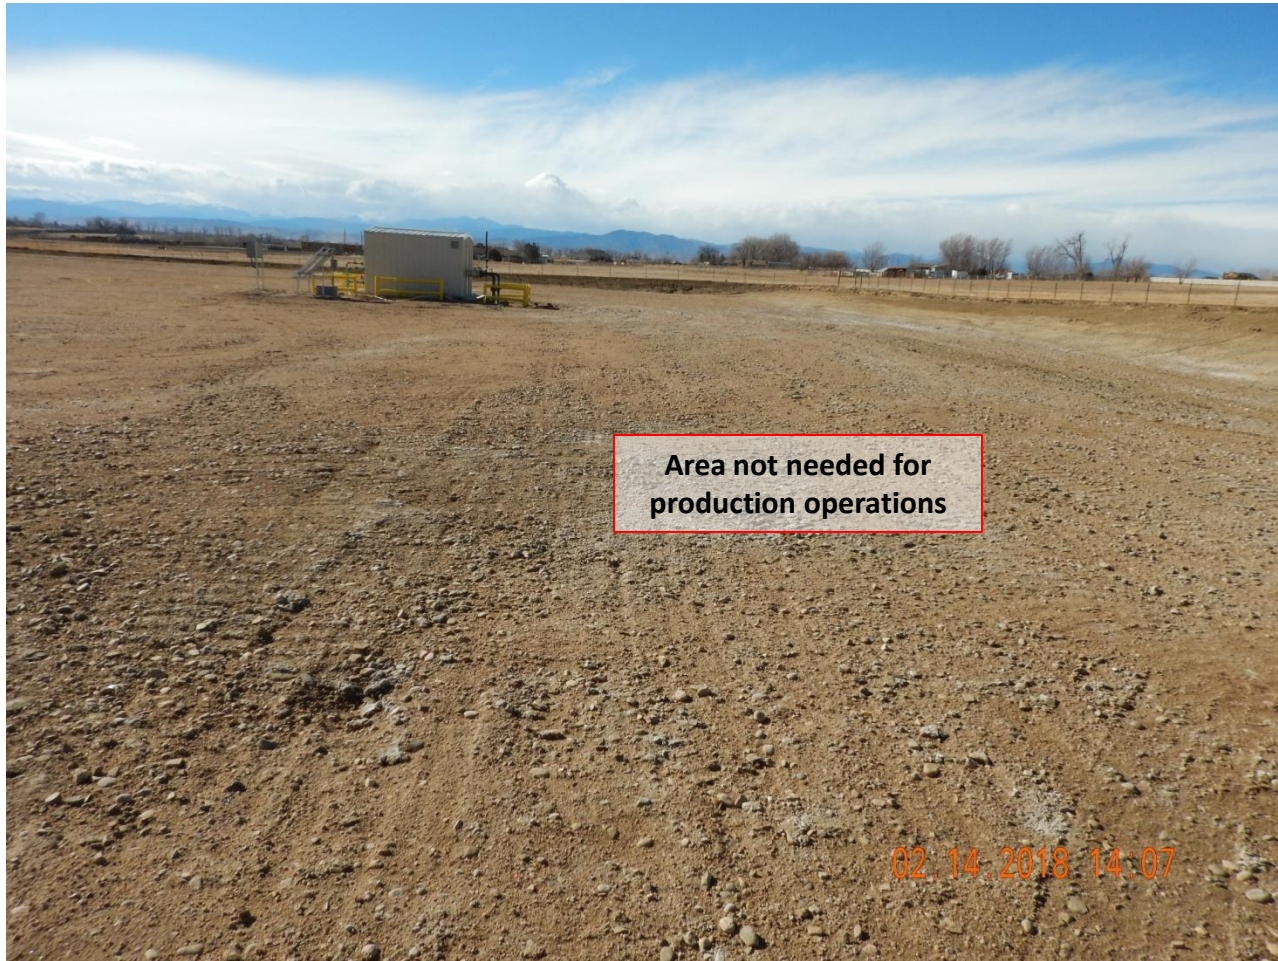
Photo 7. Photo taken from the northeastern location, facing West. Operator has failed to perform interim reclamation per Rule 1003.

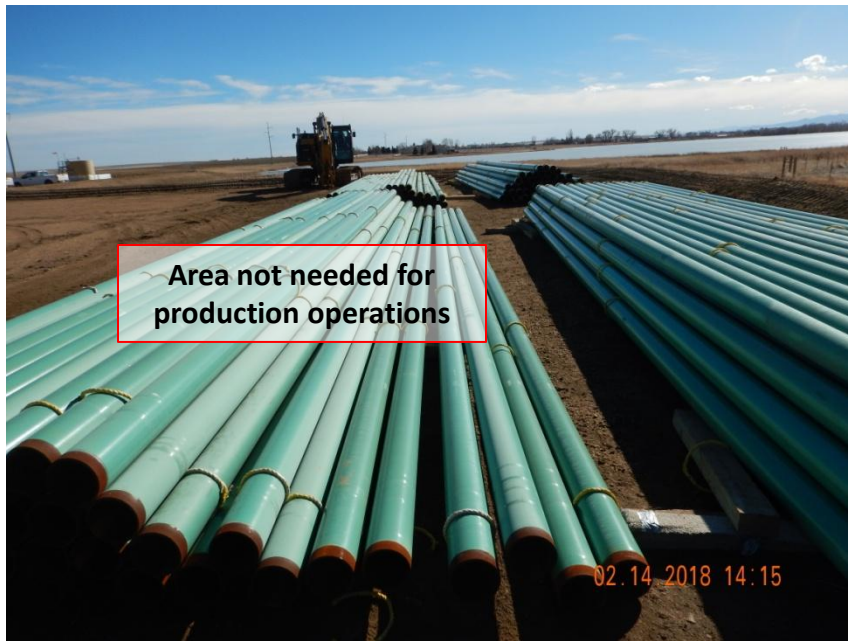
Photo 8. Photo taken from the western location, facing South. Operator is storing equipment in areas that should be reclaimed per Rule 1003.

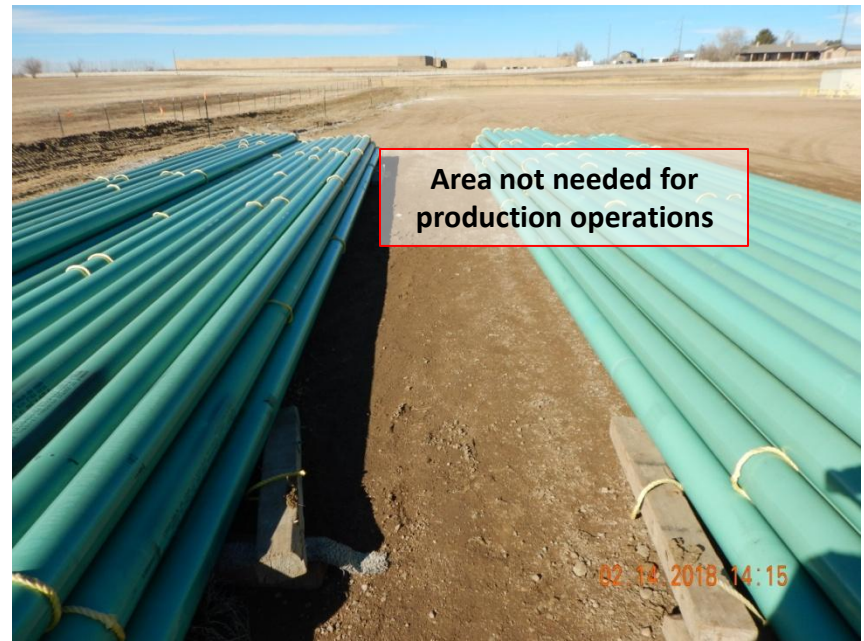
Photo 9. Photo taken from the western location, facing North. See comments under Photo 8.

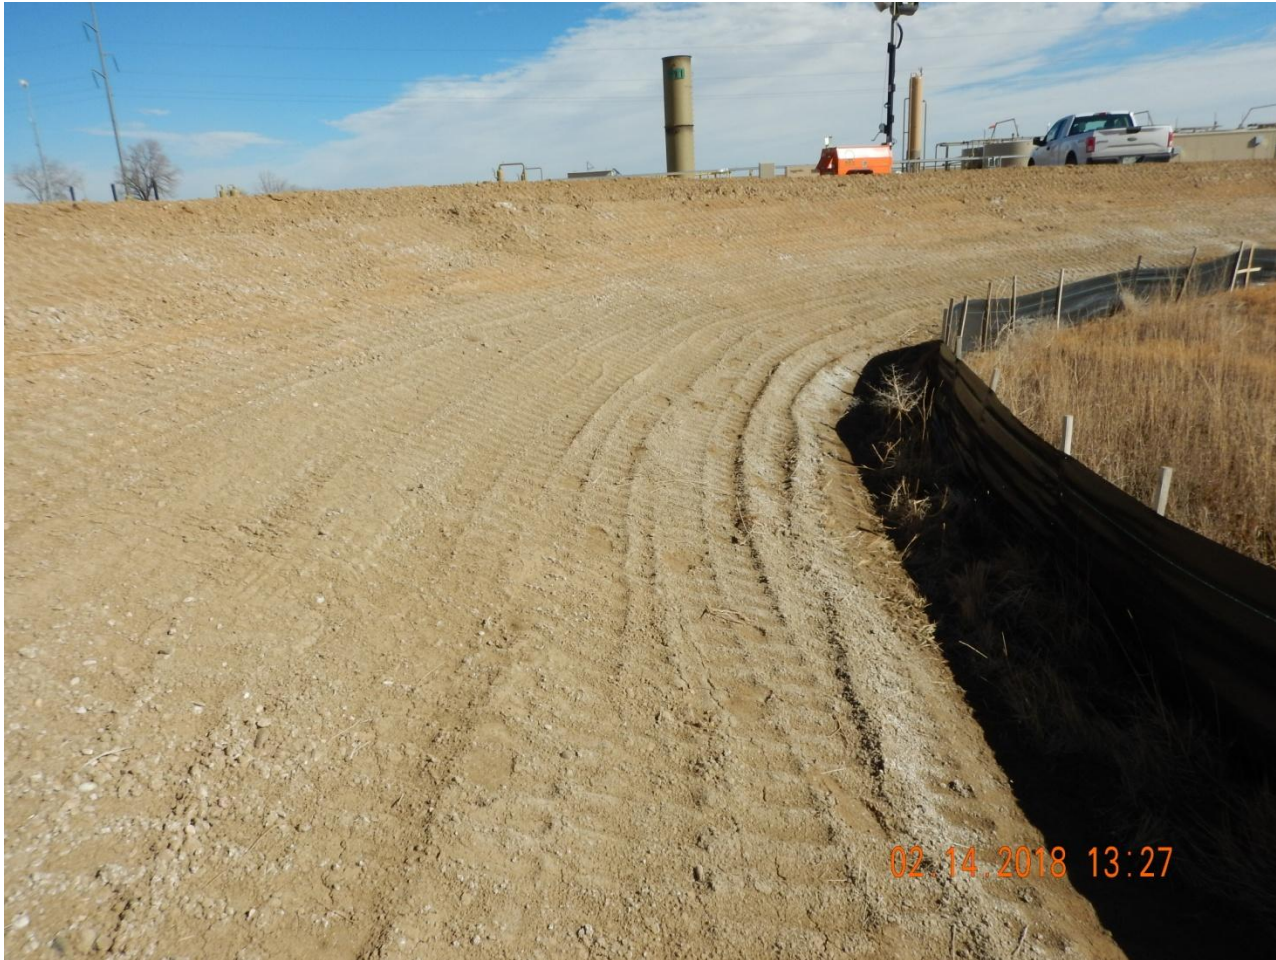
Photo 10. Photo taken from the western location, facing East. Operator has improperly tracked the western side slopes. Equipment tracking should be tracked perpendicular to the slope.
