**Inspection Photos**  
**Location Name: Royce State #36-2**  
**API: 05-067-07473**

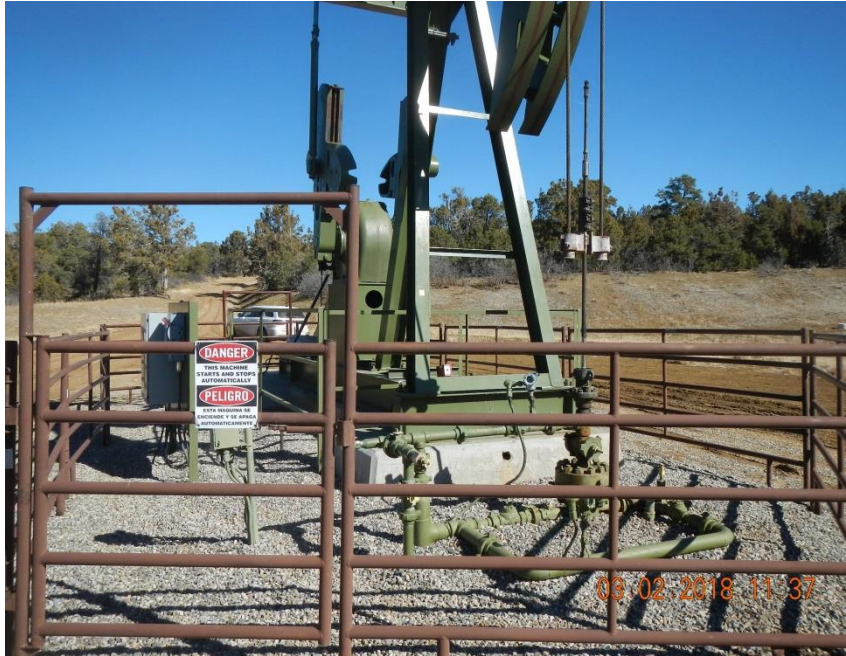
**Royce State #36-2 pump jack and well head.**

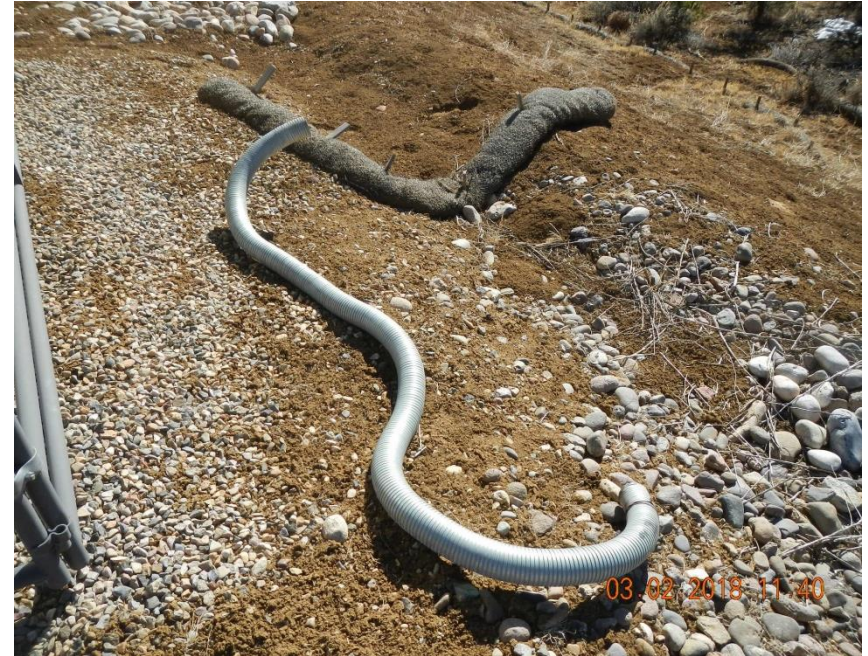
**Unused section of flex pipe on southern edge of location.**

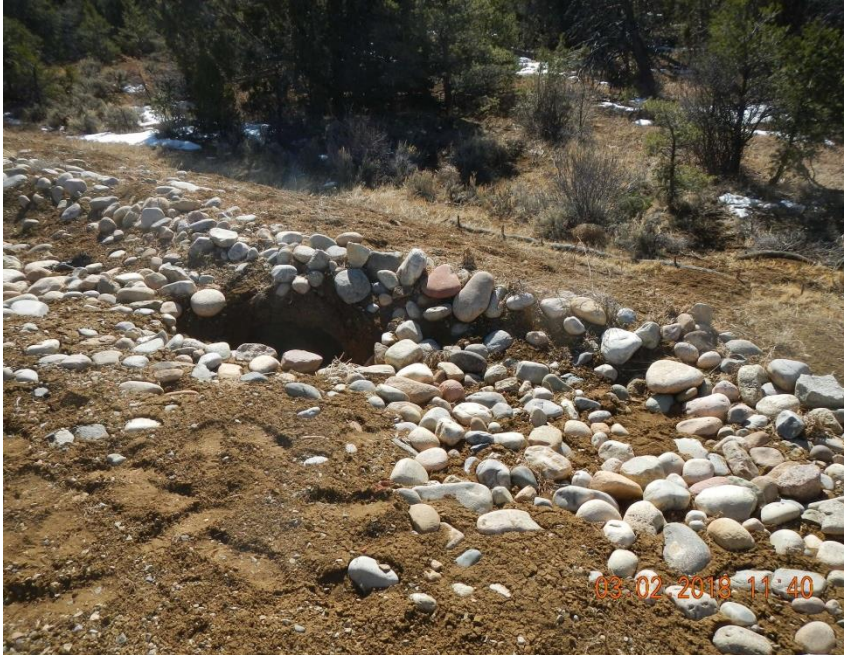
**Storm water BMP in disrepair.**

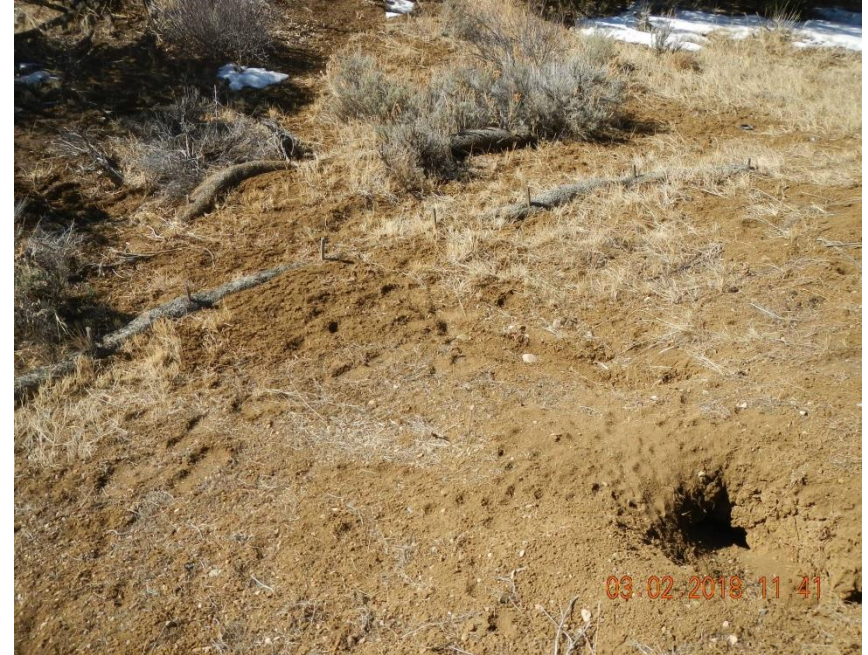
**Wattles along southern edge of location have filled in with sediment.**

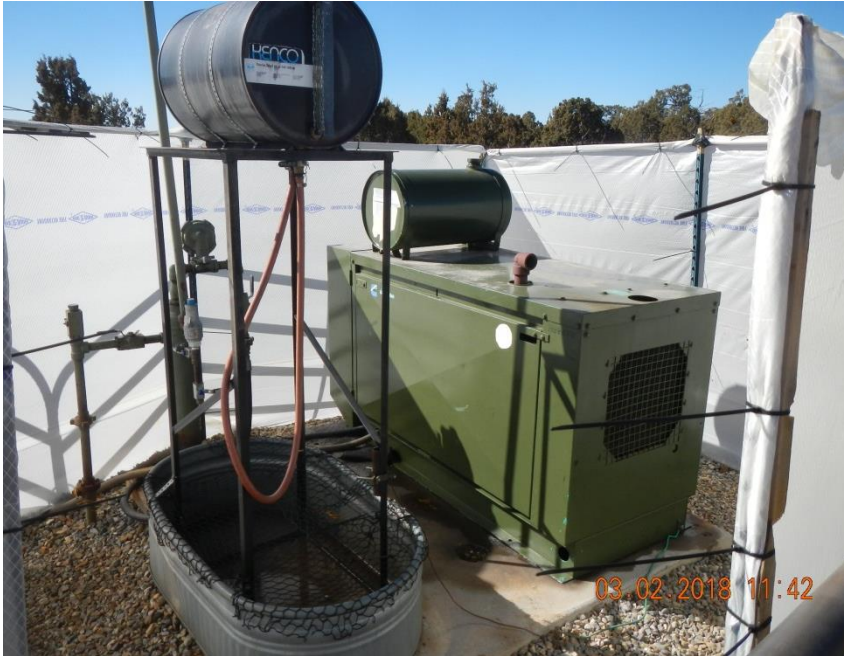
**Lube oil container with secondary containment and leaking generator.**

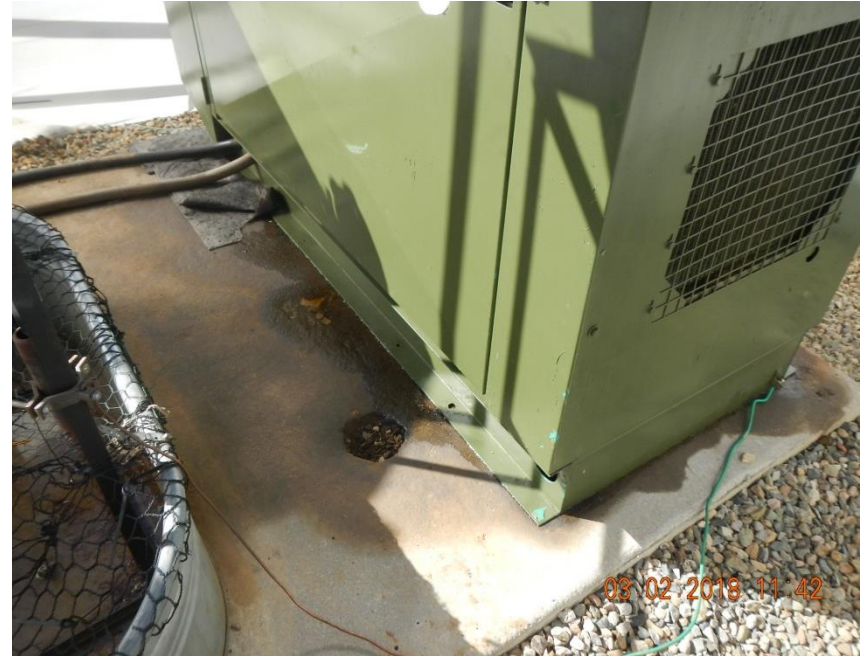
**Lube oil leaking from equipment.**
