# Inspection Photos

API: 05-067-08680

Operator: BP AMERICA PRODUCTION COMPANY

Inspection Date: 3/7/2018

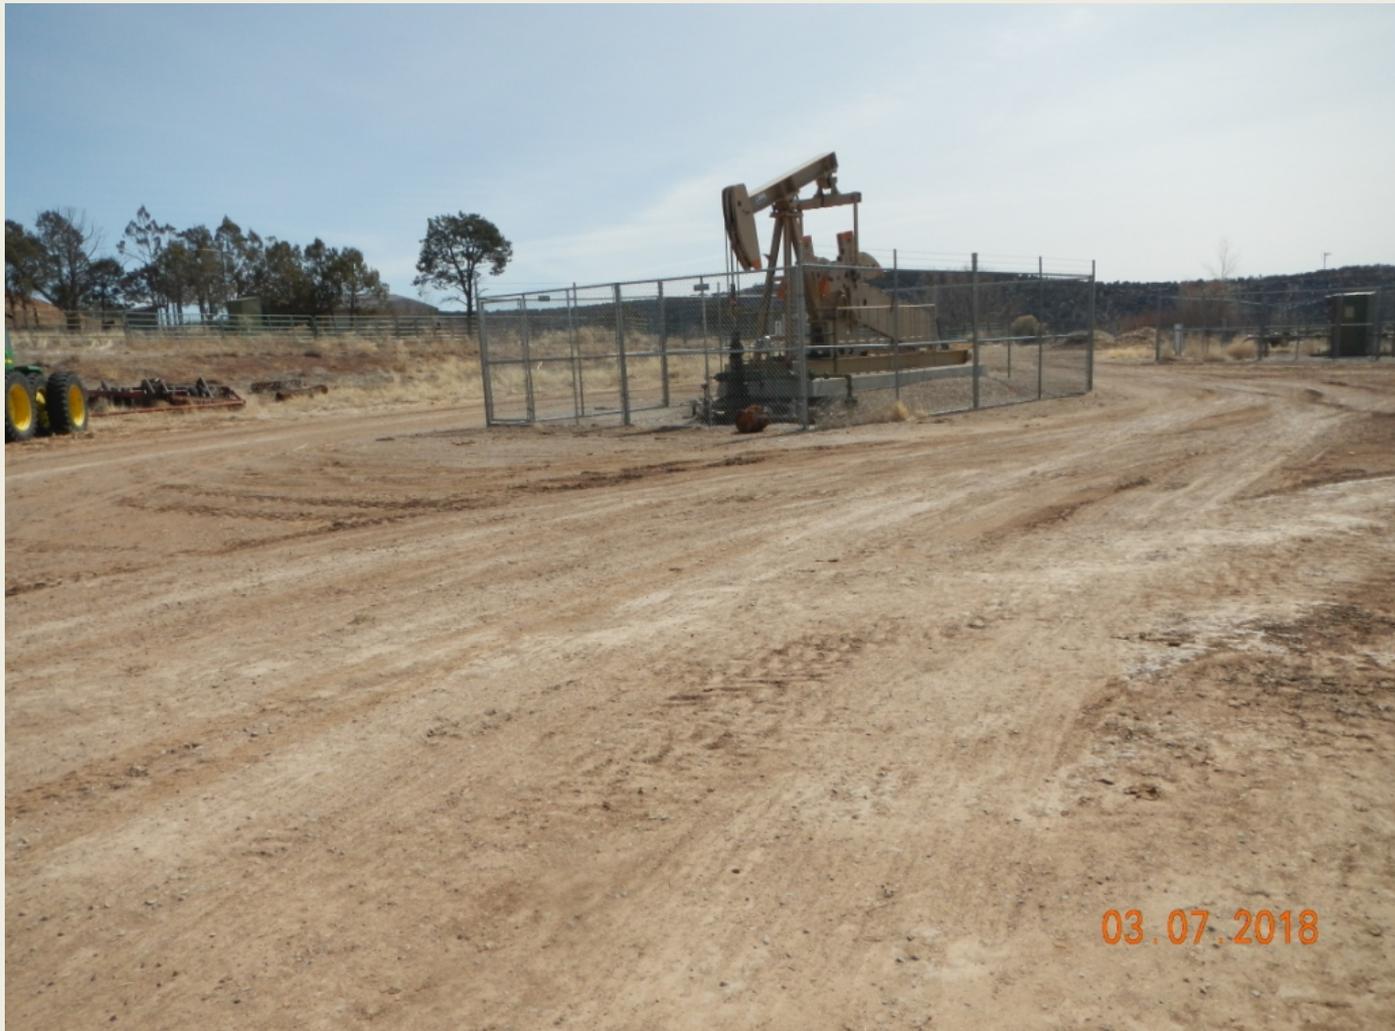
**Photo 1. View of the project area from the northwestern corner facing center.**

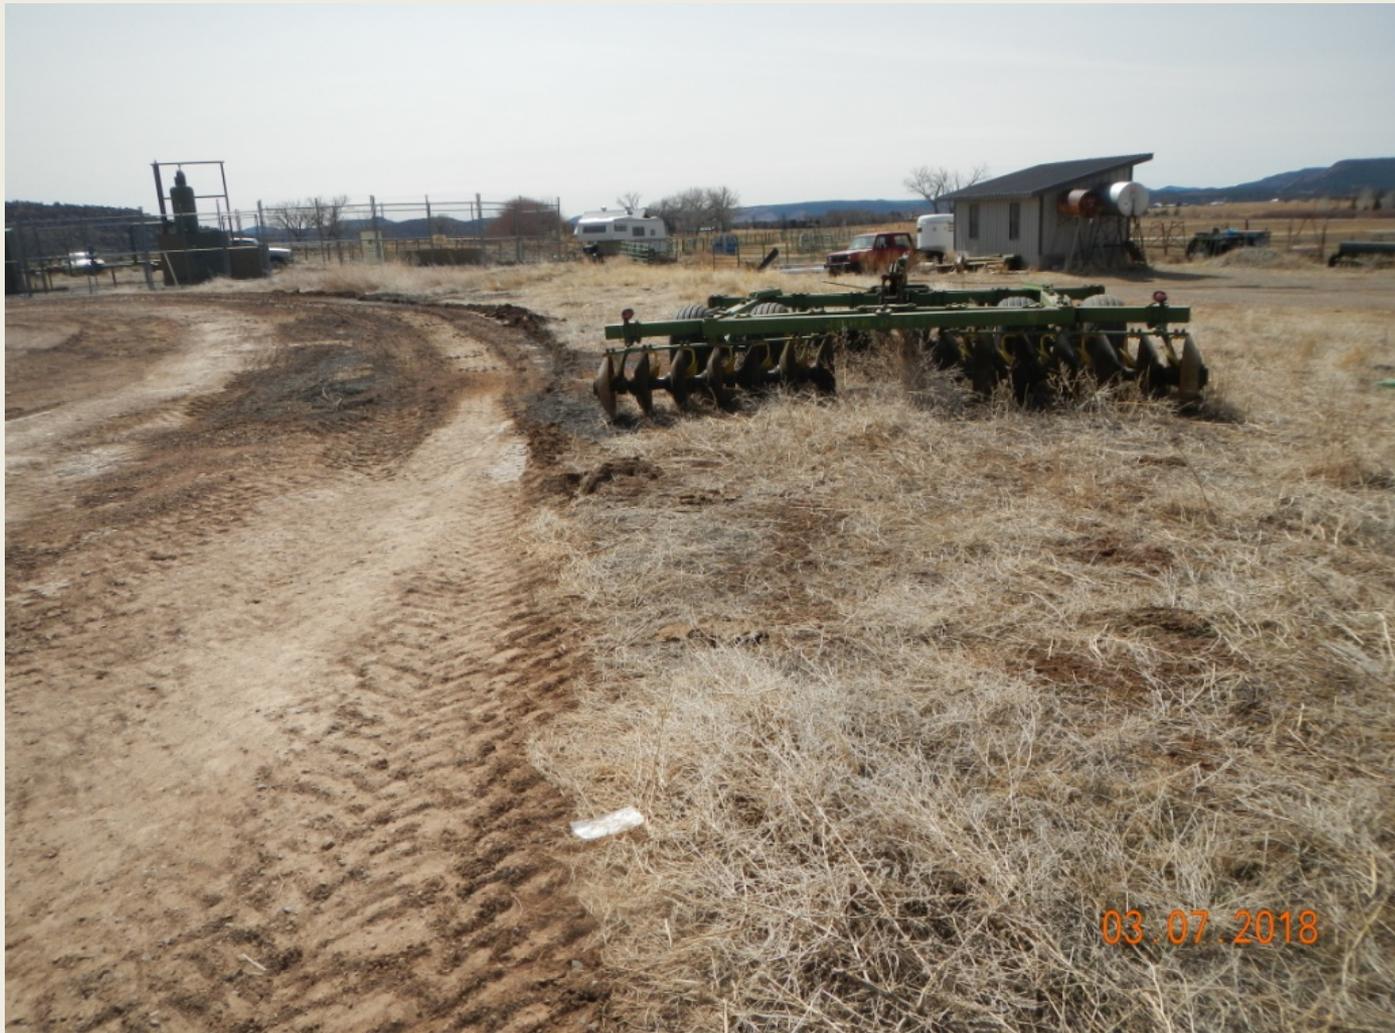
**Photo 2. View of the western portion of the project area from the northwestern corner facing southward. Revegetation is weedy with some desirable vegetation such as intermediate wheatgrass (*Thinopyron intermedium*). Surface owner equipment storage is inhibiting revegetation.**

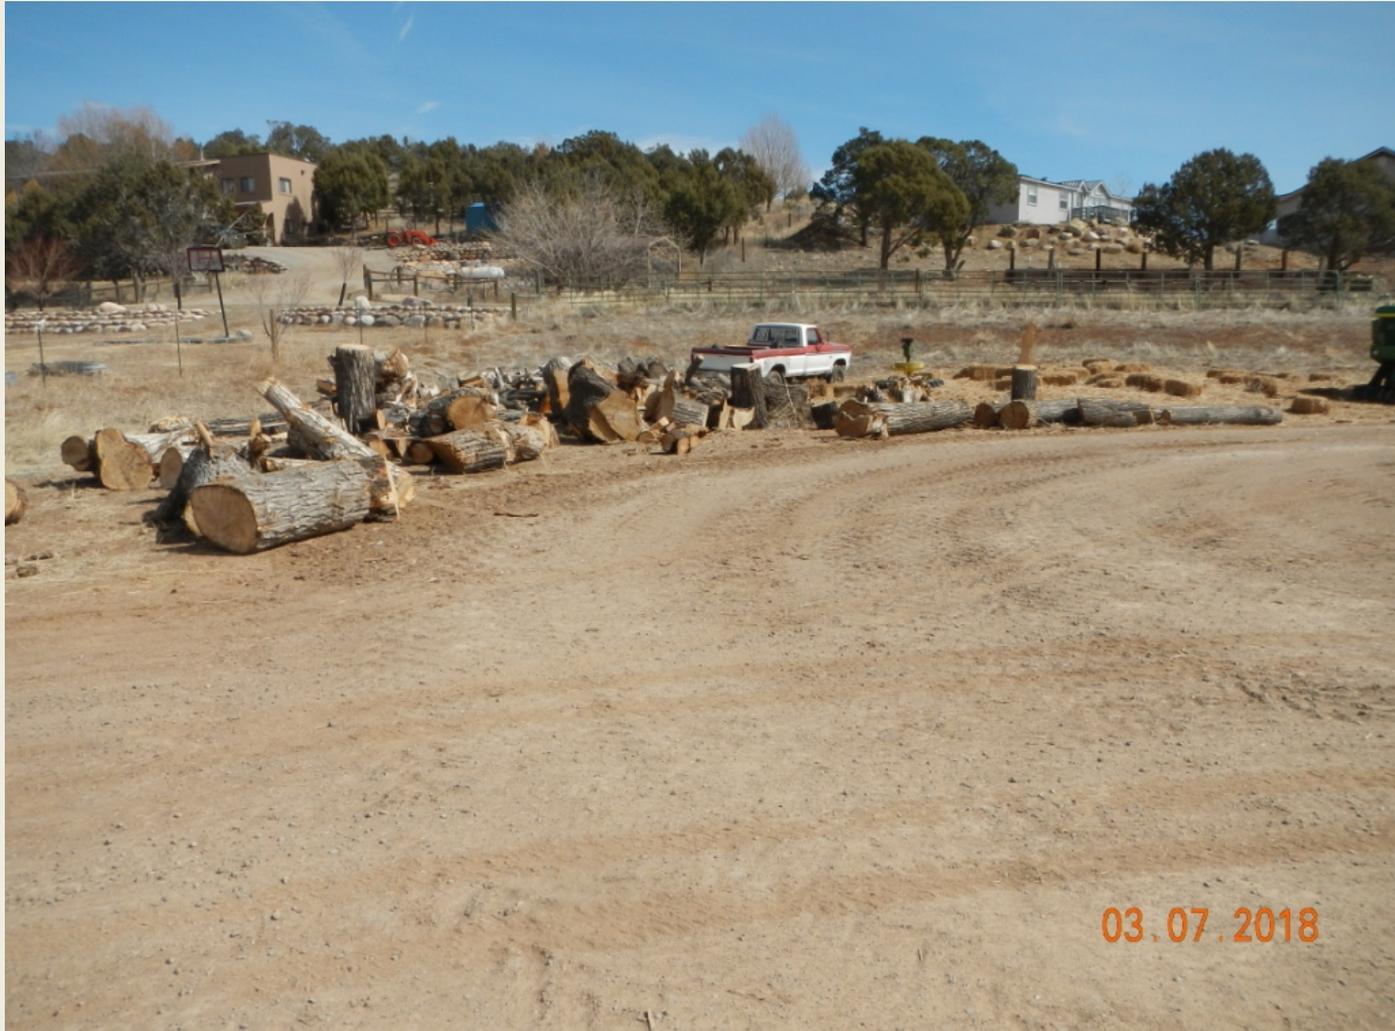
**Photo 3. View of the northern portion of the project area from the northwestern corner facing eastward.**

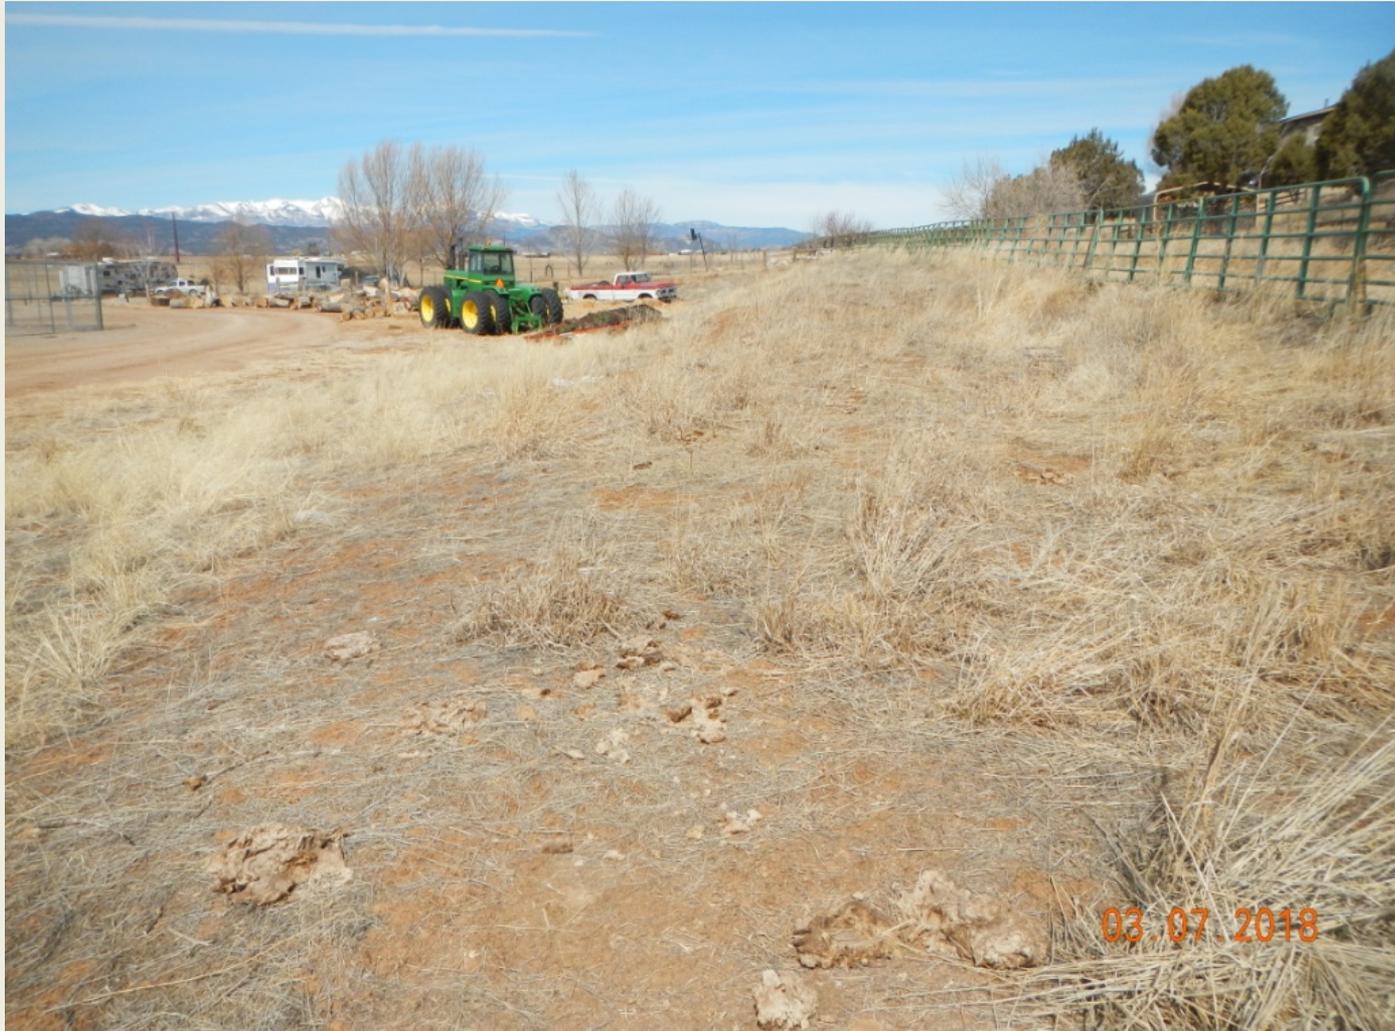
**Photo 4. View of the eastern portion of the project area from the southeastern edge facing northward.**

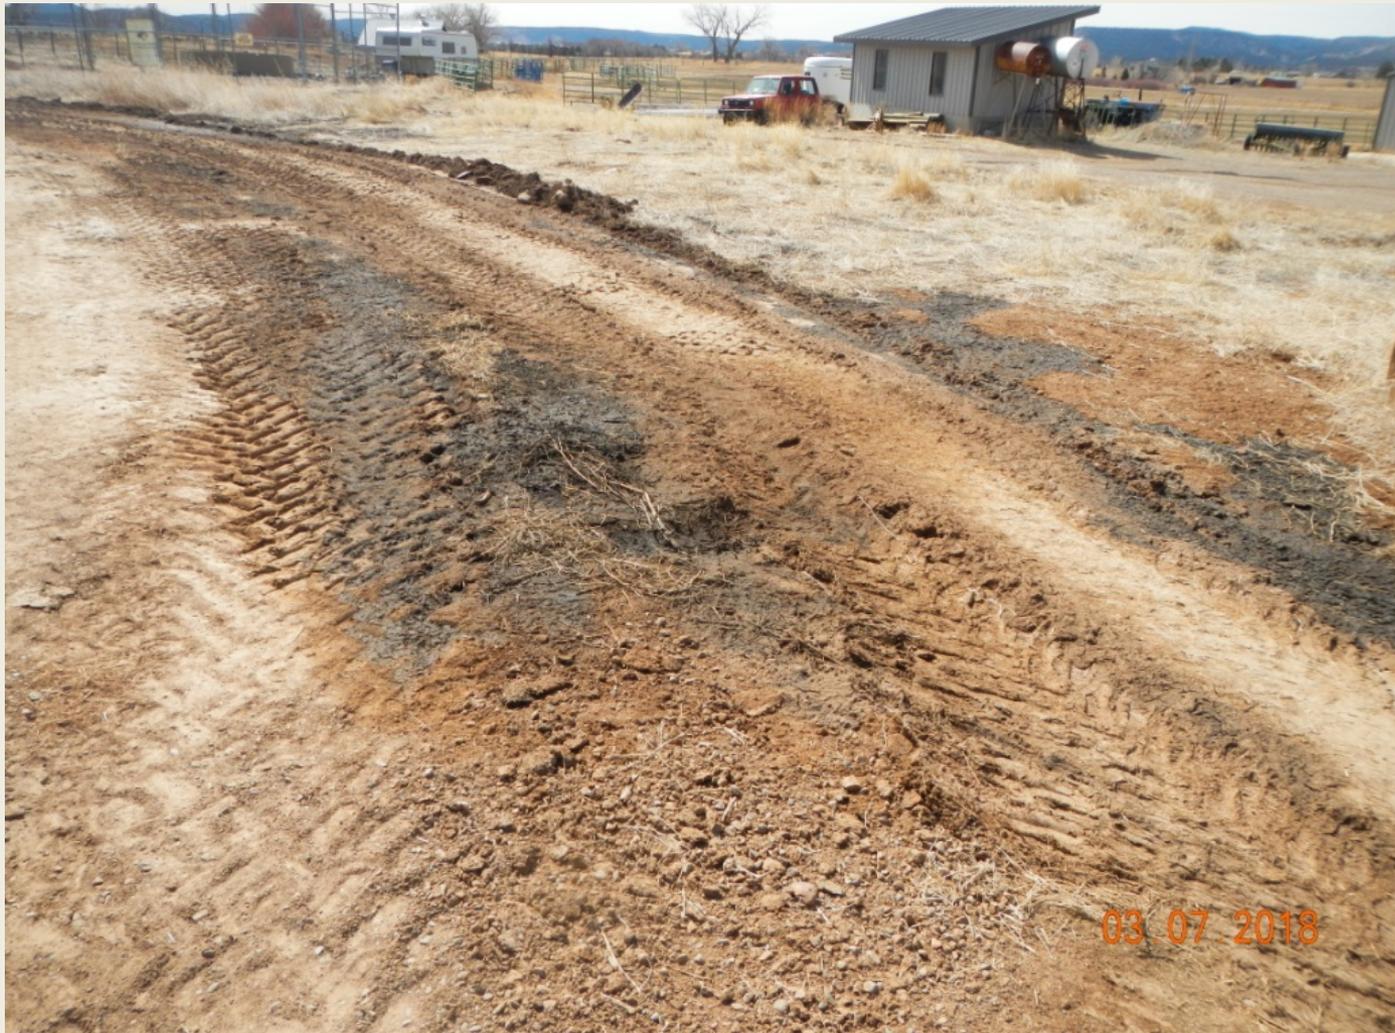
**Photo 5. View of unknown black material within the western portion of the project area, covers an area that is approximately 50 feet long and 15 feet wide, and seeping westward off of the project area.**

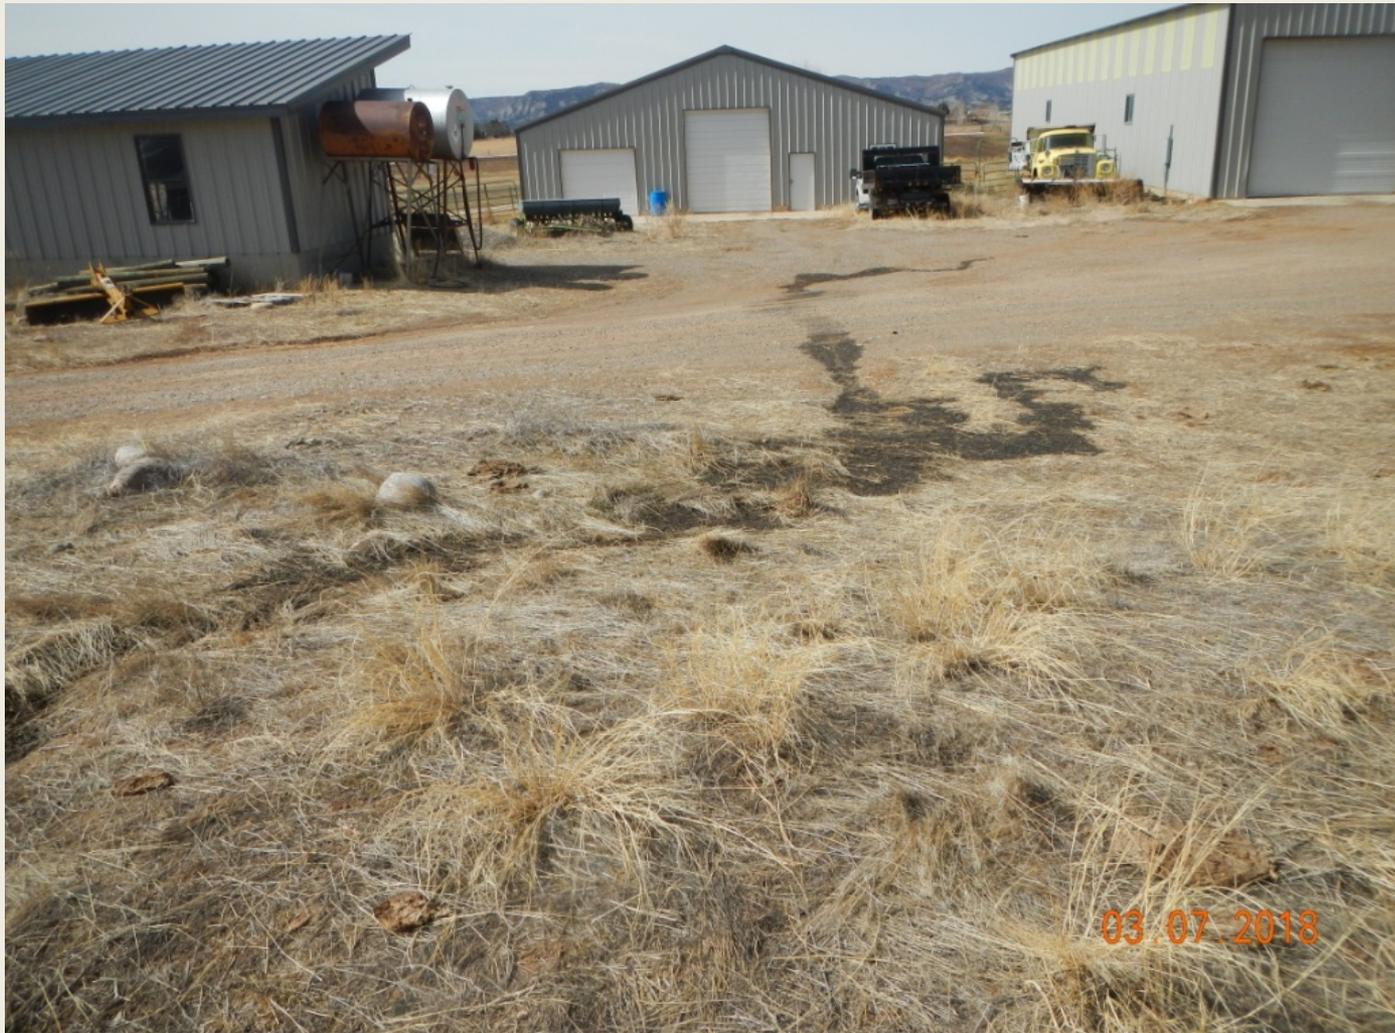
**Photo 6. View of unknown black material seeping off of the western portion of the project area.**

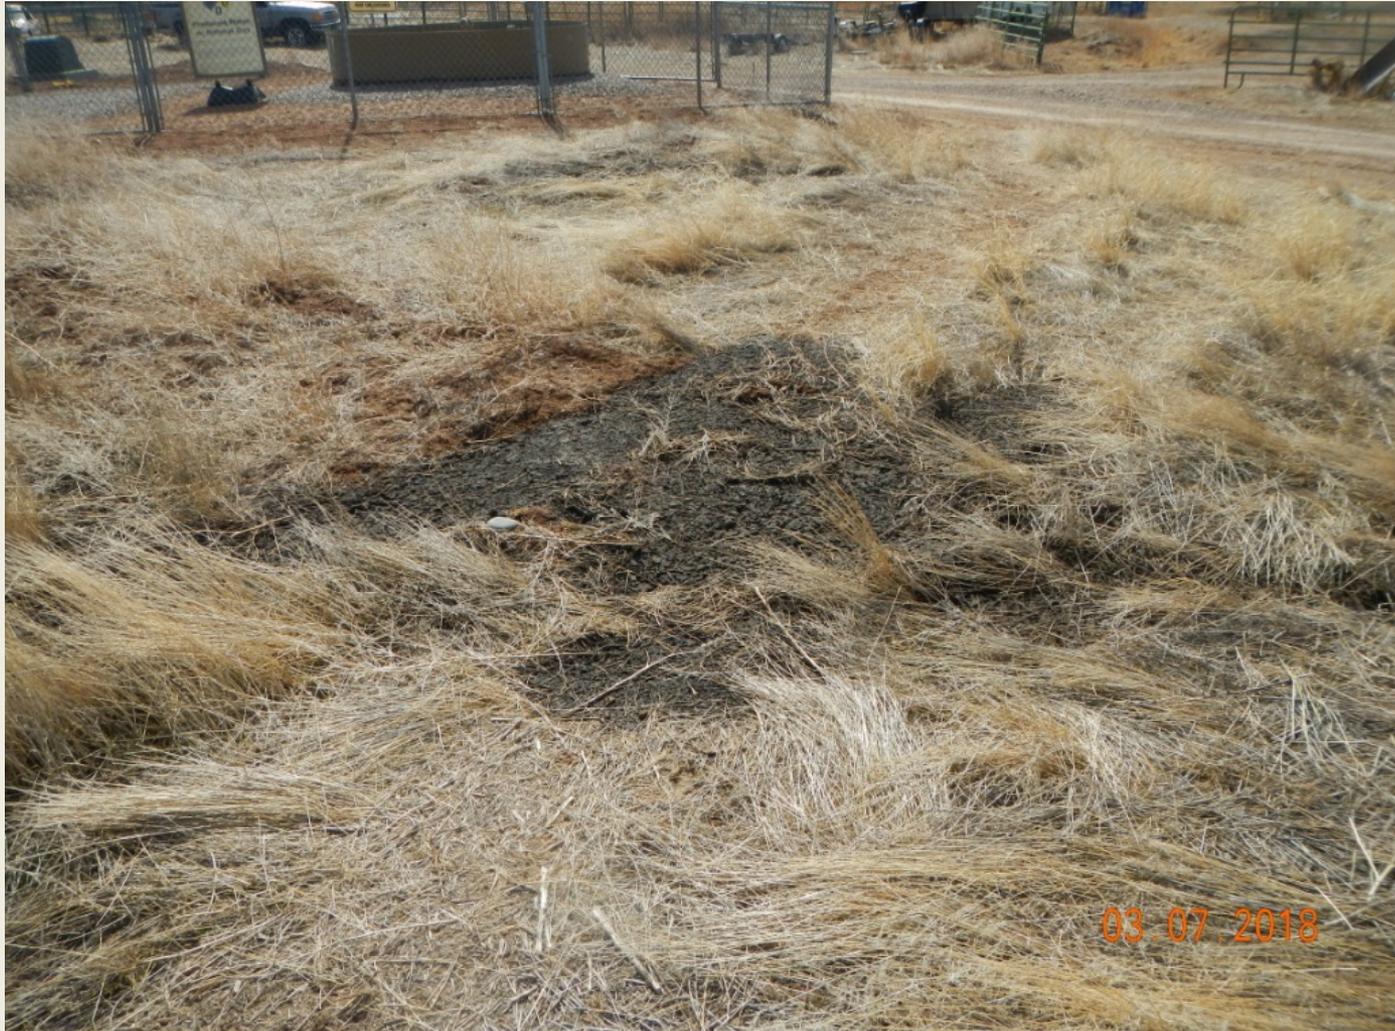
**Photo 7. View of unknown black material release within the western interim reclamation area.**

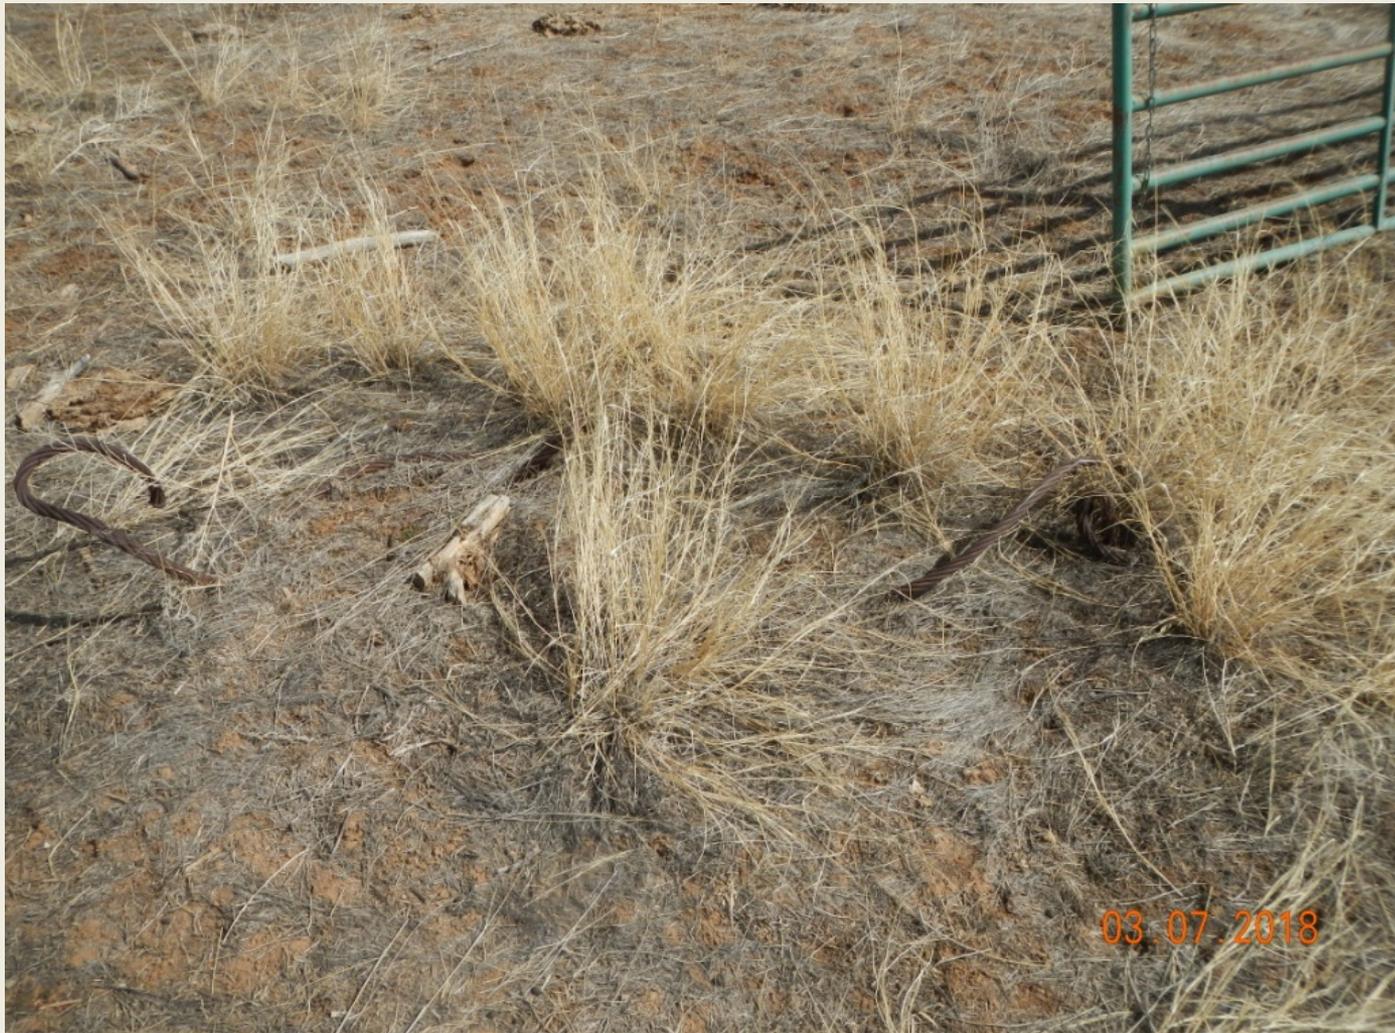
**Photo 8. View of rig cable in the southeastern interim reclamation area. Needs to be removed along with other debris such as plastic and wire.**

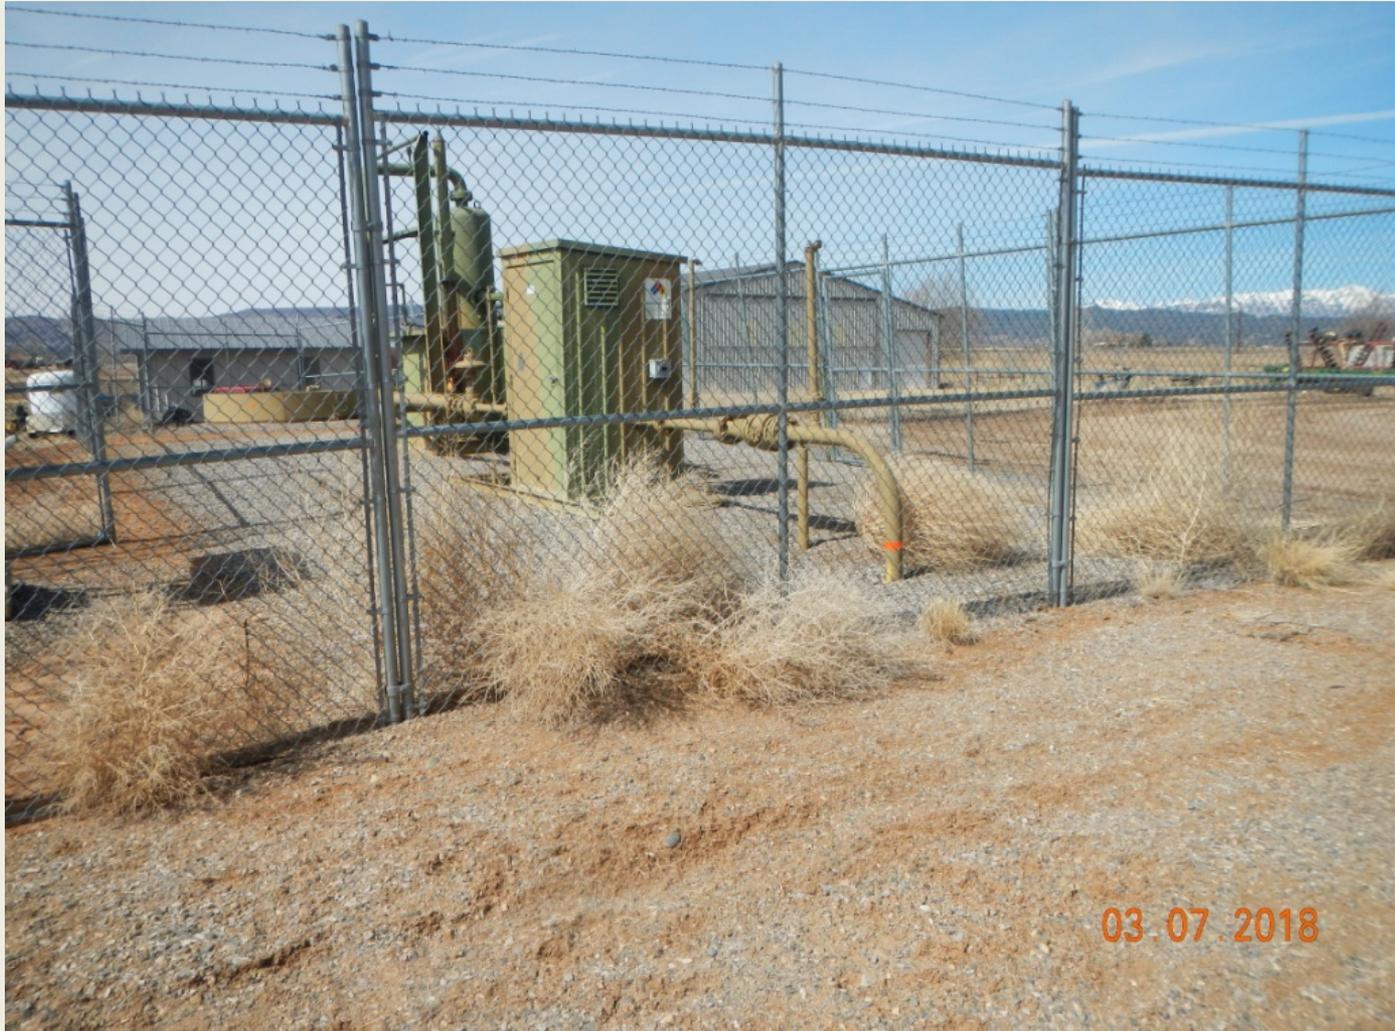
**Photo 9. View of kochia debris within the production area, that needs to be removed.**
