# Inspection Photos

Operator: WINSLOW RESOURCES INC - 97065

Location ID: 390108

Inspection Doc. Number: 682503195

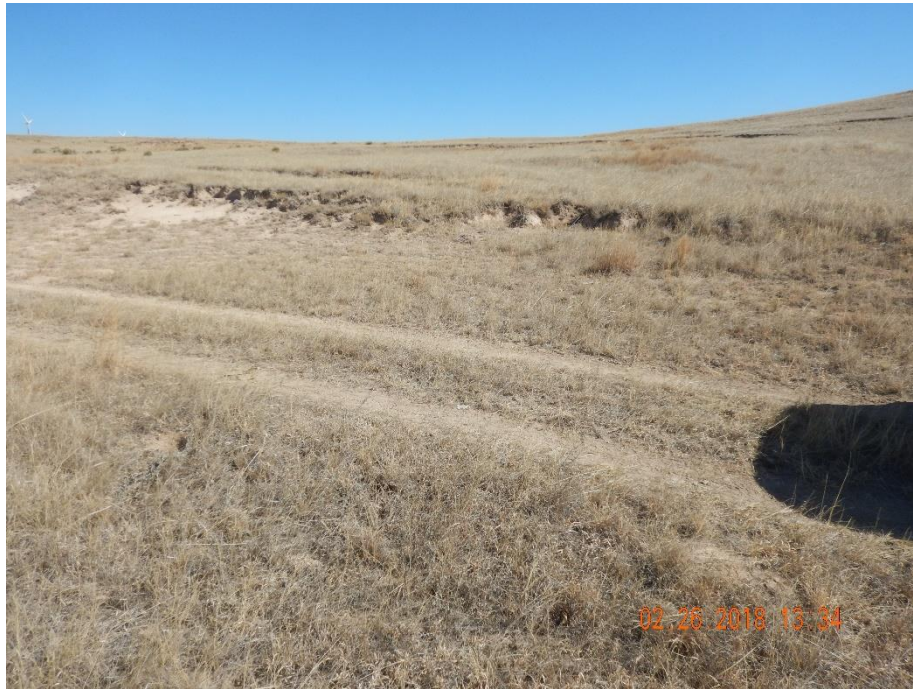
**Photo 1:** Photo taken from the south end of the location, facing northeast. Photo shows erosion and contouring concerns remain evident on the east and northeast ends of the location.

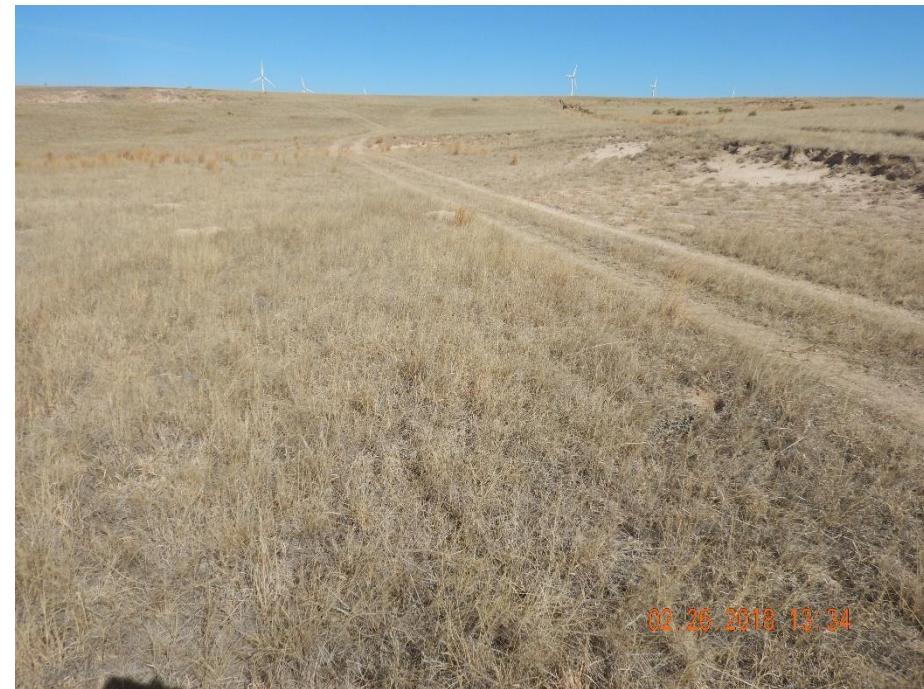
**Photo 2:** Photo taken from the south end of the location, facing northeast. Photo shows erosion and contouring concerns remain evident on the east and northeast ends of the location. Two-track road seen in photo is not the historic access road and appears to have been created relatively recently based on historic imagery.

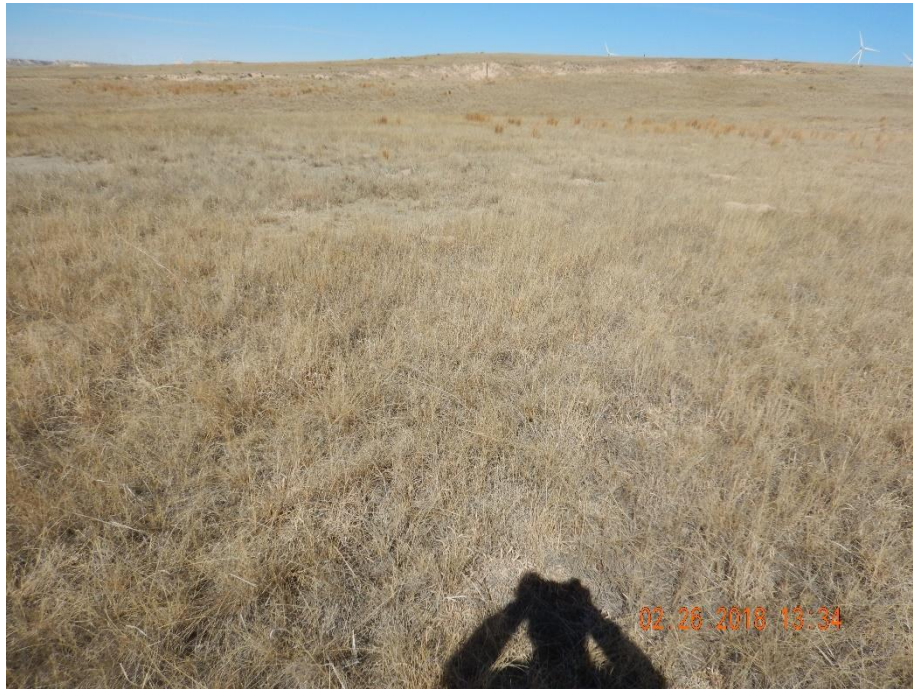
**Photo 3:** Photo taken from the south end of the location, facing northwest. The western half of the location appears to have been adequately revegetated and reclaimed.

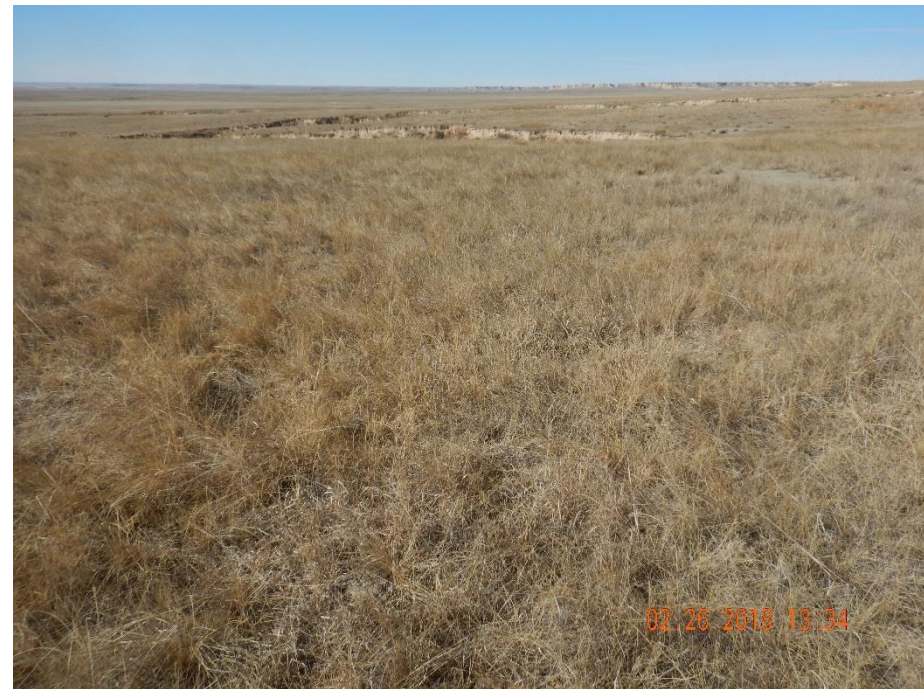
**Photo 4:** Photo taken from the south end of the location, facing west. The western half of the location appears to have been adequately revegetated and reclaimed.

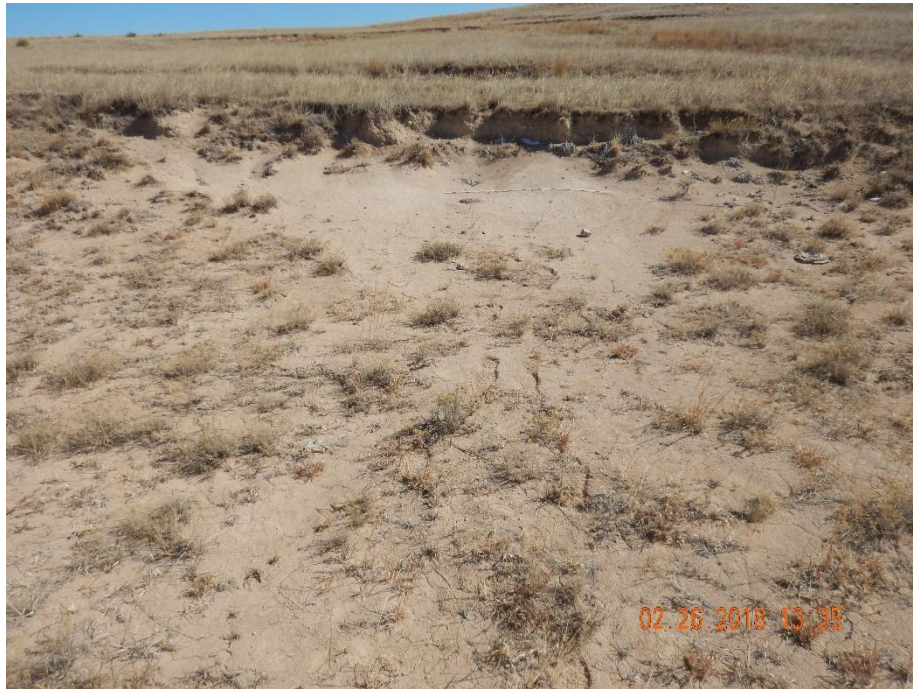
**Photo 5:** Photo taken from the east end of the location, facing east. Photo shows areas of the location where desirable perennial vegetation has failed to establish and stormwater erosion is causing degradation. These concerns appear to have been documented in previous inspections.

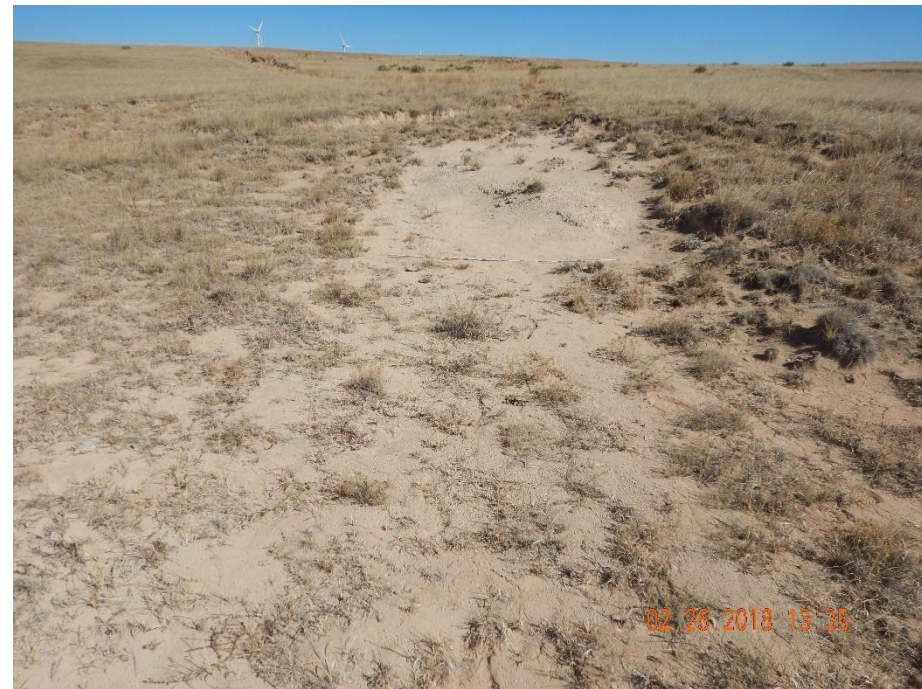
**Photo 6:** Photo taken from the east end of the location, facing northeast. Photo shows areas of the location where desirable perennial vegetation has failed to establish and stormwater erosion is causing degradation. These concerns appear to have been documented in previous inspections.

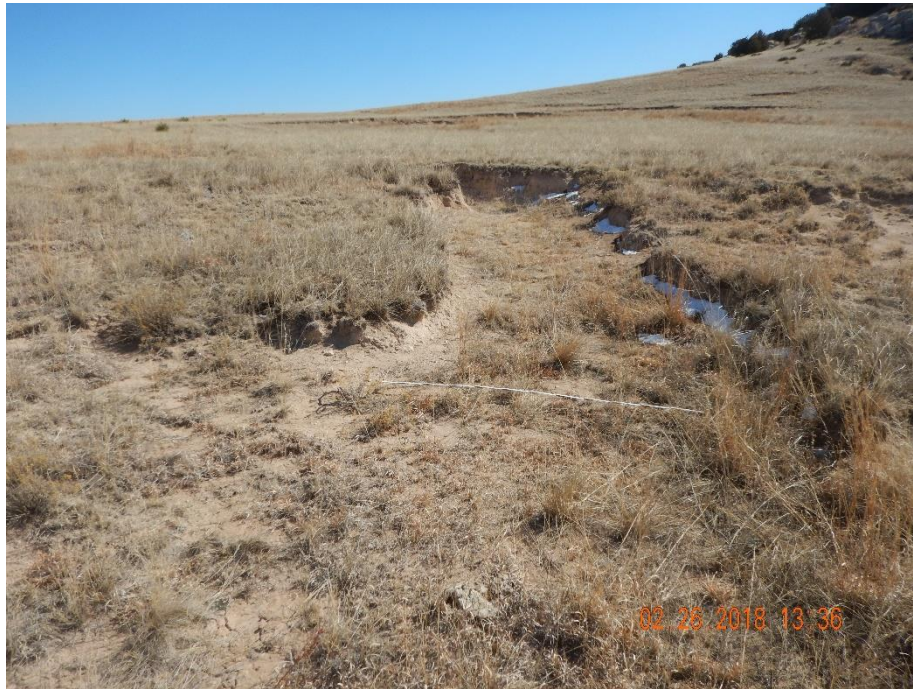
**Photo 7:** Photo taken from the northeast end of the location, facing east. Photo shows areas where stormwater runoff from the access road has eroded a large gully onto the location. 6 foot measuring stick for reference.

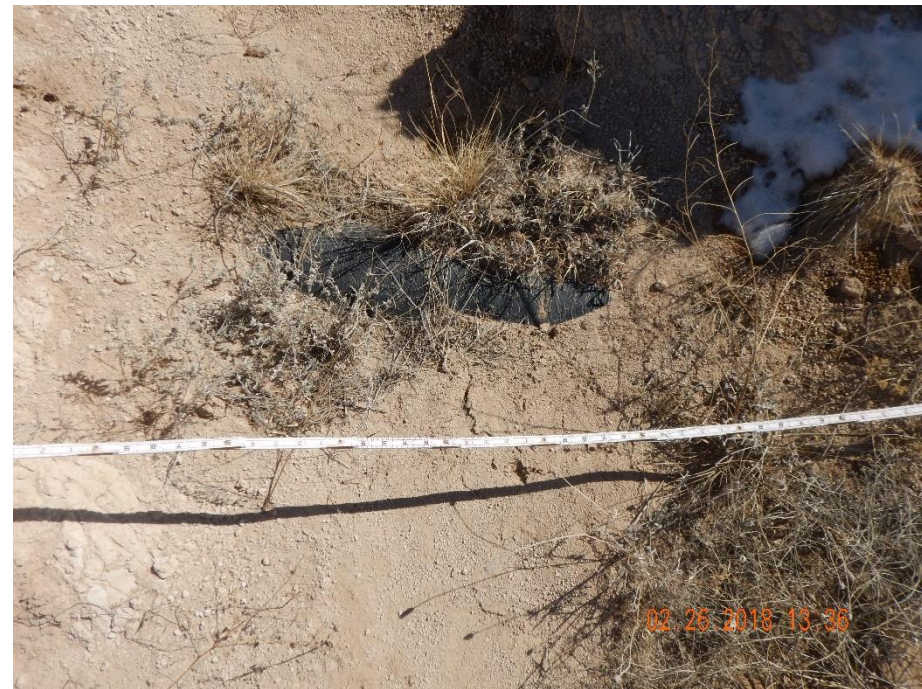
**Photo 8:** Photo taken from the erosion degradation observed on the northeast end of the location. Photo shows area of exposed pipeline likely revealed due to stormwater erosion

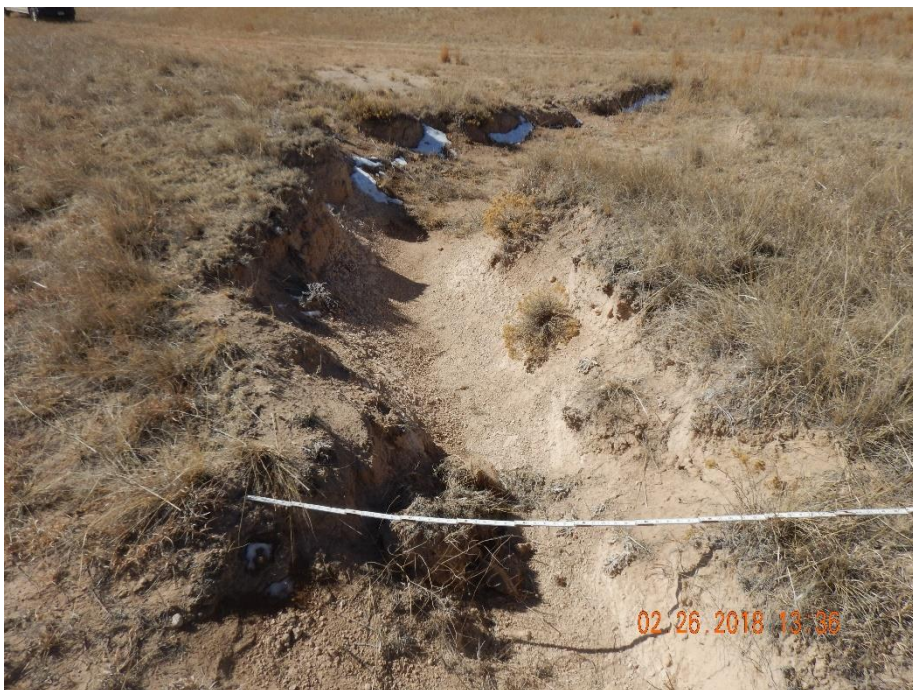
**Photo 9:** Photo taken from the northeast end of the location, facing west. Photo shows areas where stormwater runoff from the access road has eroded a large gully (see in photo 7) onto the location. 6 foot measuring stick for reference.

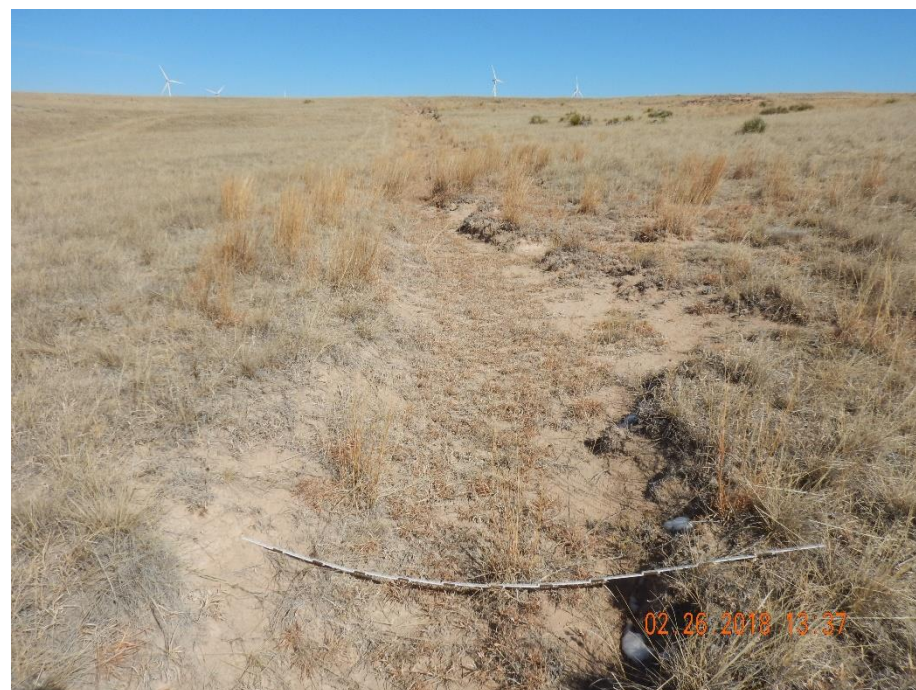
**Photo 10:** Photo taken from the access road on the northeast end of the location, facing north. Photo shows access road does not appear to have been adequately contoured and stabilized. Access road has acted as a channel for stormwater, allowing flows to concentrate and cause stormwater erosion degradation and incising to occur on both the access road and location. These concerns have been documented in previous inspections.

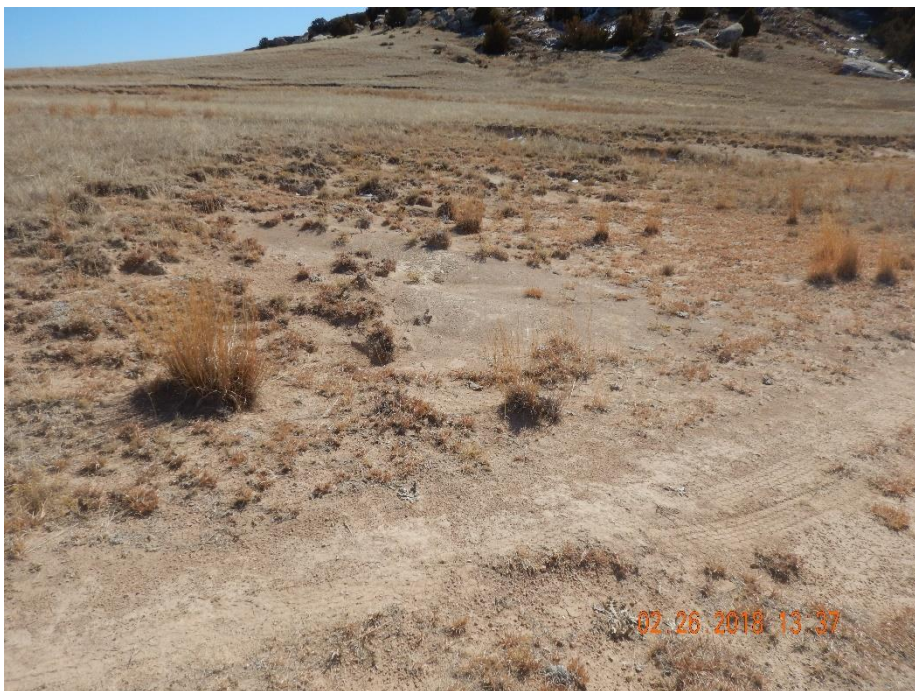
**Photo 11:** Photo taken from the northeast end of the location, facing south. Photo shows areas of the location where desirable perennial vegetation has failed to establish and stormwater erosion is causing degradation. These concerns appear to have been documented in previous inspections.

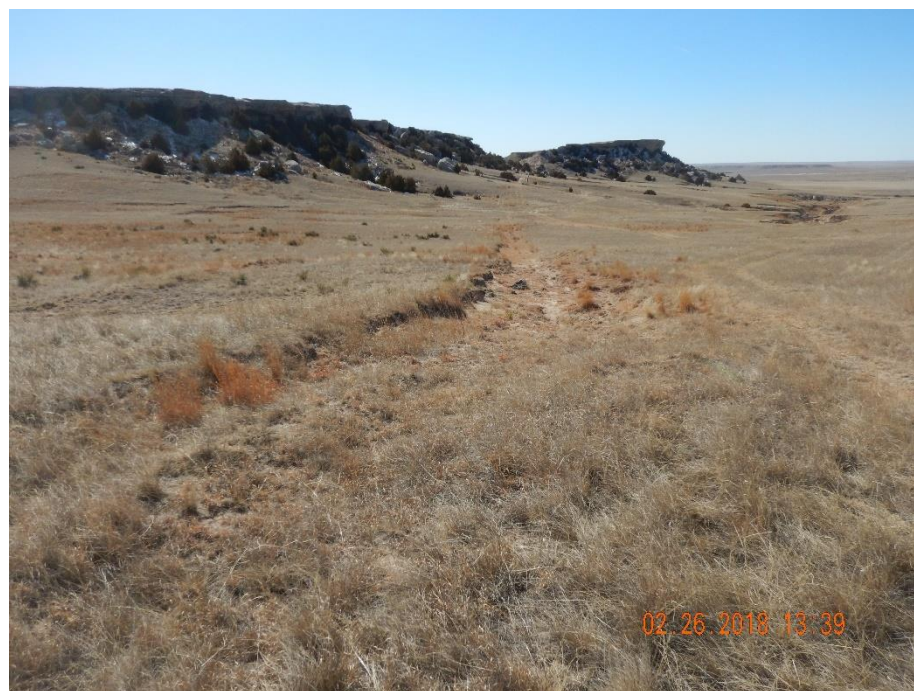
**Photo 12:** Photo taken from the access road, north of the location, facing south. Photo shows access road does not appear to have been adequately contoured and stabilized. Access road has acted as a channel for stormwater, allowing flows to concentrate and cause stormwater erosion degradation and incising to occur on both the access road and location.

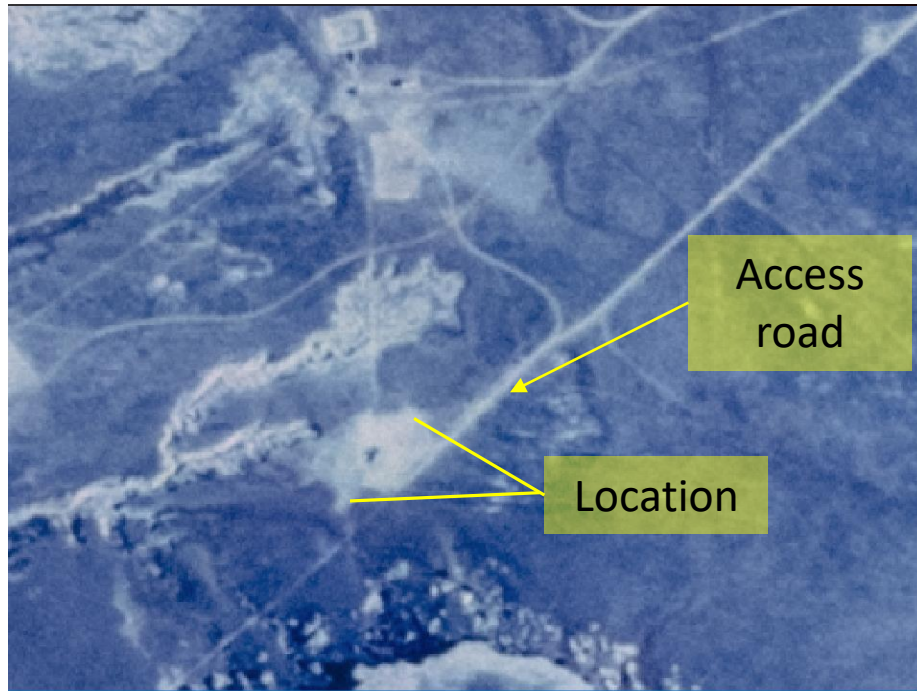
**Photo 13:** 1985 Aerial imagery. Well was PA in 1987. Photo shows the active location and access road

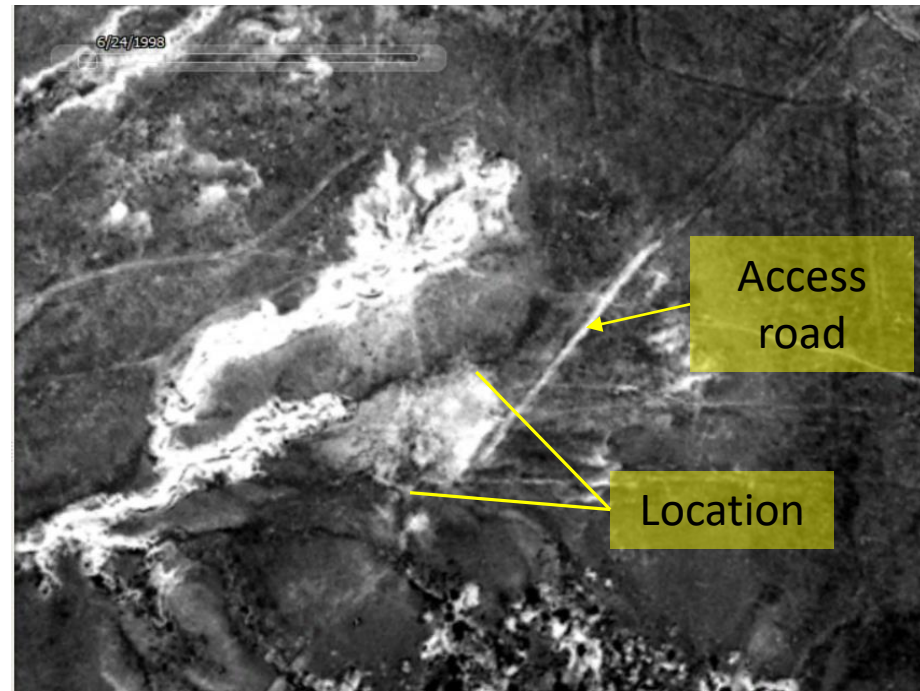
**Photo 14:** 1998 aerial imagery. PA in 1987. Photo shows location and access road remains evident 11 post plugging and abandonment.

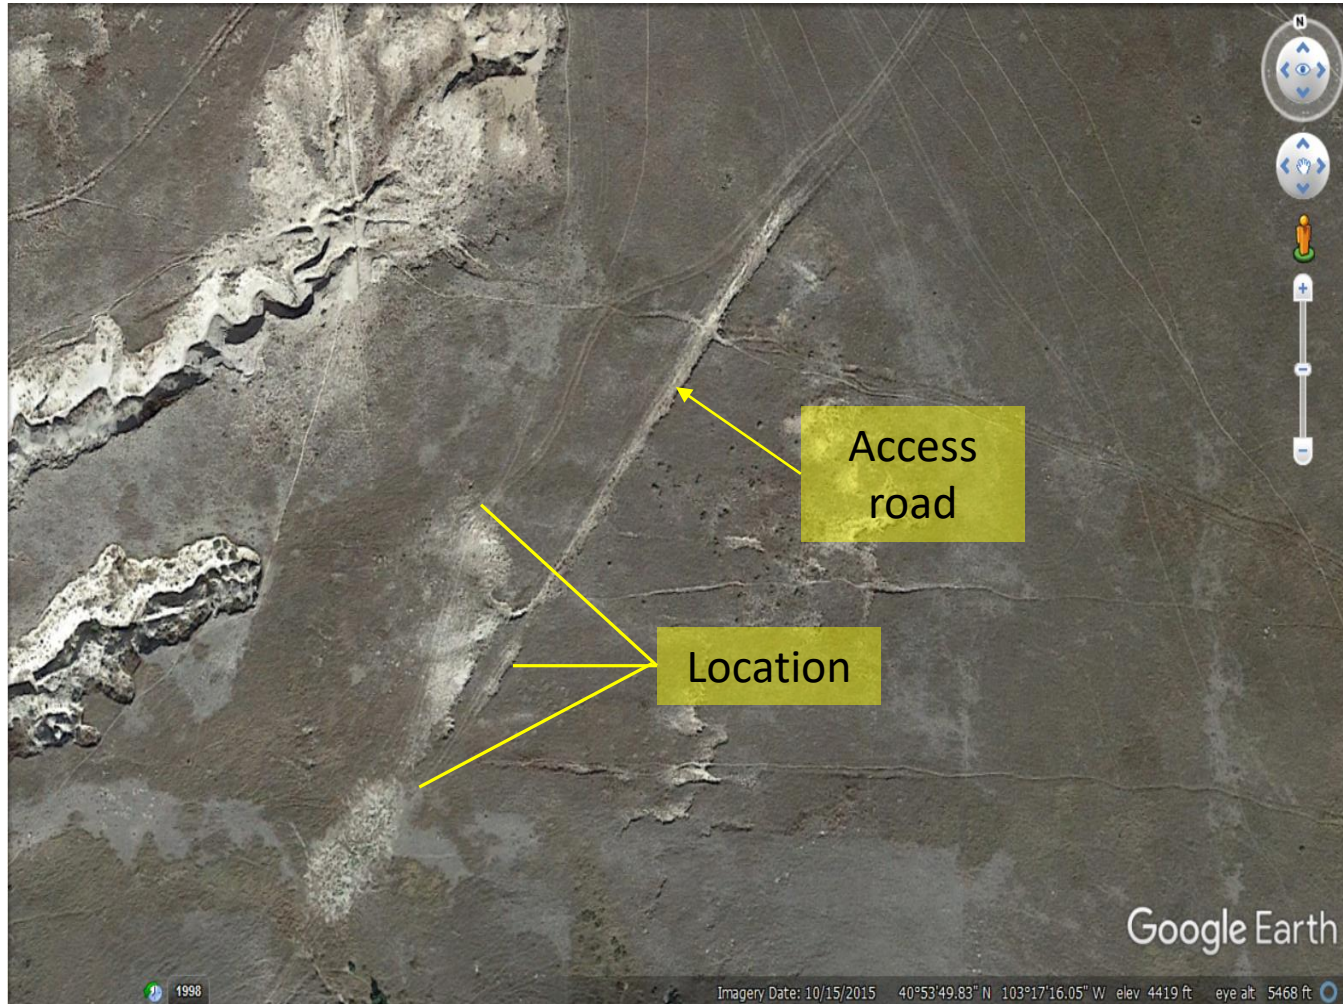
**Photo 15:** Current available aerial imager (2015). Photo shows access road and well location.
