# Inspection Photos

API: 05-007-06206

Operator: SOUTHLAND ROYALTY COMPANY

Inspection Date: 2/28/2018

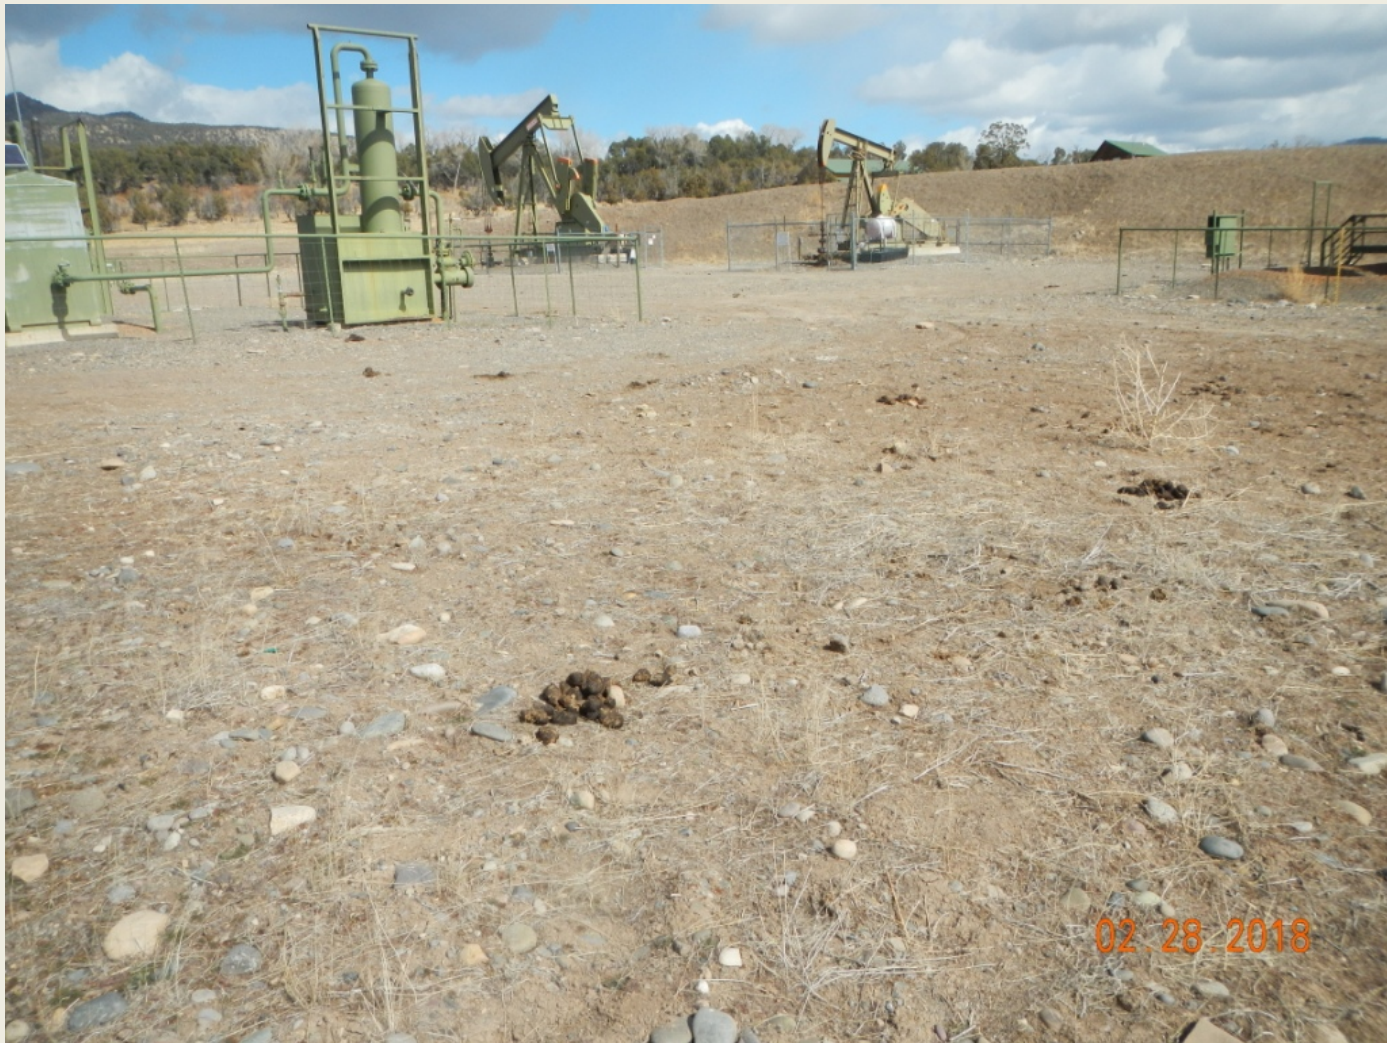
**Photo 1. View of the project area from the southwestern corner facing center.**

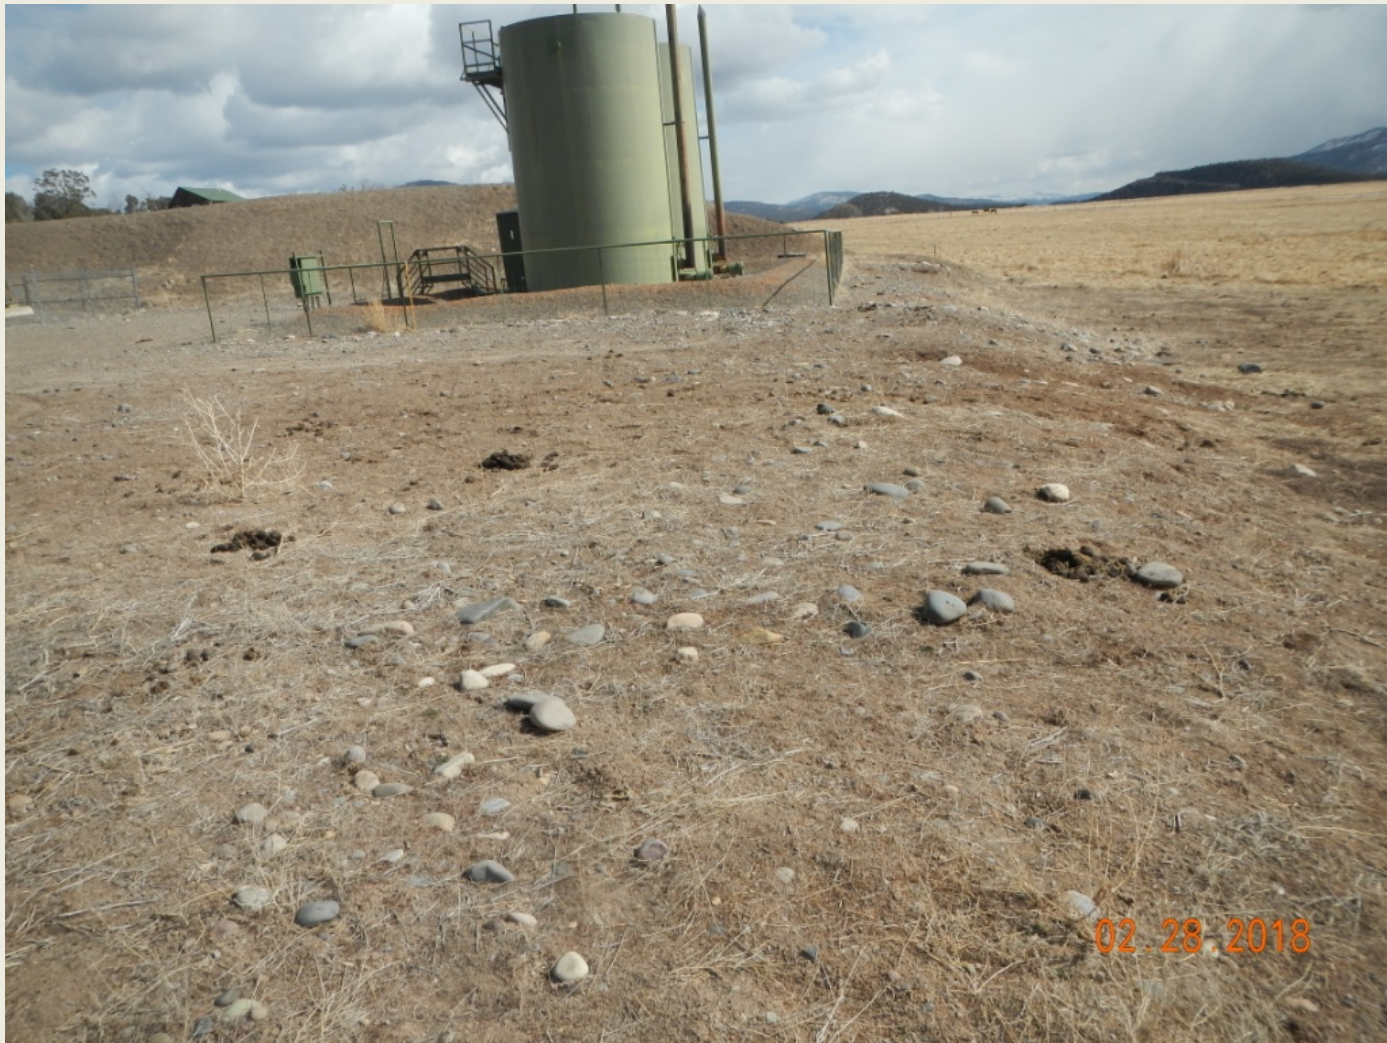
**Photo 2. View of the southern portion of the production area from the southwestern corner facing eastward. Revegetation grazed and largely not in identifiable condition.**

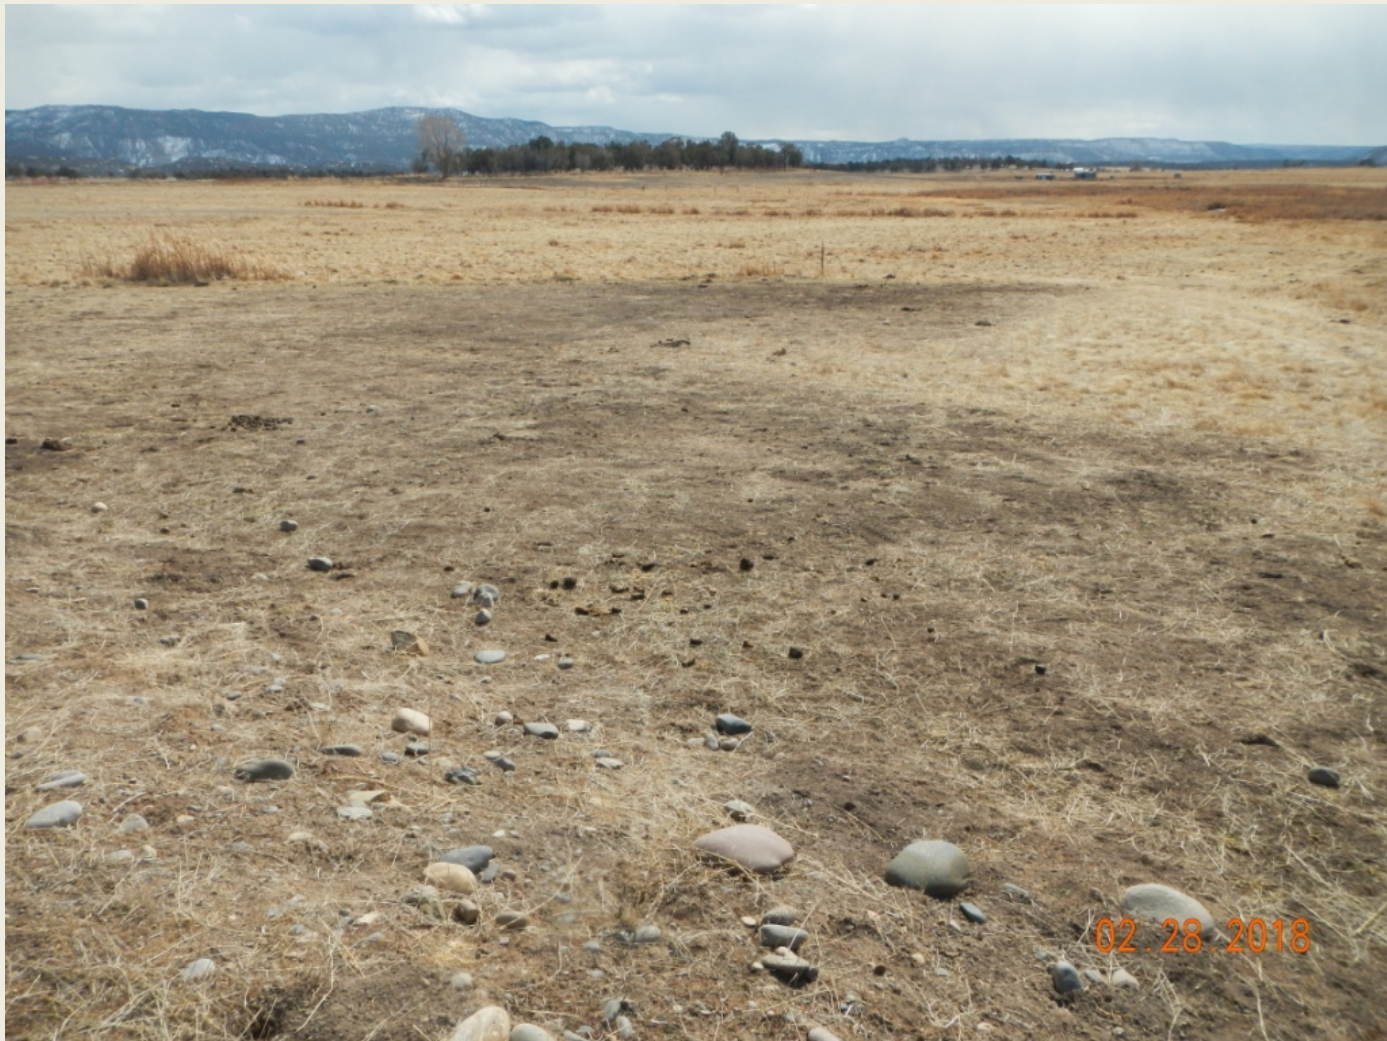
**Photo 3. View of the southern portion of the project area from the southeastern edge of the production area facing southward. Poor revegetation observed here.**

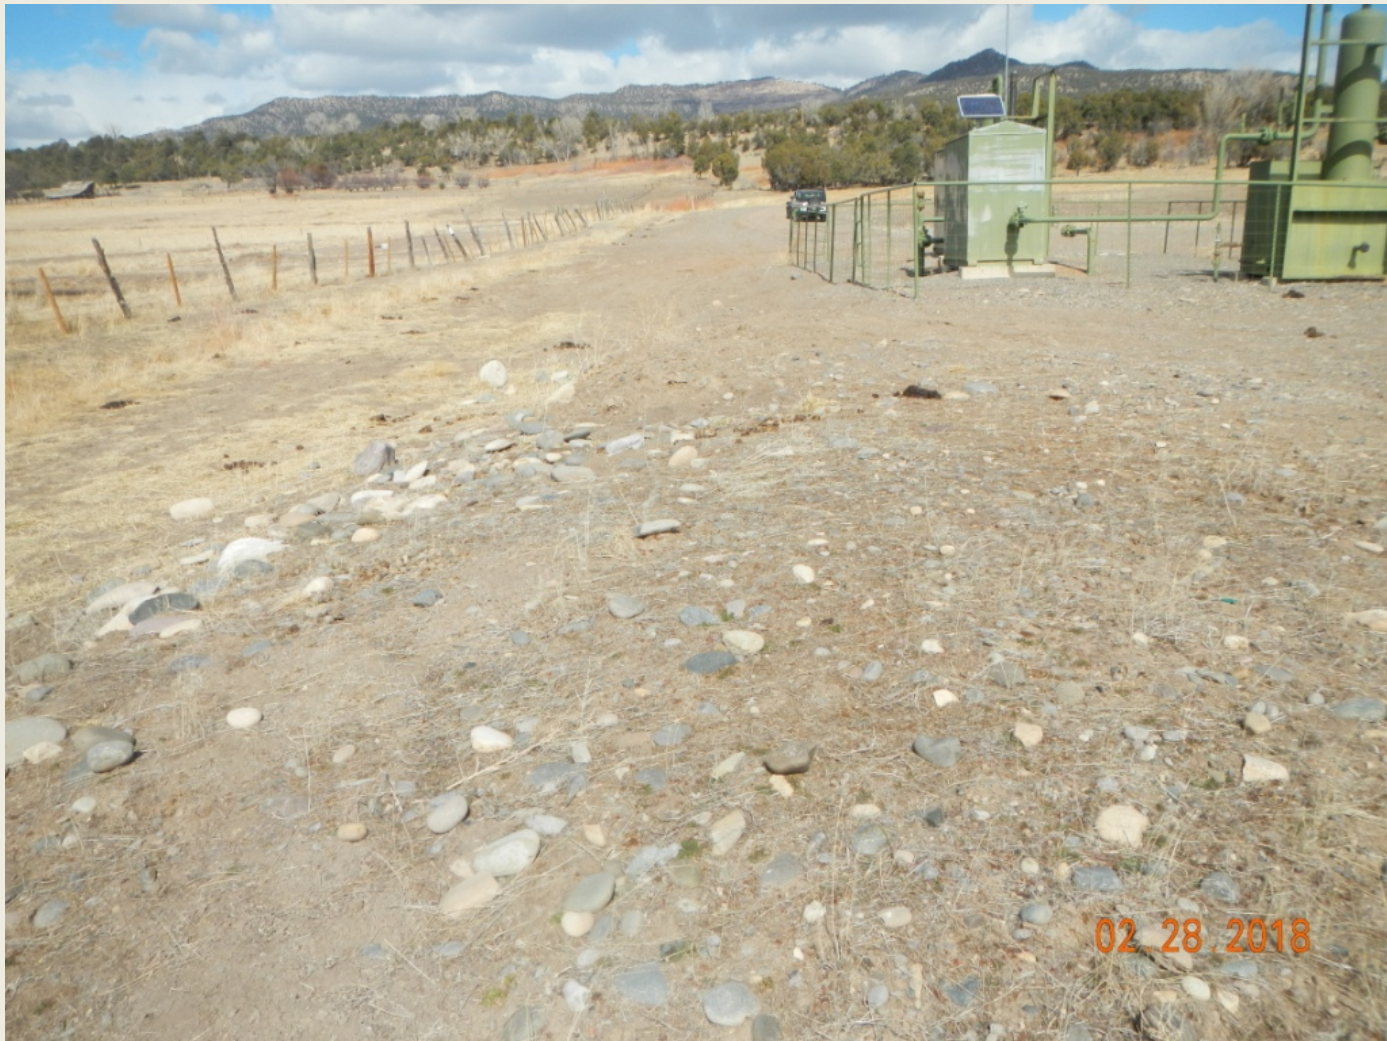
**Photo 4. View of the western portion of the project area from the southwestern corner facing northward.**

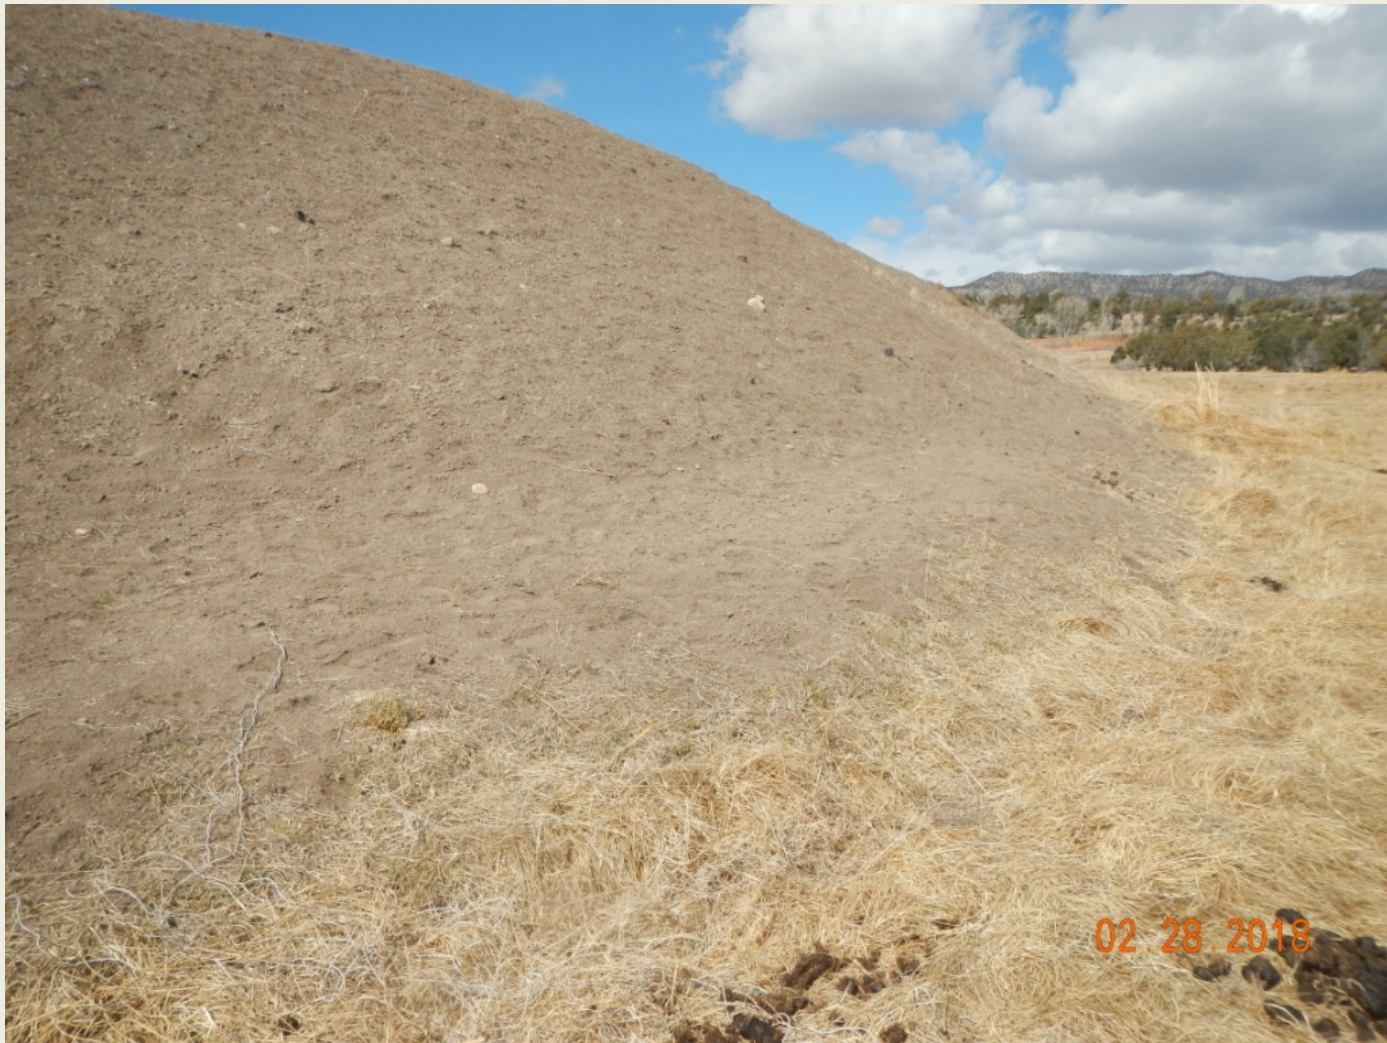
**Photo 5. View of the eastern edge of the project area from the southeastern corner facing northward. Poor revegetation on soil berm. Needs to be stabilized with vegetation.**
