Final Reclamation Inspection

March 7, 2018

Operator: CRESTONE PEAK RESOURCES OPERATING LLC- #10633

Location Name: ERIE CHAMPLIN B UNIT #2

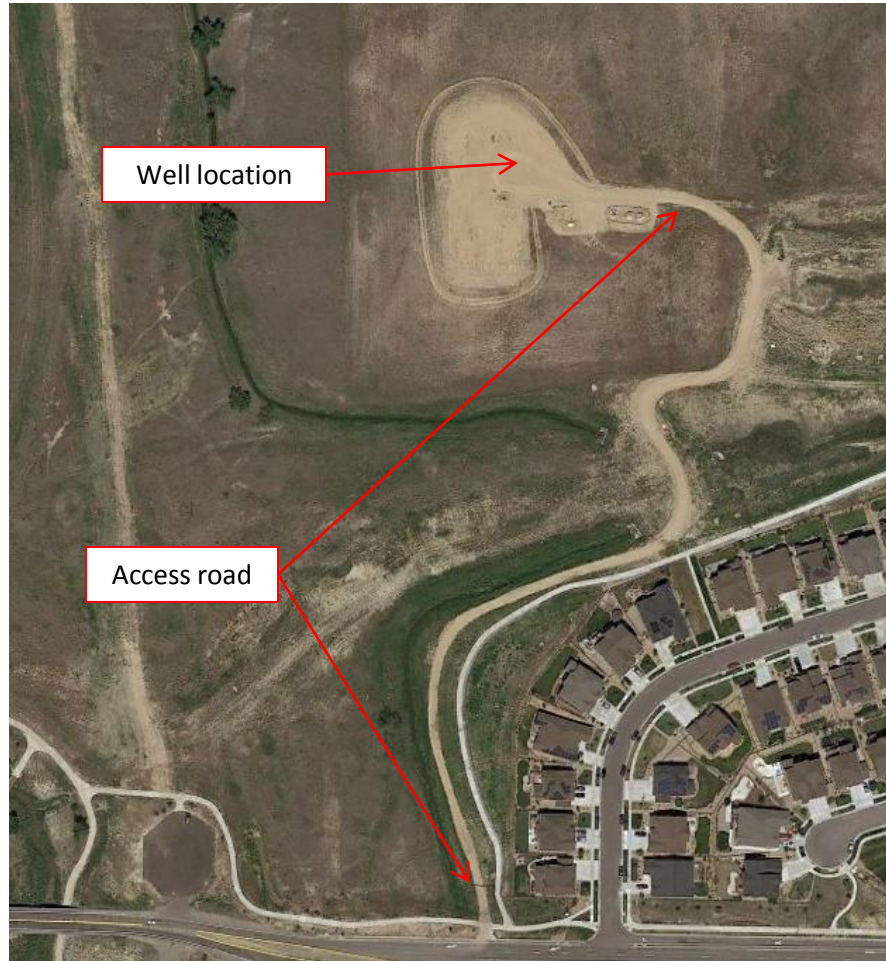
Google Earth aerial imagery taken June 9, 2017, during active operations, illustrates the well location and access road used from the Erie Champlin B Unit #2. No visual evidence of equipment on location during this inspection on March 7, 2018.

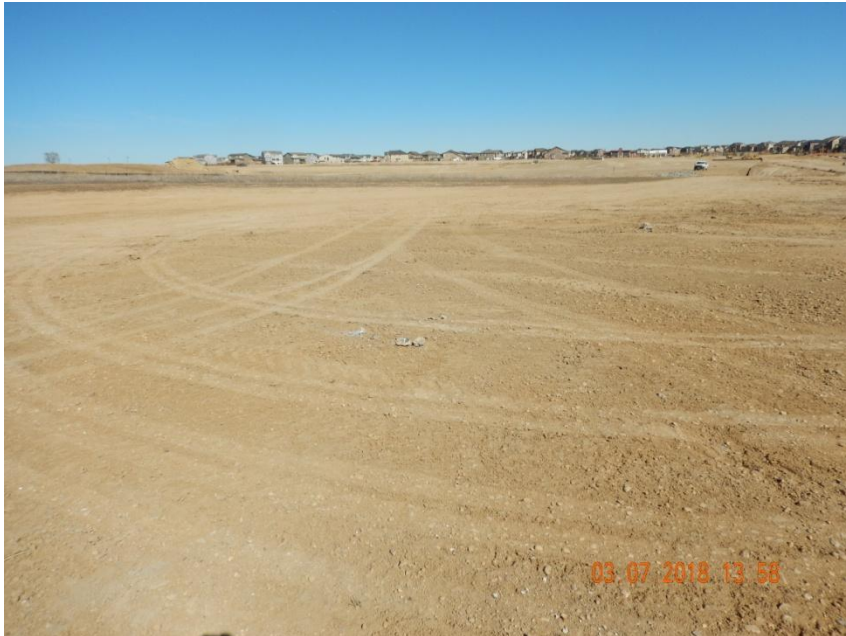
Photo 1. Photo taken from the facility/well location, facing East. No visual evidence of equipment on location. Well was plugged 02/2018.

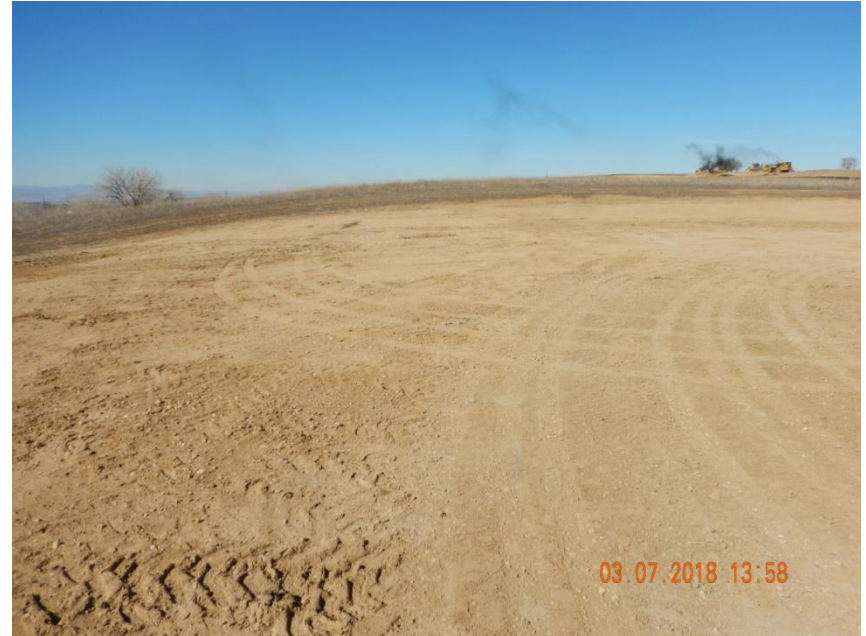
Photo 2. Photo taken from the facility/well location, facing North. See comments under Photo 1.

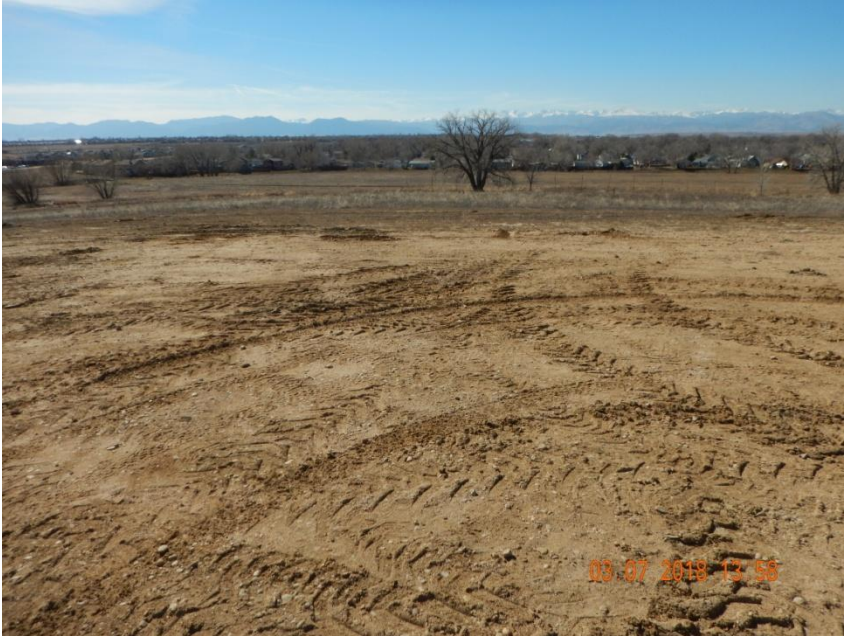
Photo 3. Photo taken from the facility/well location, facing West. See comments under Photo 1.

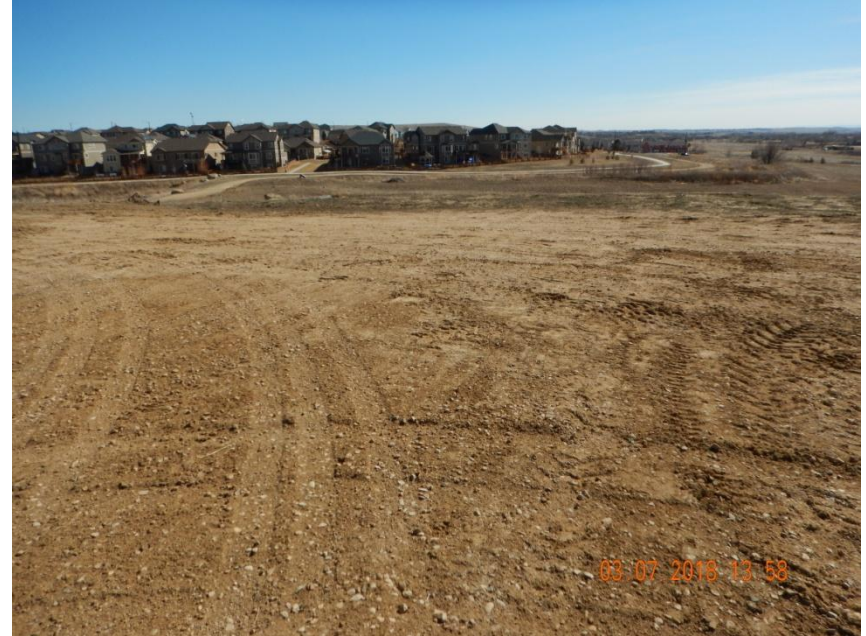
Photo 4. Photo taken from the facility/well location, facing South. See comments under Photo 1.

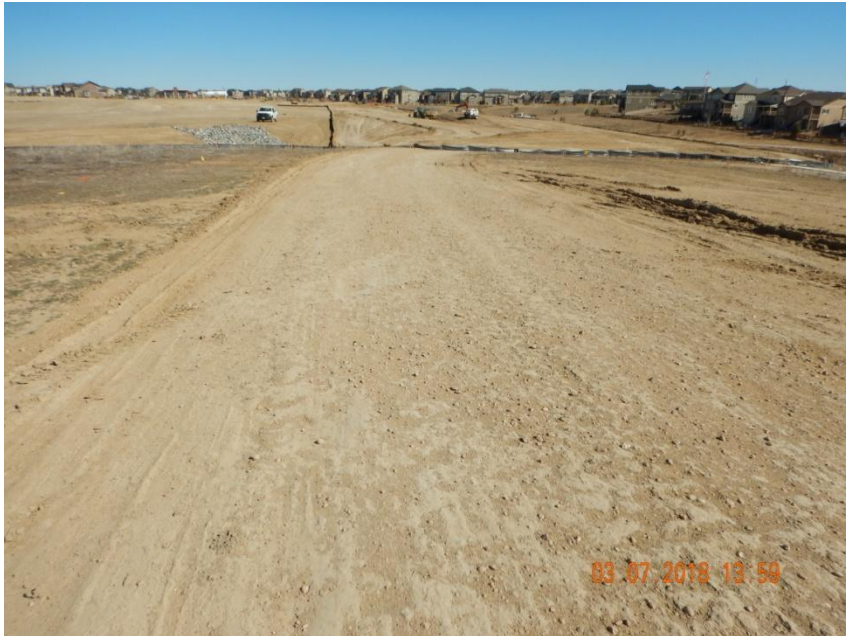
Photo 5. Photo taken from the facility/well location, facing East. Photo illustrates the access road used for the location.

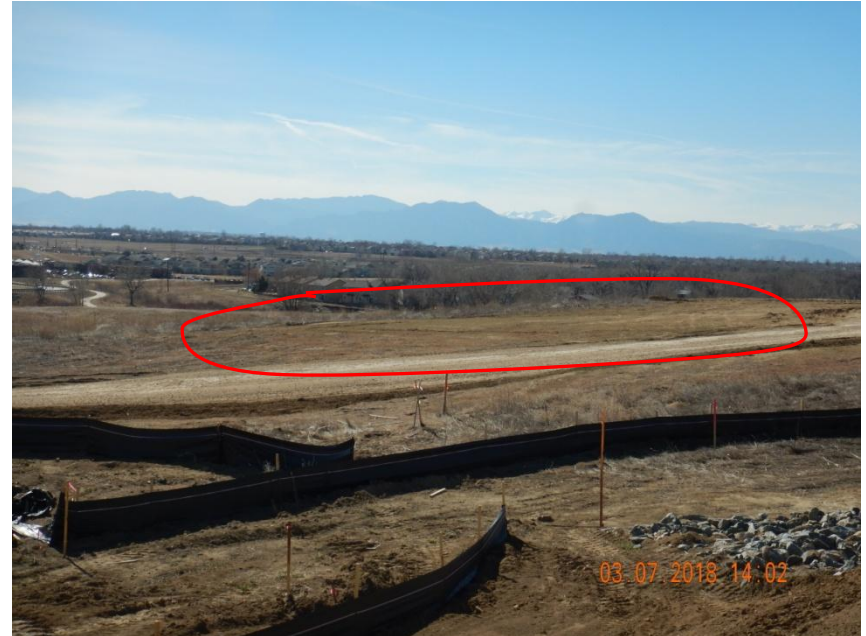
Photo 6. Photo taken east of the location, facing West. Photo illustrates equipment has been removed from the southeast location.
